Photo Schedule

35 Queens Grove
London
NW8

September 2010

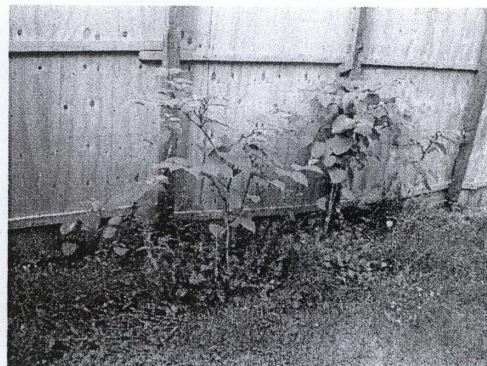
Photo 12 – Japanese Knotweed

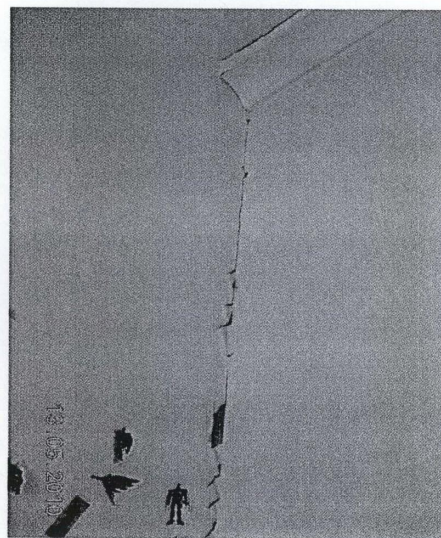
Photo 36 – Second Floor, bedroom,
vertical cracking in corner
