PHOTOGRAPHIC RECORD OF ARCHITECTURAL FEATURES AT 61 MARCHMONT STREET

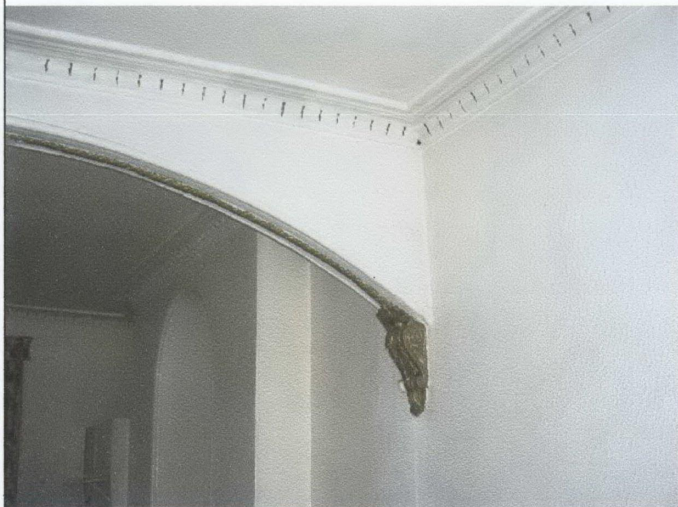
1	F/f Lounge arch to be retained. Investigate cleaning of coving
2	Stairs painted s/w to be cleaned and repainted.
3.	2/f kitchen no features
4.	F/f coving as 1 Moulding around windows to be cleaned and repainted
5.	Panel doors to be repainted investigate method of fireproofing
6.	3/f window. No coving. Moulding to be cleaned and repainted.
7.	4f flat kitchen. No features
8.	4f front door to be removed
9.	3/f bed woodwork to be cleaned and repainted
10.	4f no features
11.	3f lounge. Overhaul w/work
12.	As 10
13.	Ff lounge arch and full height window w/work to be overhauled
14.	Moulding around door to be overhauled and made good where necessary
15.	Ff Fireplace to be removed and opened
16.	Ff fireplace to be opened
17.	2f fireplace to be opened
18.	Entrance hall. Meters to e boxed in 1/2hr FR
19.	Rear view.
