| LONDON BOROUGH OF CAMDEN<br><br>HIGHGATE BRANCH LIBRARY<br><br><b>Dannatt, Johnson Architects</b><br>52c Borough High Street, London, SE1 1XN<br>Telephone (020) 7357 7100 Fax (020) 7357 7200 | ELEVATION DETAIL | | | Drawing Number<br>462-BD-01 | | Revision<br>- |

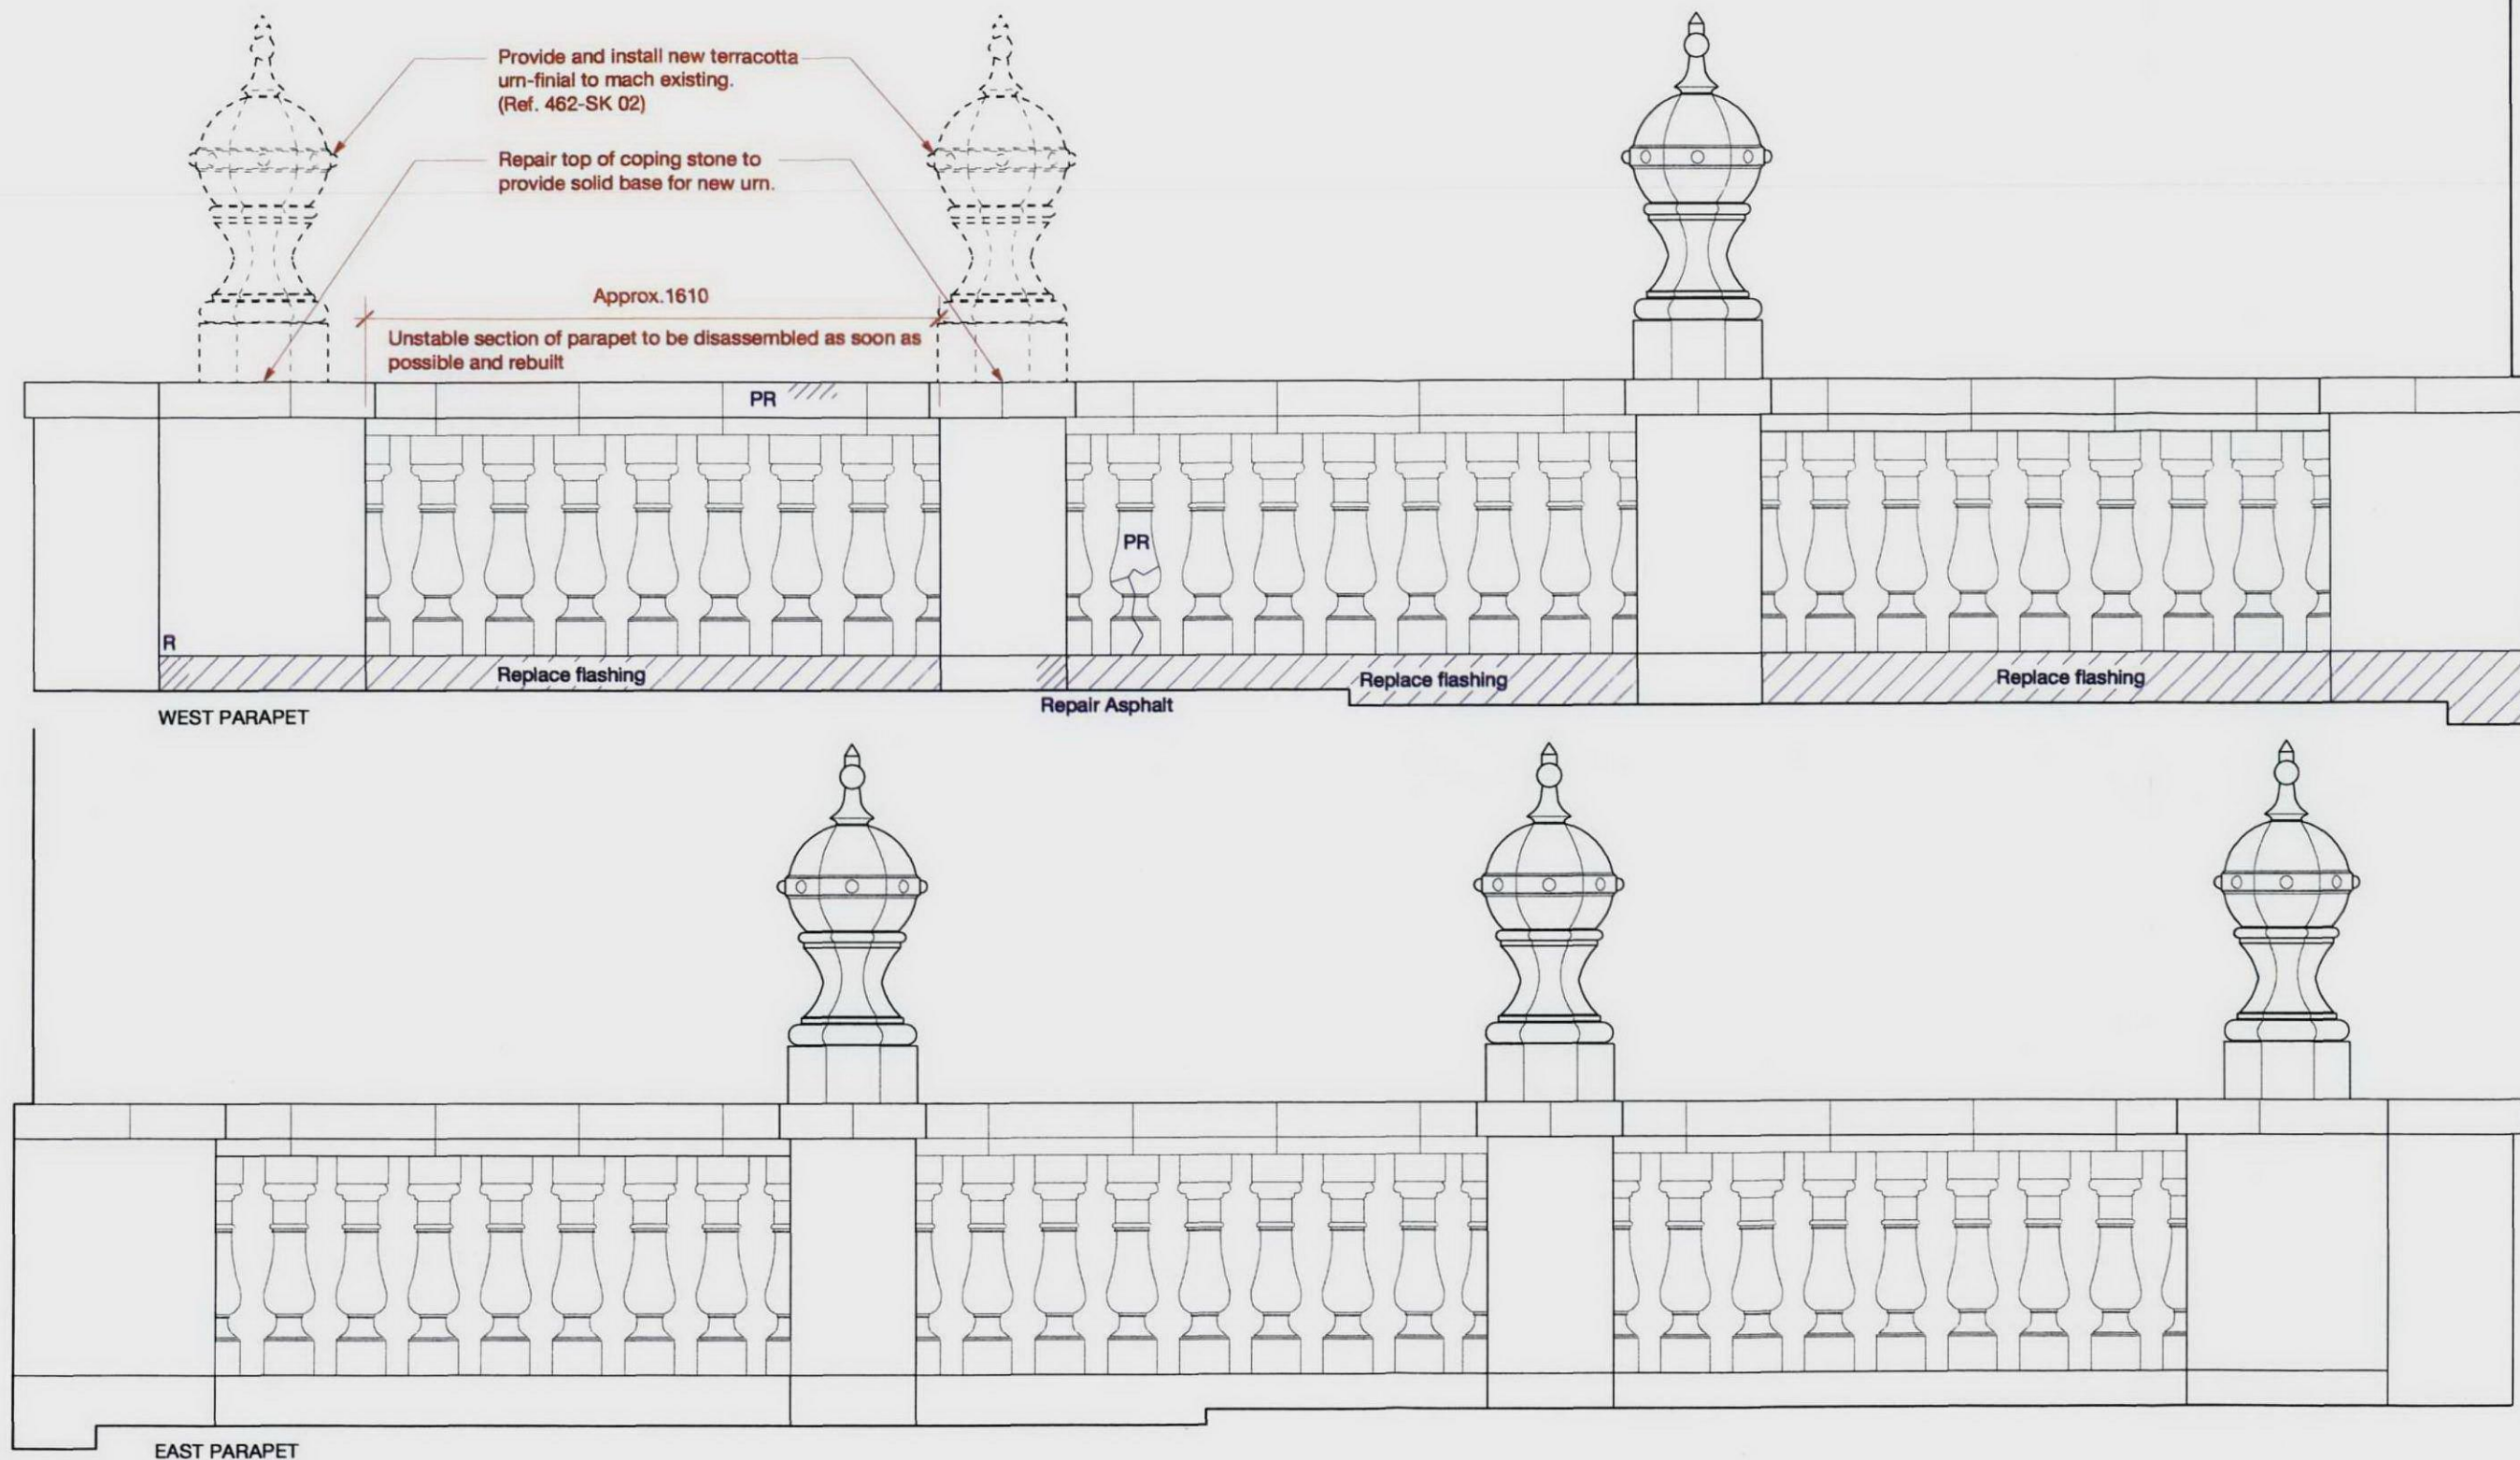
Structural engineer advice to be sought on parapets' strength and potential reinforcement requirement. During our inspection we noted that on the west elevation the top of the window arch (key stone and approx. 3-4 bricks on each side) have dropped. This corresponds with the position of the unstable parapet.

From the details of the falls and the surrounding construction, we believe that both roofs were originally lead covered. The west roof surface is now asphalt while the east is felt. Both roofs are in questionable condition and replacement would be desirable in order to prevent future failure and water ingress into the building

#### GENERAL RECOMMENDATION:

Dry brush clean to both parapets.  
 Remove vegetation. Carefully remove vegetation from terracotta joints. Treat with herbicide.  
 Doff clean coping stones.  
 Repoint all joints using lime mortar.  
 Replace parapet flashings. (This will require rebuilding of parapet balustrade)
