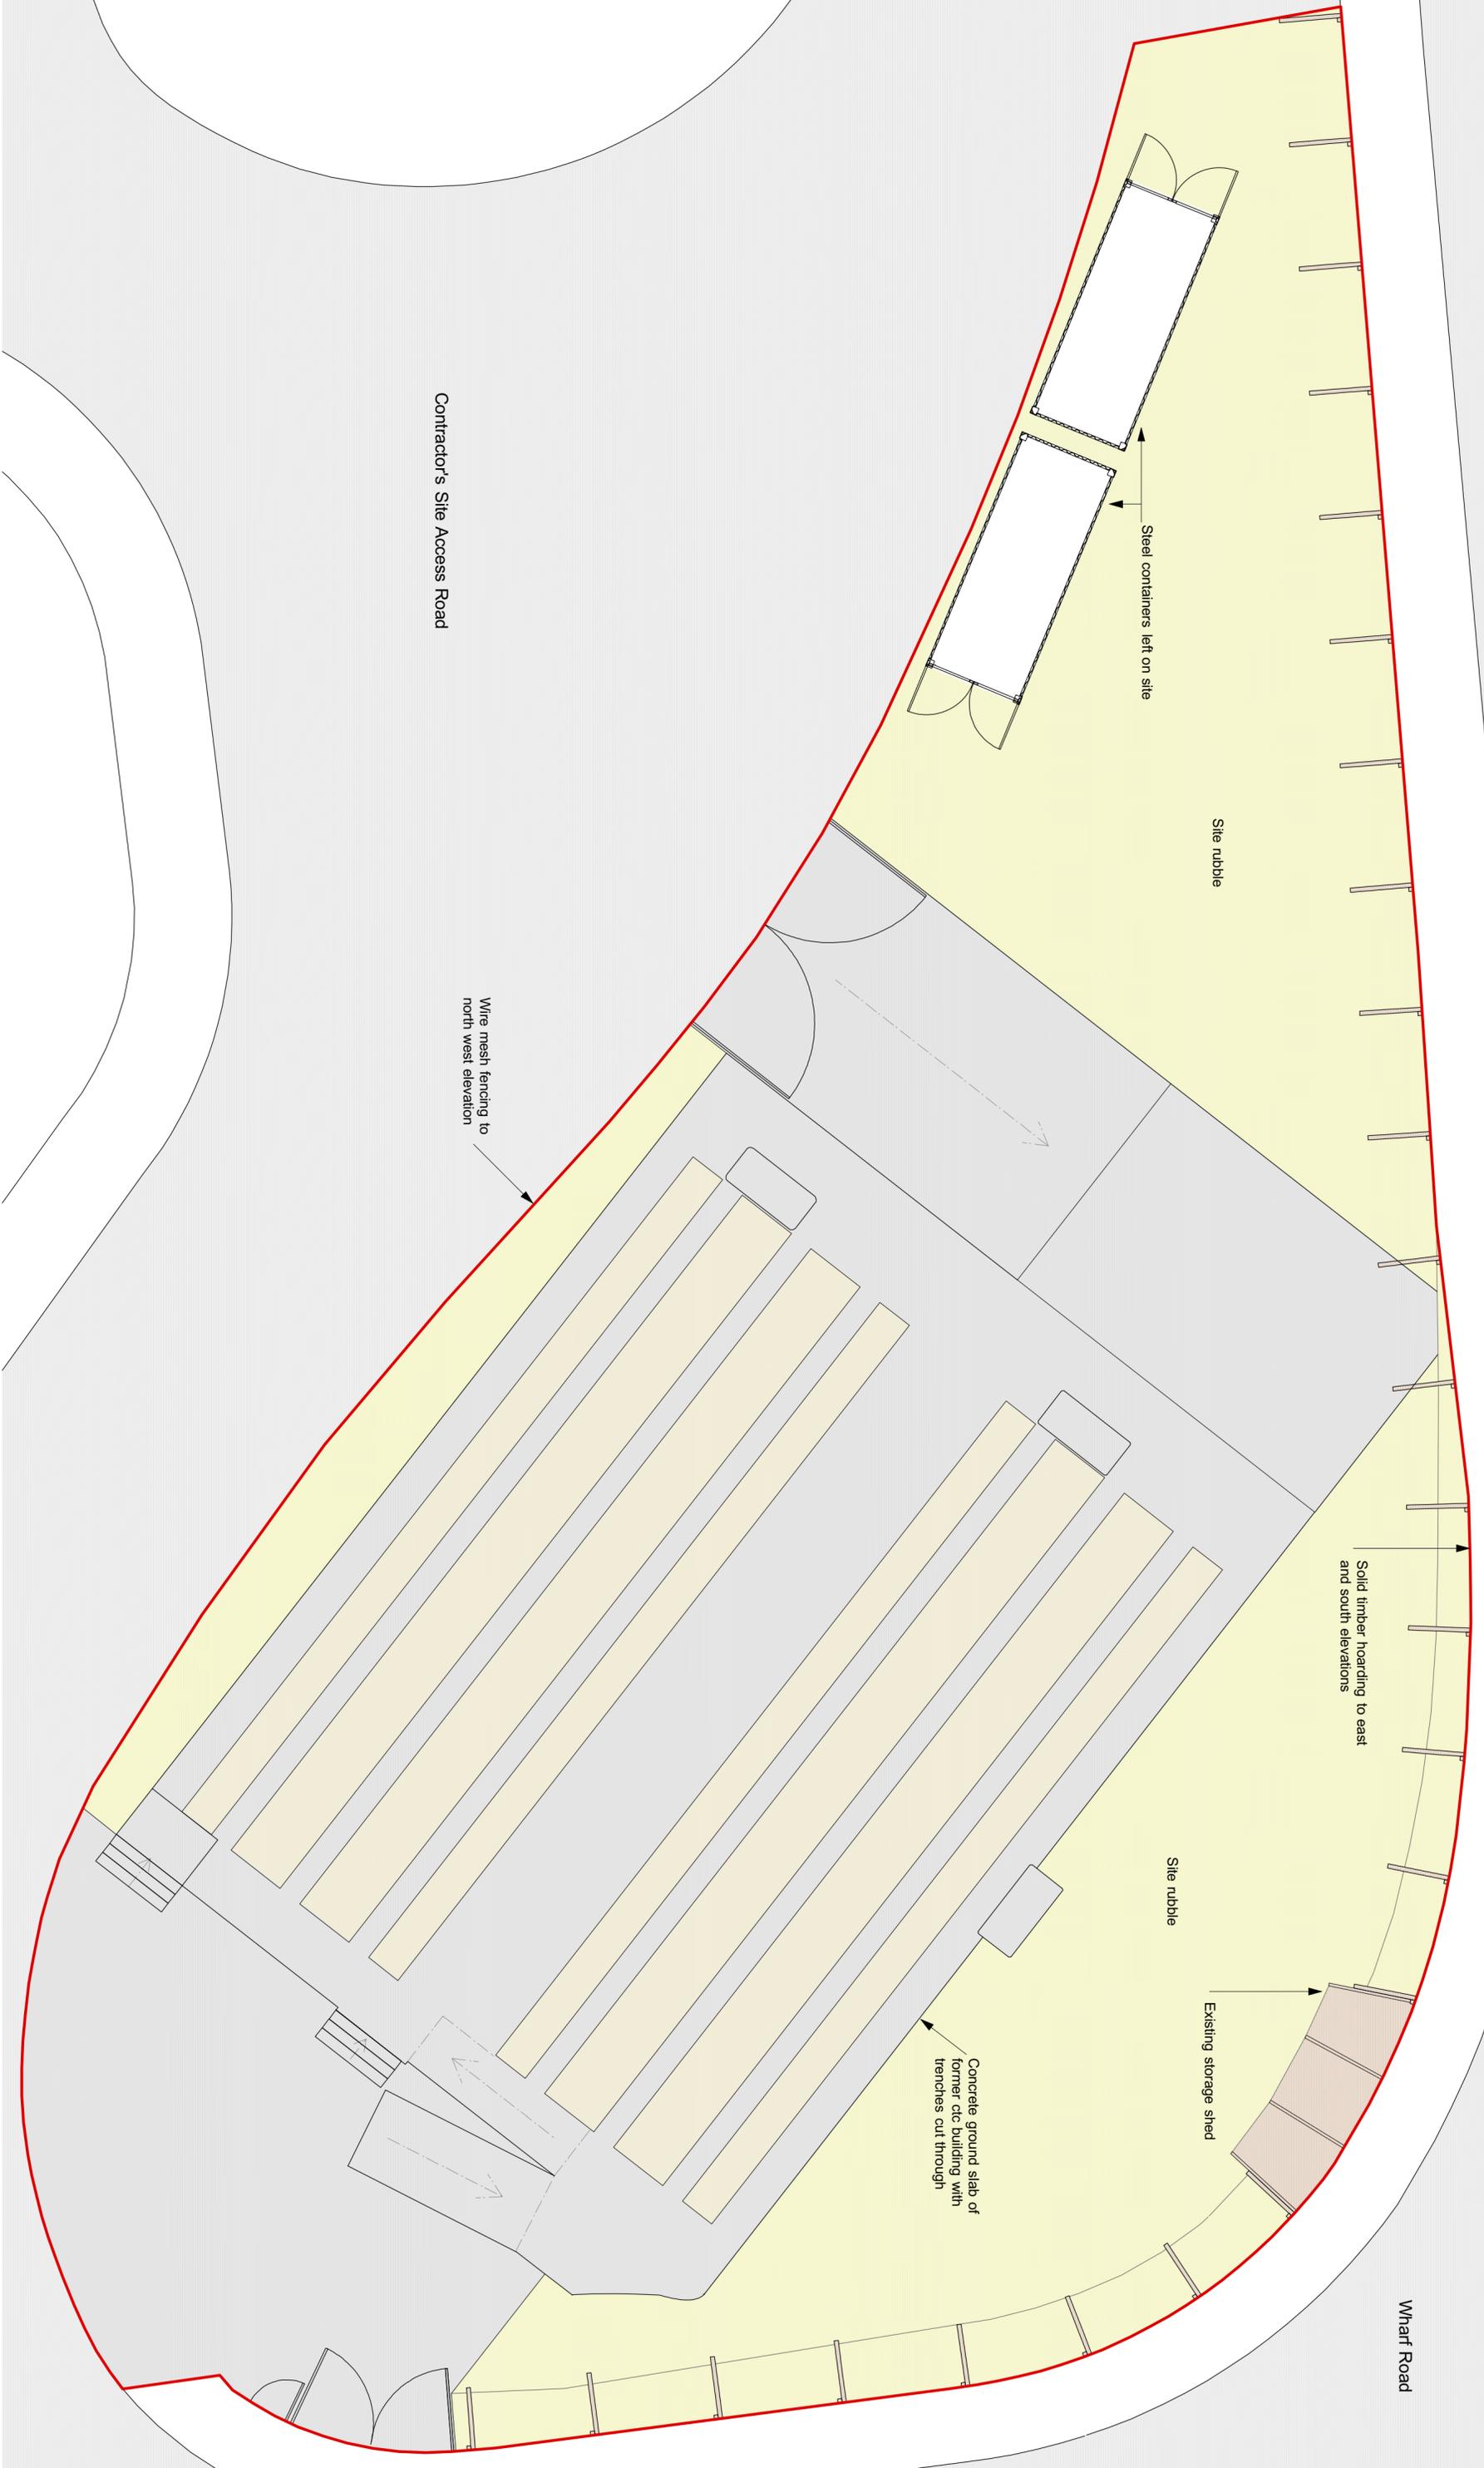
Solid timber hoarding to east and south elevations

Site rubble

Existing storage shed

Steel containers left on site

Concrete ground slab of former c/c building with trenches cut through

Wire mesh fencing to north west elevation

Contractor's Site Access Road
