Custom Cutters Tree Specialists
5 day Notice

West Hill Court
Millfield Lane
London
N6 6JJ

TREE INSPECTION REPORT

Client: Faraday Property Management Limited, for Clients
Location: West Hill Court, Millfield Lane, London N6 6JJ
Date of inspection: 21 January 2010
Inspected by: J.Harraway FArborA, MICFor

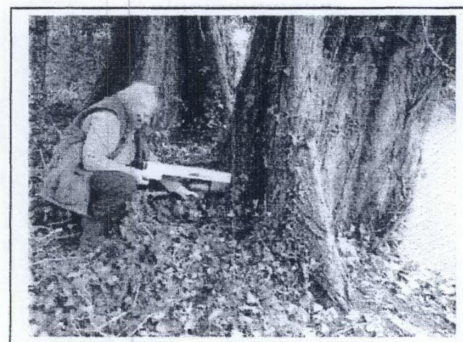
Resistograph in use
at the base of T26

No significant indications of structural weakness were evident from external inspection, other than a small area of the lower stem on the north side of the stem, which produced a hollow resonance when tapped with the hammer.

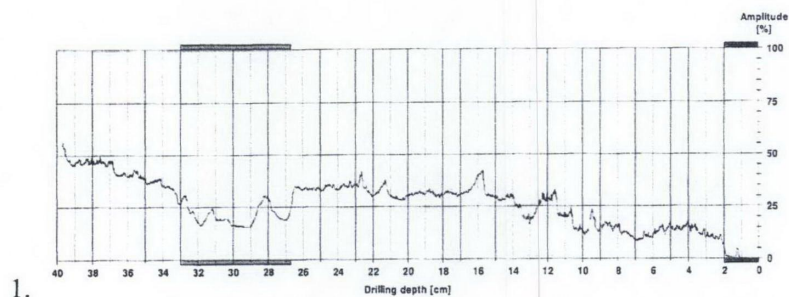
The reduction in drilling resistance at a depth of 28-33cm is unlikely to be due to decay and probably indicates the level at which the probe passed across an area of ingrown (included) bark.

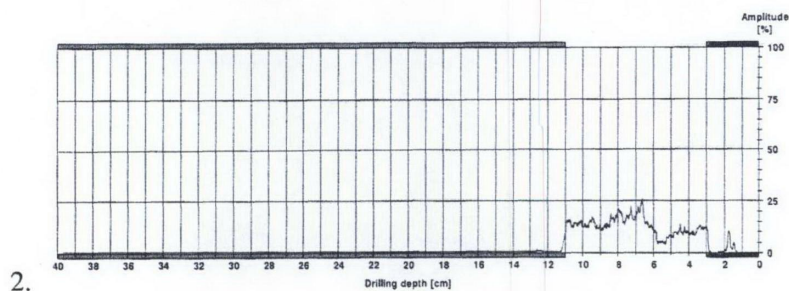
Drilling resistance drops abruptly at a depth of 11cm into a hollow area which extends to at least 40cm, the maximum drilling depth of the instrument.

Overall the investigation confirms the presence of hollowing in one location on the north side of the stem of T26.

Some localised hollowing was also discovered in the base of T26, on the north side. This may well be associated with decay entering through one damaged or dead root and I do not consider it likely that this tree is in an unstable condition at present. However, further deterioration could occur and, if the tree is retained beyond the short term, it should be subject to regular inspection by an arboriculturist and an assessment of decay repeated in, say, three years.

- *Remove Lombardy poplar T27 to ground level as soon as practicable*
- *Consider the removal of T26 in the short term or, if retained, ensure it is subject to specialist inspection, as described in this report*
- *Establish replacement plantings of the same species to provide future amenity*

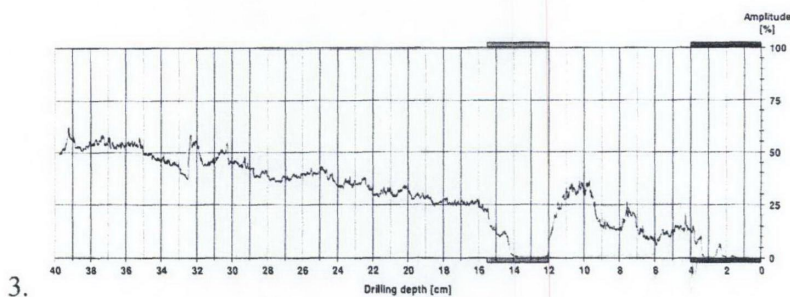
No decay indicated, but a brief drop at 12-15cm is probably due to included bark.

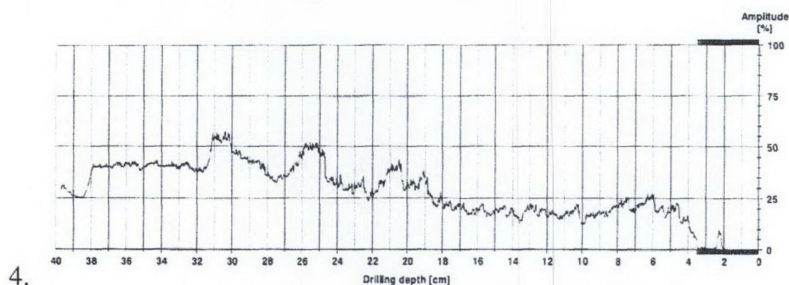
No decay indicated.

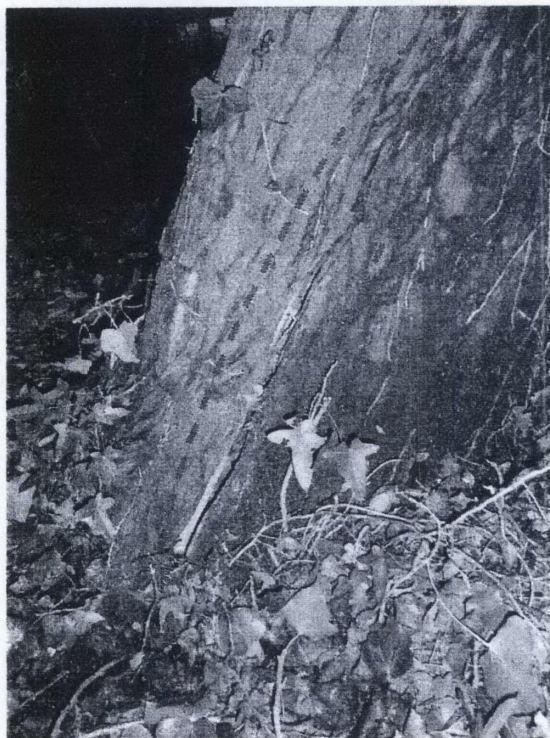
Tapping with the hammer indicated possible hollowing on the west and south sides of the stem. Most importantly, the removal of thick ivy from the lower stem revealed a long crack in a major root buttress on the north west side, on the opposite side from the lean. See photo below:

To summarize the results of the investigation on T27, it is clear that widespread decay and hollowing has occurred in much of the lower stem. The long crack in the large root buttress on the north west side is further evidence that the tree is becoming unstable.

It is most apparent, from visual assessment and the results of the Resistograph investigation, that not only is T27 extensively hollowed at the base but it is also unstable. I am unsure how long ago the stem developed a lean but the long crack in an important root buttress suggests that the tree's stability is deteriorating.

I therefore consider it a priority that this tree is made safe by felling to ground level as soon as practicable, regrettable as this is to the history and layout of the gardens. I further advise that use of the garden area to the south east of the tree is suspended until this can be achieved (I informed Ian Gilbert of Faradays of this recommendation by telephone on the day of my visit).

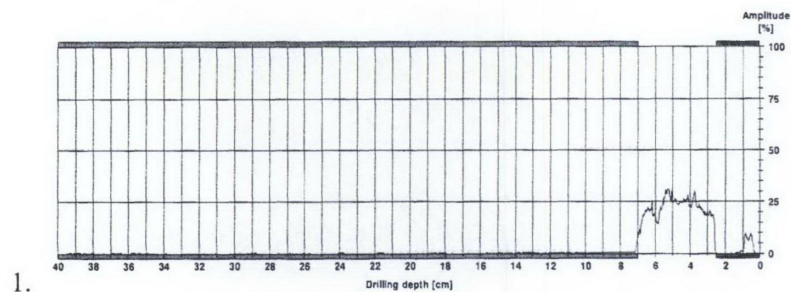
A few centimetres of wood surrounds hollowing at this point which extends to at least 40cm.

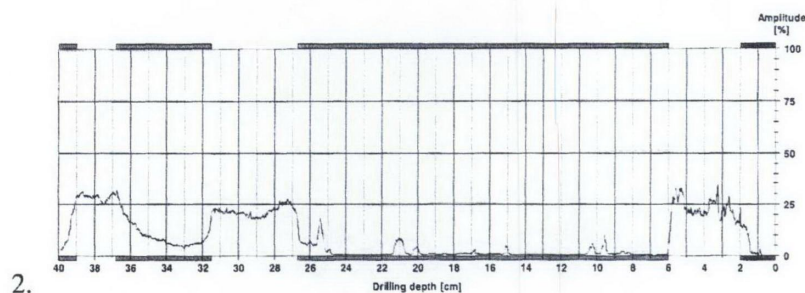
Extensive hollowing is also indicated at this point, interrupted by only brief rises in drilling resistance.

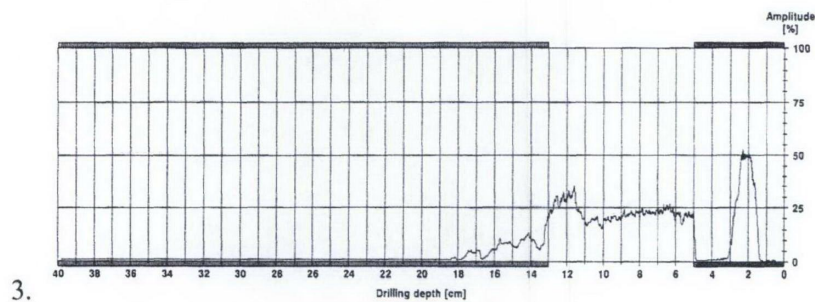
Hollowing is encountered from a depth of 13cm.

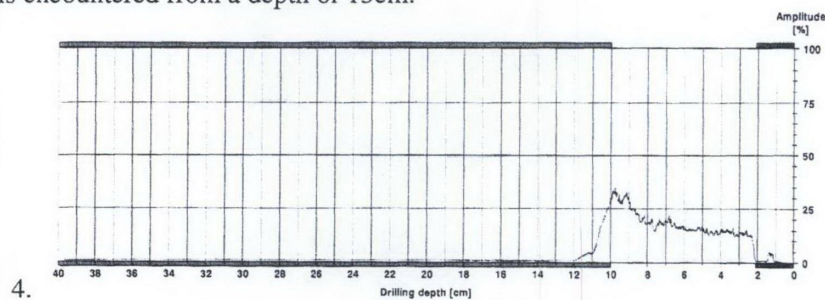
Hollowing indicated from a depth of 10cm.

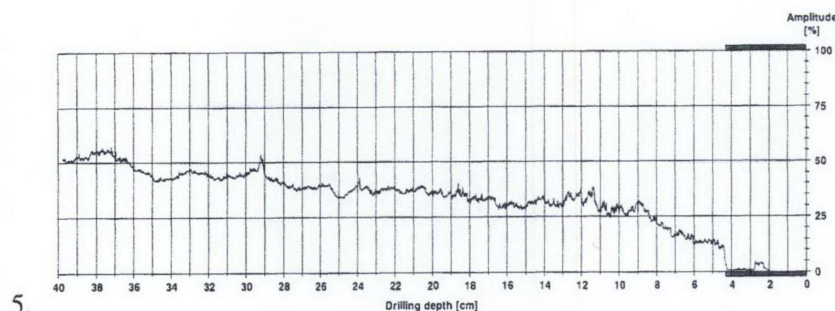
No decay indicated to the maximum drilling depth.

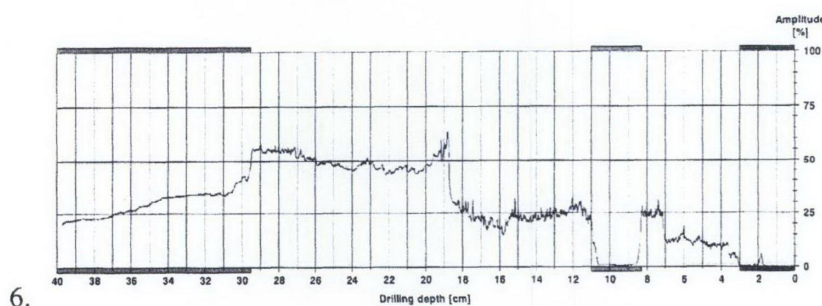
The brief drop at 8-11 cm is probably included bark. The onset of decay indicated at a depth of 30cm.

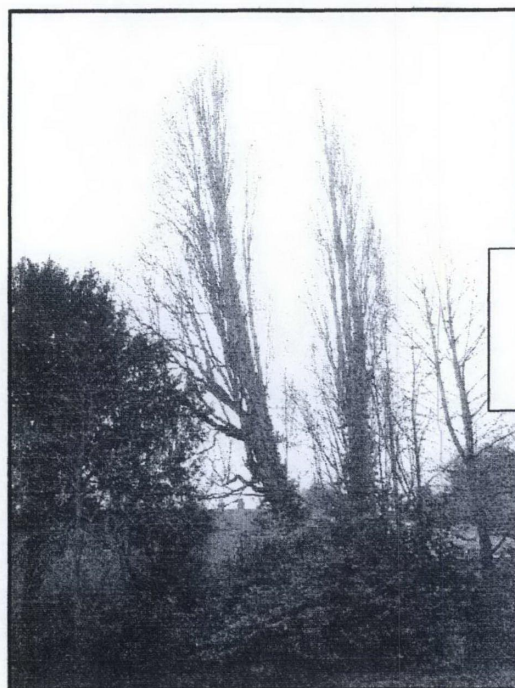
View of the two trees from the north:

Note separation
between crowns,
indicative of recent
movement
