Application for tree works: works to trees subject to a tree preservation order (TPO)
and/or notification of proposed works to trees in a conservation area.

ADDITIONAL INVESTIGATION REPORT

CRACK DAMAGE

Address of Insured: 3 Boscastle Road
London
NW5 1EE

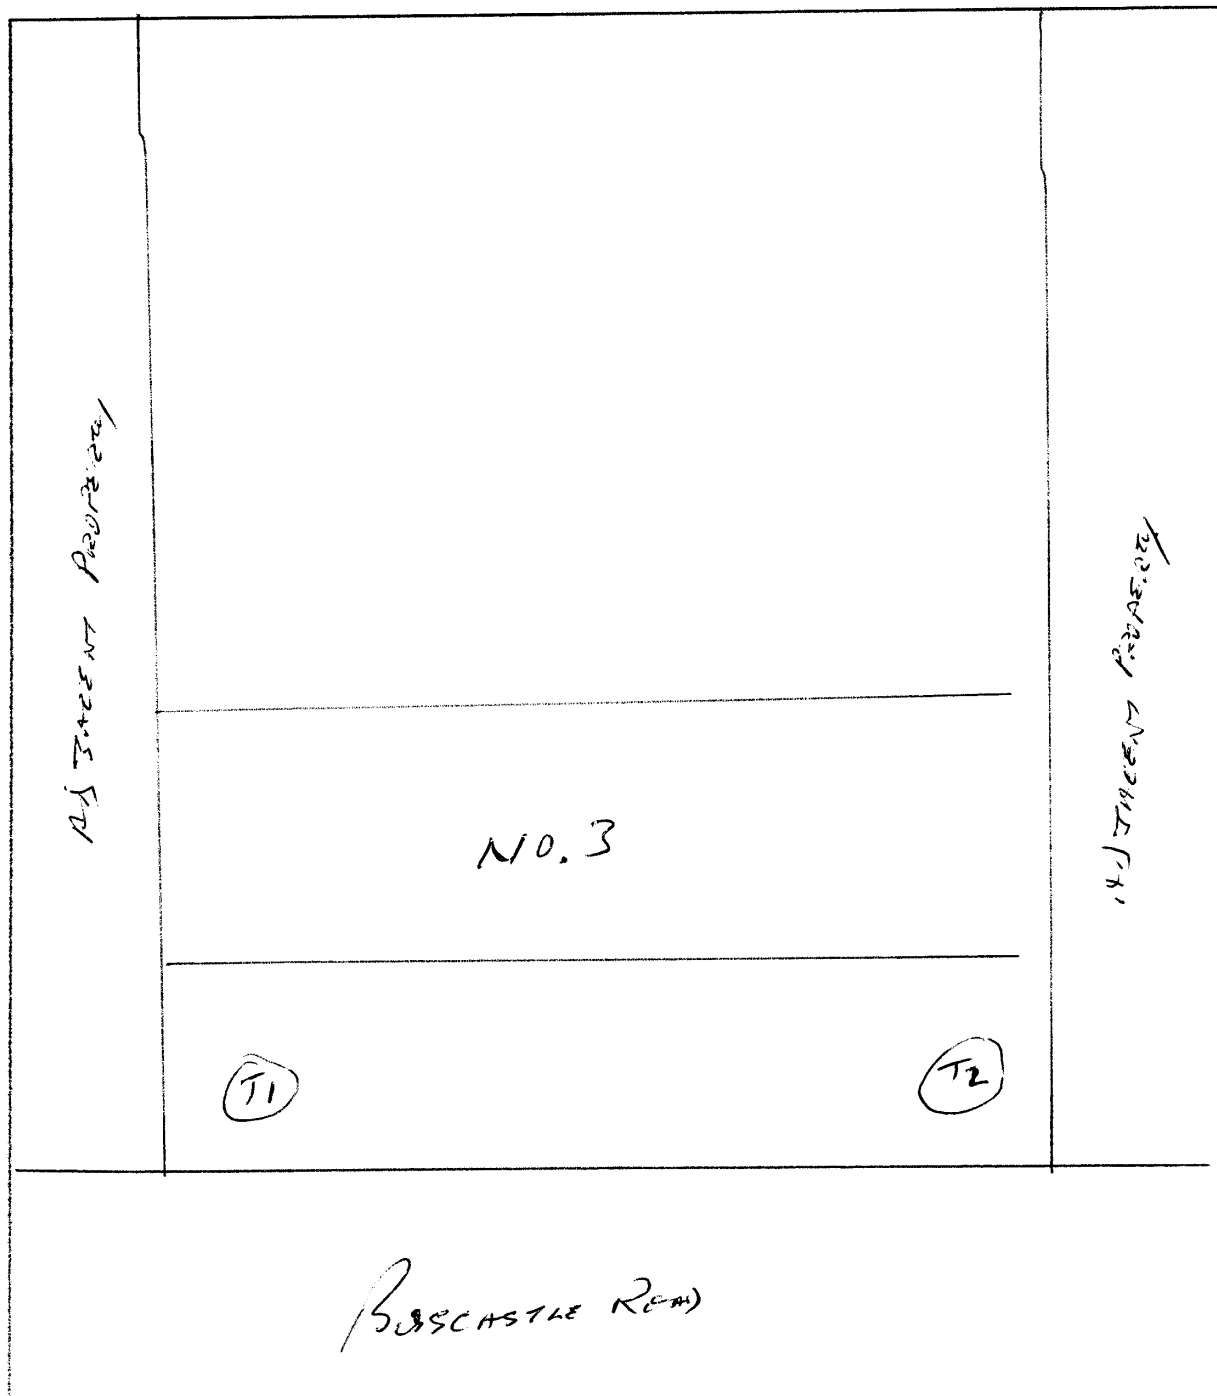
This is a very rough drawing to show approx
positions of trees only and is not to scale

T1 PRESERVED - CRAB APPLE FELL

T2 CONSERV AREA - CHERAM - FELL

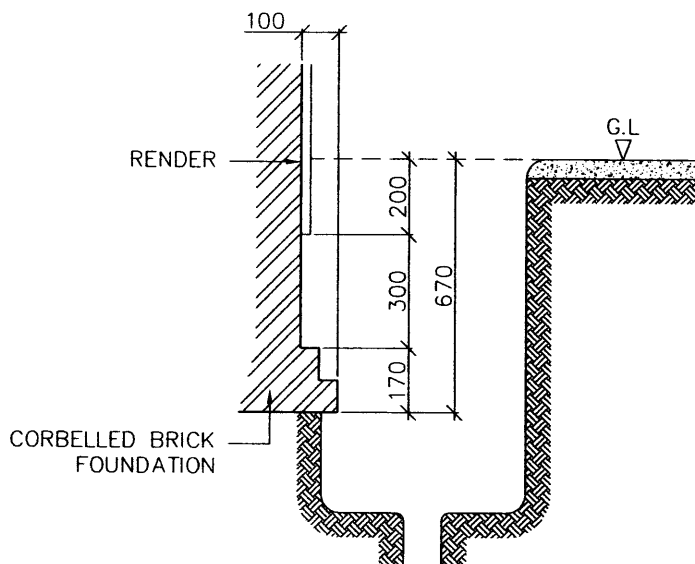
Job Number: 05336
Borehole Number T.H.1
Location:

- (i) Foundation
 - (a) Type: Corbelled brick spreader
 - (b) Depth below ground level: 670mm
- (ii) Soil
 - (a) Type: Silty Clay
 - (b) Plasticity: Medium plastic, therefore, prone to volumetric change with variations in moisture content.
- (iii) Roots
 - (a) Type: Cherry and Bay
 - (b) Location of tree root identified: Within risk address

Daily Prog.	Water Level	Insitu Tests	Samples Taken	Sample Depths	Remarks	Depth (m)	Strata Descriptions	Red. Level	Legend
						0.00	50mm CONCRETE over MADE GROUND with roots.		
			D	0.70		0.30	Sandy silty CLAY with gravel and brick fragments.		
			D	1.00		0.50	Sandy silty CLAY with roots.		
						0.70	Dark brown silty CLAY with fine roots.		
						1.00	Orange brown silty CLAY with occasional gravel (No roots).		
							End of Trial Hole		
						2.00			
						3.00			
						4.00

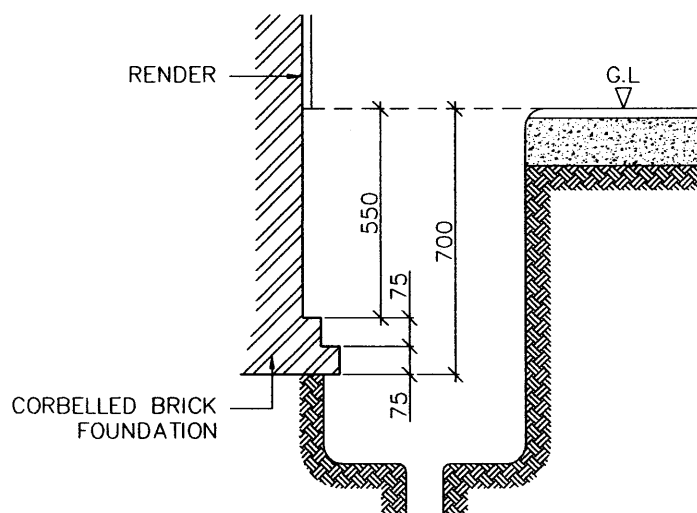
Contract: 3 BOSCASTLE ROAD, LONDON, NW5 1EE Client:		Coordinates: Date: 1 SEPT 2009
Equipment & Methods HAND DUG	Job Number: 05336 Borehole Number T.H.2 Location:	Orientation: VERTICAL Ground Level:

- (i) Foundation
 - (a) Type: Corbelled Brick Spreader
 - (b) Depth below ground level: 700mm
- (iii) Soil
 - (a) Type: Silty, sandy clay
 - (b) Plasticity: Medium plastic, therefore, prone to volumetric change with variations in moisture content.
- (iii) Roots
 - (a) Type: Crab Apple and Cherry
 - (b) Location of tree root identified: Within risk address

Daily Prog.	Water Level	Insitu Tests	Samples Taken	Sample Depths	Remarks	Depth (m)	Strata Descriptions	Red. Level	Legend
			D	0.70		0.00 0.15 0.50 0.70 2.00 3.00 4.00	Stone slabs on 150mm concrete MADE GROUND— sandy clay with gravel and brick fragments and roots. Silty sandy CLAY with roots. Hard, light brown, silty, slightly sandy CLAY with fine roots and occasional gravel. End of Trial Hole

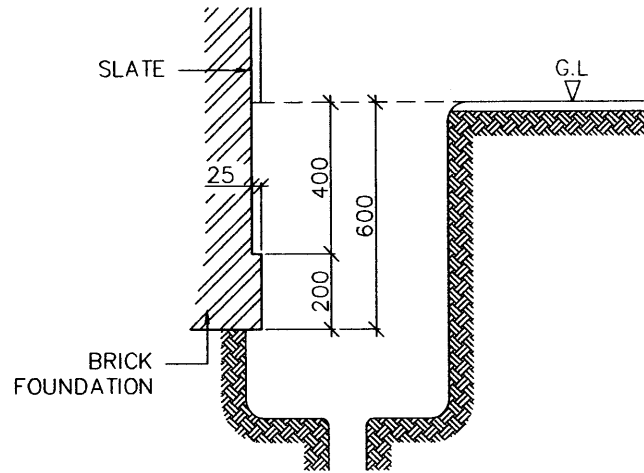
Contract: 3 BOSCASTLE ROAD, LONDON, NW5 1EE Client:		Coordinates: Date: 1 SEPT 2009
Equipment & Methods HAND DUG	Job Number: 05336 Borehole Number T.H.3 Location:	Orientation: VERTICAL Ground Level:

- (i) Foundation
 - (a) Type: Brick spreader
 - (b) Depth below ground level: 600mm
- (ii) Soil
 - (a) Type: Silty Clay
 - (b) Plasticity: Low plastic, therefore, prone to some volumetric change with variations in moisture content.
- (iii) Roots
 - (a) Type: Acer and Unidentified Shrub
 - (b) Location of tree root identified: Acer within neighbour's rear garden

Daily Prog.	Water Level	Insitu Tests	Samples Taken	Sample Depths	Remarks	Depth (m)	Strata Descriptions	Red. Level	Legend
			D	0.60		0.00	Stone slabs over MADE GROUND—sandy clay with gravel and brick fragments and roots (some large).		
						0.55	Buff/brown silty CLAY		
						0.60	Dark brown silty CLAY with occasional gravel and fine roots.		
							End of Trial Hole		
						2.00			
						3.00			
						4.00
