Application for tree works: works to trees subject to a tree preservation order (TPO)
and/or notification of proposed works to trees in a conservation area.

ADDITIONAL INVESTIGATION REPORT

CRACK DAMAGE

Address of Insured: 3 Boscastle Road
London
NW5 1EE

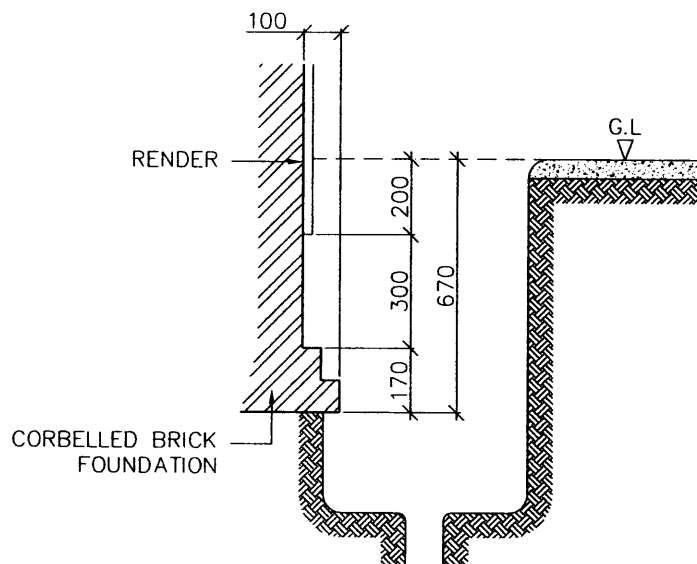
Job Number: 05336
Borehole Number T.H.1
Location:

A Trial Pit 1

- (i) Foundation
 - (a) Type: Corbelled brick spreader
 - (b) Depth below ground level: 670mm
- (ii) Soil
 - (a) Type: Silty Clay
 - (b) Plasticity: Medium plastic, therefore, prone to volumetric change with variations in moisture content.
- (iii) Roots
 - (a) Type: Cherry and Bay
 - (b) Location of tree root identified: Within risk address

Roots were found below foundation level in both trial holes at the front and have been identified as being from the Cherry and Crab Apple trees. A further root has been identified as being from a Bay tree (Laurel).

Daily Prog.	Water Level	Insitu Tests	Samples Taken	Sample Depths	Remarks	Depth (m)	Strata Descriptions	Red. Level	Legend
						0.00	50mm CONCRETE over MADE GROUND with roots.		
			D	0.70		0.30	Sandy silty CLAY with gravel and brick fragments.		
			D	1.00		0.50	Sandy silty CLAY with roots.		
						0.70	Dark brown silty CLAY with fine roots.		
						1.00	Orange brown silty CLAY with occasional gravel (No roots).		
							End of Trial Hole		
						2.00			
						3.00			
						4.00

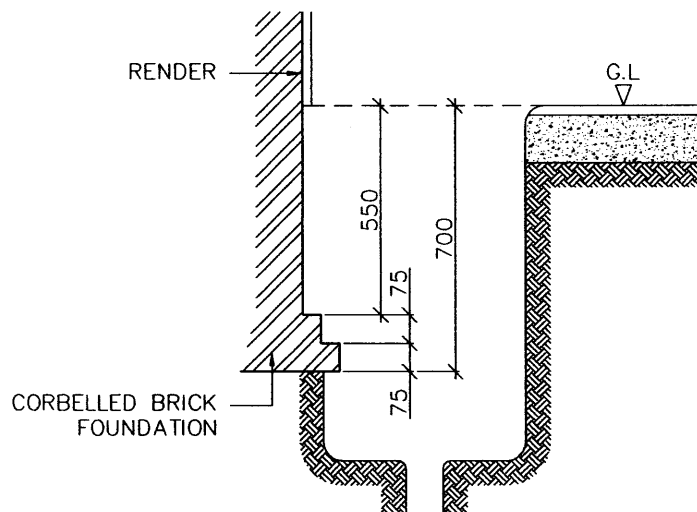
Contract: 3 BOSCASTLE ROAD, LONDON, NW5 1EE Client:		Coordinates: Date: 1 SEPT 2009
Equipment & Methods HAND DUG	Job Number: 05336 Borehole Number T.H.2 Location:	Orientation: VERTICAL Ground Level:

A Trial Pit 2

- (i) Foundation
 - (a) Type: Corbelled Brick Spreader
 - (b) Depth below ground level: 700mm
- (iii) Soil
 - (a) Type: Silty, sandy clay
 - (b) Plasticity: Medium plastic, therefore, prone to volumetric change with variations in moisture content.
- (iii) Roots
 - (a) Type: Crab Apple and Cherry
 - (b) Location of tree root identified: Within risk address

The soil has been analysed as being of medium shrinkability at foundation level, and comparison of moisture contents with Atterberg Limits indicates the clay soil is desiccated in TH2. Unfortunately, due to equipment breakage during augering we were unable to retrieve samples from depth to determine the depth of any further desiccation that may be present.

Daily Prog.	Water Level	Insitu Tests	Samples Taken	Sample Depths	Remarks	Depth (m)	Strata Descriptions	Red. Level	Legend
			D	0.70		0.00 0.15 0.50 0.70 2.00 3.00 4.00	Stone slabs on 150mm concrete MADE GROUND— sandy clay with gravel and brick fragments and roots. Silty sandy CLAY with roots. Hard, light brown, silty, slightly sandy CLAY with fine roots and occasional gravel. End of Trial Hole

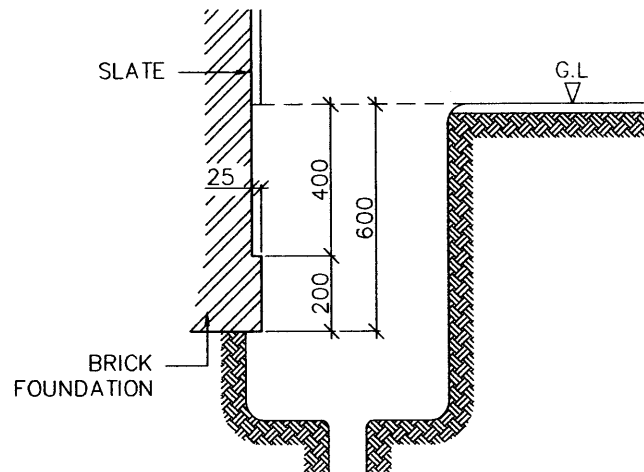
Contract: 3 BOSCASTLE ROAD, LONDON, NW5 1EE Client:		Coordinates: Date: 1 SEPT 2009
Equipment & Methods HAND DUG	Job Number: 05336 Borehole Number T.H.3 Location:	Orientation: VERTICAL Ground Level:

A Trial Pit 3

- (i) Foundation
 - (a) Type: Brick spreader
 - (b) Depth below ground level: 600mm
- (ii) Soil
 - (a) Type: Silty Clay
 - (b) Plasticity: Low plastic, therefore, prone to some volumetric change with variations in moisture content.
- (iii) Roots
 - (a) Type: Acer and Unidentified Shrub
 - (b) Location of tree root identified: Acer within neighbour's rear garden

The trial pit excavated at the rear has confirmed that the house has a brick spreader foundation to a depth of 600mm (similar to that proved in the original site investigation). This bears onto a low plasticity silty clay soil, and soils analysis indicates no desiccation to be present at foundation level.

Roots found below foundation level have been identified as being from an Acer and unidentified shrub. No roots from the Ash tree in the neighbour's garden were found.

Daily Prog.	Water Level	Insitu Tests	Samples Taken	Sample Depths	Remarks	Depth (m)	Strata Descriptions	Red. Level	Legend
			D	0.60		0.00	Stone slabs over MADE GROUND—sandy clay with gravel and brick fragments and roots (some large).		
						0.55	Buff/brown silty CLAY		
						0.60	Dark brown silty CLAY with occasional gravel and fine roots.		
							End of Trial Hole		
						2.00			
						3.00			
						4.00
