PHOTOGRAPHIC SCHEDULE

62 Doughty Street

Date: 11 May 2009

PRELIMINARIES - SCHEDULE OF CONDITION

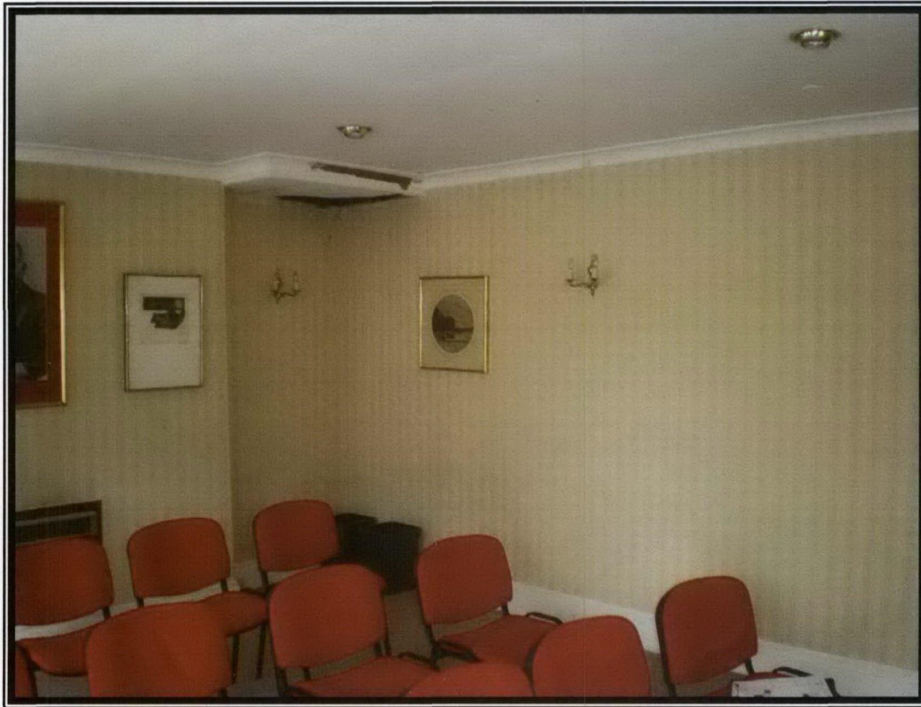
Photograph 1 – Water damage in north eastern corner

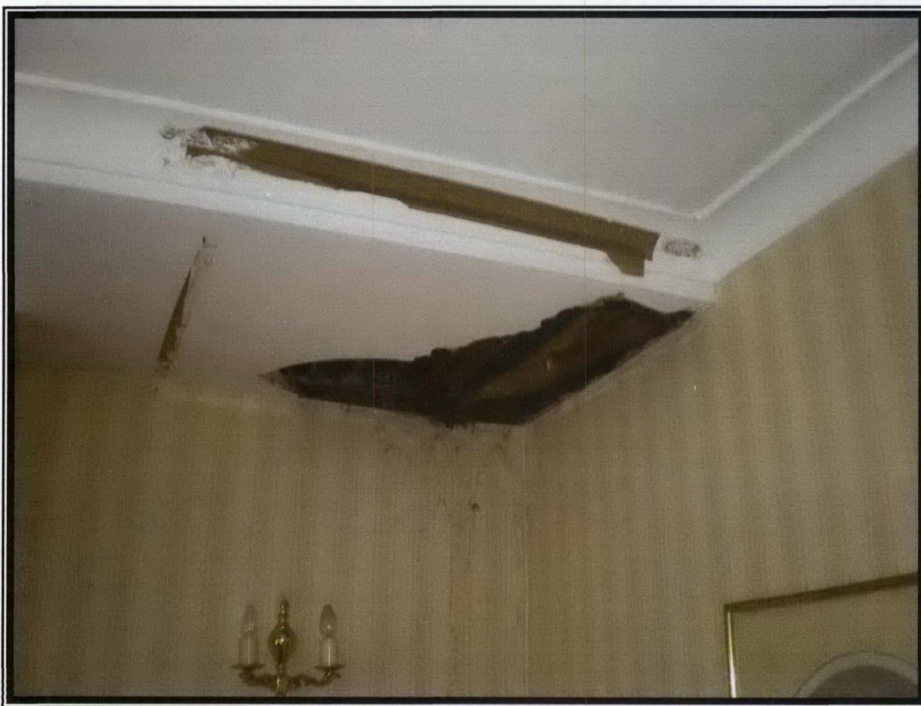
Photograph 2 – Displaced plaster board ceiling and exposed water damaged roof structure

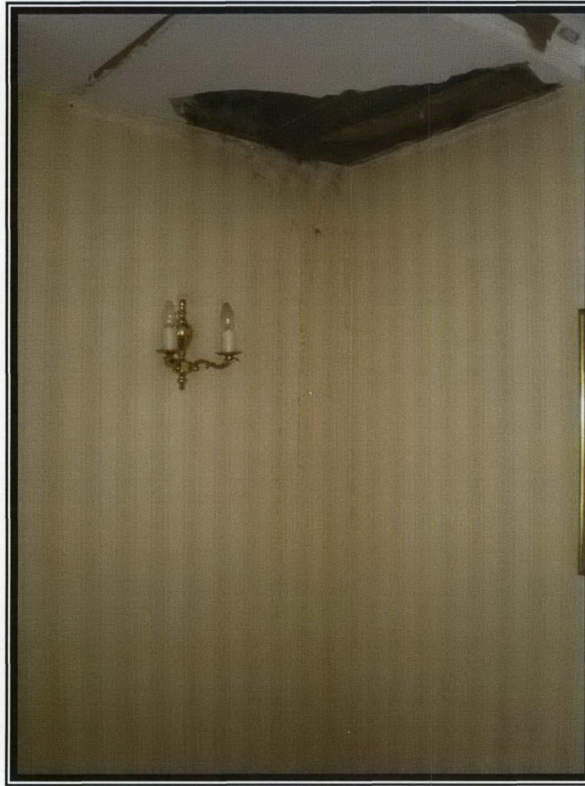
Photograph 3 – Damp staining to wall and damaged wall paper coverings

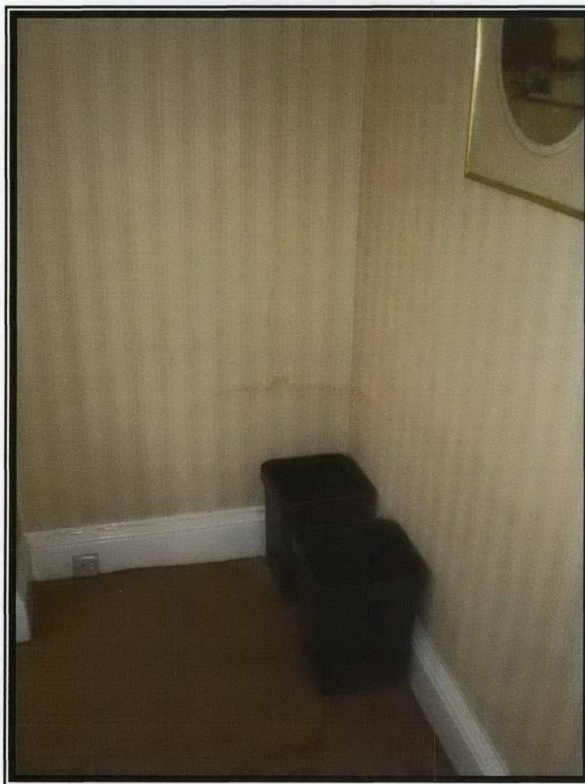
Photograph 4 – Water damage at base of wall and staining to carpet

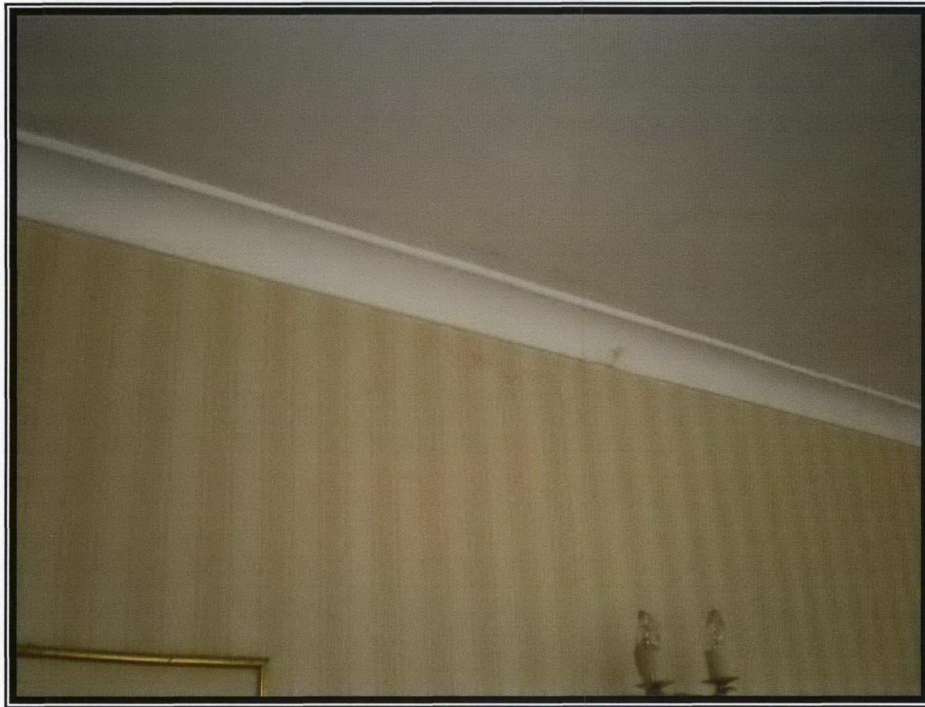
Photograph 5 – Water staining to ceiling and coving along eastern wall

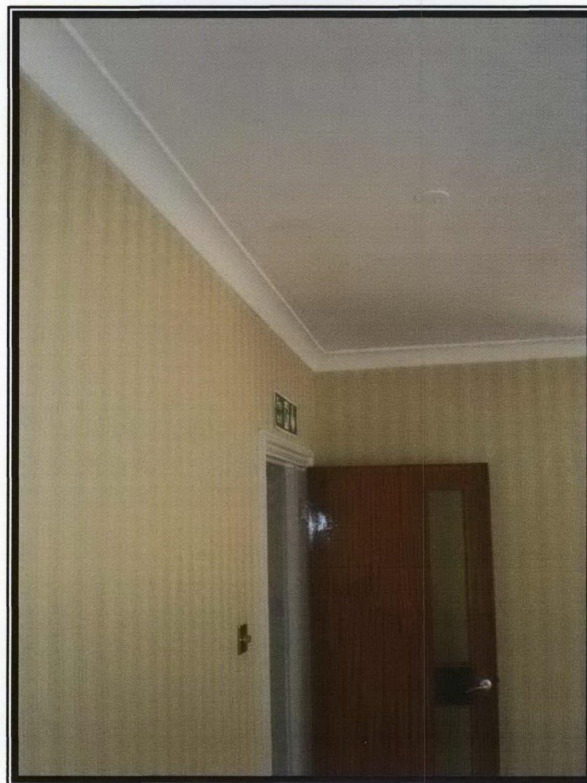
Photograph 6 – Damp staining and cracking to plaster board ceiling above door

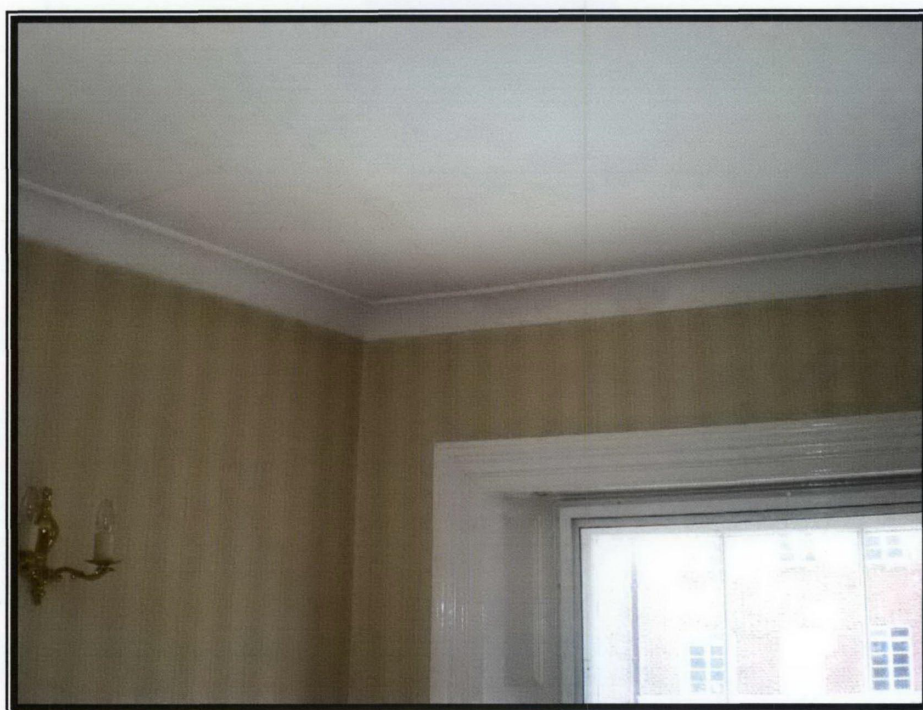
Photograph 7 – Joint separation to plaster board ceiling, in south western corner. Hair line cracking to plaster coving

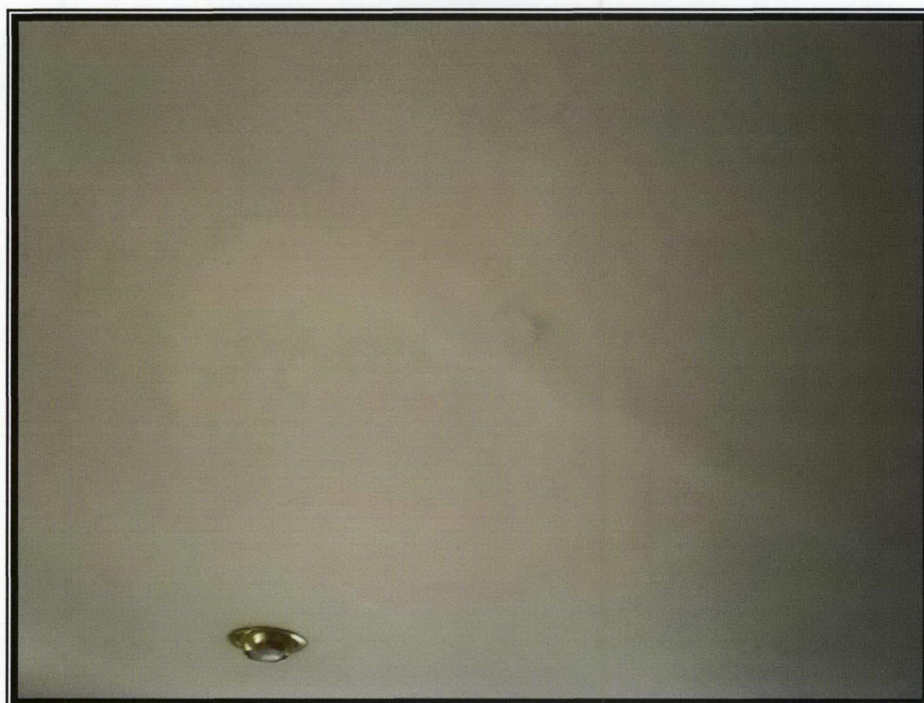
Photograph 8 – Patch repaired pendant fitting within ceiling

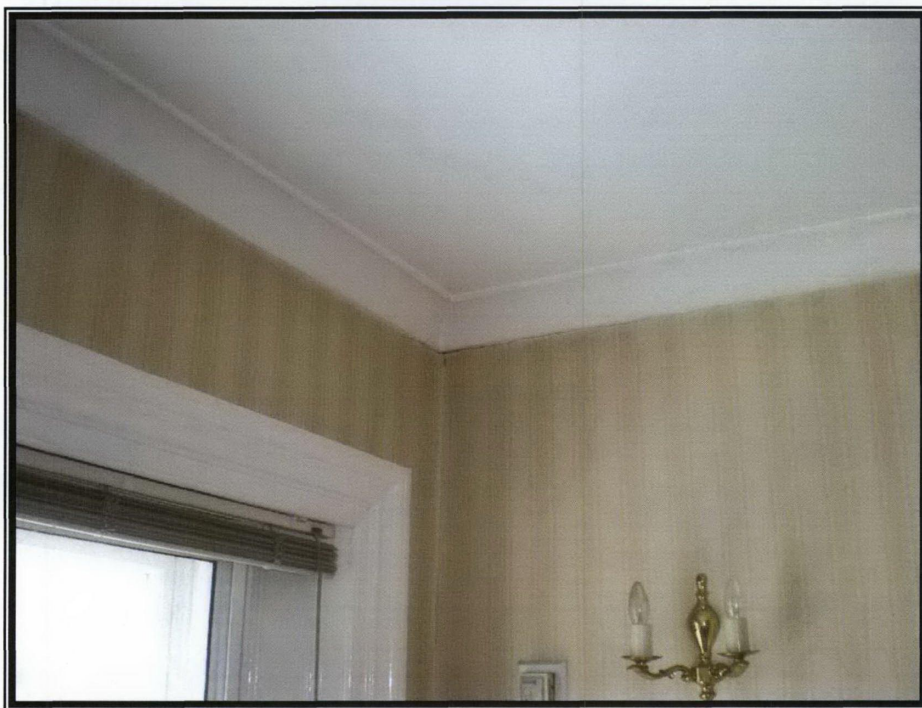
Photograph 9 – Damp staining and displaced wall paper to north western corner, rucked paper through corner

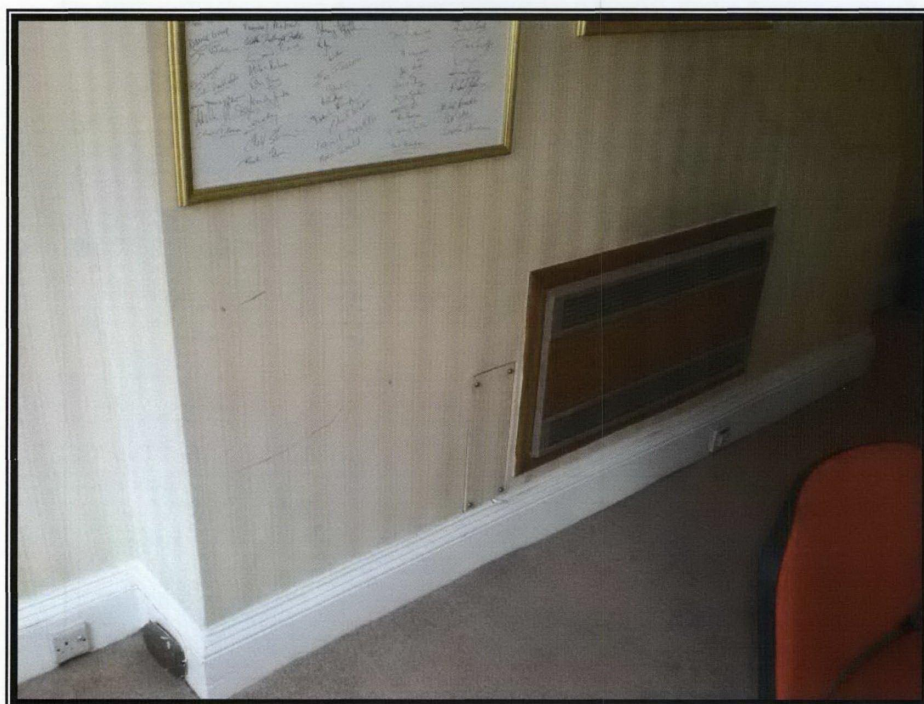
Photograph 10 – Hollowed plasterwork to left side of chimney breast

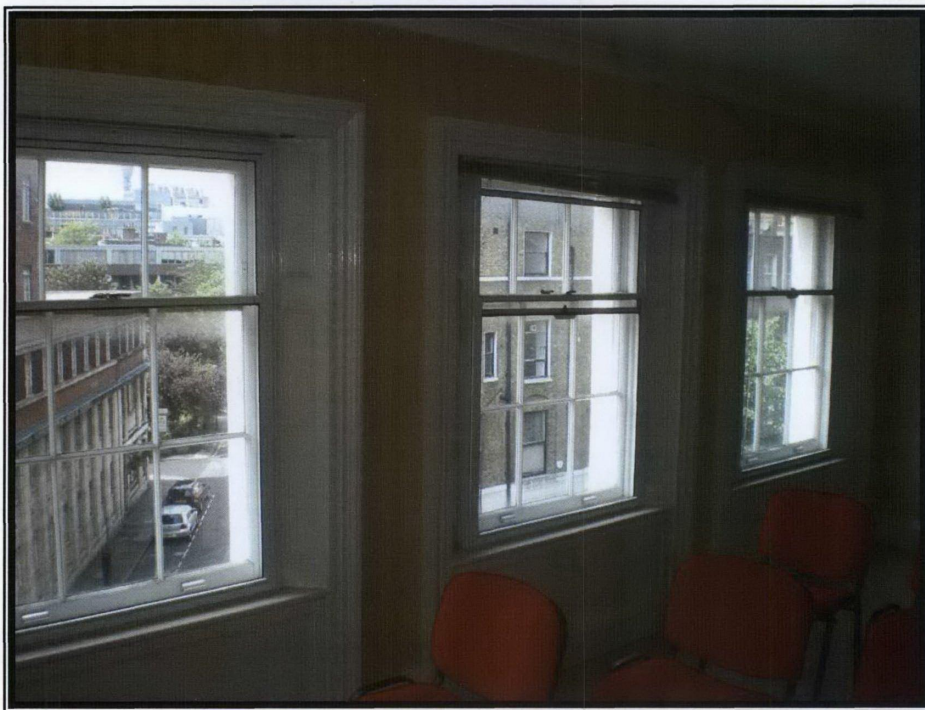
Photograph 11 – Secondary glazing to window openings

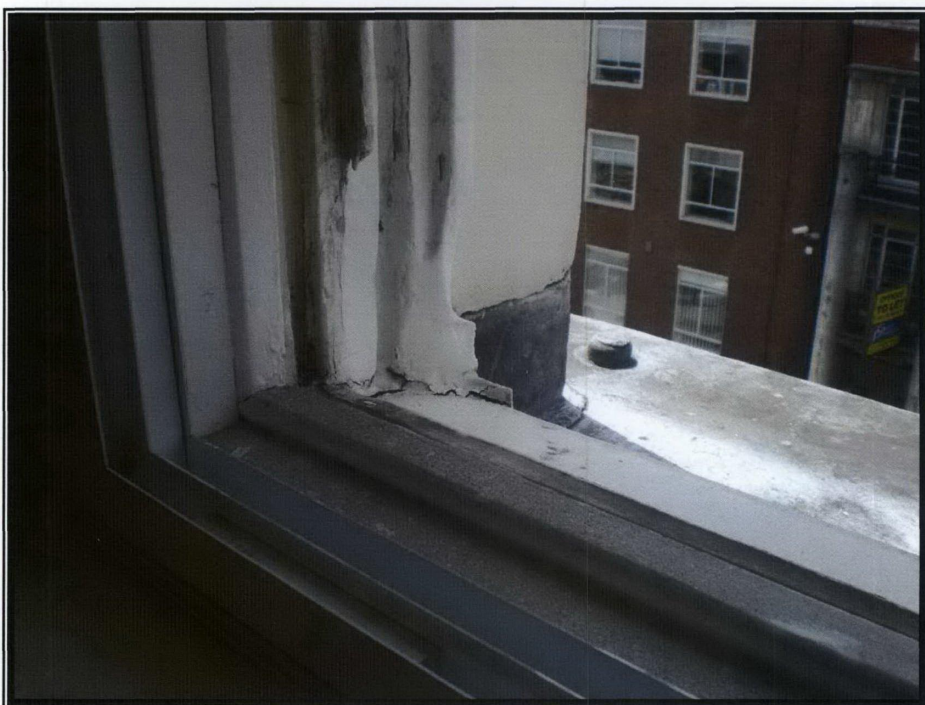
Photograph 12 – Sash frame damaged and filled

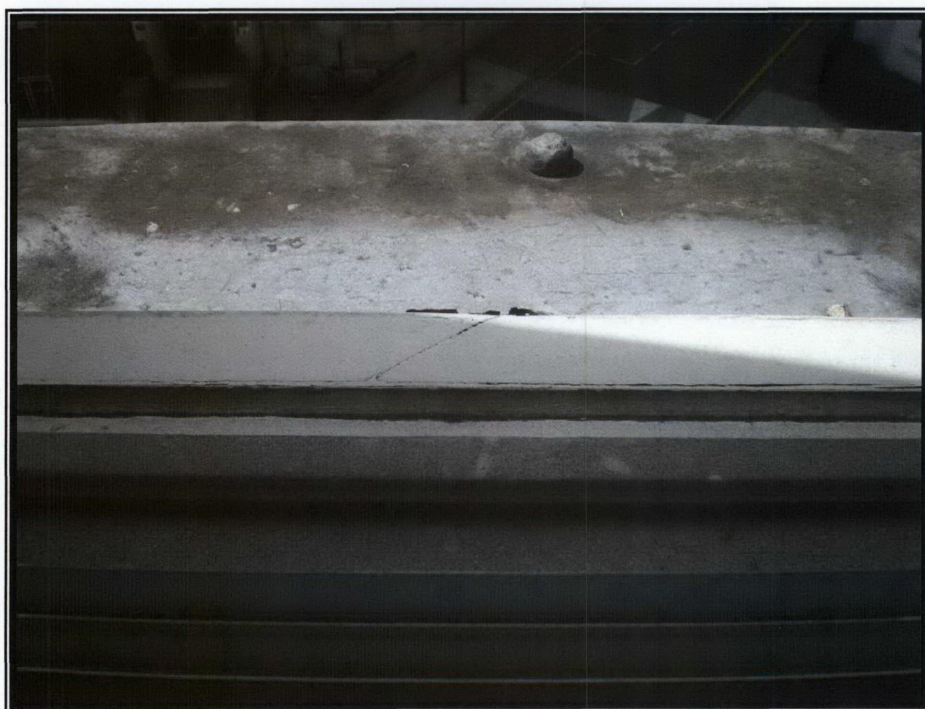
Photograph 13 – Scarfed joint repair to timber sill

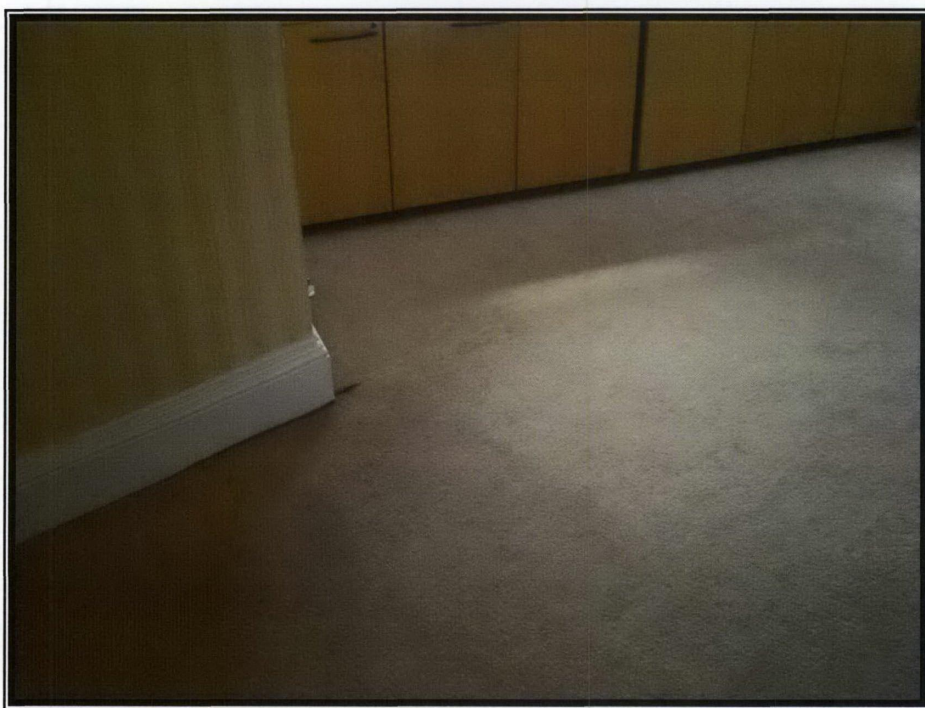
Photograph 14 – Separation to fitted carpet

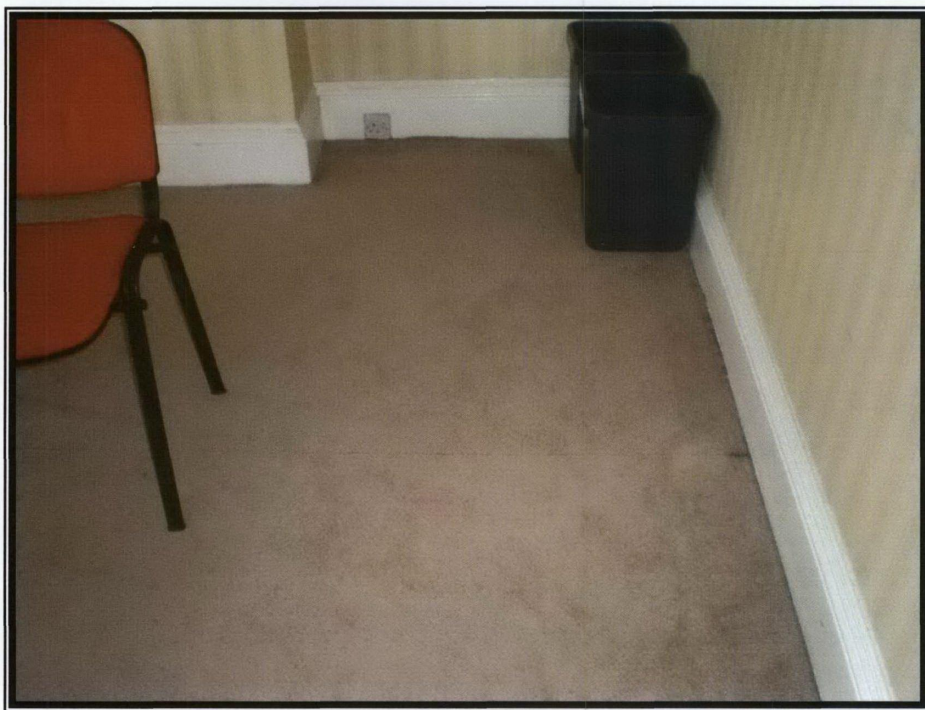
Photograph 15 – Separation in fitted carpet, light discolouration and wear

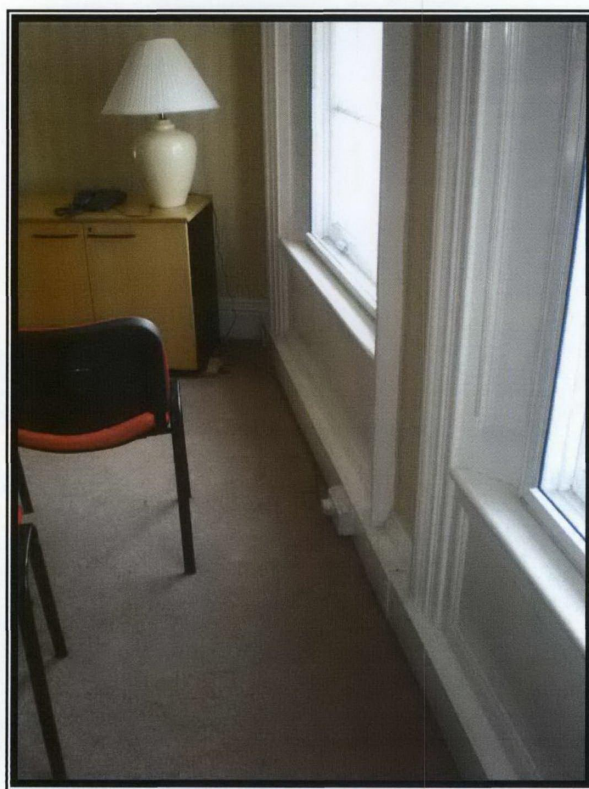
Photograph 16 – Displaced telephone socket set within trunking

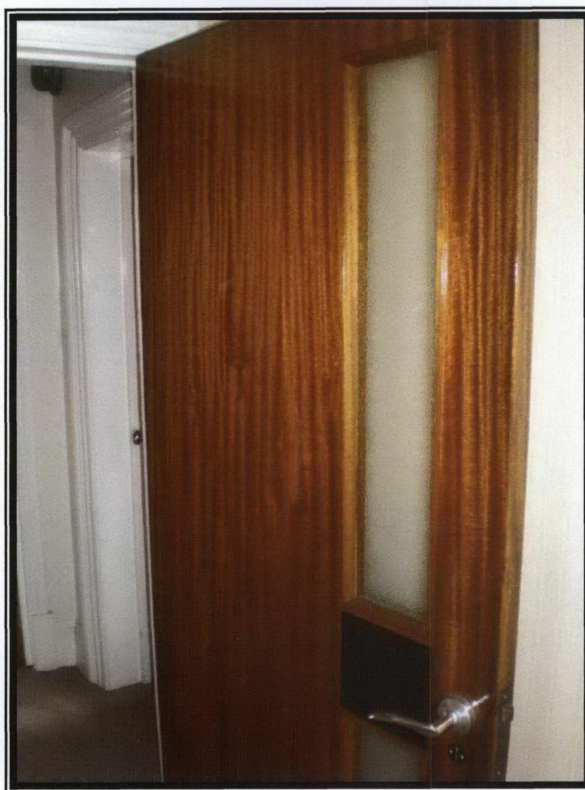
Photograph 17 – Chipped varnish to door

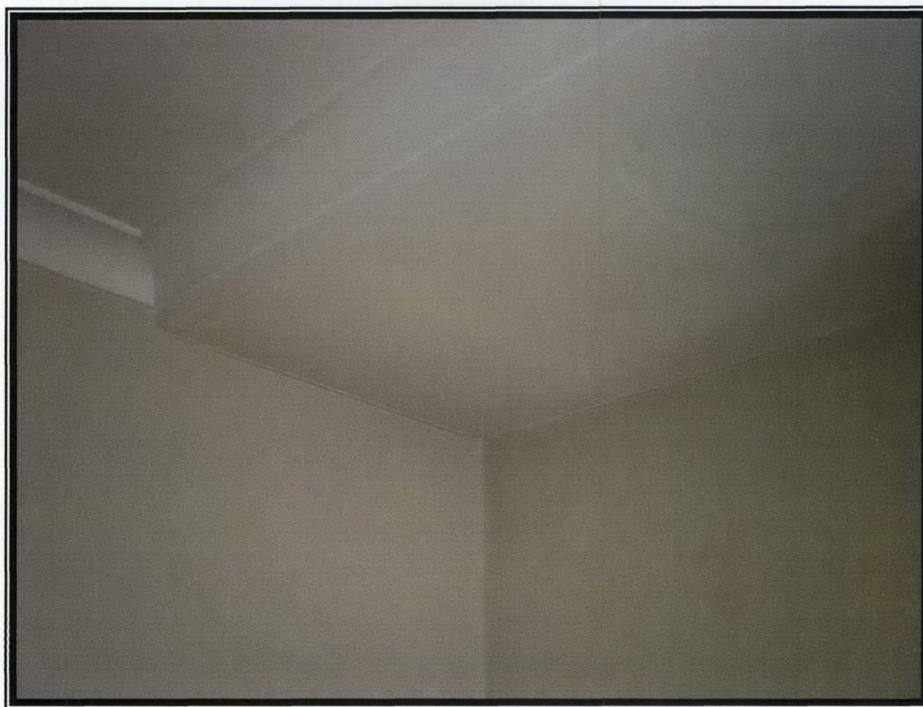
Photograph 18 – Cracking to ceiling soffit and coving within north western corner

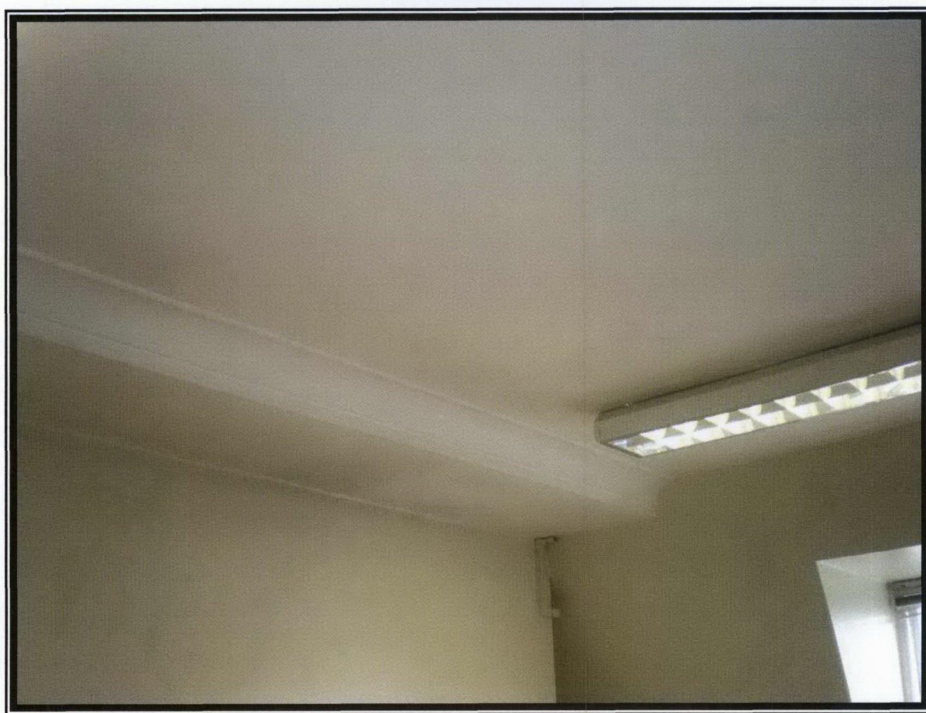
Photograph 19 – Separation to plaster board joints

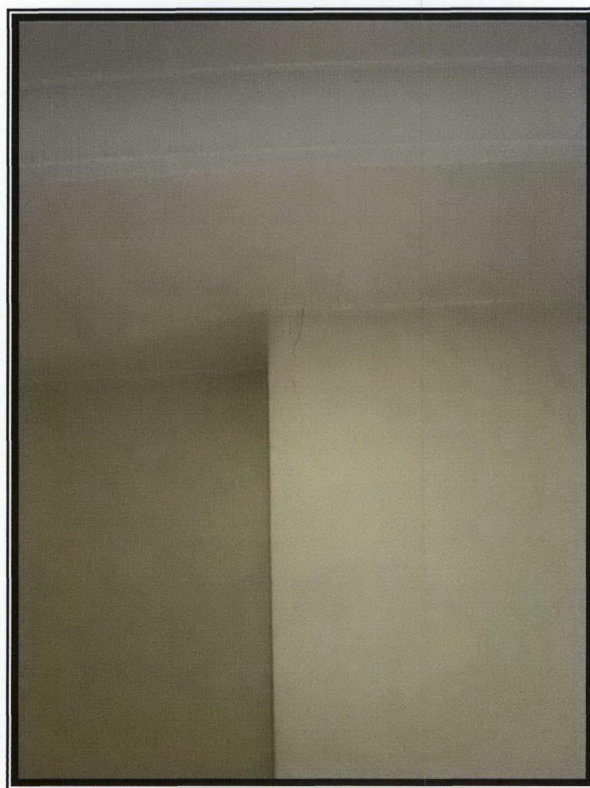
Photograph 20 – Left hand corner of chimney breast crack within plasterwork and separation in ceiling soffit
