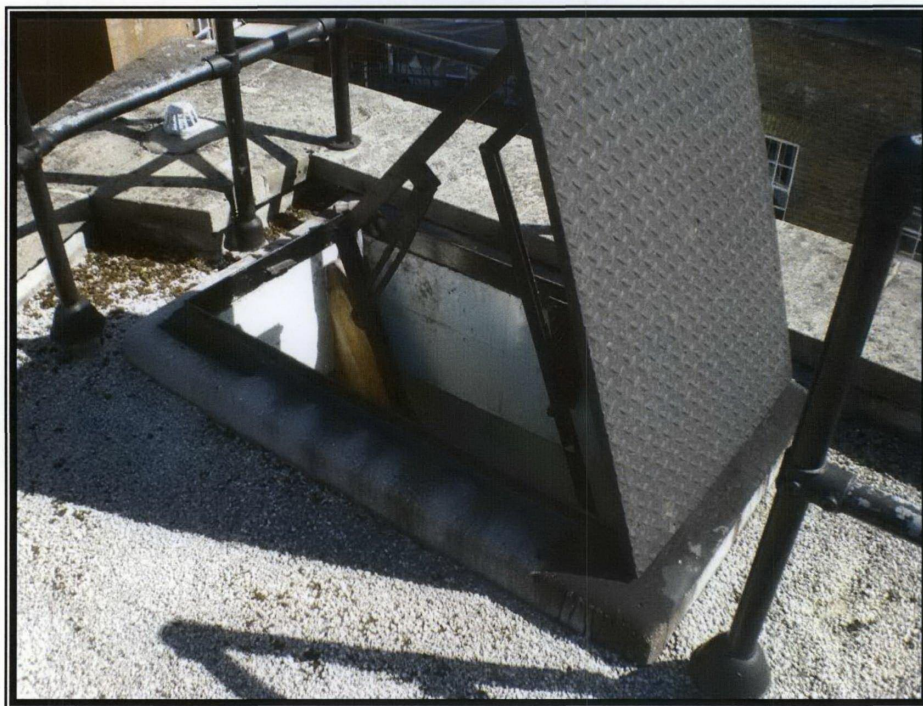
Photograph 49 – Roof hatch

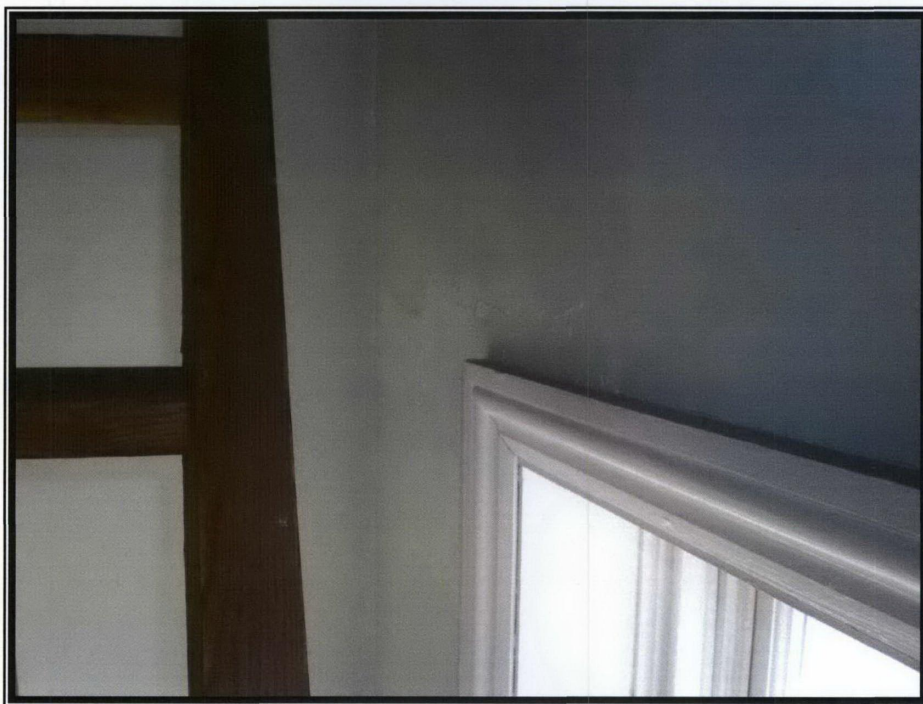
Photograph 50 – Blown plasterwork and crack running to left of window opening

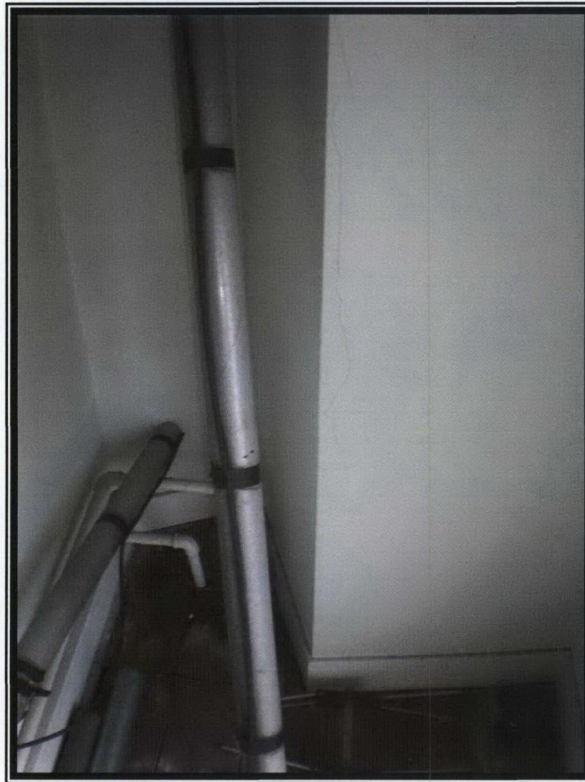
Photograph 51 – Hairline crack running vertically down eastern wall

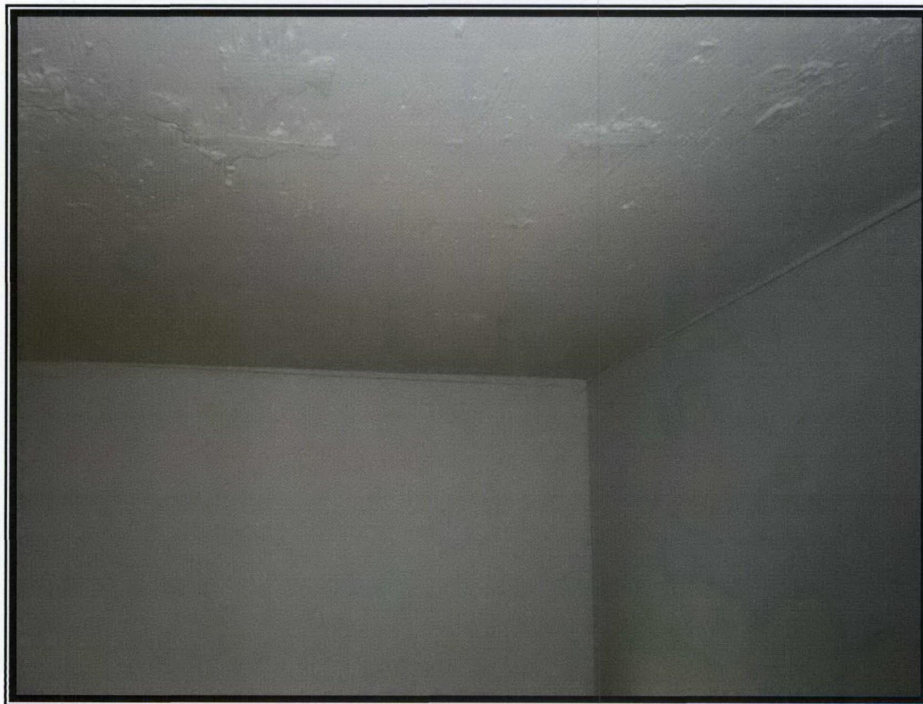
Photograph 52 – Separation between exposed ceiling partition walls

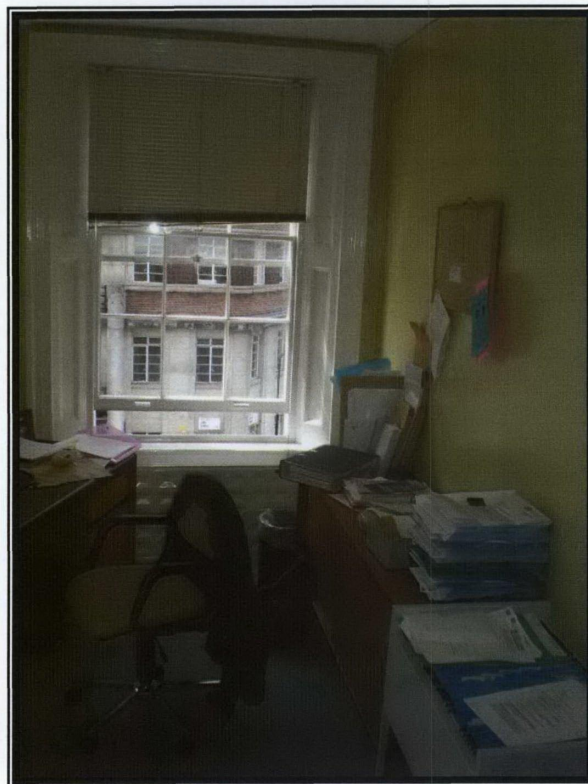
Photograph 53 – Separation between partition walls, solid walls and ceiling

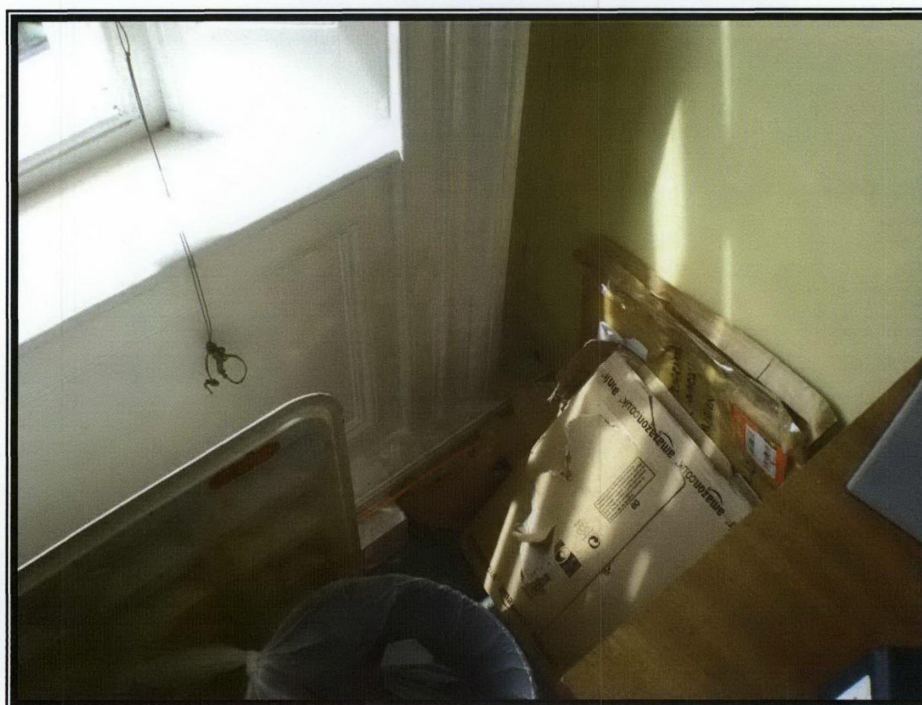
Photograph 54 – Separation between partition walls and solid wall

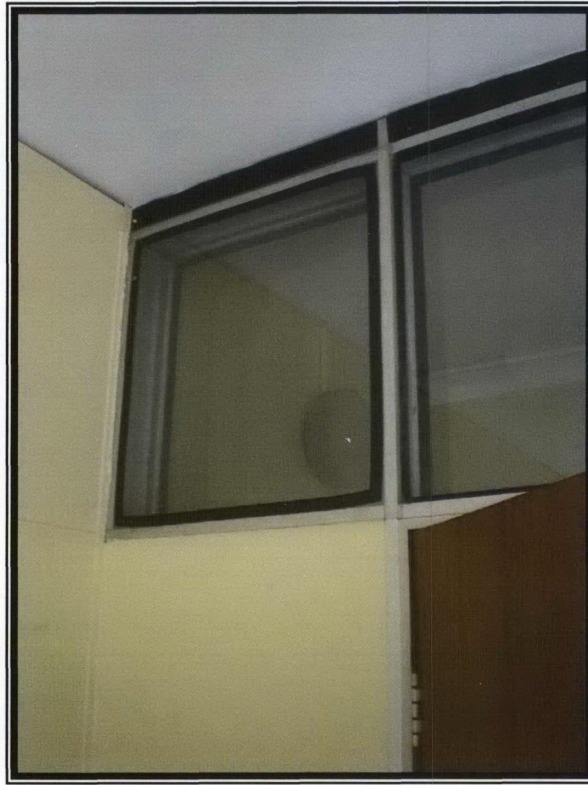
Photograph 55 – Glazing repair top left pane over door opening

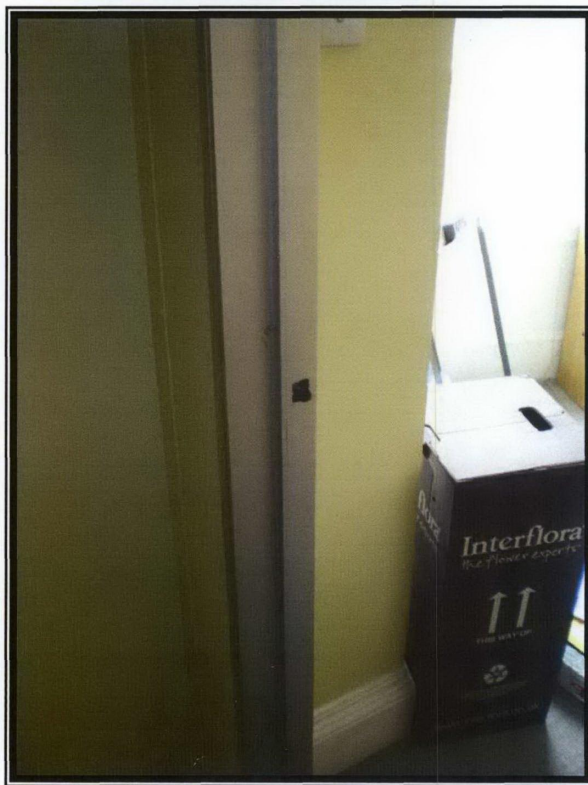
Photograph 56 – Door latch-keep damaged

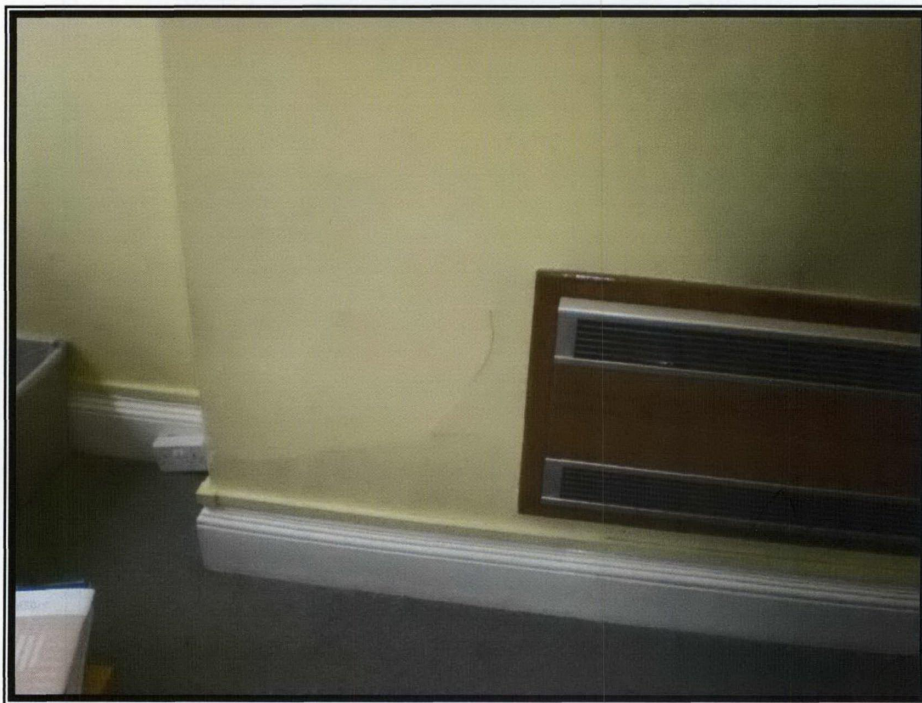
Photograph 60 – Blown plasterwork to chimney breast

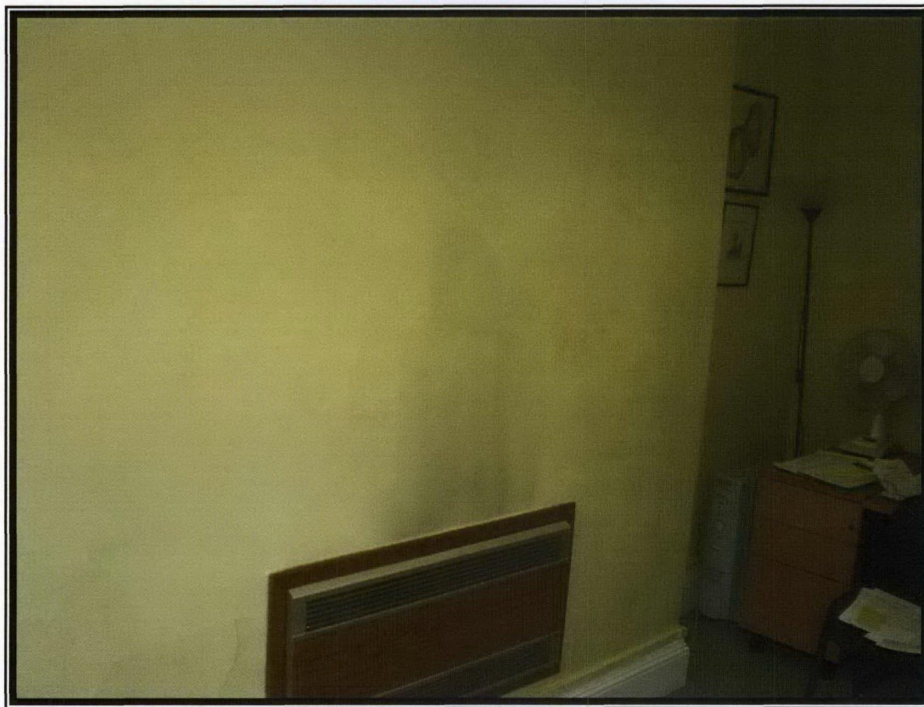
Photograph 61 – Blown plasterwork to chimney breast

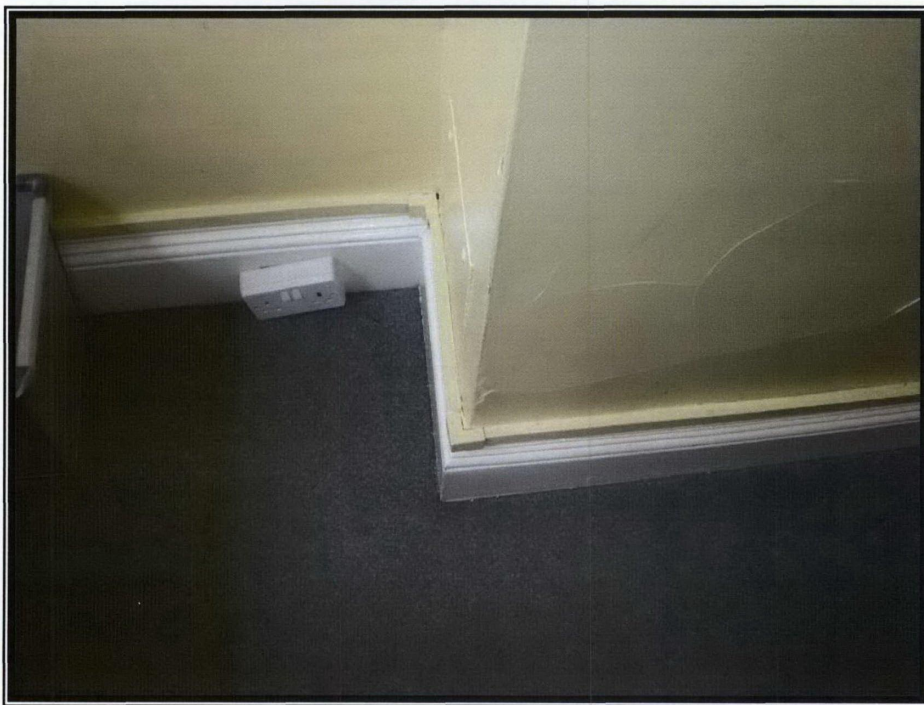
Photograph 62 – Displaced double socket to left of chimney breast

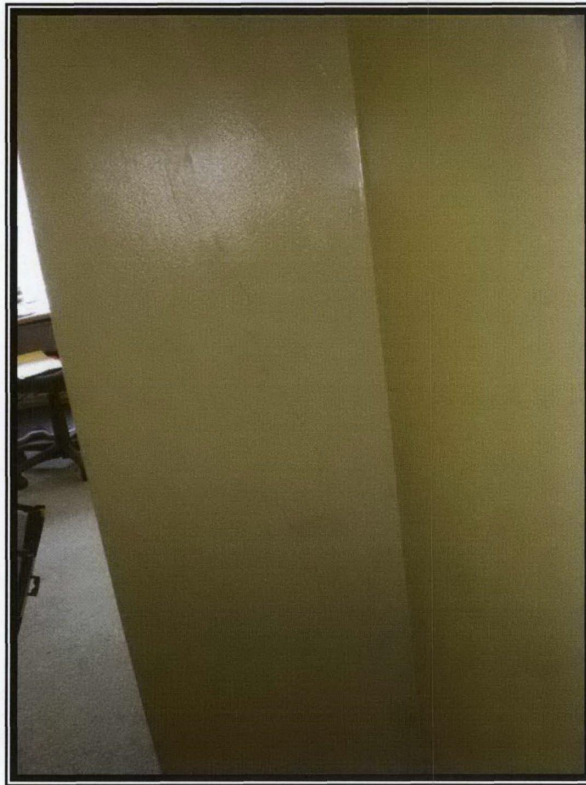
Photograph 63 – Hairline stress crack running down right hand side face of breast

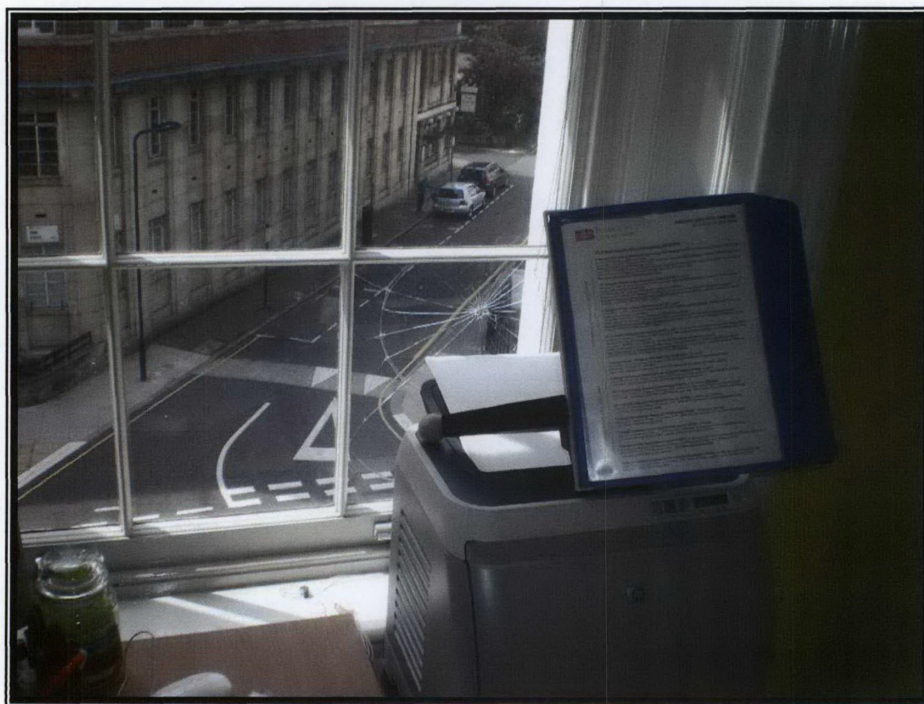
Photograph 64 – Broken window pane to bottom sash of right hand window

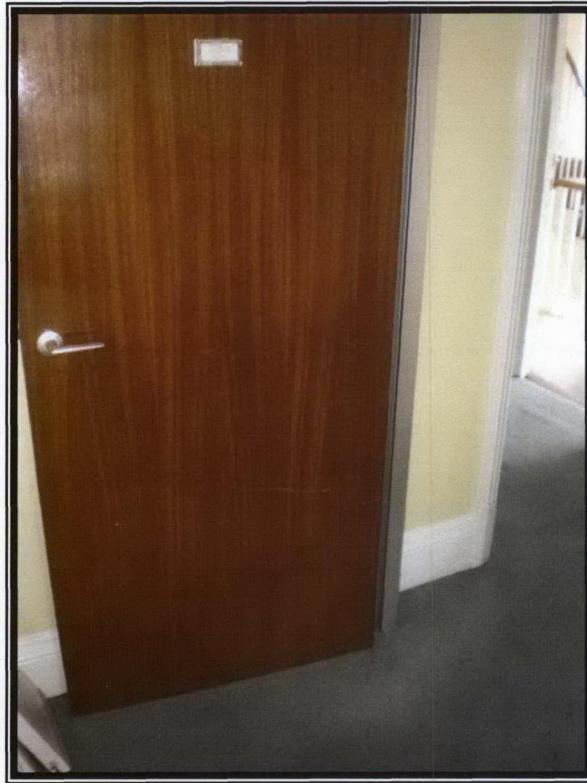
Photograph 65 – Scraps to outside face of door

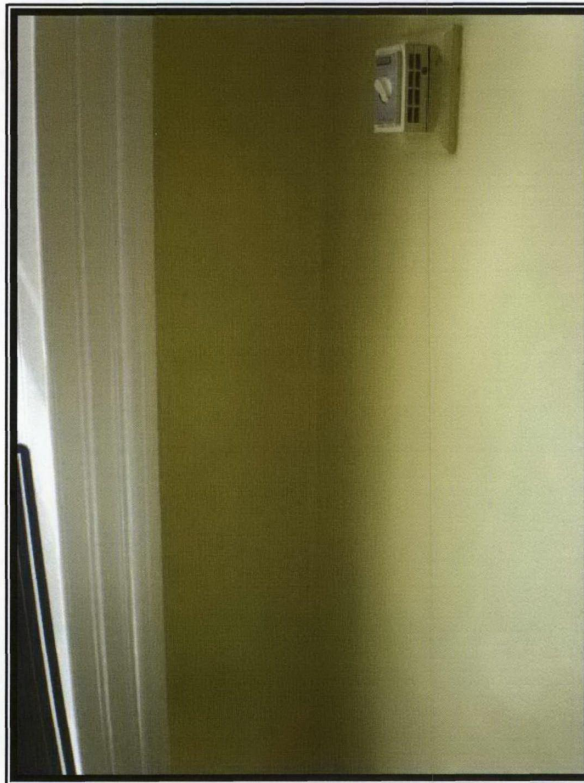
Photograph 67 – Crack running down north western corner

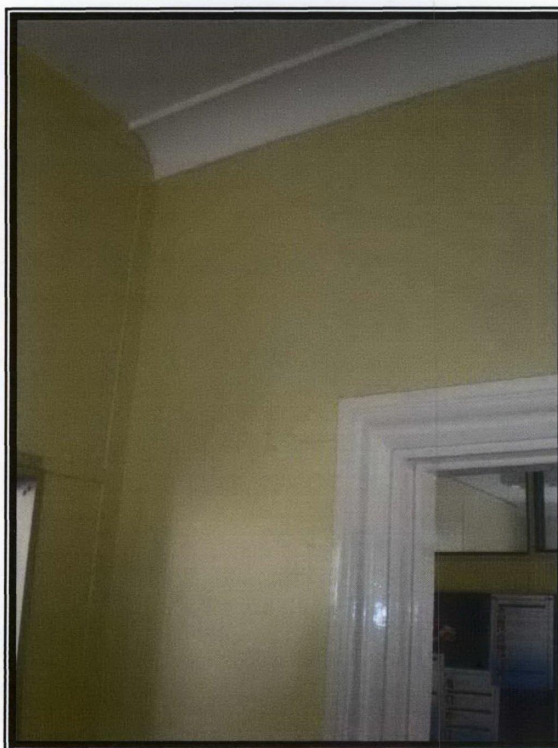
Photograph 68 – Raking crack over door to lobby on both sides

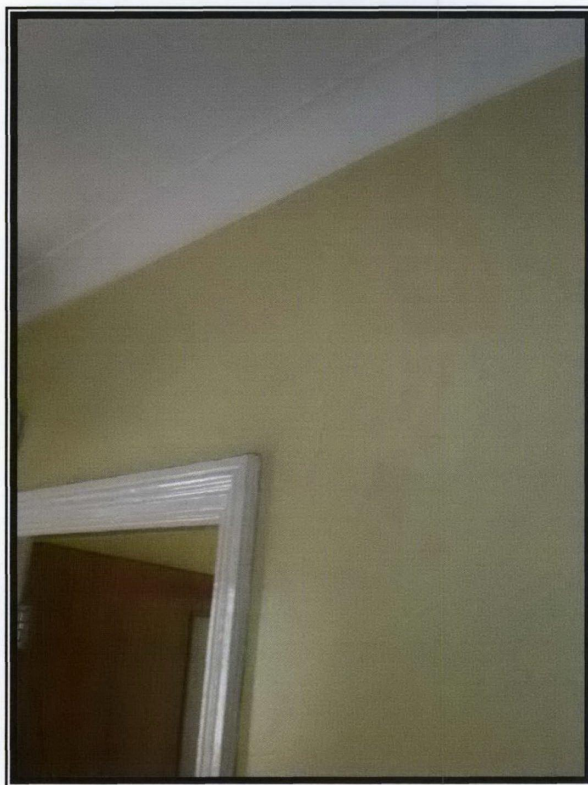
Photograph 69 – Separation above partition walls

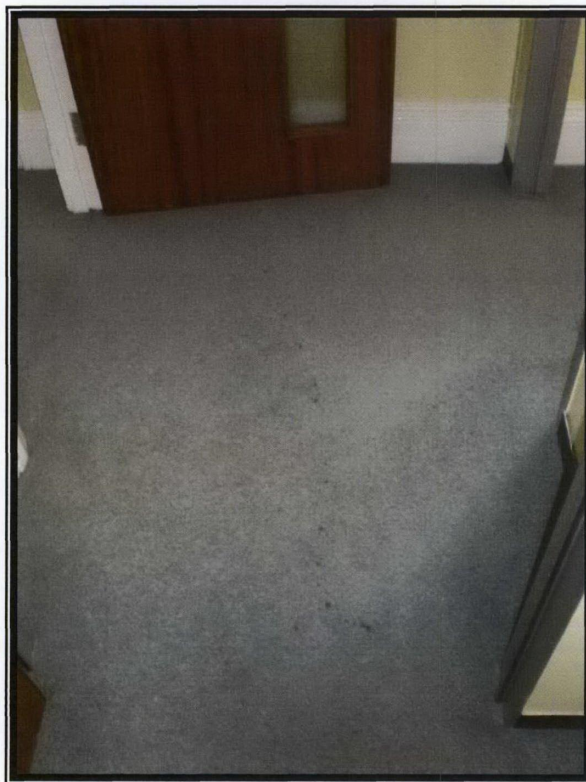
Photograph 70 – Stains to carpet

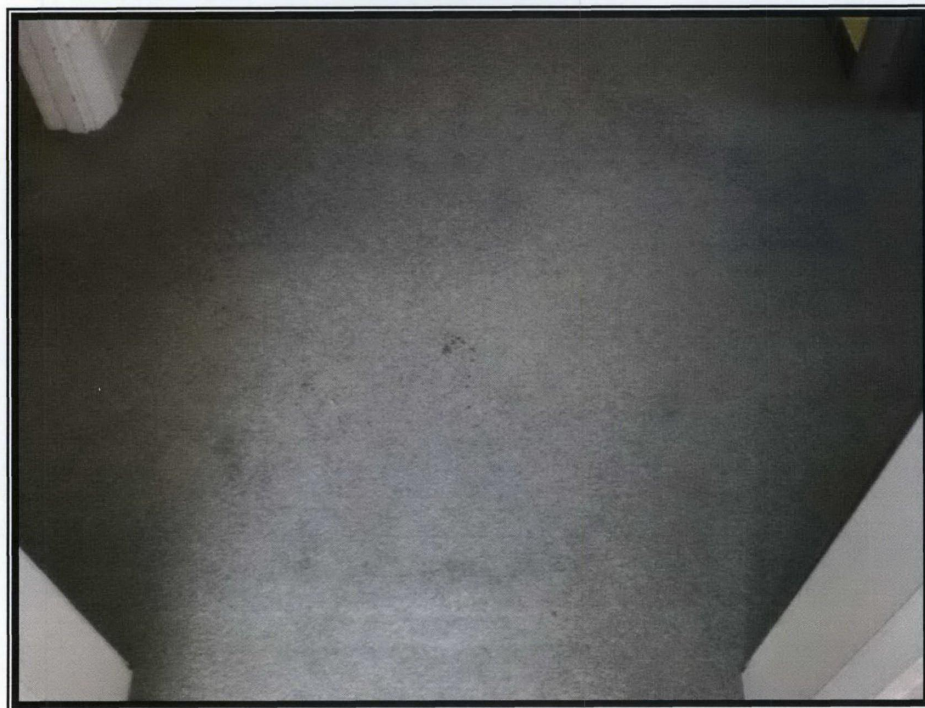
Photograph 71 – Stains to carpet

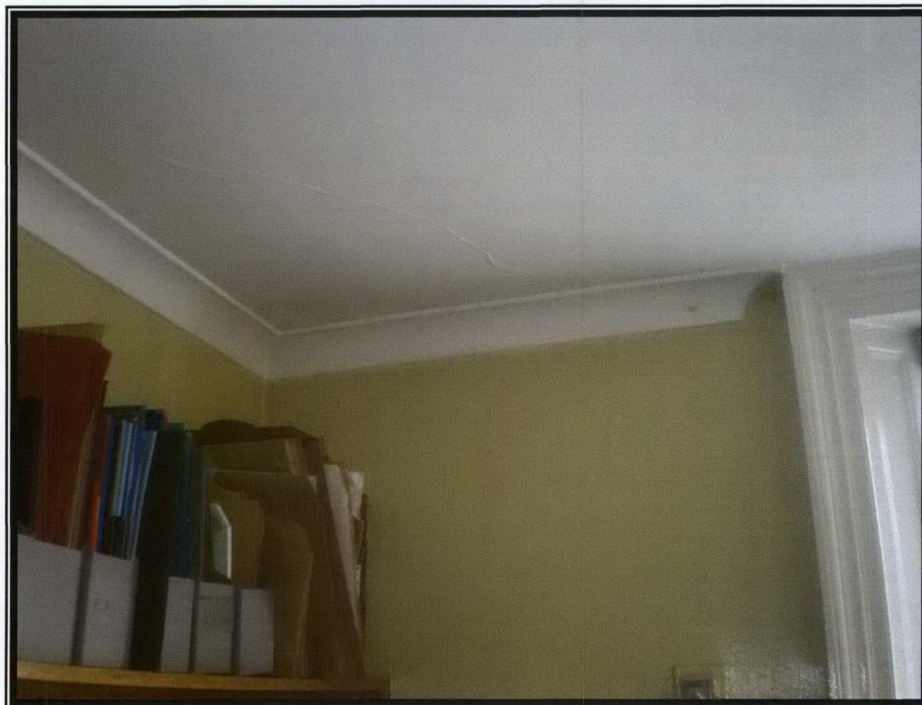
Photograph 73 – Damp staining and damaged decorations in north eastern corner to wall and ceiling

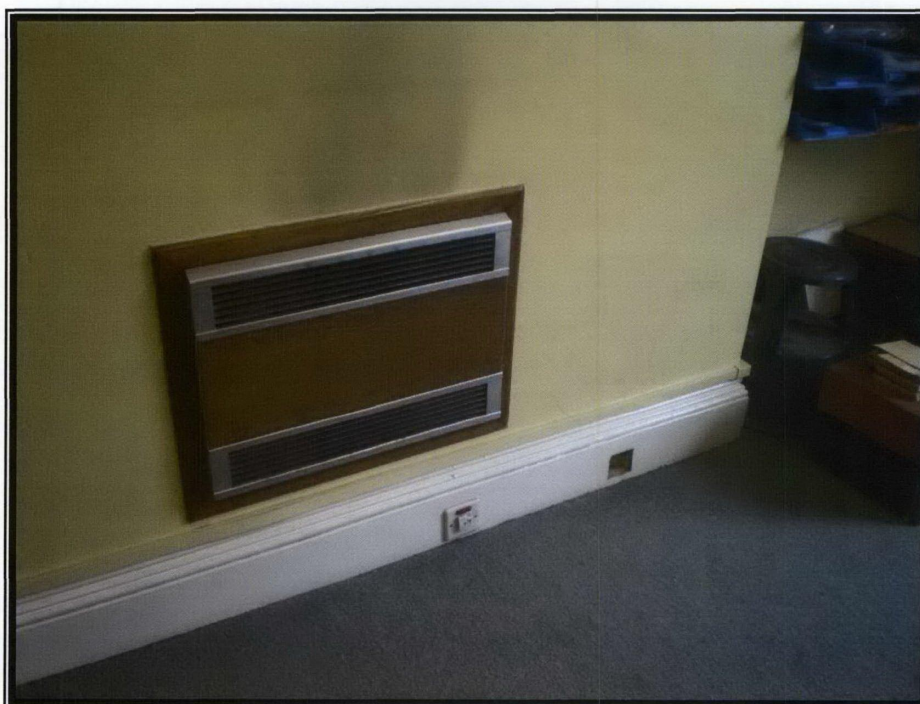
Photograph 74 – Cracked plaster to left of heater and missing socket in skirting

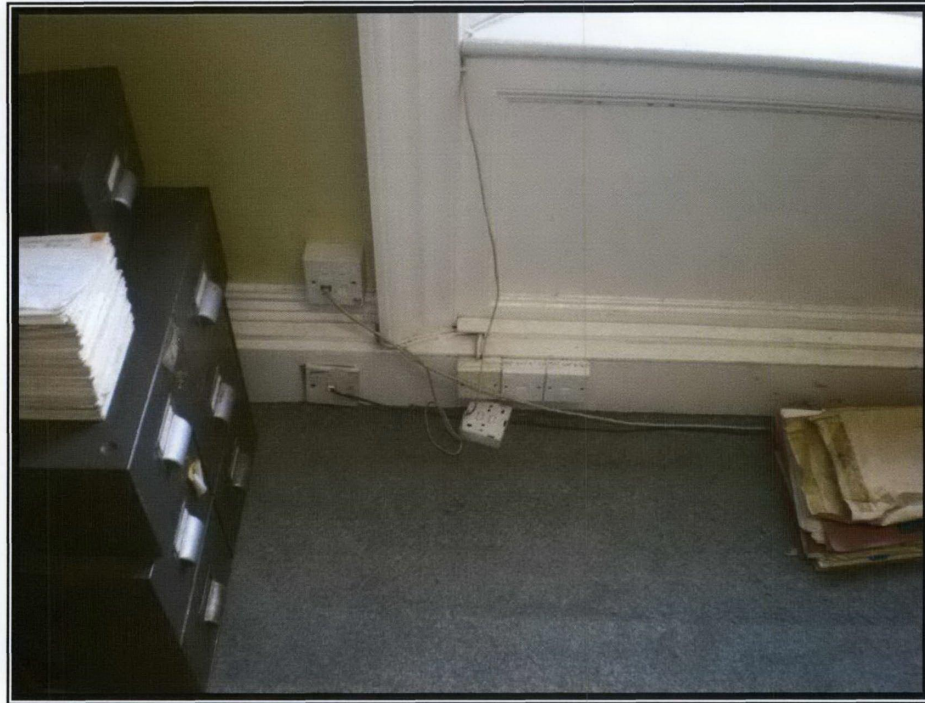
Photograph 75 – Displaced socket below window

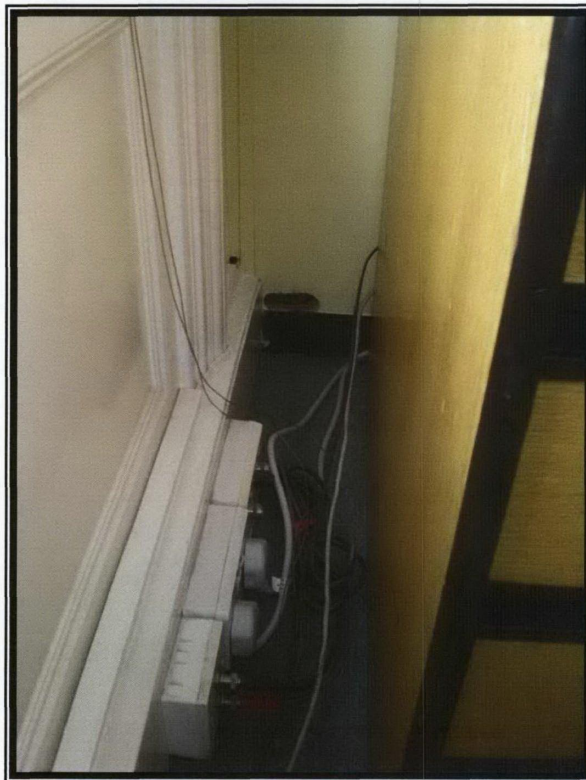
Photograph 76 – Hole in partition wall within south eastern corner

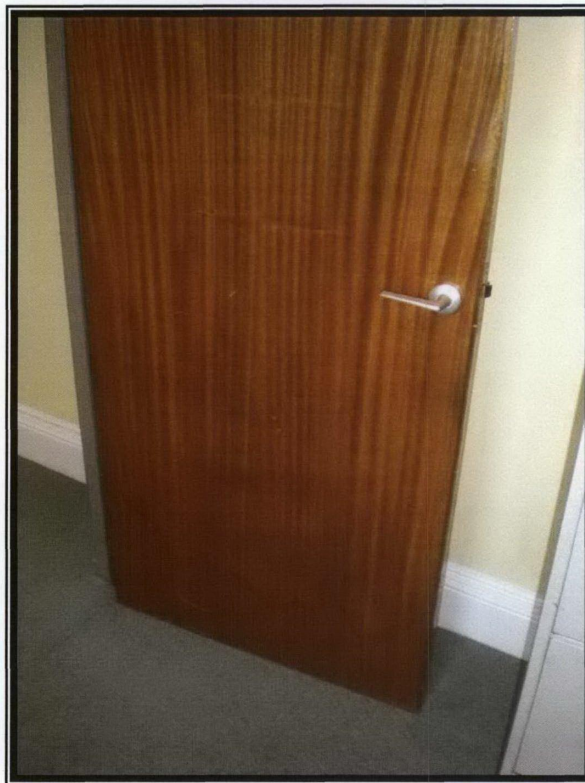
Photograph 77 – Scraps and scuffs to door
