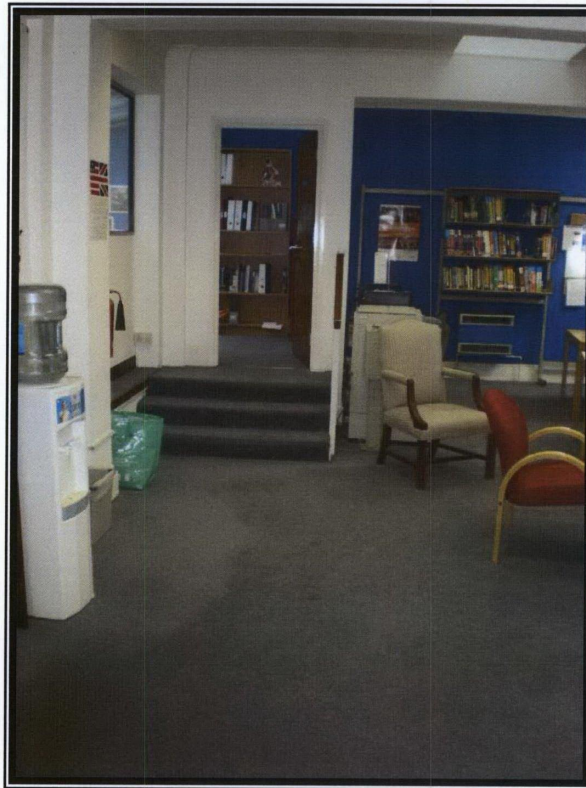
Photograph 167 – Carpet discoloured

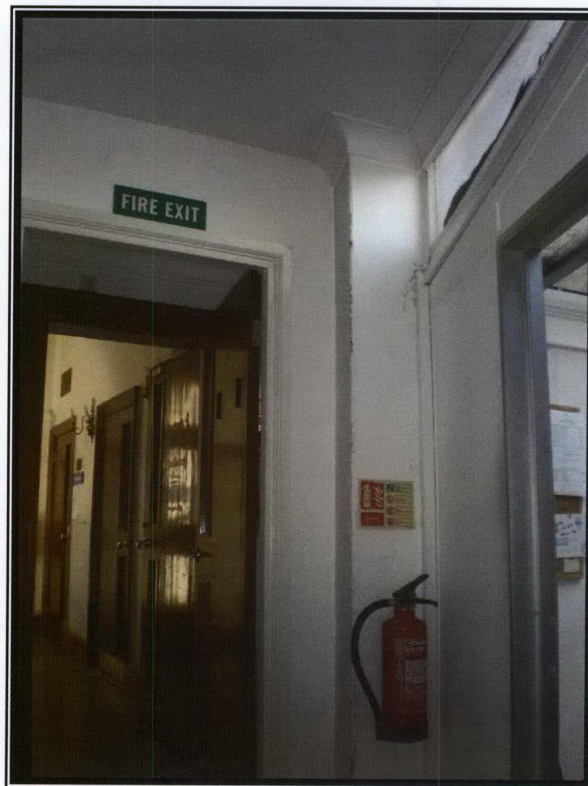
Photograph 168 – Water staining to pillar abutting pitched roof

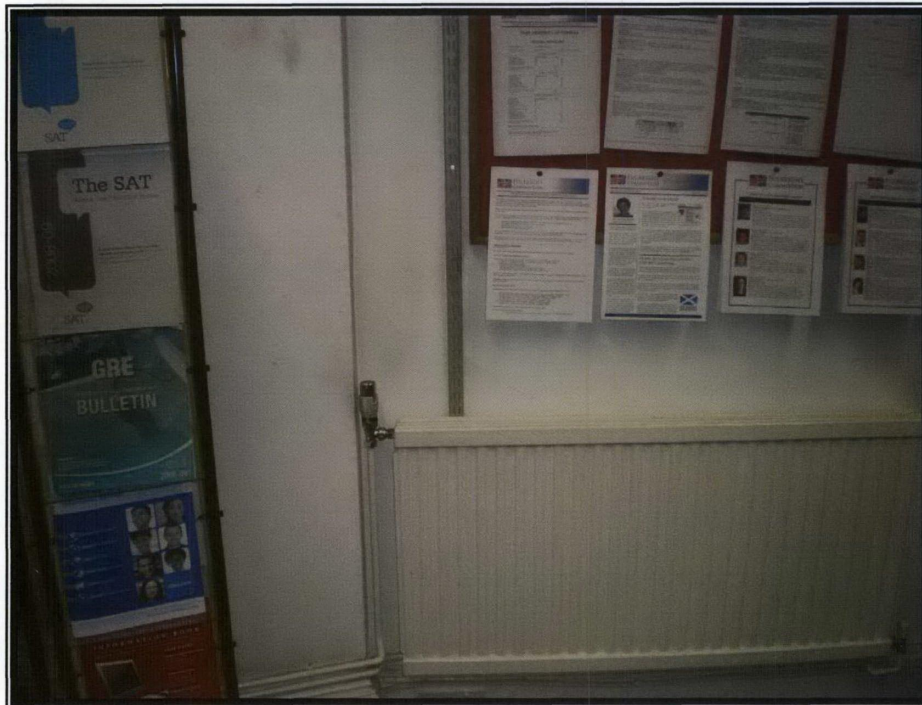
Photograph 169 – Diagonal crack within north eastern corner behind radiator

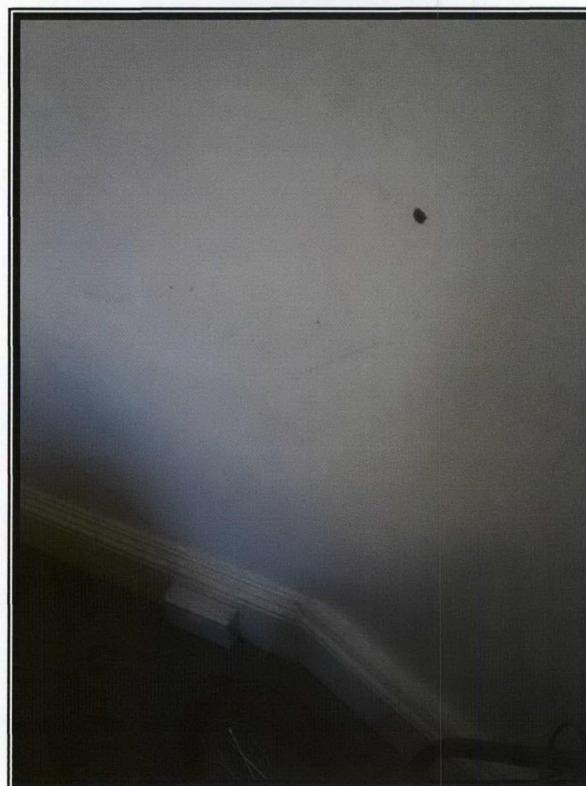
Photograph 170 – Hairline crack and damage to wall within northern wall between timber stud partition and solid wall

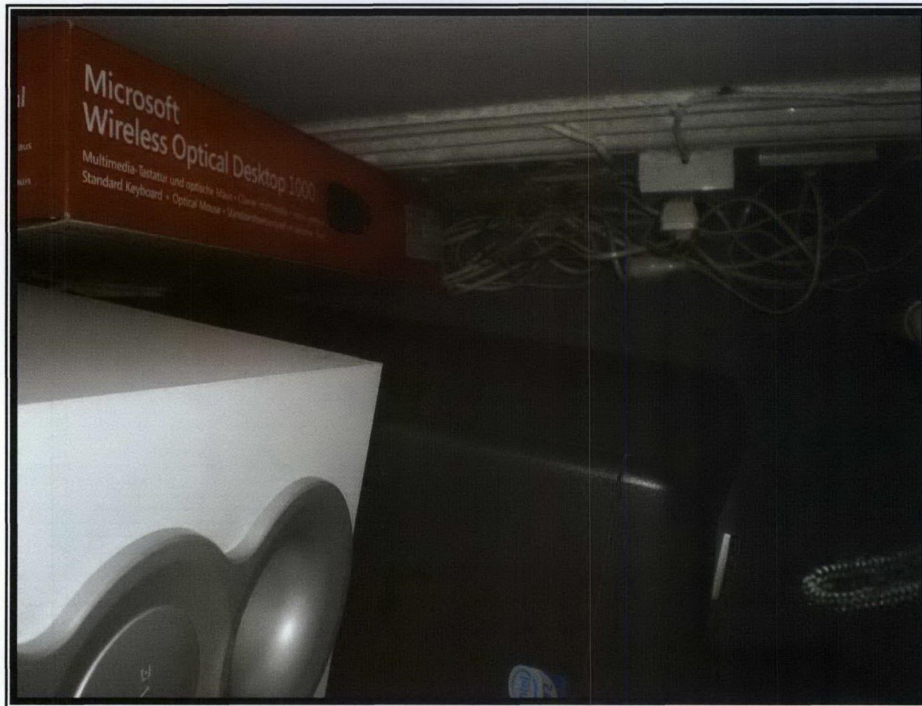
Photograph 171 – Damaged communications socket

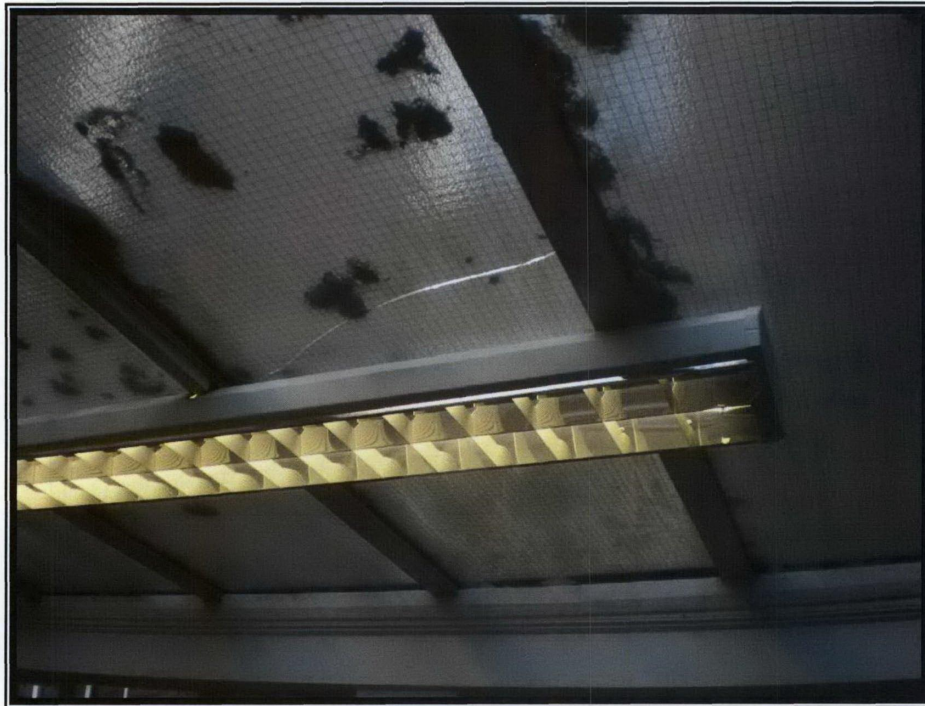
Photograph 173 – Crack in glazed roof pane

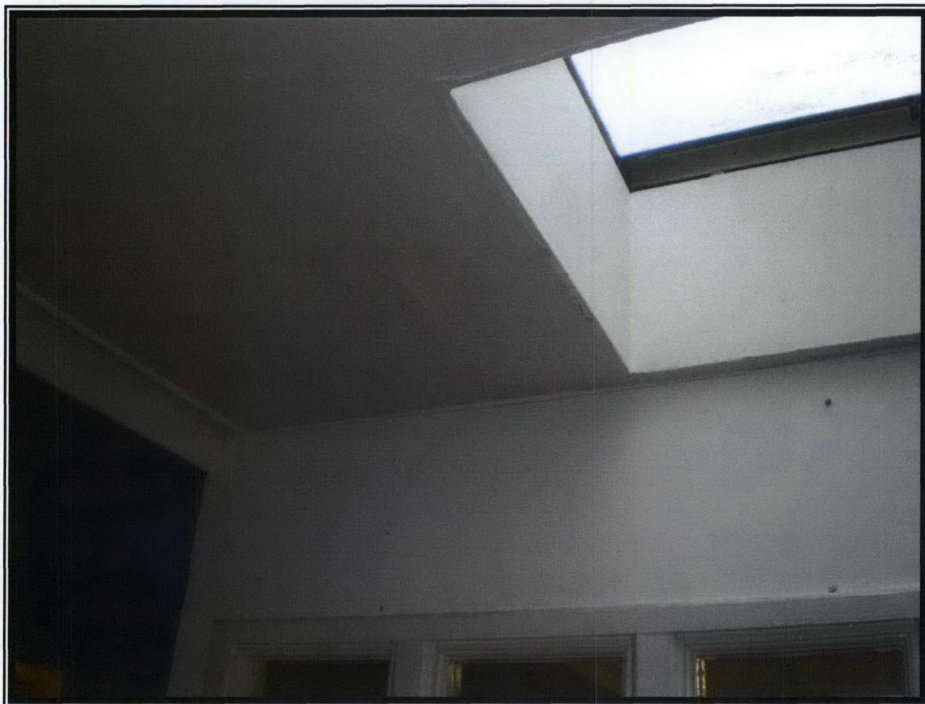
Photograph 174 – Cracking around perimeter of room and skylight opening

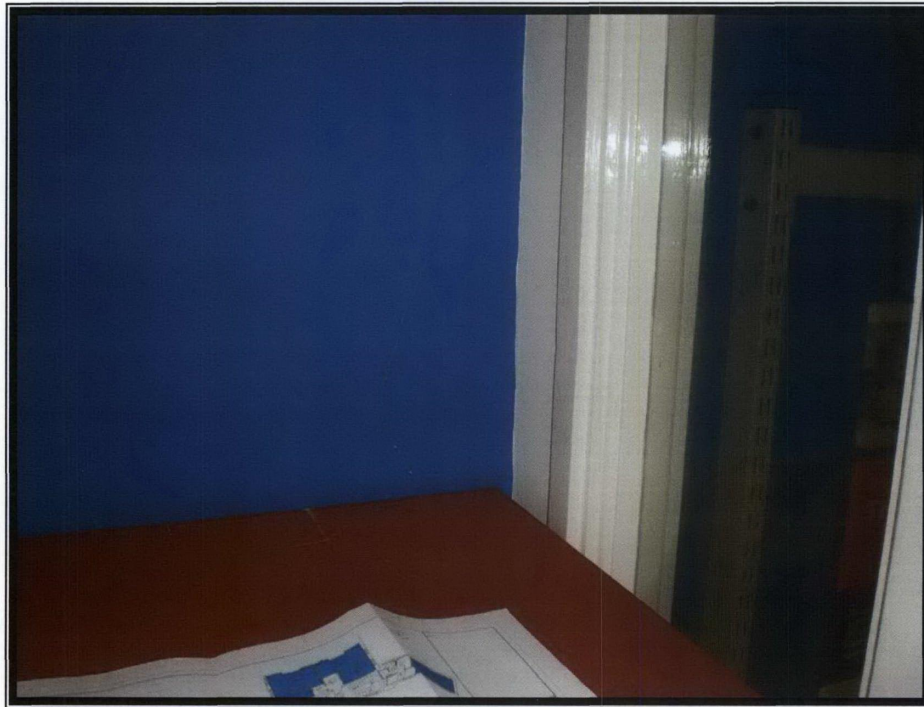
Photograph 175 – Crack in plasterwork to north eastern corner

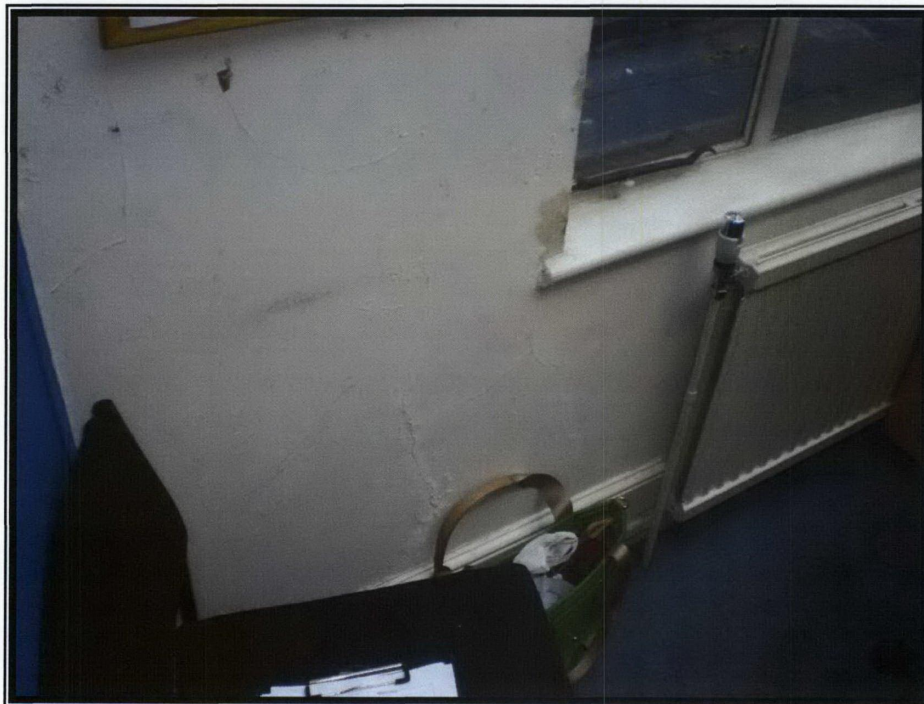
Photograph 176 – Cracked and damp plasterwork to western wall

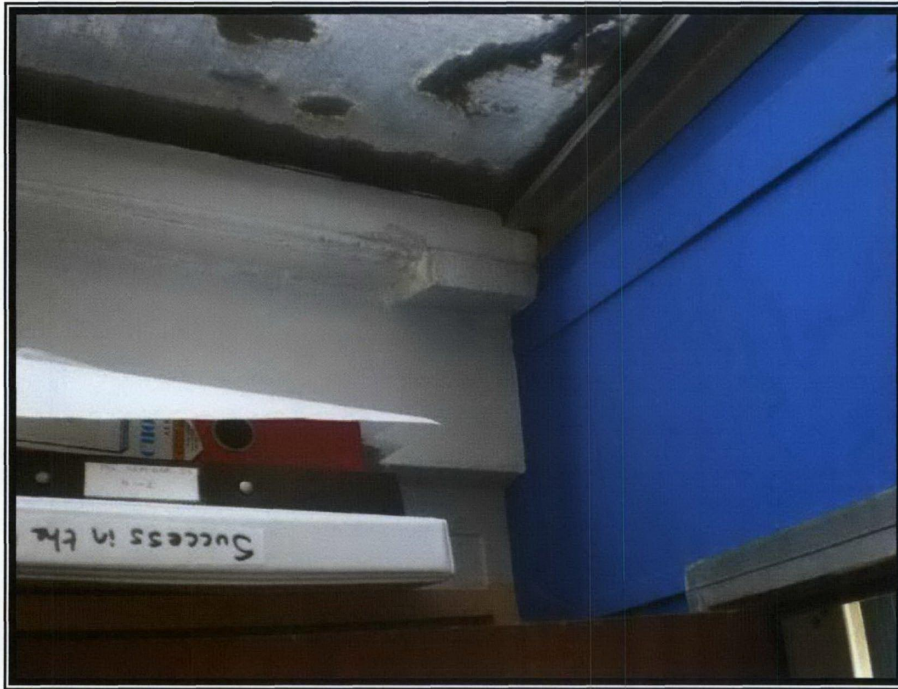
Photograph 177 – Damp stain to bulkhead of western wall

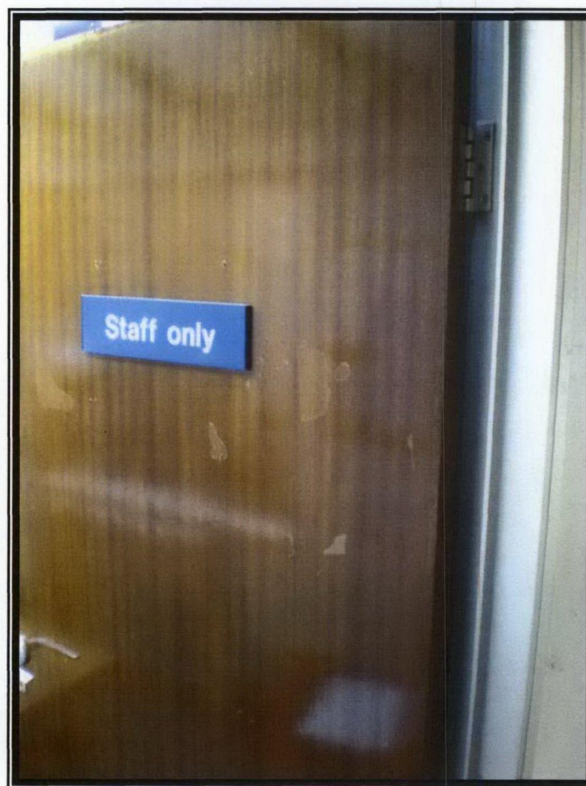
Photograph 178 – Door coating chipped and worn

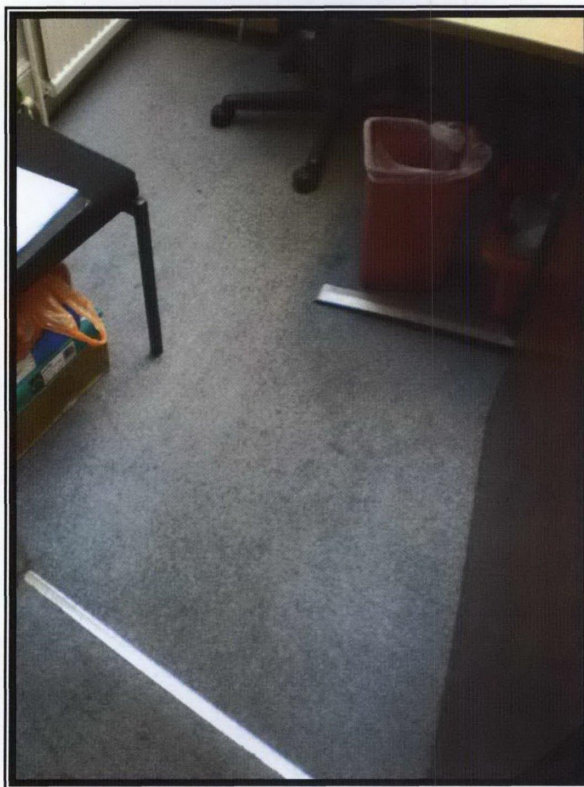
Photograph 179 – Carpet soiled

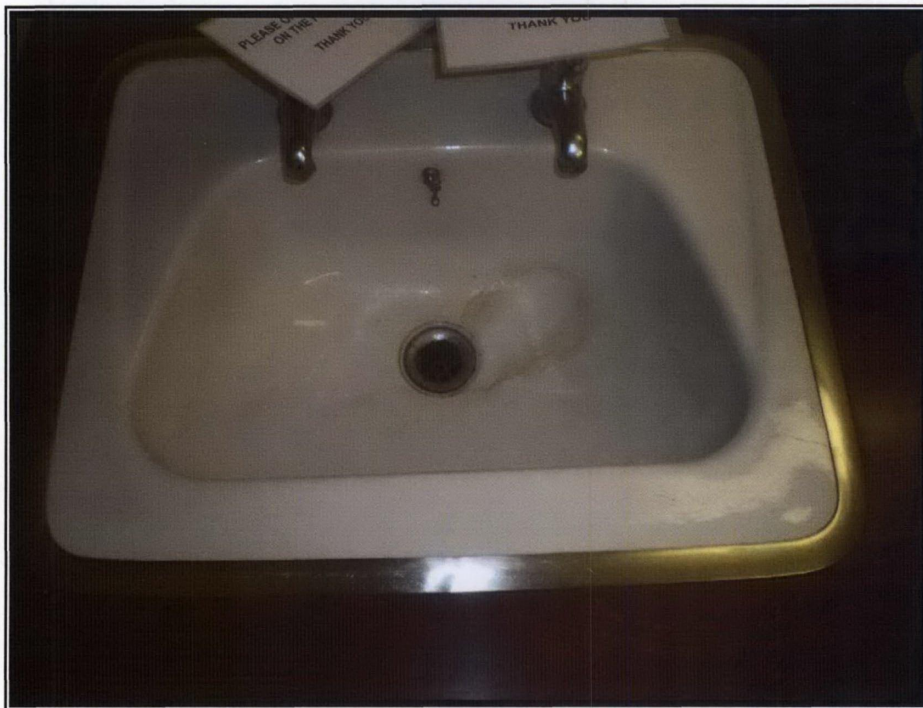
Photograph 181 – Stained basin

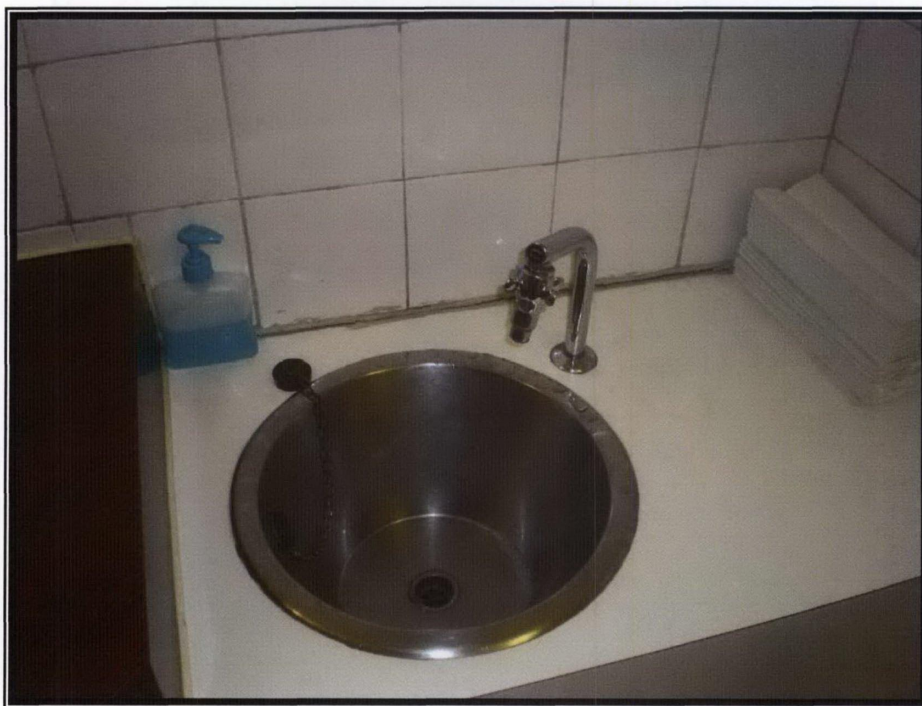
Photograph 182 – Separation between sink top and tiled surround

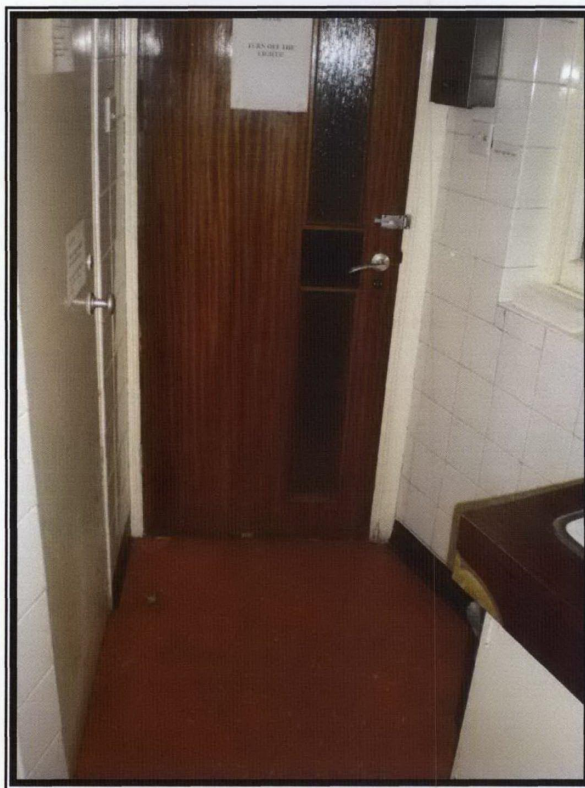
Photograph 183 – Base of door and sink top chipped

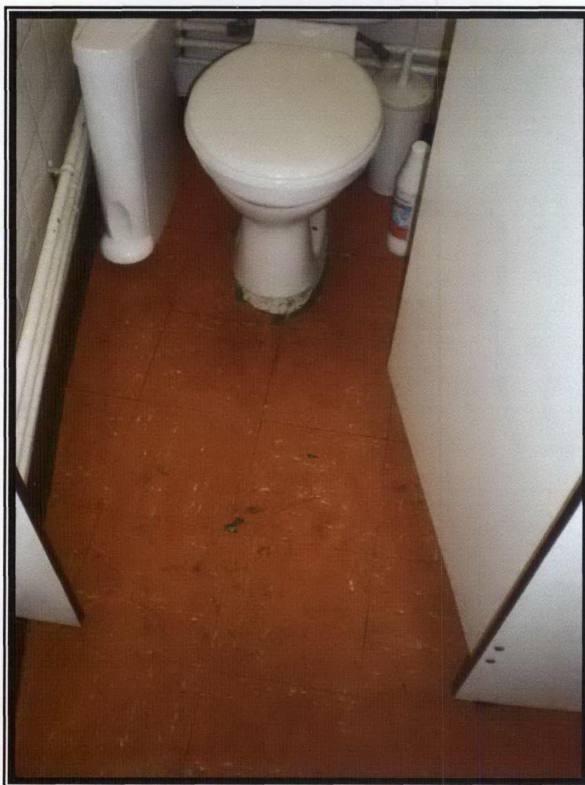
Photograph 184 – Floor stained, chipped and gap around toilet pedestal

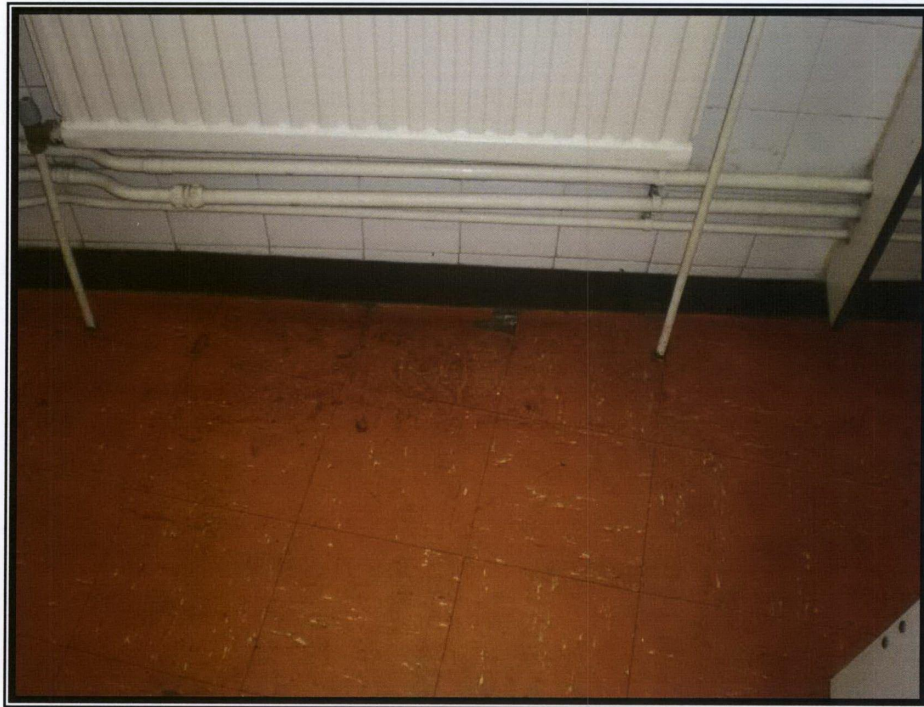
Photograph 185 – Damage to floor finish

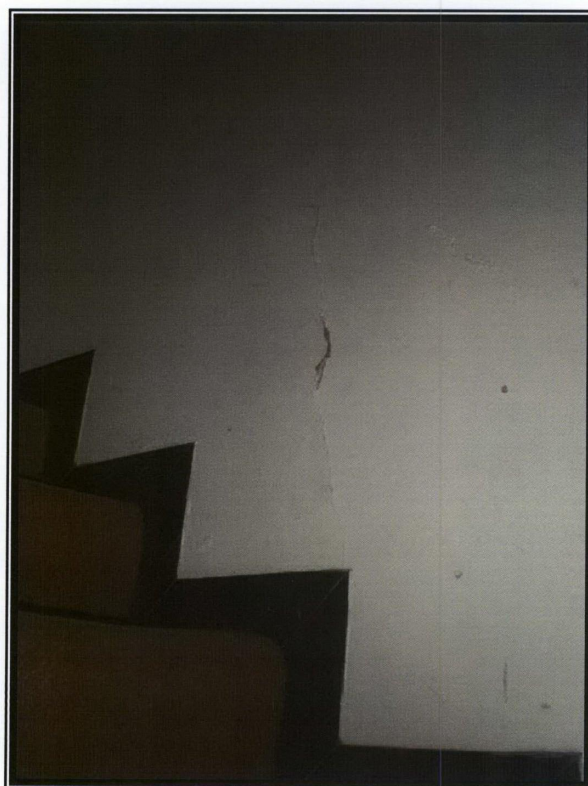
Photograph 188 – Plasterwork cracked above stairs

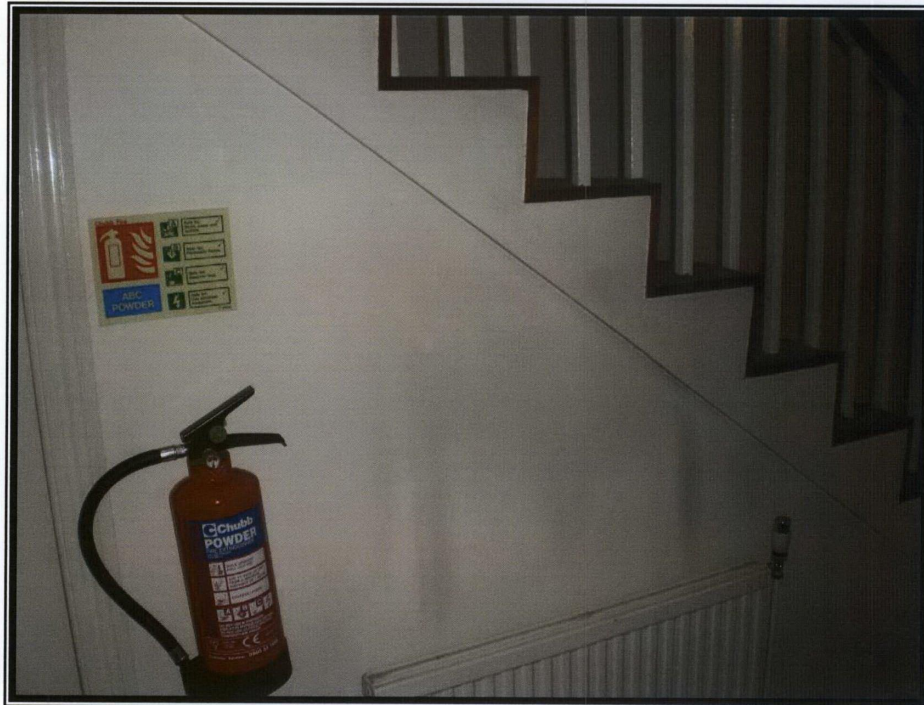
Photograph 189 – Blown plasterwork below stairs

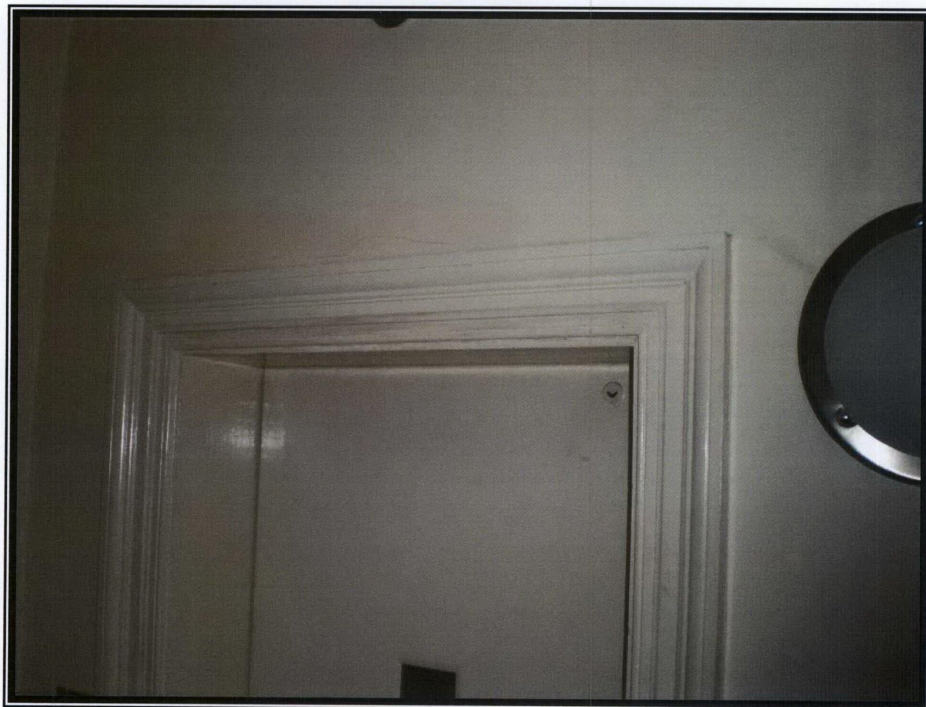
Photograph 190 – Horizontal crack above lift door opening

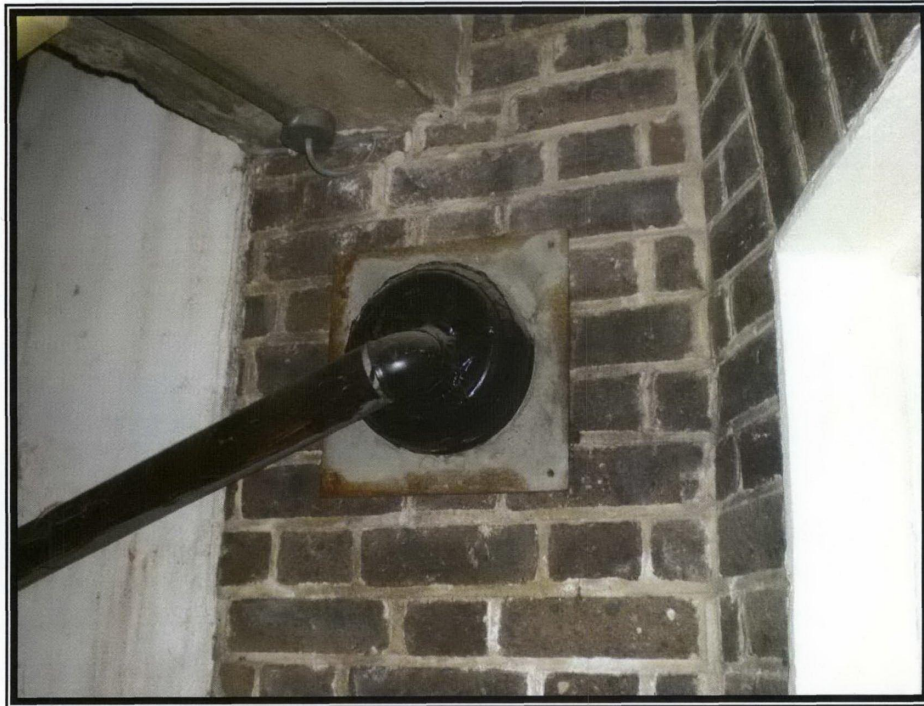
Photograph 193 – Alteration to vent outlet

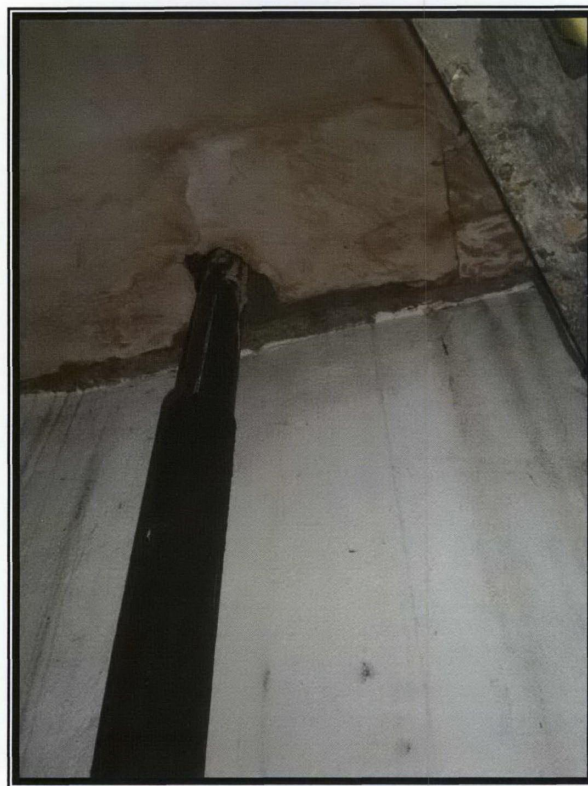
Photograph 194 – Damp staining to ceiling close to down pipe

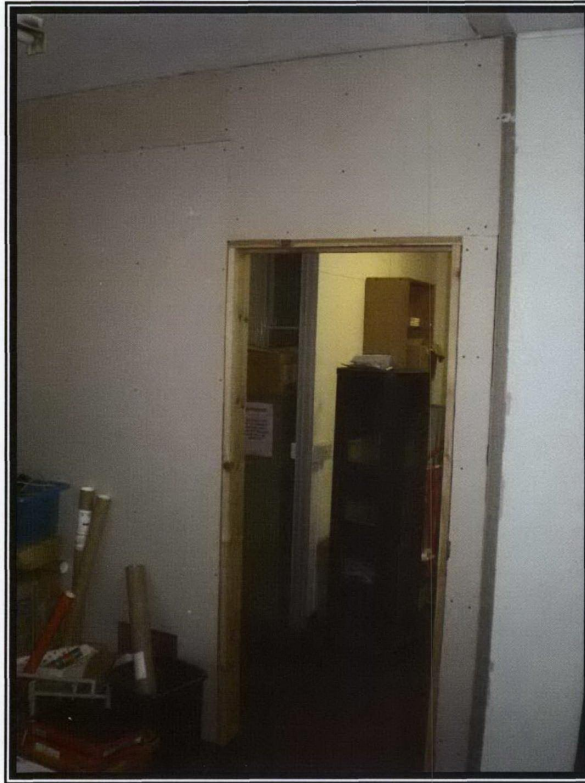
Photograph 197 – Partition wall un-decorated

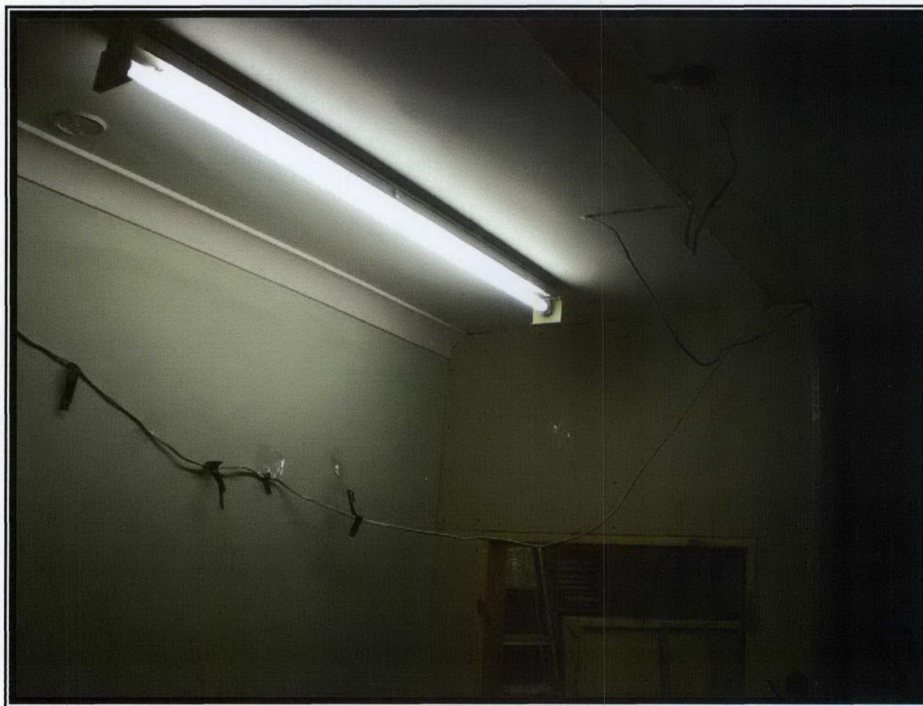
Photograph 198 – Ceiling damaged and wiring loose where partition wall removed
