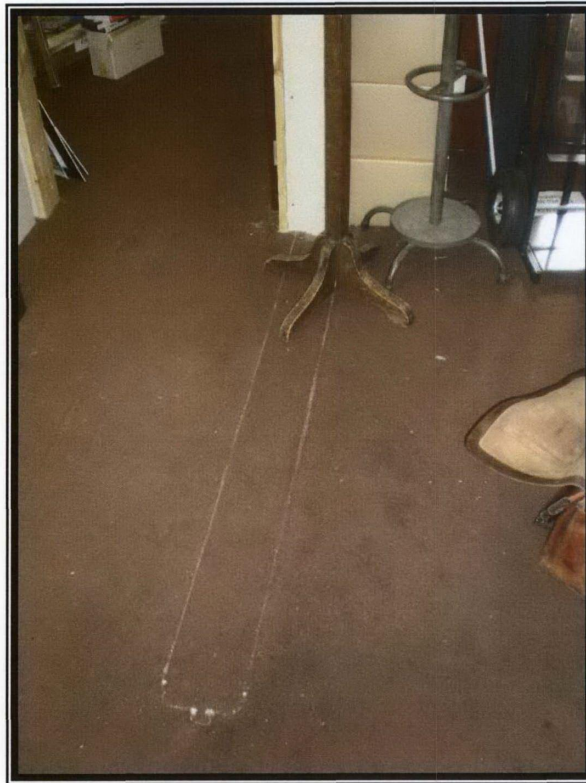
Photograph 199 – Carpet pieced in where partition wall removed

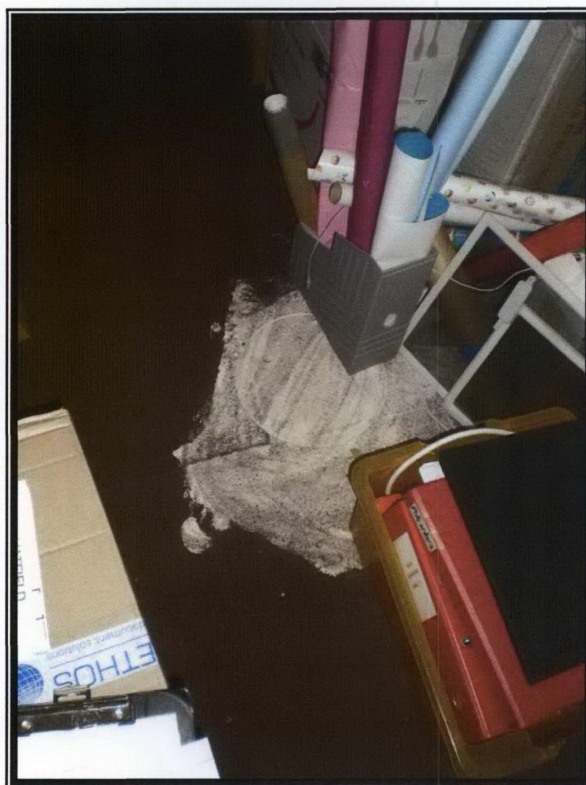
Photograph 200 – Paint damage to carpet

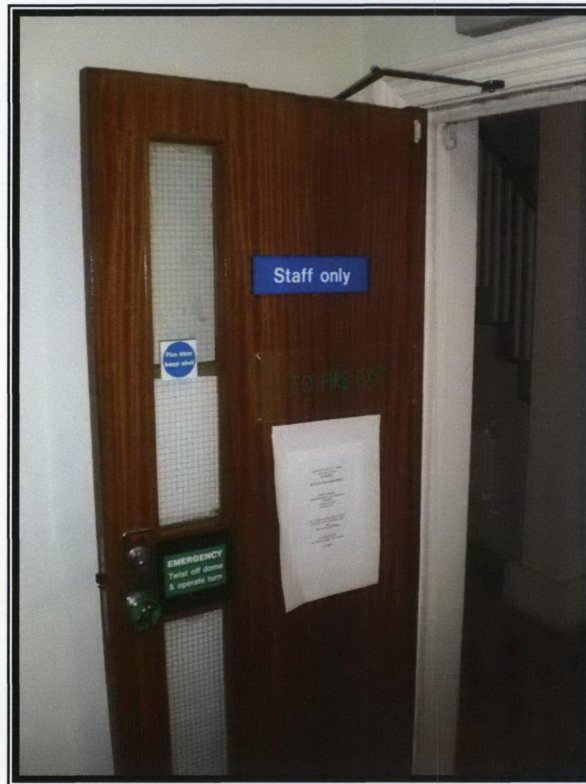
Photograph 201 – Door opening

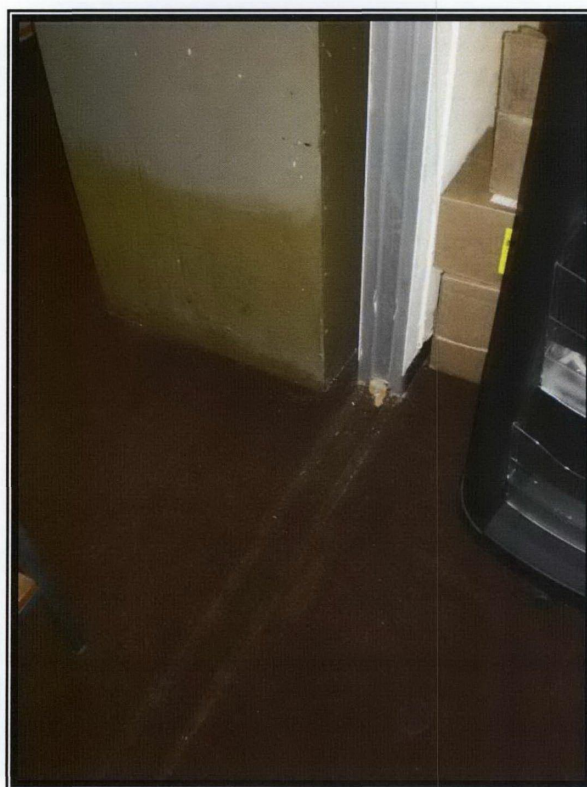
Photograph 204 – Displaced partition wall

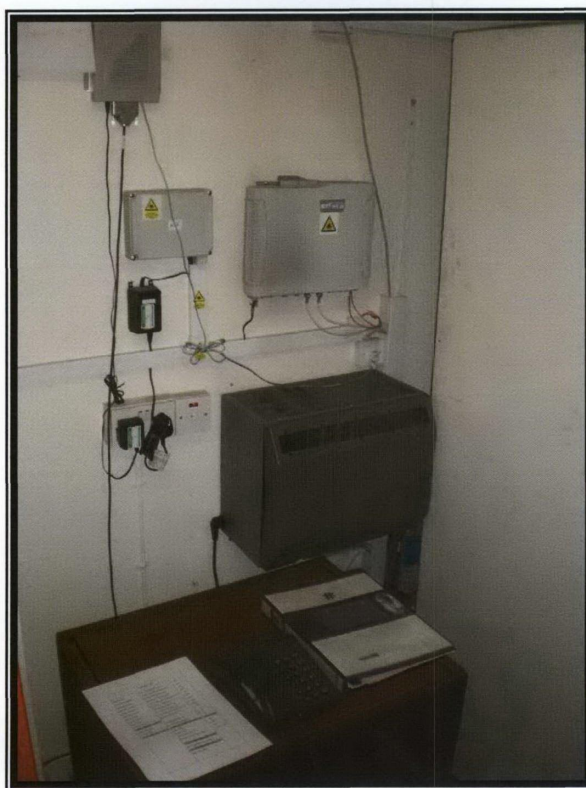
Photograph 205 – Communication fixtures

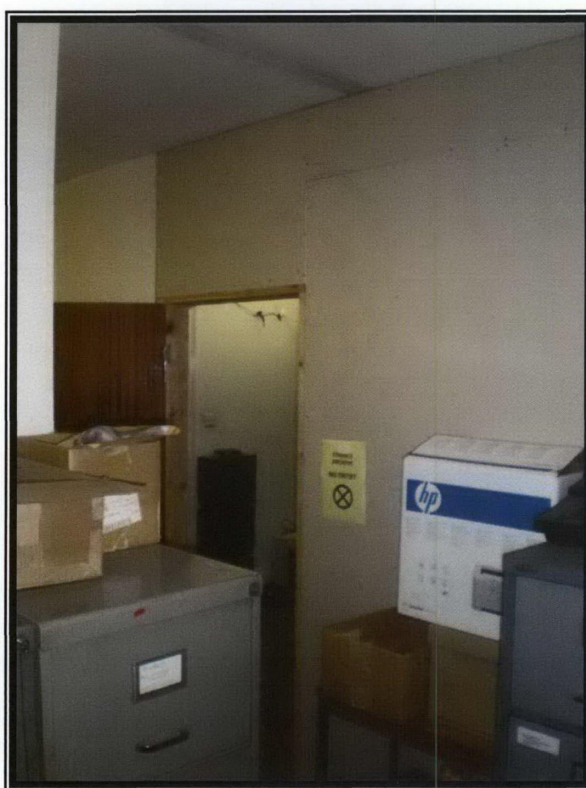
Photograph 206 – Partition walling

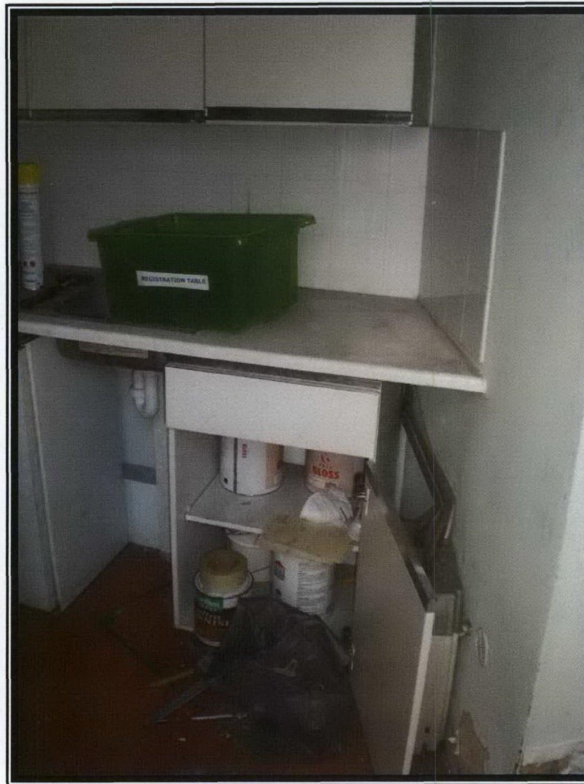
Photograph 209 – Kitchenette soiled

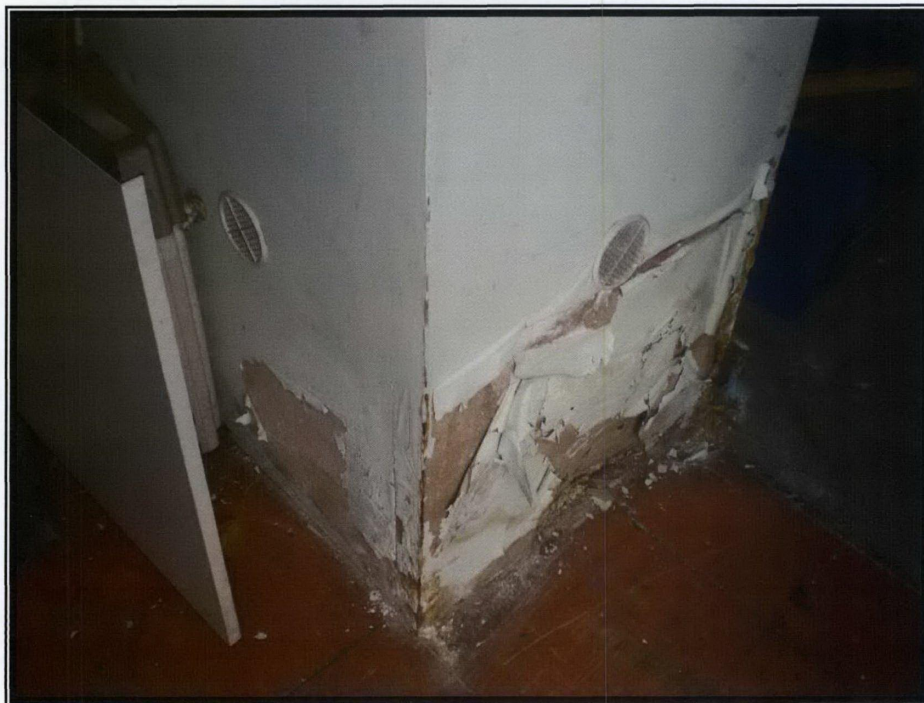
Photograph 210 – Damp damage to base of column

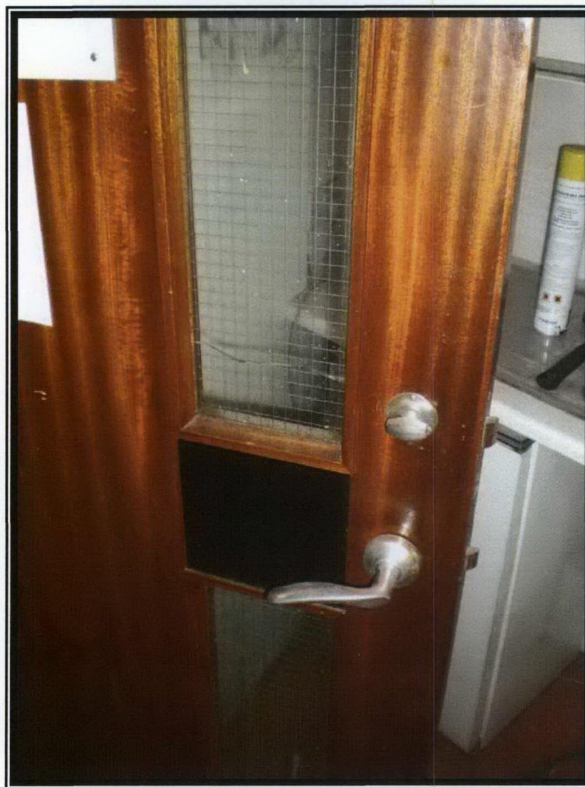
Photograph 211 – Glazed panel cracked within door

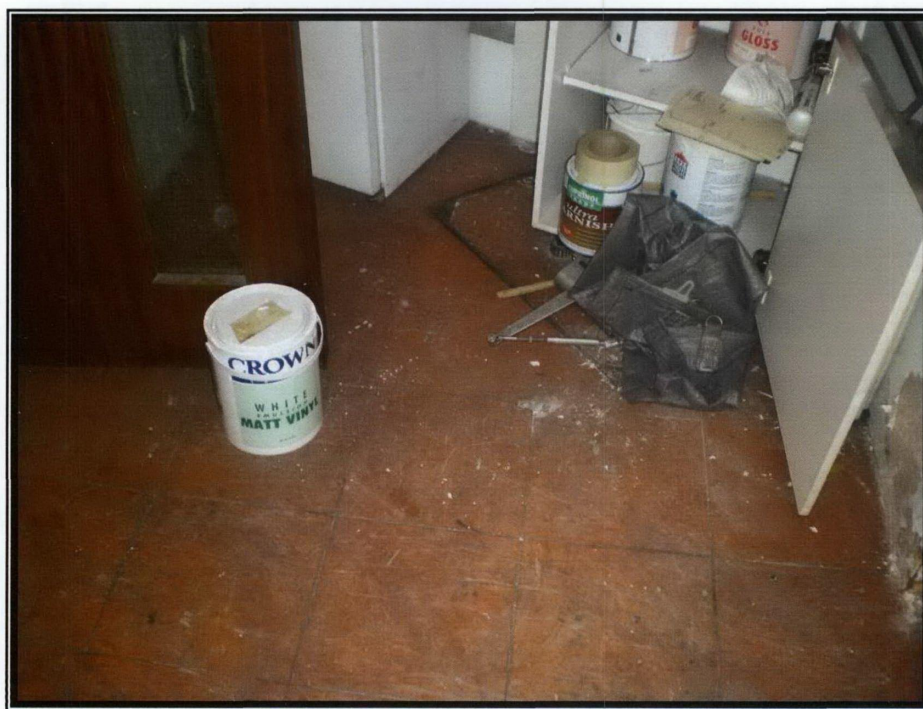
Photograph 212 – Vinyl floor covering damaged

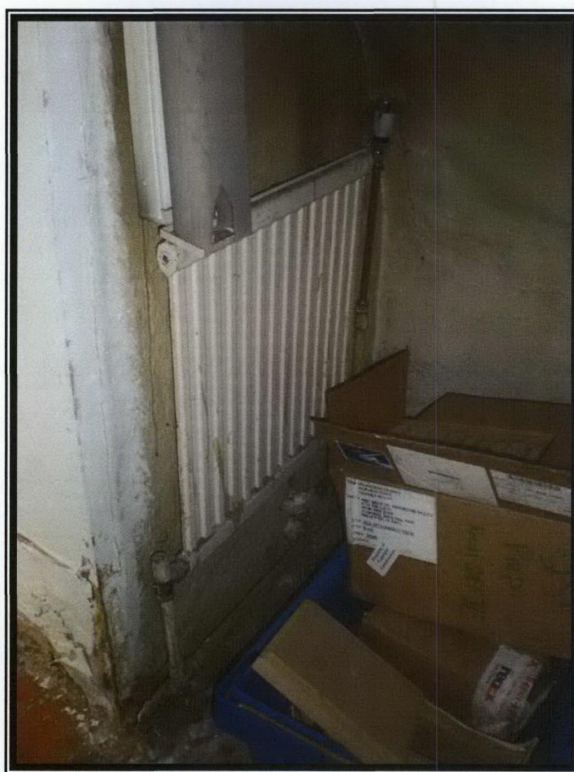
Photograph 214 – Damp damage to wall and damaged light fitting and radiator pipework

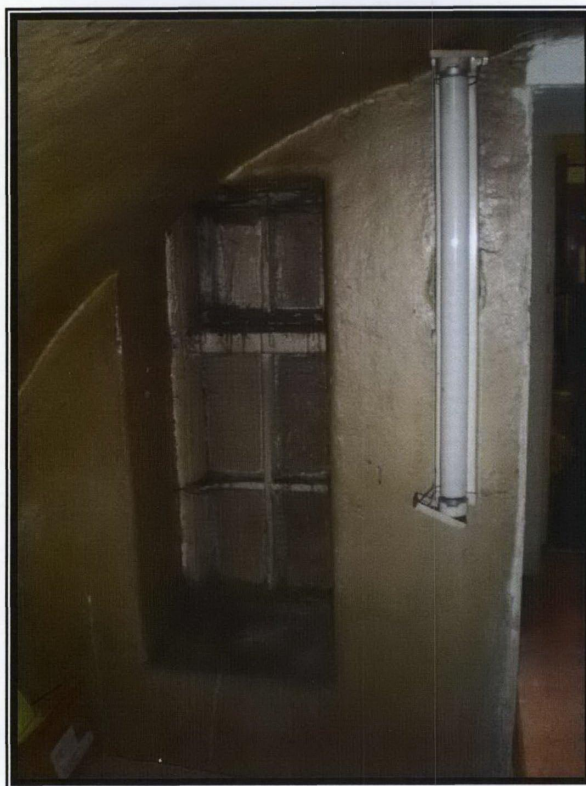
Photograph 215 – Boarded up window

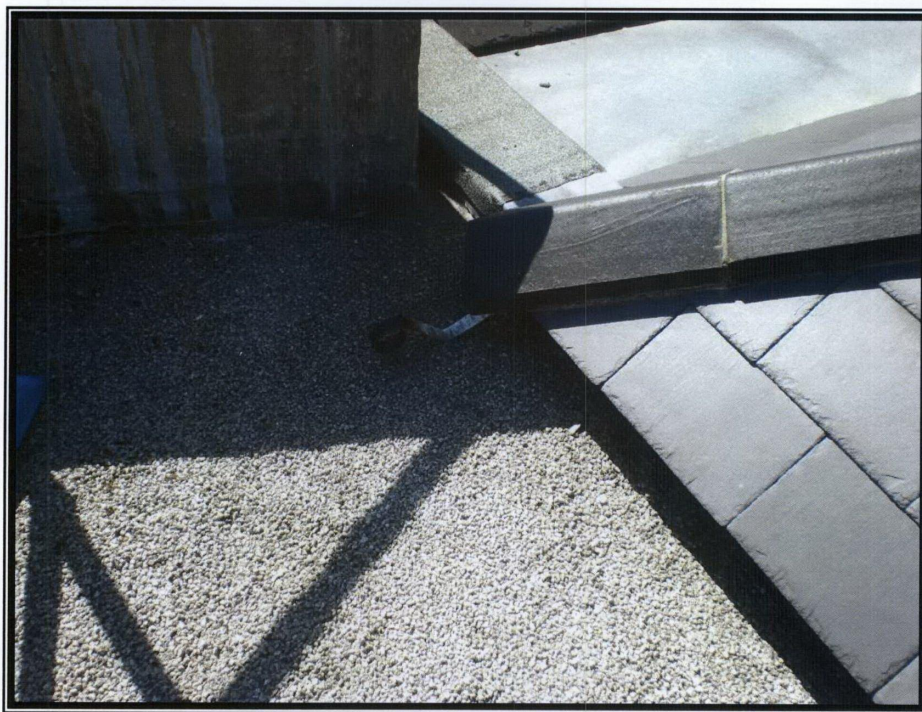
Photograph 220 – Bent hip iron

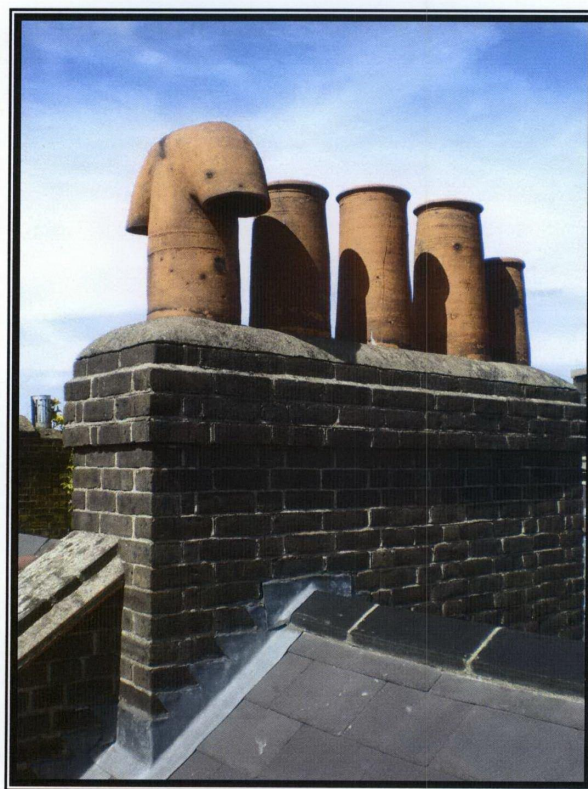
Photograph 221 – Rear chimney stack, open joint below flaunching

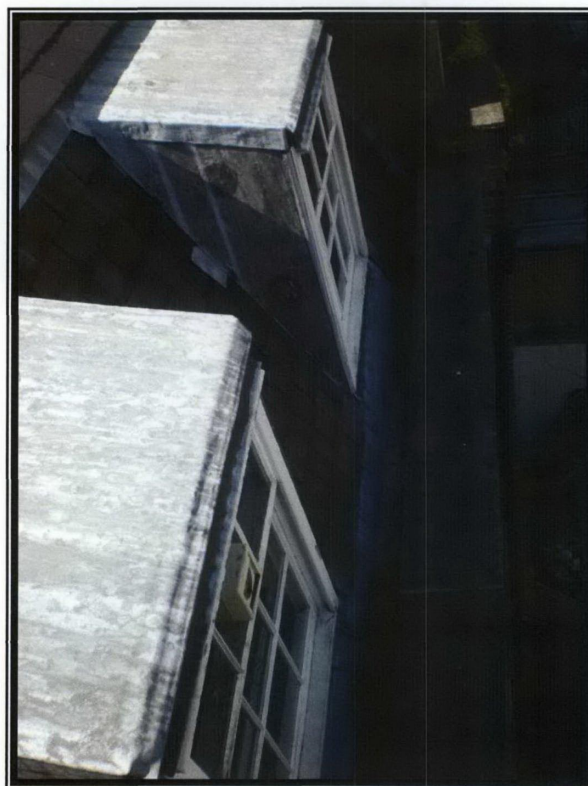
Photograph 223 – Lead covered dormer windows

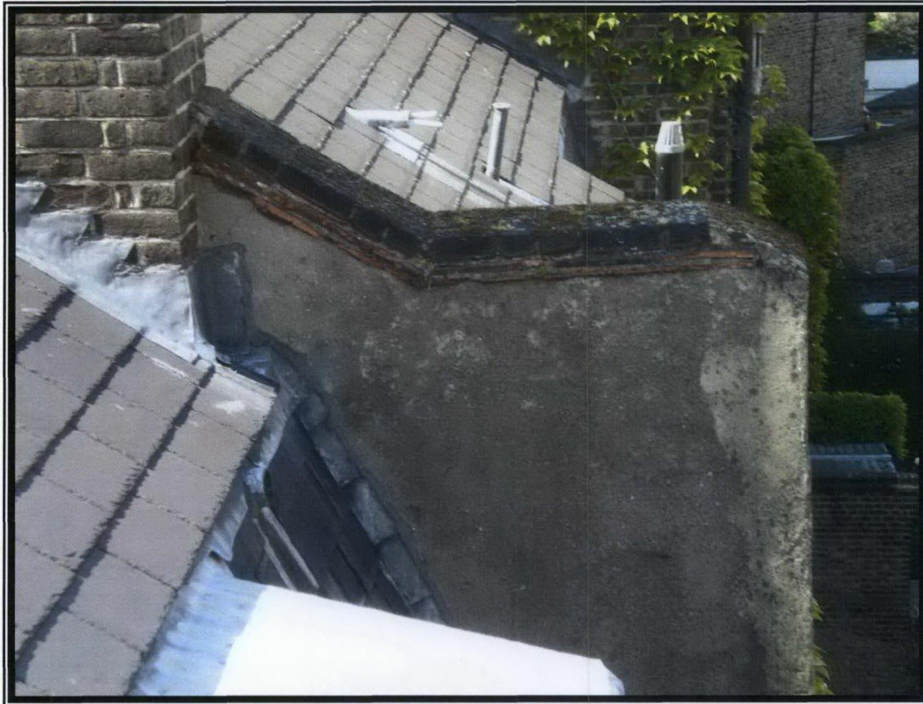
Photograph 224 – Cracked render and chipped creasing tiles to party parapet wall
