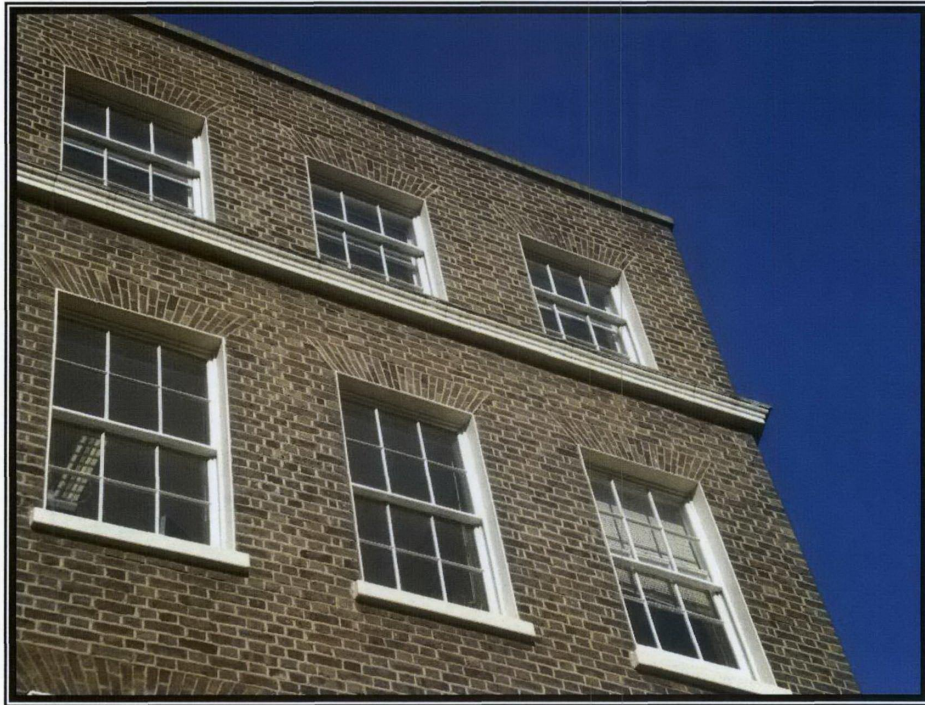
Photograph 261 – Front elevation – Hairline crack to rendered band

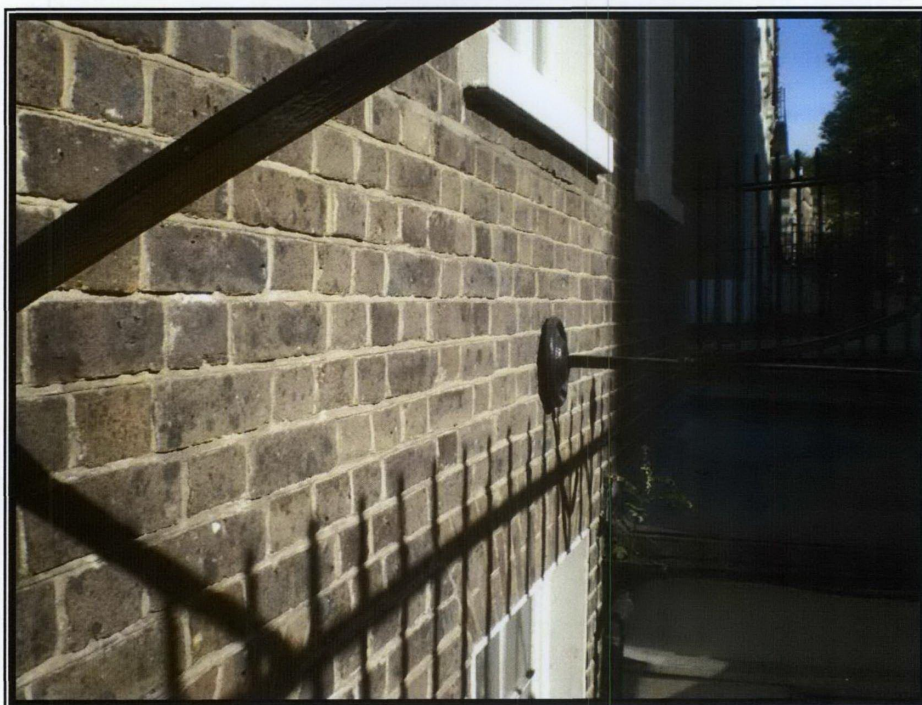
Photograph 263 – Cast iron plate not flush to wall

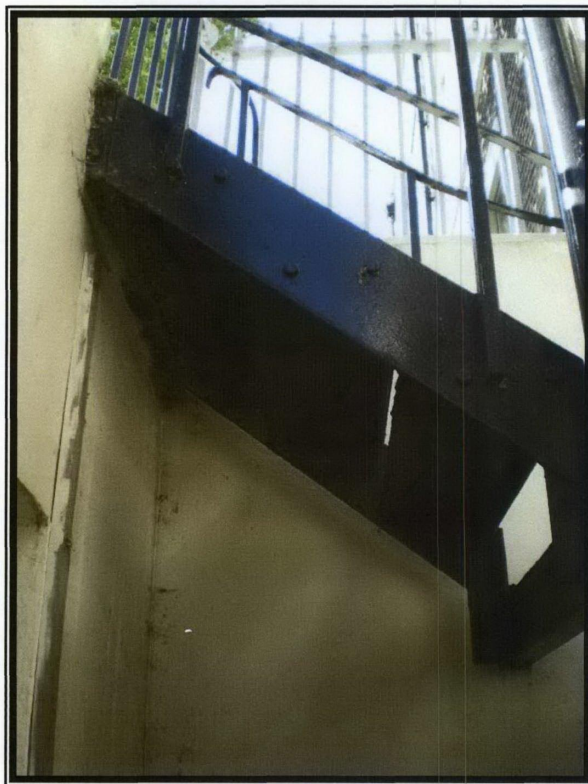
Photograph 266 – Corrosion to underside of metal steps

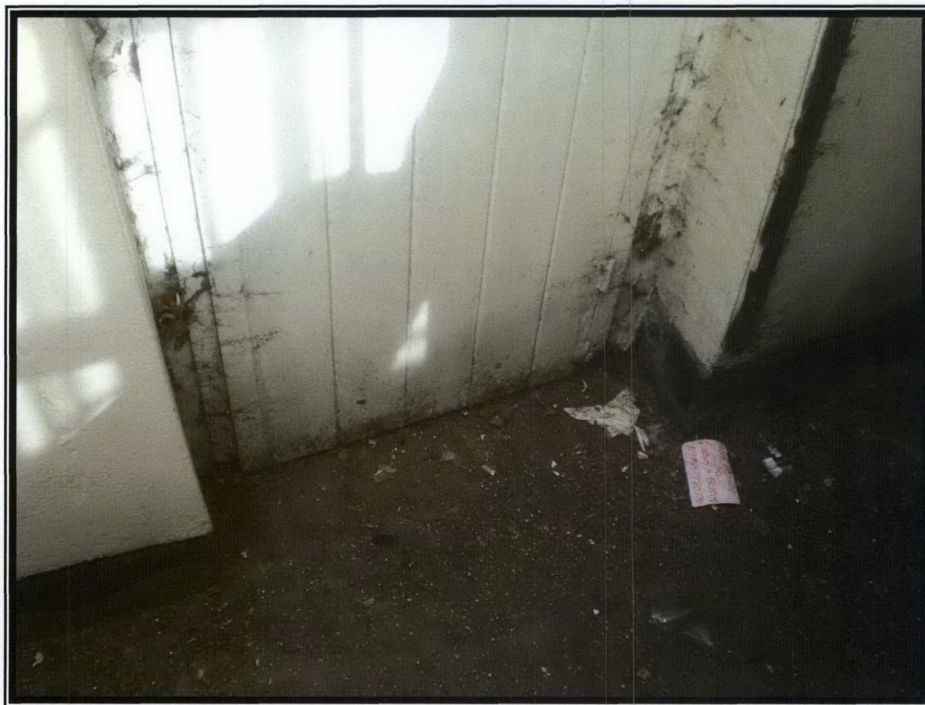
Photograph 268 – Timber decay to base of timber door to under pavement vault
