Pre-development Arboricultural Report

Site Details: 73-74, Guilford Street, London WC1.

Report compiled by: Jonathan Ives BSc. Hons (For) M. Arbor. A.

Date: 11 February 2009

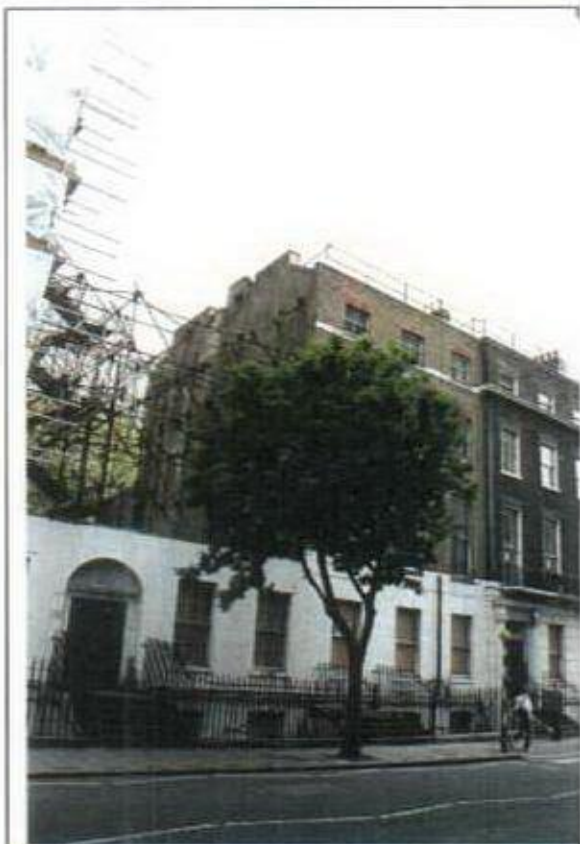
Tree to front of properties summer 2008

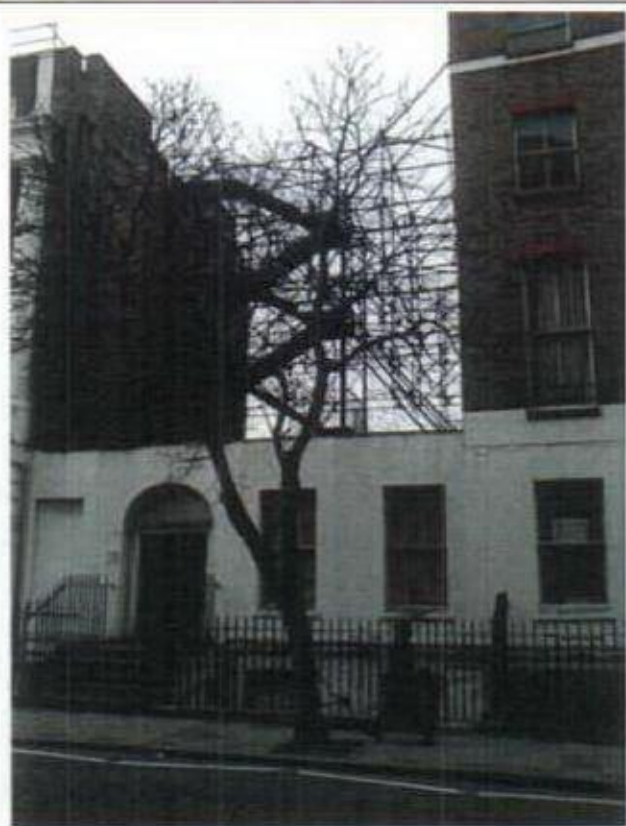
Tree to front of properties February 2009
