Job Title  
Kings Cross Station  
Redevelopment Programme  
Package 2

Drawing Title  
South Facade  
Existing Elevation and Defects

Job No	Drawing No	Issue
B40234	MSR-CSS-0127	03

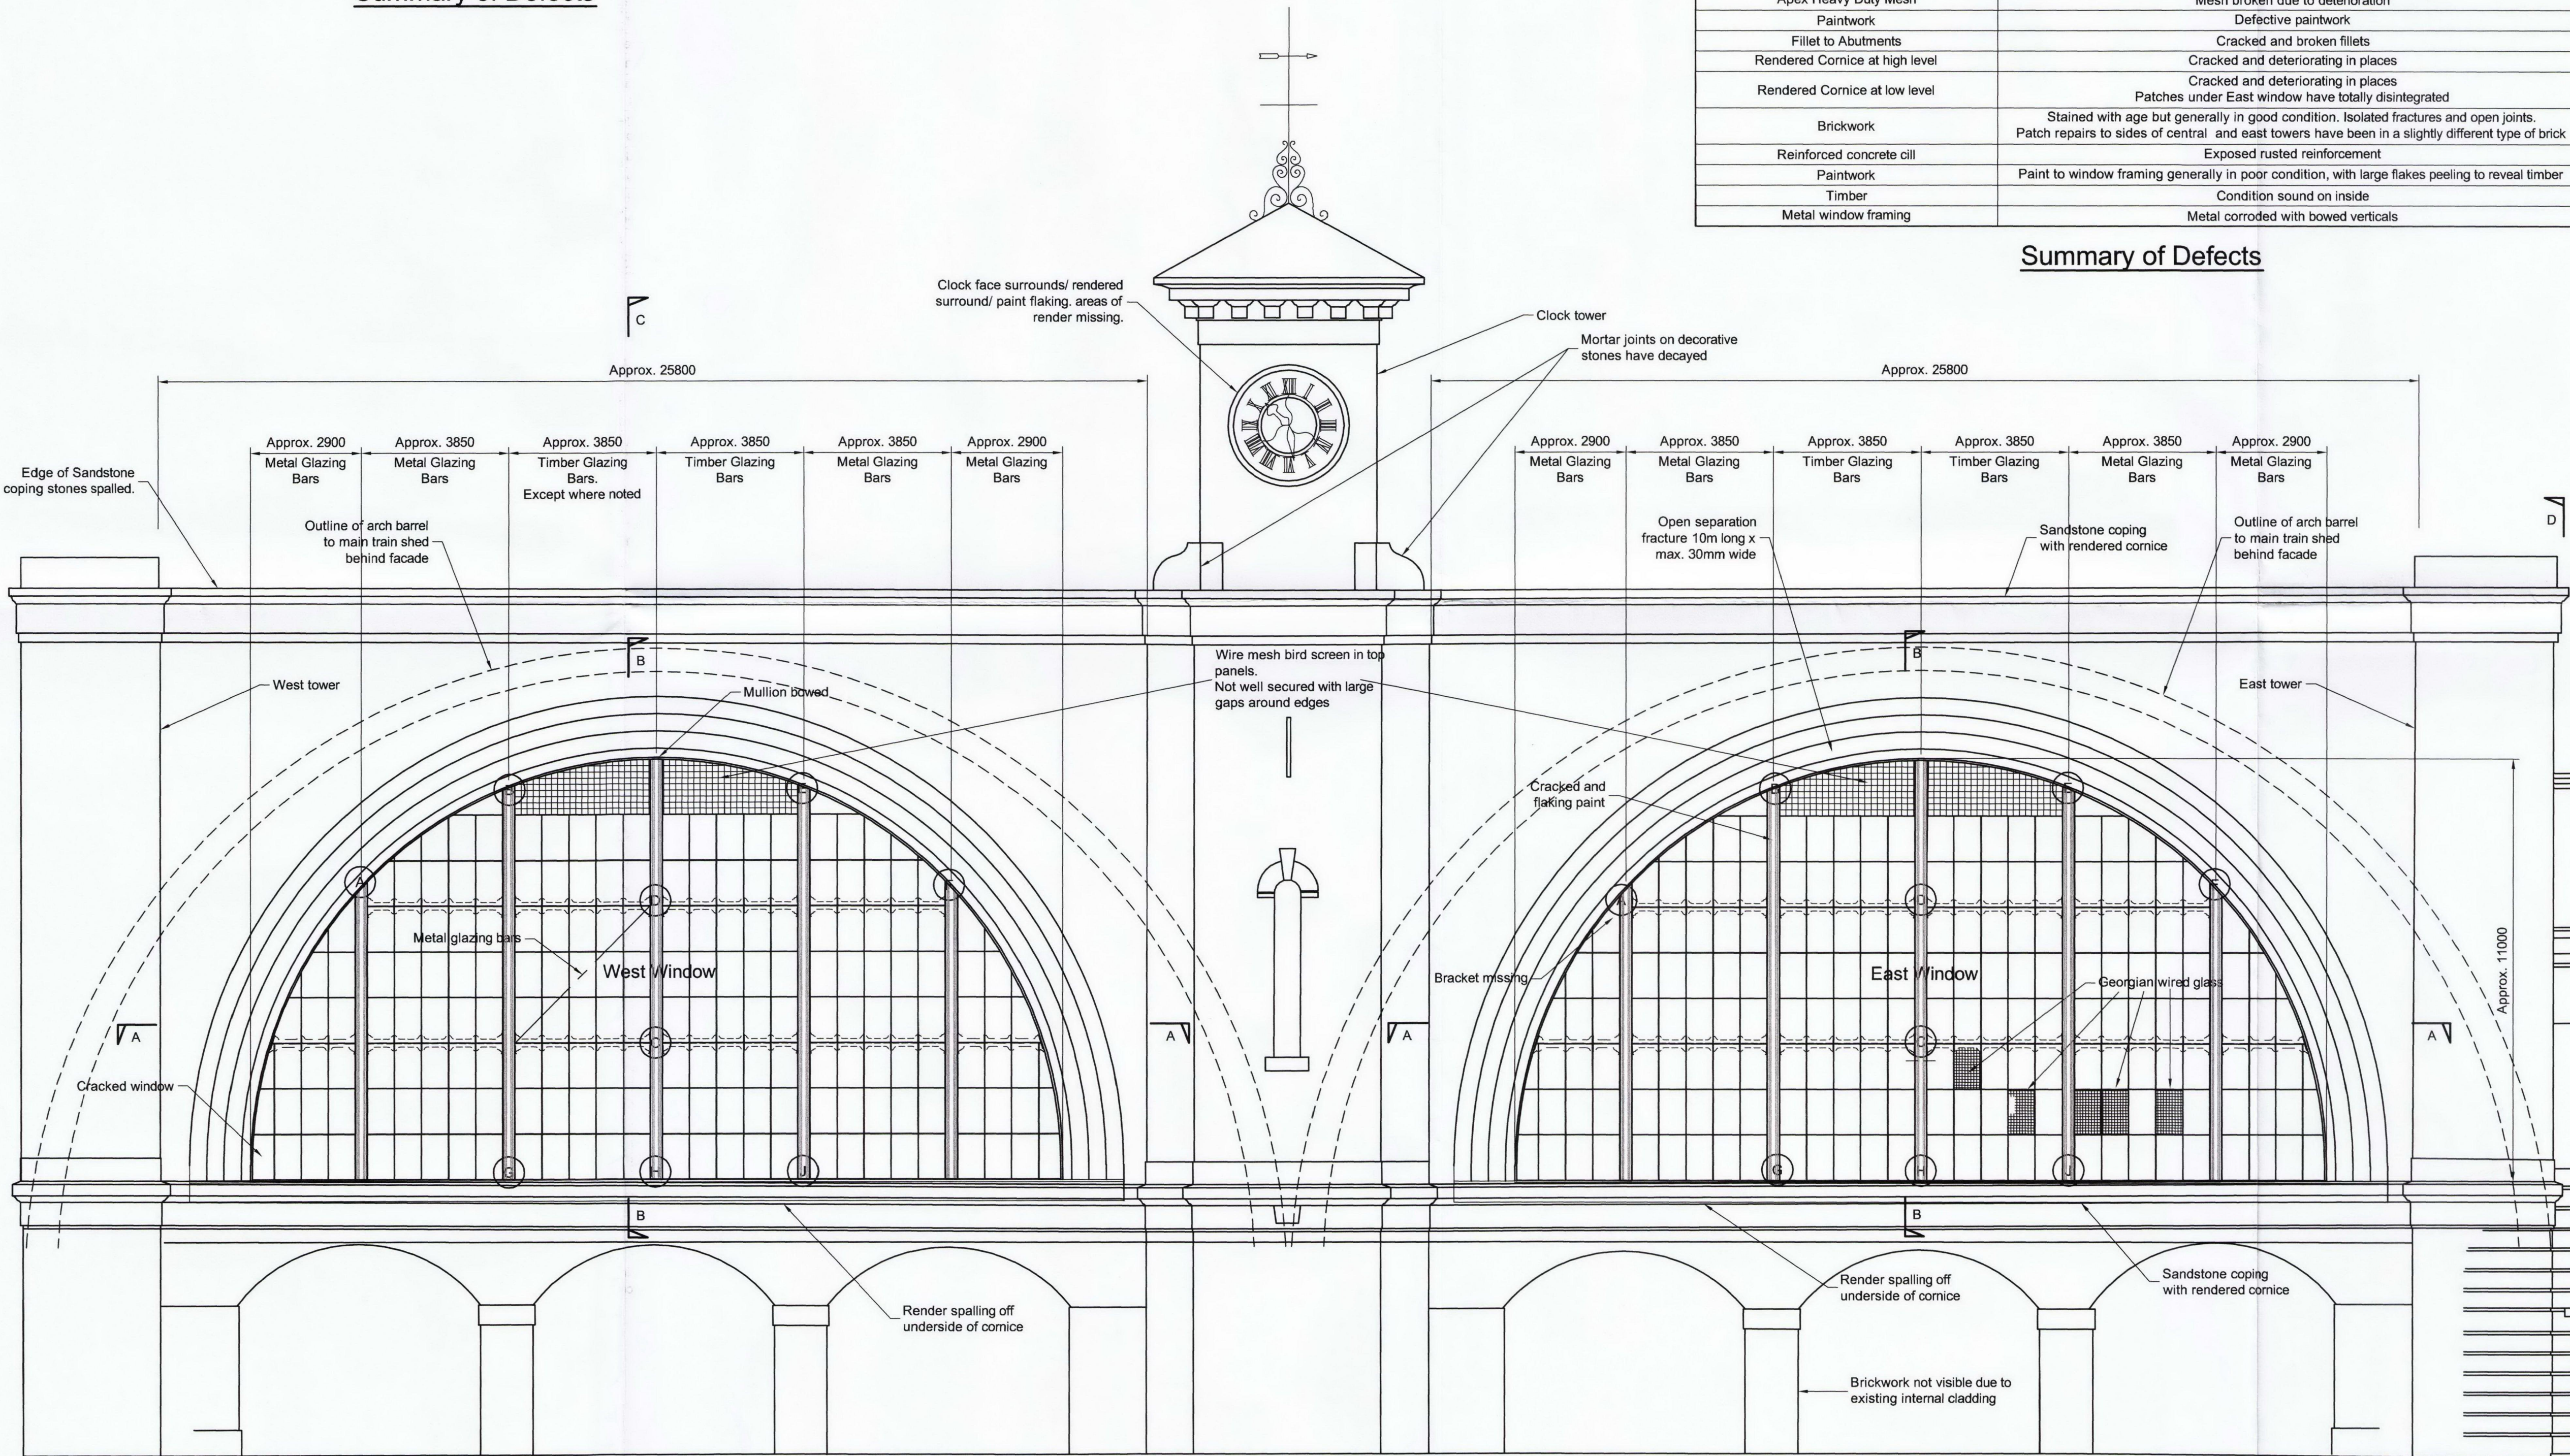
Elevation On South Facade Looking North  
External Southern Concourse omitted for clarity  
Scale 1:100

Location	Location Description	Steelwork Condition	Timber Condition	Masonry Condition
West Window				
A	Timber Clad Mullion	Fair	Good	
B	Timber Clad Mullion	Fair	Poor	
C	Timber Clad Mullion	Fair	Sound	
D	Timber Clad Mullion	Fair	Poor	
E	Timber Clad Mullion	Fair	Poor	
F	Timber Clad Mullion	Fair	Poor	
G	Timber Clad Mullion	Surface corrosion	Poor	
H	Timber Clad Mullion	Surface corrosion	Poor	
J	Timber Clad Mullion	Surface corrosion	Poor	
West Elevation / Top Left Corner				Weathering/ substantial edge spalling to cornice 450x40x20mm
West Elevation Parapet				General weathering of mortar joints

Location	Location Description	Steelwork Condition	Timber Condition	Masonry Condition
East Window				
A	Timber Clad Mullion	Fair	Sound	
B	Timber Clad Mullion	Fair	Sound	
C	Timber Clad Mullion	Fair	Rotten	
D	Timber Clad Mullion	Fair	Saturated/Damp for 2.2m Height	
E	Timber Clad Mullion	Fair	Good	
F	Timber Clad Mullion	Fair	Damp	
G	Timber Clad Mullion	Surface Corrosion	Poor	
H	Timber Clad Mullion	Surface Corrosion	Poor	
J	Timber Clad Mullion	Surface Corrosion	Poor	
Inner step of return, crown of arch				Horizontal crack 10m long x 30mm wide. brick movement gauges not moved since 30/11/1968
Both Screens				
Glazing		Approx. 20No broken panes and rusting glazing bars		
Apex Heavy Duty Mesh		Mesh broken due to deterioration		
Paintwork		Defective paintwork		
Fillet to Abutments		Cracked and broken fillets		
Rendered Cornice at high level		Cracked and deteriorating in places		
Rendered Cornice at low level		Cracked and deteriorating in places

Patches under East window have totally disintegrated		
Brickwork		Stained with age but generally in good condition. Isolated fractures and open joints. Patch repairs to sides of central and east towers have been in a slightly different type of brick		
Reinforced concrete cill		Exposed rusted reinforcement		
Paintwork		Paint to window framing generally in poor condition, with large flakes peeling to reveal timber		
Timber		Condition sound on inside		
Metal window framing		Metal corroded with bowed verticals
