**Kings Cross Station
Redevelopment Programme
Package 2**

**South Facade
Proposed Works**

Job No	Drawing No	Issue
B40234	MSR-CSS-0180	07

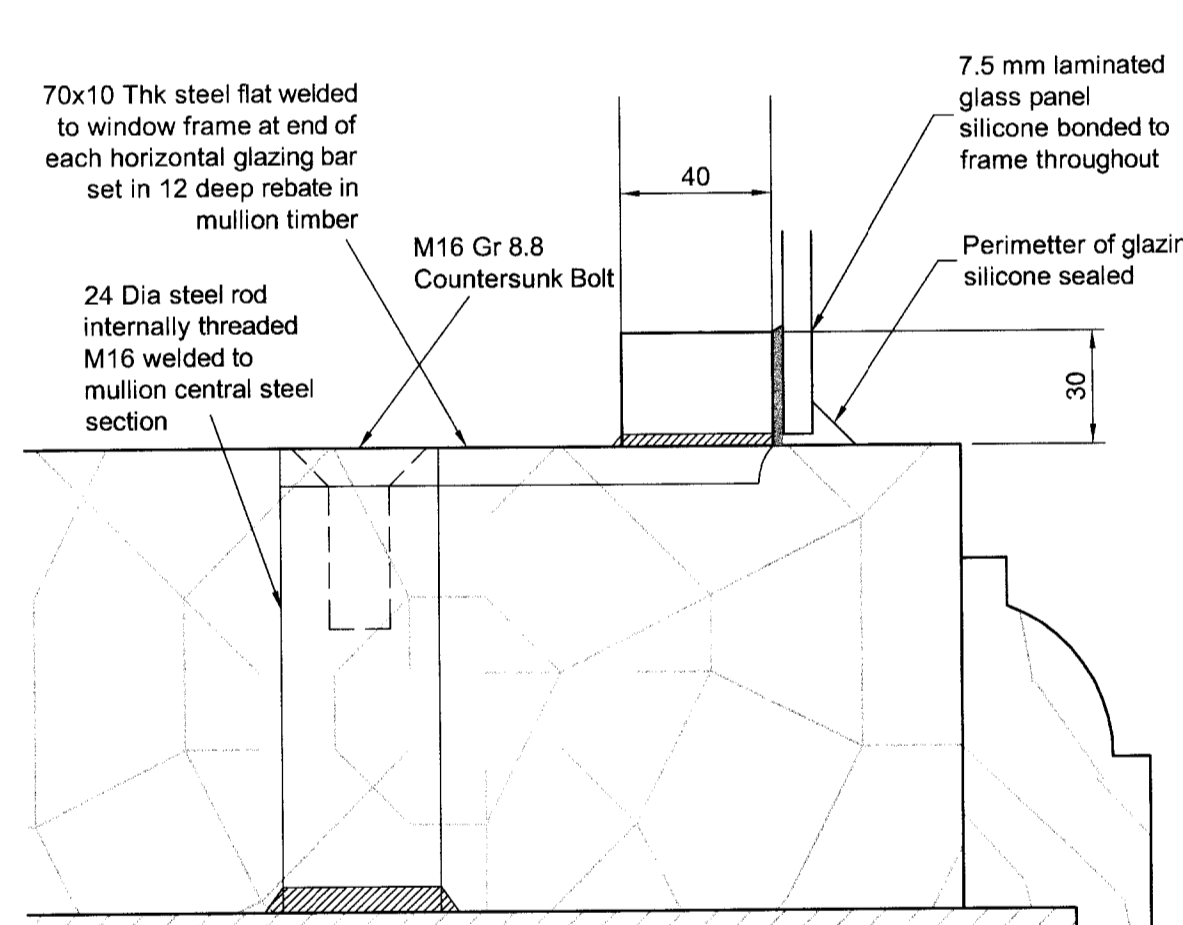
Proposed Glazing Bar to Mullion Connection Detail - Detail Occurs at end of all Horizontal Glazing Bars
Scale 1:2

Note!
All joints between proposed main glazing bars to be full strength.

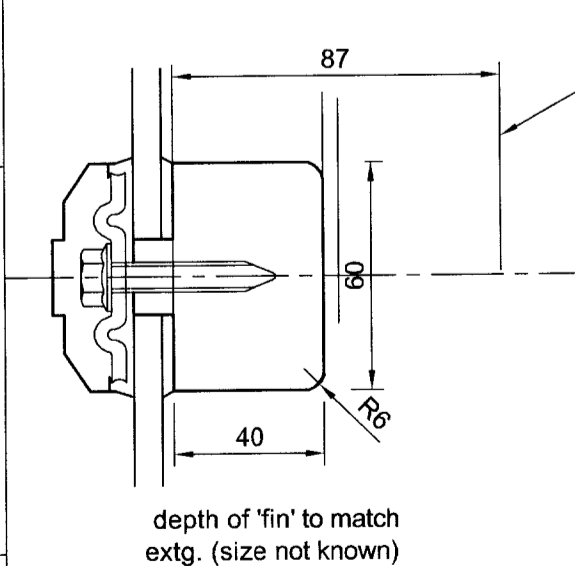
Proposed Metal Horizontal Glazing Bar Detail
Scale 1:2

Angle of exiting profile not known (representational only). Angle increase helps retain minimal 'flats' to minimise overall width increase to accommodate bomb blast criteria from glass rebates

- Fabricate and install new steel glazing bars throughout. Proposed steelwork and mullion uprights to be painted to system N1 with proposed glazing rebates masked following application of metal spray.
