**ARBORICULTURAL REPORT FOR
INSURANCE PURPOSES**

**1 Belsize Park
London
NW3 4ET**

290507-MD-02

June 2009

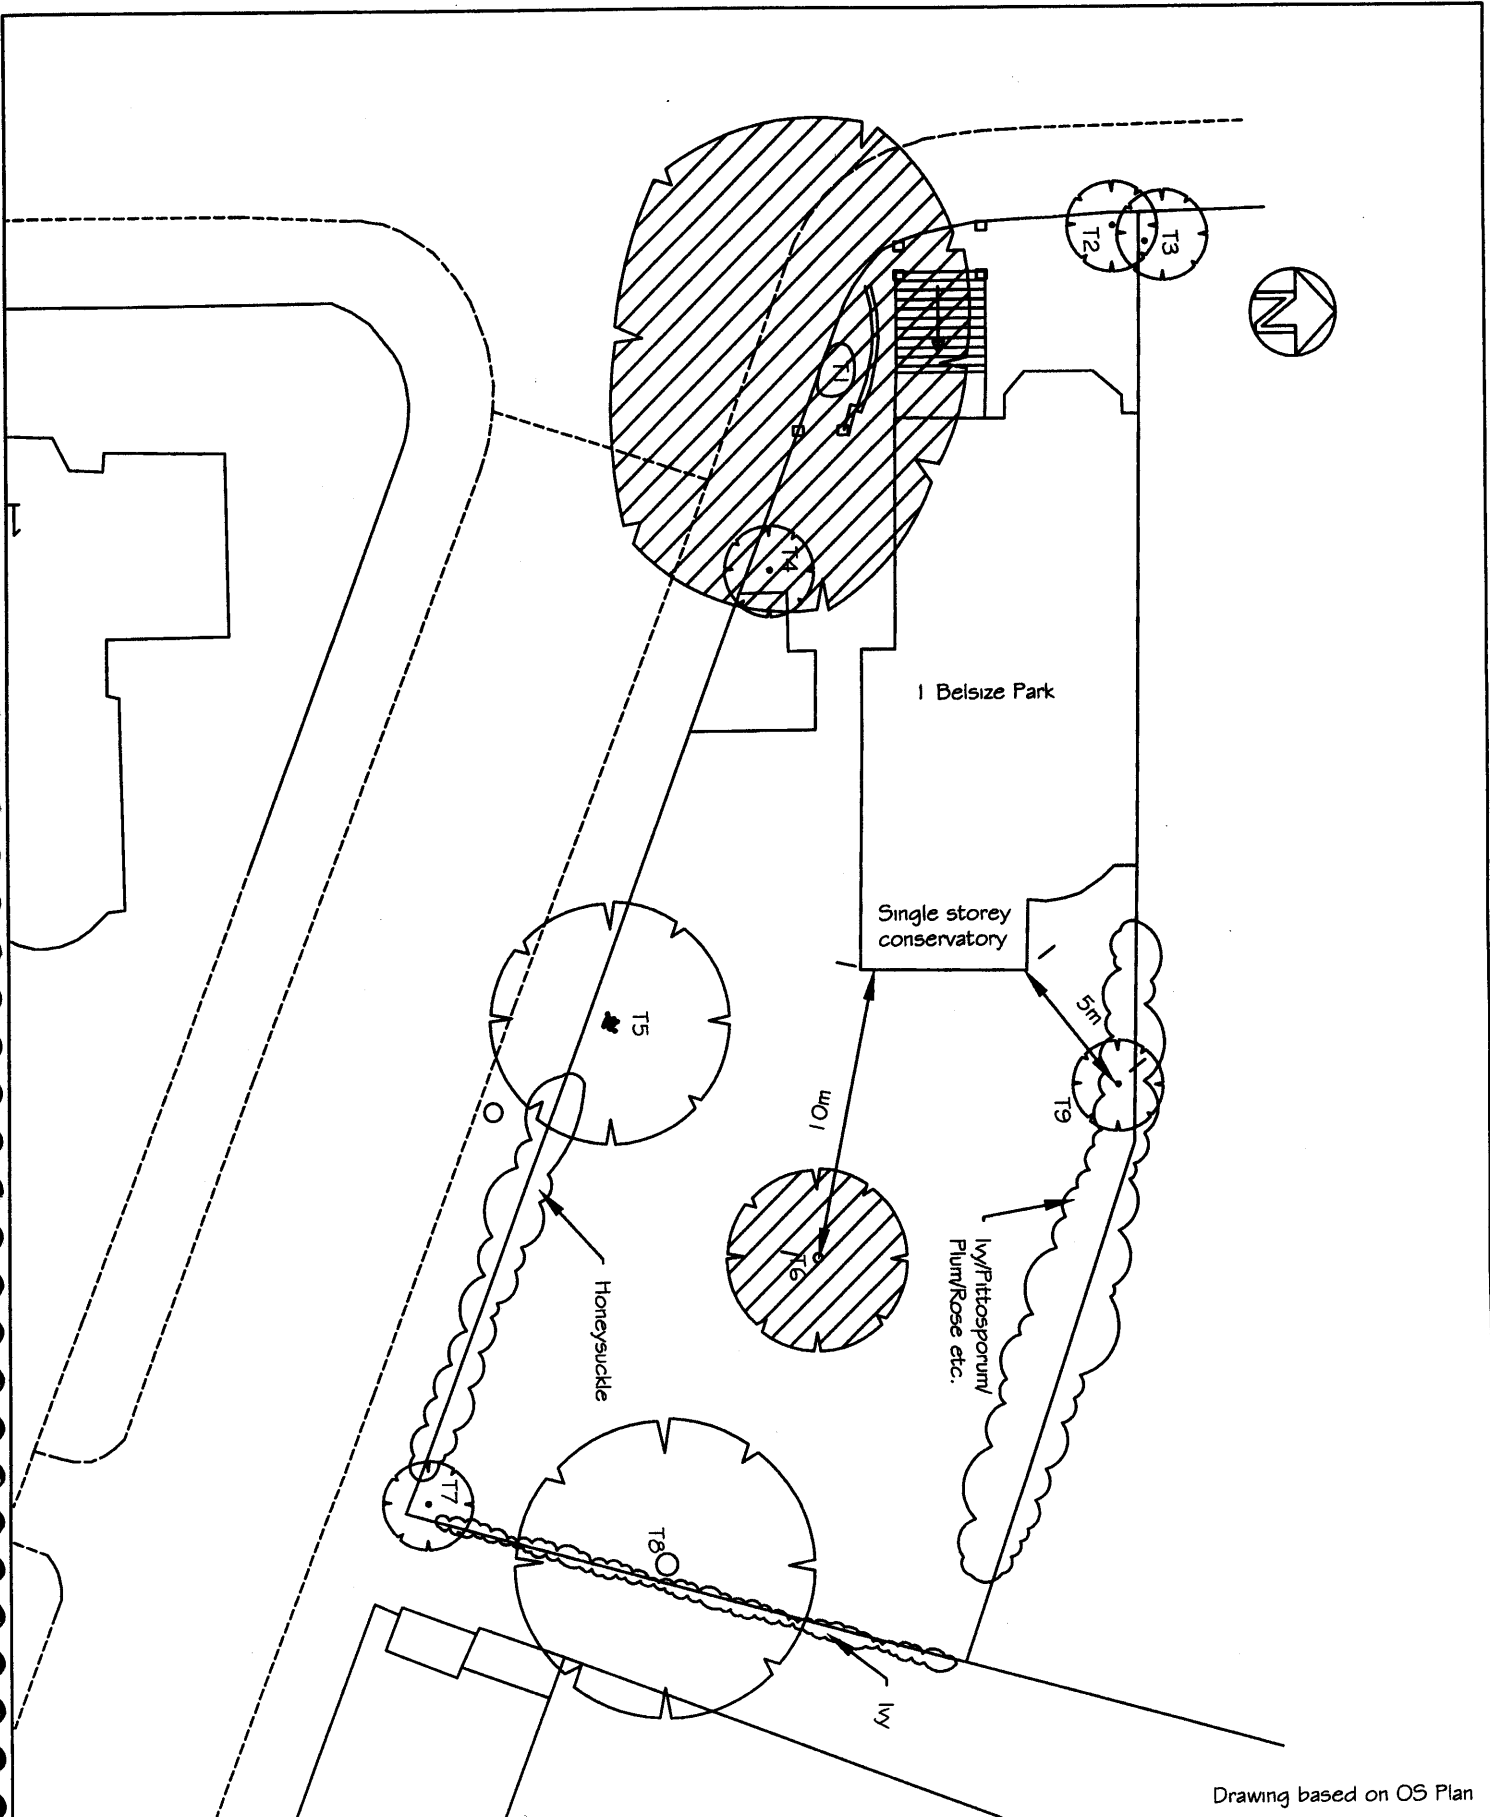
Drawing No	290507-01
Date	June 2009
Scale	Not to scale Use figured dimensions

The trees inspected have been assessed from ground level and the information on them is contained in the schedule attached to this report. The trees in question are numbered T1-T9 are located on the sketch plan which is attached to this report.

Two trees have been identified as posing a potential risk to the main property:

- T1 London plane
- T6 Willow

This established mature tree is growing within 2m of the main house and entrance steps. The tree has a history of crown reduction and has re-grown some 2m in both height and radial spread since last reduced. There is some concern about the soil volume available for the growth of structural roots but the tree appears to have established structural integrity at least in relation to the managed and reduced

This is a fast growing tree in middle age with significant future growth potential. The tree is growing 10m from the single storey rear extension to the property and has been crown reduced within the past 2 years. Due to the known ability of this species to influence clay soil at depth and the potential future size of the tree it is recommended that it be maintained at a reduced size. The recommendation is for the tree to be reduced again this year to the previously established crown volume and that the reduction should be maintained by subsequent pruning every 2 years in the summer before August.

In view of the potential for further growth of this large tree, its restricted rooting area and the risk of further dry summers it is recommended that it be reduced immediately to the previously established crown volume and that this reduction be maintained every 2 years. It is recommended that subsequent crown reductions should take place during the summer months before August on each occasion.
