24 Russell Square Before Works

24 Russell Square After Works

W080224 L(0)43

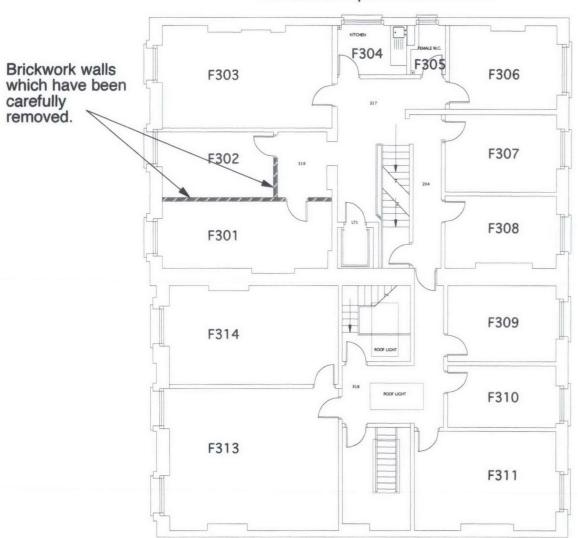
Heavy brickwork partition wall between rooms 301 and 302 was causing deflection to the timber floor structure on which it was situated. The deflection was being caused because there was no support for the wall from below causing the timber joists to be badly over stressed.

The brickwork partion was not an original wall but a later addition to the building

The heavy brickwork wall which was causing deflection was carefully removed. The 2 No. existing doors where carefully removed before any works were undertaken and carefully stored so that they could be reused.
