WITANHURST
STRUCTURAL REPORT ON THE GARDEN STRUCTURES
11 MAY 2009 rev 26 May 2009

The following report is the result of a visual inspection of the garden structures made by Michael Barclay Partnership LLP on 29 and 30 April 2009.

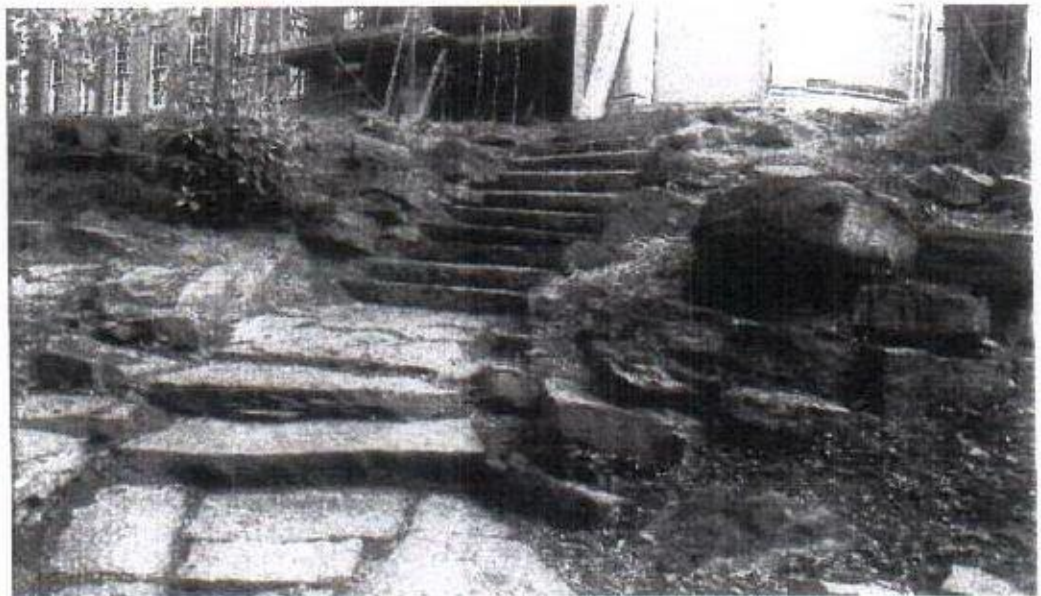
PHOTO 1: TERRACE AND ROCKERY STEPS

PHOTO REF.	LOCATION		CONDITION	RECOMMENDATIONS
1	1	Terrace and rockery steps	The sandstone(?) is of good quality, but both the terrace and steps are very uneven and almost certainly bedded on poor quality subbase material and underlying fill.	The terrace should be taken up and re-laid on compacted material. The steps should be taken up and re-laid on compacted material.
2, 3, 4, 5	2	Garden retaining wall of soft brick construction, retaining up to 1.3m of ground.	Poor, bricks loose, and wall up to 50mm out of plumb.	Take down and rebuild.
5, 5	2a	Brick paving and steps	Poor, bricks badly weathered and uneven. Inadequate subbase material.	Take down and rebuild.
6	3	Garden retaining wall of soft brick construction.	Poor, bricks loose, parts of the wall have collapsed.	Take down and rebuild.
8	4	Steps and wall.	Later addition in improved brickwork. Retains 1.7m of ground. Approx 30mm out of plumb. Severe deterioration in adjoining wall.	Rebuild required at north end.

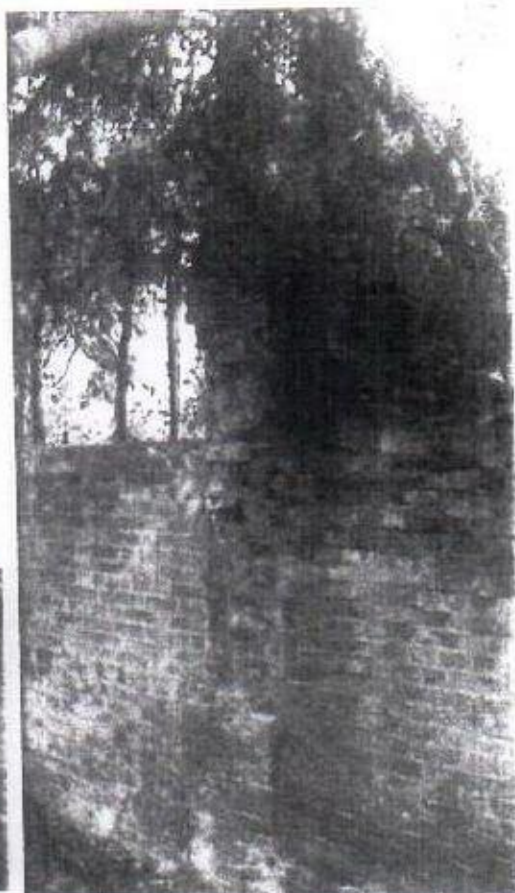
PHOTO 9: BOUNDARY WALL 5

9	5	Boundary wall	Could not be inspected from adjoining property. The wall at the east half has been rebuilt within the last 30/40 years. Brickwork weathered with cracking and severe deterioration at west end close at junction with wall 4.	Repair and partial rebuild required.
12	5, 7 and 8	There are three walls set in terraces leading from the tennis court up to the boundary wall at the top. The total earth retention is more than 3m. There are trees and scrub at the lower levels and a hedge at the top.		
9, 10, 11 and 12	6, 7	The top and middle soft brick walls are the earliest in construction - possibly designed as a composite system. The top wall is buttressed and the middle wall batters back.	The top wall could not be fully inspected without access from the adjoining properties. The walls are generally in poor condition. The top of wall 6 has a gap in the brickwork and is at least 100mm out of plumb. Parts may be dangerous.	Further inspection is required. Remedial measures may include partial reconstruction.

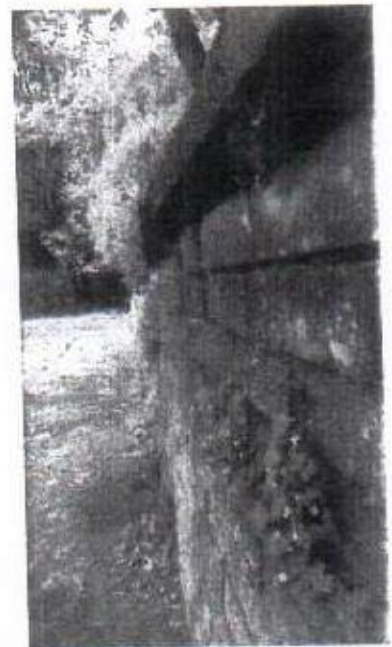
PHOTO 13: TENNIS COURT WALL 8

13	8	Tennis court wall. Wall of later construction, possibly 1950's	The bricks themselves are in reasonable condition, but the mortar is poor allowing slipping of the upper courses.	Repair and partial rebuild required.
14	8	Continuation of 1950's tennis court perimeter wall. The bank behind is overhung with decking to adjoining house.	Bricks reasonable, mortar poor.	Repair.
15	10	Buttressed 4.5m high retaining wall to the west side of the tennis court.	Diagonal cracks suggest foundation movement in the area of the pond. It is possible that the part above the pond has more substantial foundations than at the two sides.	Further investigation required including trial pits to assess the foundation. It may be possible to repair this wall.
16	11	Curved random stone wall to the east of the tennis pavilion.	This wall is in very poor condition.	Rebuild.
17, 18	12	Curved stair and square limestone(?) faced wall, backed in brickwork.	Stair steps uneven. Many of the limestone facings are weathered.	The steps require attention, but it may be possible to repair the wall.

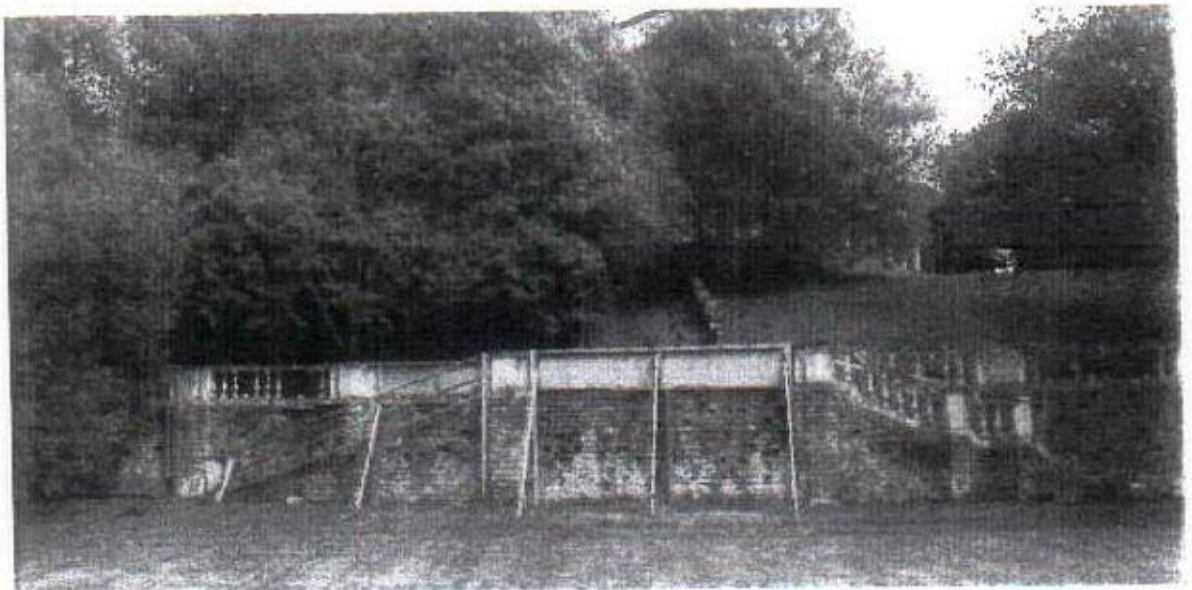
PHOTO 19: GRAND STAIR, LOWER TERRACE 13

19, 20, 21, 22, 22, 23, 24, 25	13	The walls to the lower terrace and grand staircase are of sandstone(?) blocks facing to a rough brick wall with an overall thickness of about 450mm. The coping and balustrades on the top are of softer limestone(?). The total ground retention is about 2m.	The sandstone blocks are of good quality, but the construction is very poor. The stones are not bonded to the brick and have bowed out from the face of the wall. The bricks are laid in a random manner. The copings and balustrade are severely weathered and partially collapsed. The sandstone steps and terrace have settled and are very uneven - an indication of poor subbase.	Take down and rebuild, the wall on a new foundation and re-lay the terrace and steps on compacted granular fill. It should be possible to save and re-use much of the durable sandstone facings and walking surfaces.

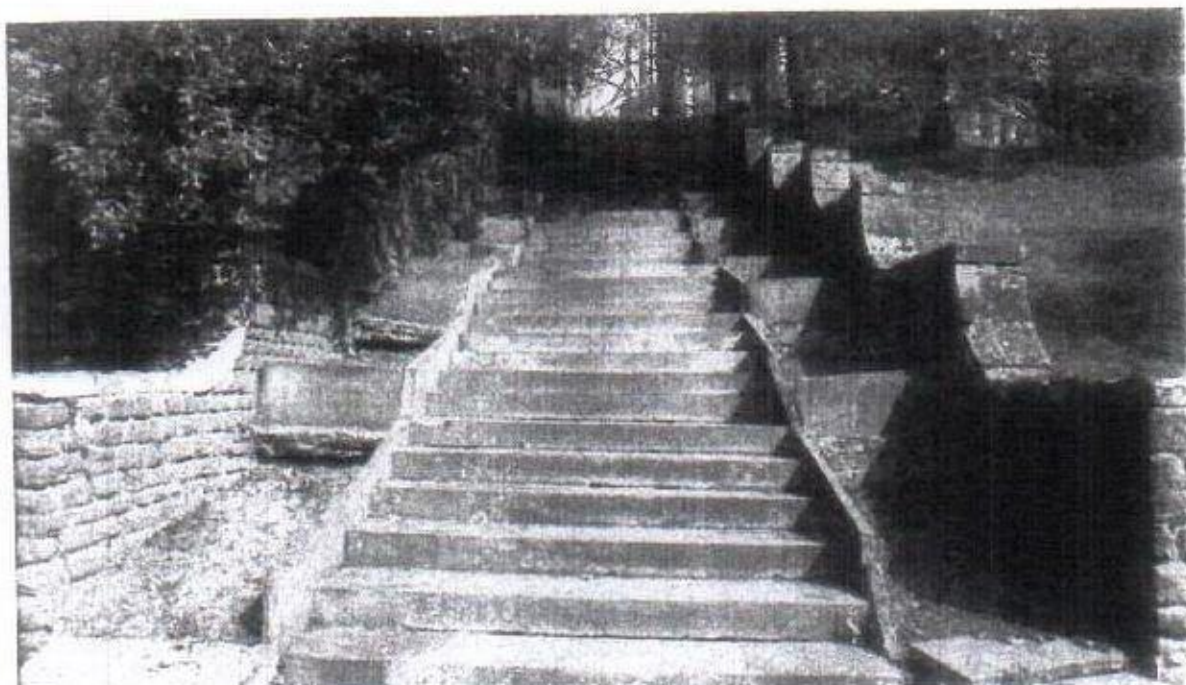
PHOTO 27: GRAND STAIRCASE 14

PHOTO REF.	LOCATION	CONDITION	RECOMMENDATIONS	
27, 28	14	Grand staircase	Similar construction to 13 above.	As 13
29	15	Curved stair and square limestone(?) faced wall, backed in brickwork and terrace	Wall construction similar to 13 above, but less deterioration. Terrace uneven.	Terrace should be re-laid on compacted granular material
30, 31	16	Sandstone (?) steps and low brickwall.	Stone is good, but sloping and uneven. Brick work is damaged.	Flagstones should be re-laid on compacted granular material. Rebuild brick walls.
	17	Sandstone (?) steps and low brickwall.	as 16	as 16
	18 - 23	Terraced Italian gardens	These gardens generally are in poor condition. The limestone copings and columns are all severely weathered and broken and the quality of the original construction poor: much of the construction is thought to have been built off inadequately compacted fill. Detailed comments on each element follow below.

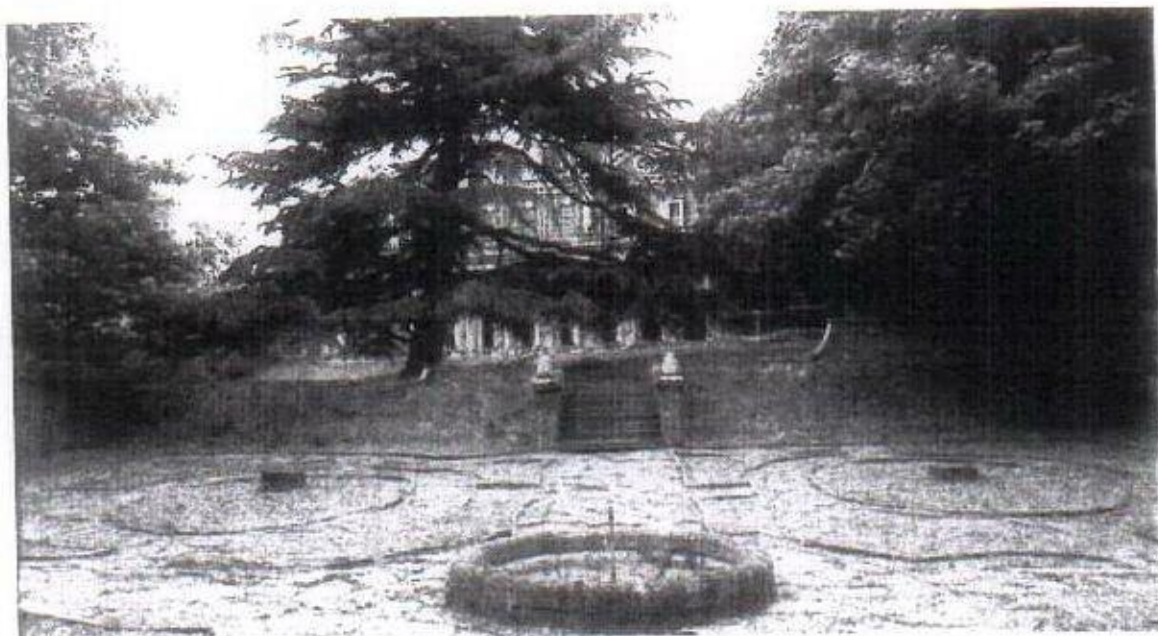
PHOTO 32: ITALIAN TERRACED GARDENS TOP HEAD WALL 18

32, 33, 34, 35	18	Top head wall and central steps.	Brickwork weathered and cracking on both sides. East side 100mm out of plumb, west side 300mm out of plumb and now dangerous. Steps uneven.	Take down and re-build
32	19	Stone paving	Uneven	Re-lay on compacted granular material.
	20	East side walls and steps	Brickwork weathered and out of plumb.	Take down and re-build.
36	21	Middle head wall and steps	Brickwork weathered. Noticeable settlement - the two flanks slope at about 1 in 50 towards central stair	Take down and re-build
37	22	Middle east side wall and steps	Walls severely out of plumb.	Take down and re-build
36	23	Stone paving	Mostly already taken up and stacked.	
	24	Side wall	Severely out of plumb	Take down and re-build
38, 39, 40, 41	25	Bottom head brick wall, stone balustrade, central steps, side openings	Bad weathering to stone balustrade, slipped lintel to left side opening, cracking at junction with west side wall. Brick retaining wall appears to be reasonably robust. Steps uneven, plinths distorted.	Replace severely damaged features. Possibly repair the wall itself.

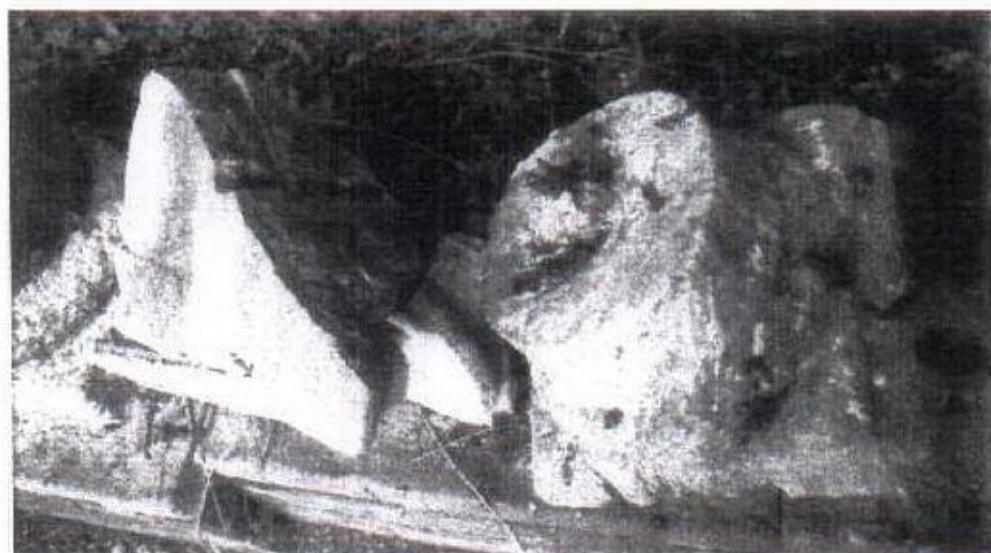
PHOTO 43: ITALIAN TERRACE GARDEN LOWEST TERRACE 27

26	Stone paving	Uneven	Re-lay on compacted granular material.
43, 44	27	Colonnades and pergolas	Timber mostly gone. Limestone (?) badly weathered and damaged and already dismantled. Most of the timber beams between the columns have gone.	Replace
45	28	Pool and walls, of concrete or possibly rendered masonry construction	Wall cracked and de-laminating.	Replace
46	29	Boundary wall in brick with 3.7m ground retention, possibly built up from concrete base.	Could not be fully examined as inspection only possible from one side..	Should examined from adjoining property.
47	30	Boundary wall in brick with large buttress behind. 3.8m ground retention	Could not be fully examined as inspection only possible from one side..	Should examined from adjoining property.
48, 49, 50, 51, 52	31	West wall of terraced gardens. A second brick wall is built on top of an earlier wall which was laid to a sloping brick course. Ground retention is up to about 1.5m	The brickwork is weathered, loose and generally in poor condition. In places it is as much as 225mm out of plumb	This wall should be taken down and re-built.

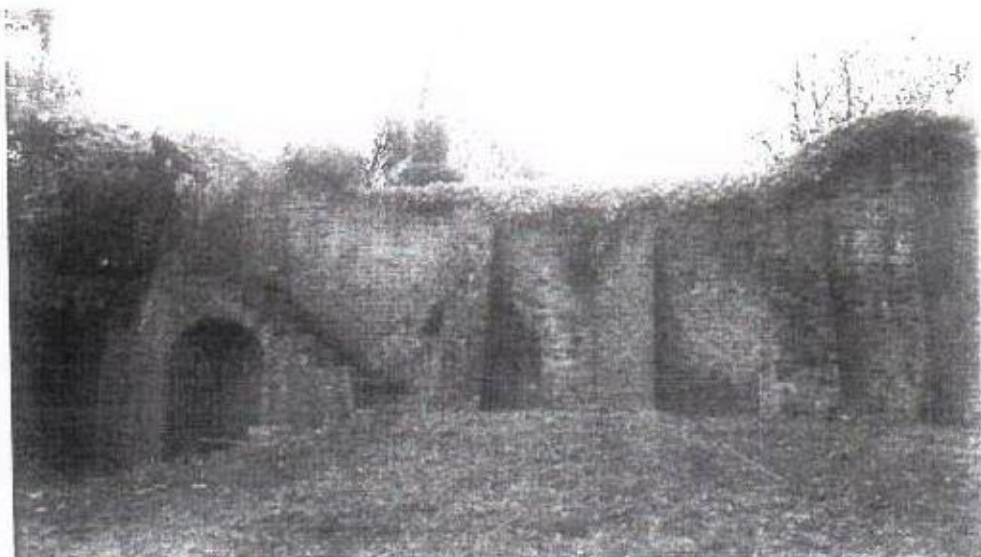
PHOTO 54: NORTH WEST BOUNDARY WALL 32

54, 55, 56	32	North west boundary wall. Brick with buttresses.	The wall is well buttressed and apart from weathering damage etc, the general condition appears to be fair. However this is a major retaining wall which could only be examined from one side.	Should examined from adjoining property and its stability further considered.
55	33	Garden room	Poor	Reconstruction may be necessary.
