42 NETHERHALL GARDENS, NW3

Arboriculture Reports

Pre-development Arboricultural Report

Re: 42 Netherhall Gardens, London, NW3 5RG

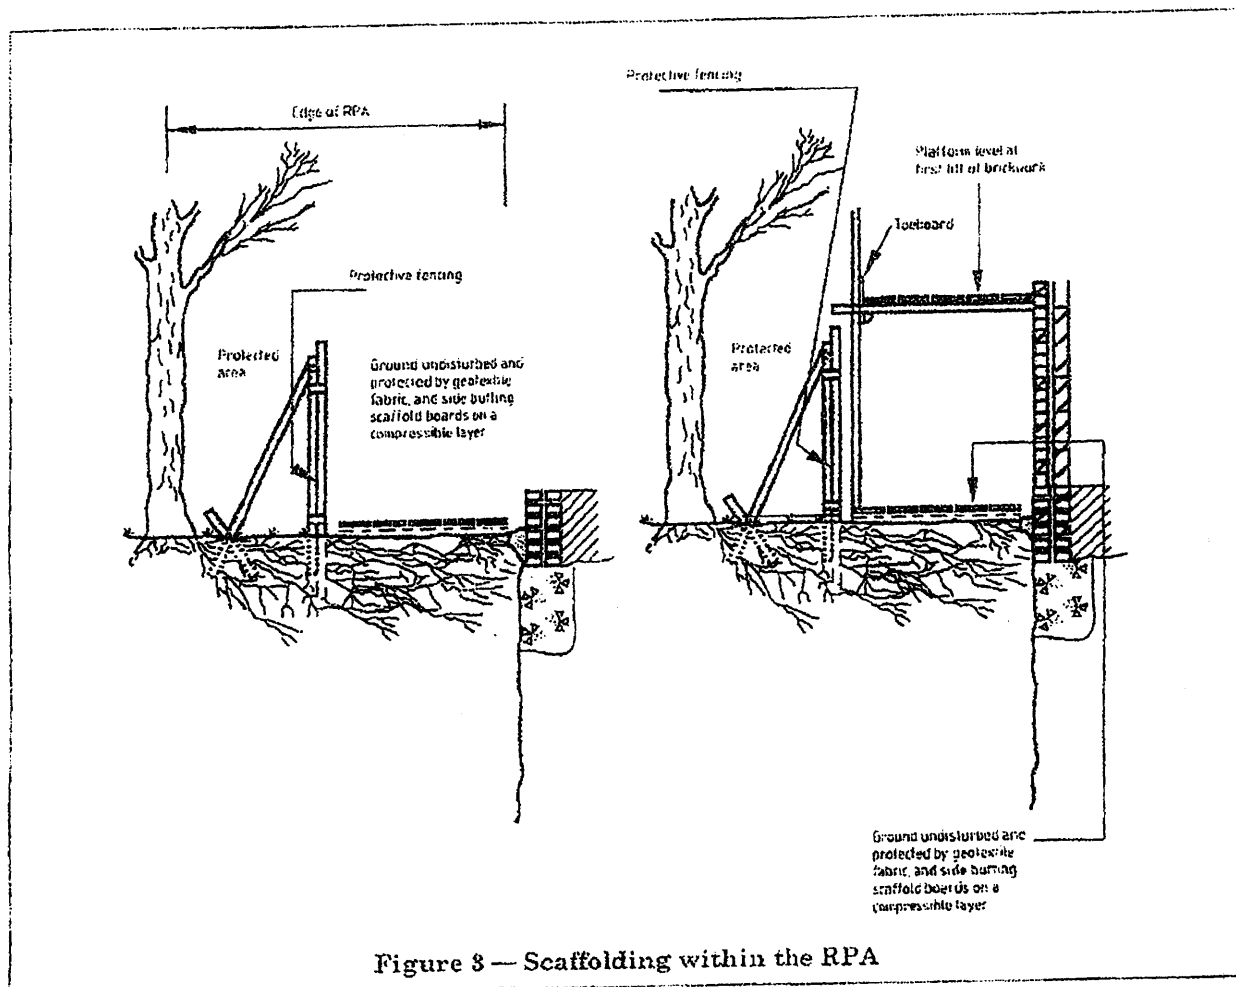
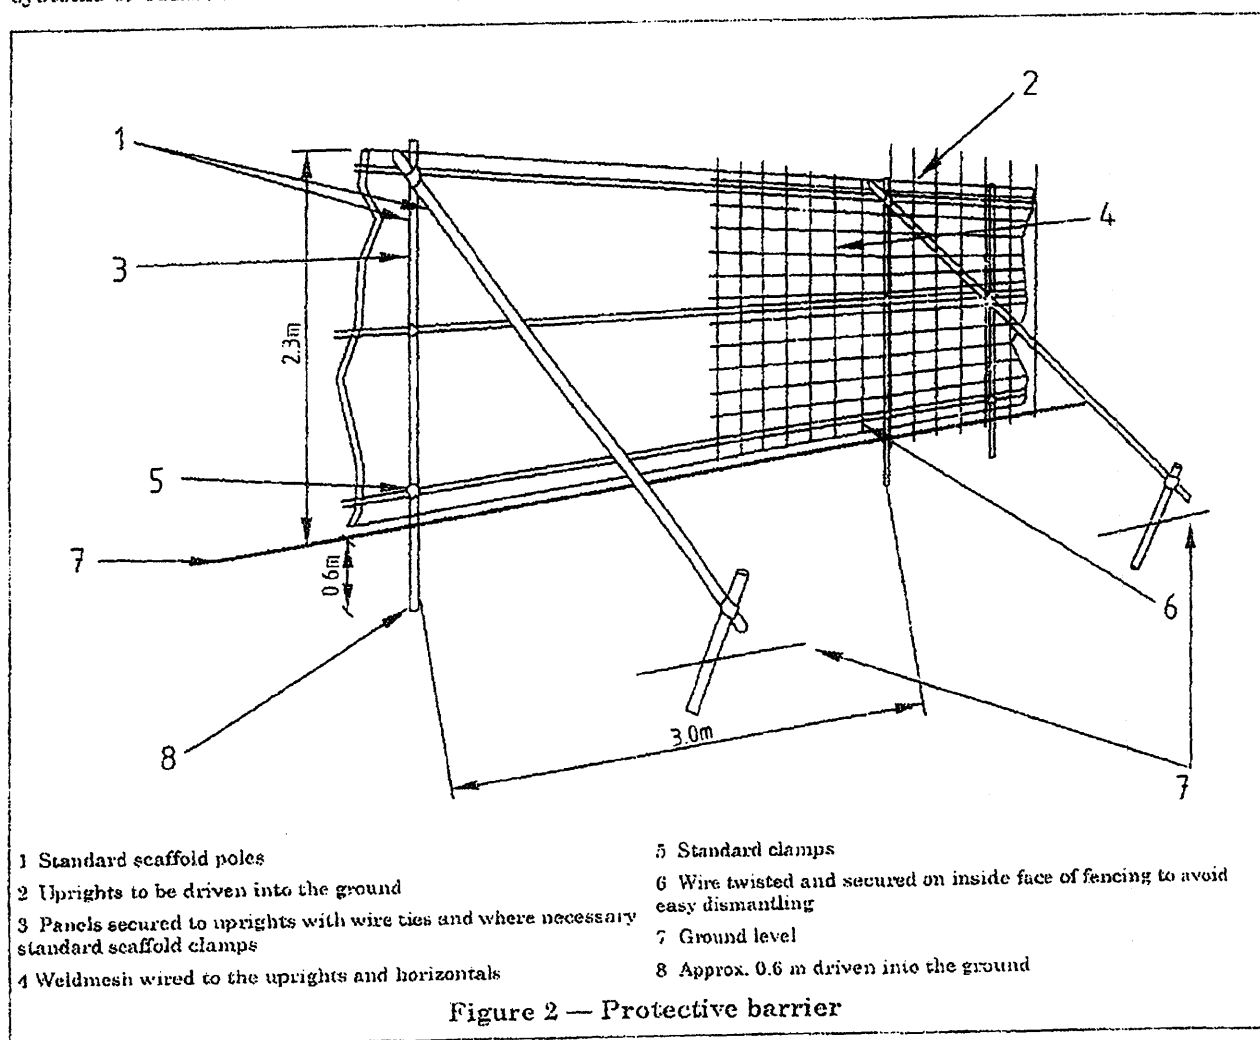
Figure 3 — Scaffolding within the RPA

9.3.2 For pedestrian movements within the RPA the installation of ground protection in the form of a single thickness of scaffold boards on top of a compressible layer laid onto a geotextile, or supported by scaffold, may be acceptable (see Figure 3).

Therefor the installation of ground protection is required in the form of a single thickness of scaffold boards on top of a compressible layer laid onto geotextile in accordance with BS 5837 Figure 3 (a copy of which is enclosed within the appendix).

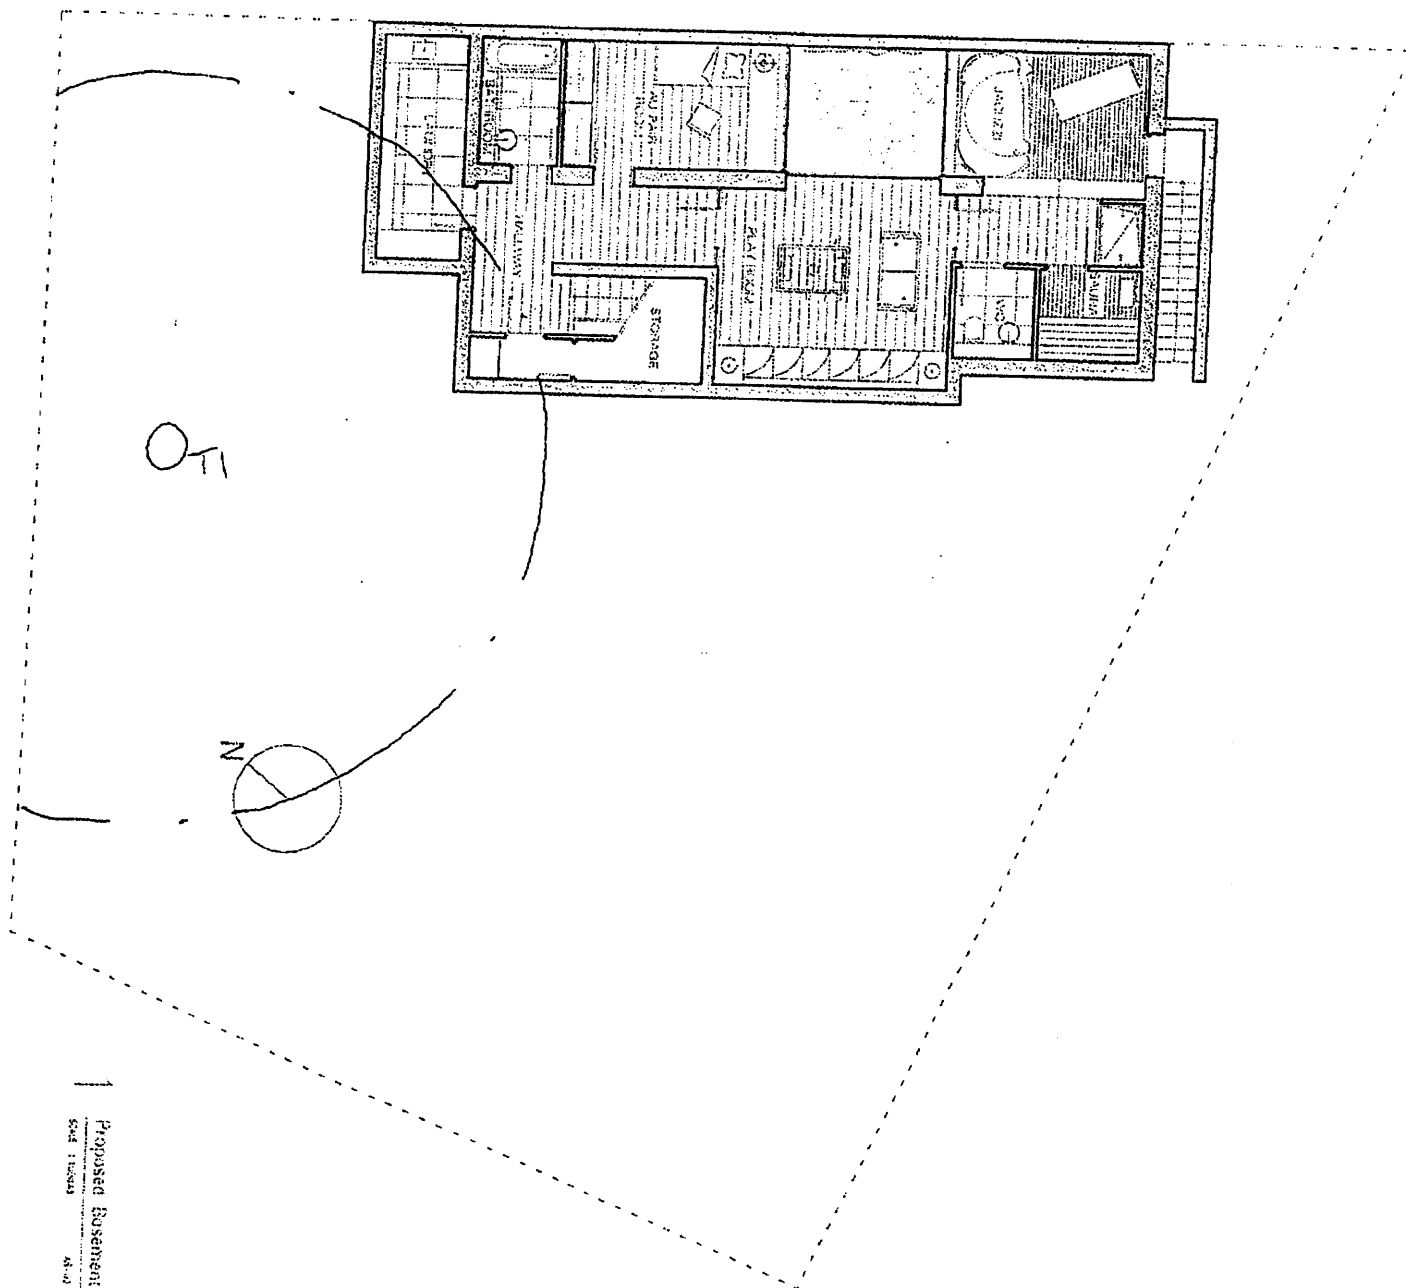
Proposed Basement Plan
Scale: 1/8" = 1'-0"

Pedestrian Guard
Protection
