### 33 CHALCOT SQUARE, LONDON NW1 8YA

#### PRELIMINARY SITE INVESTIGATIONS 20.05.09 (Refer to 3245/EX10 (PI) A)

Opening up carried out in conjunction with Planning and Listed Building Applications Ref 2009/1108P & 1112L

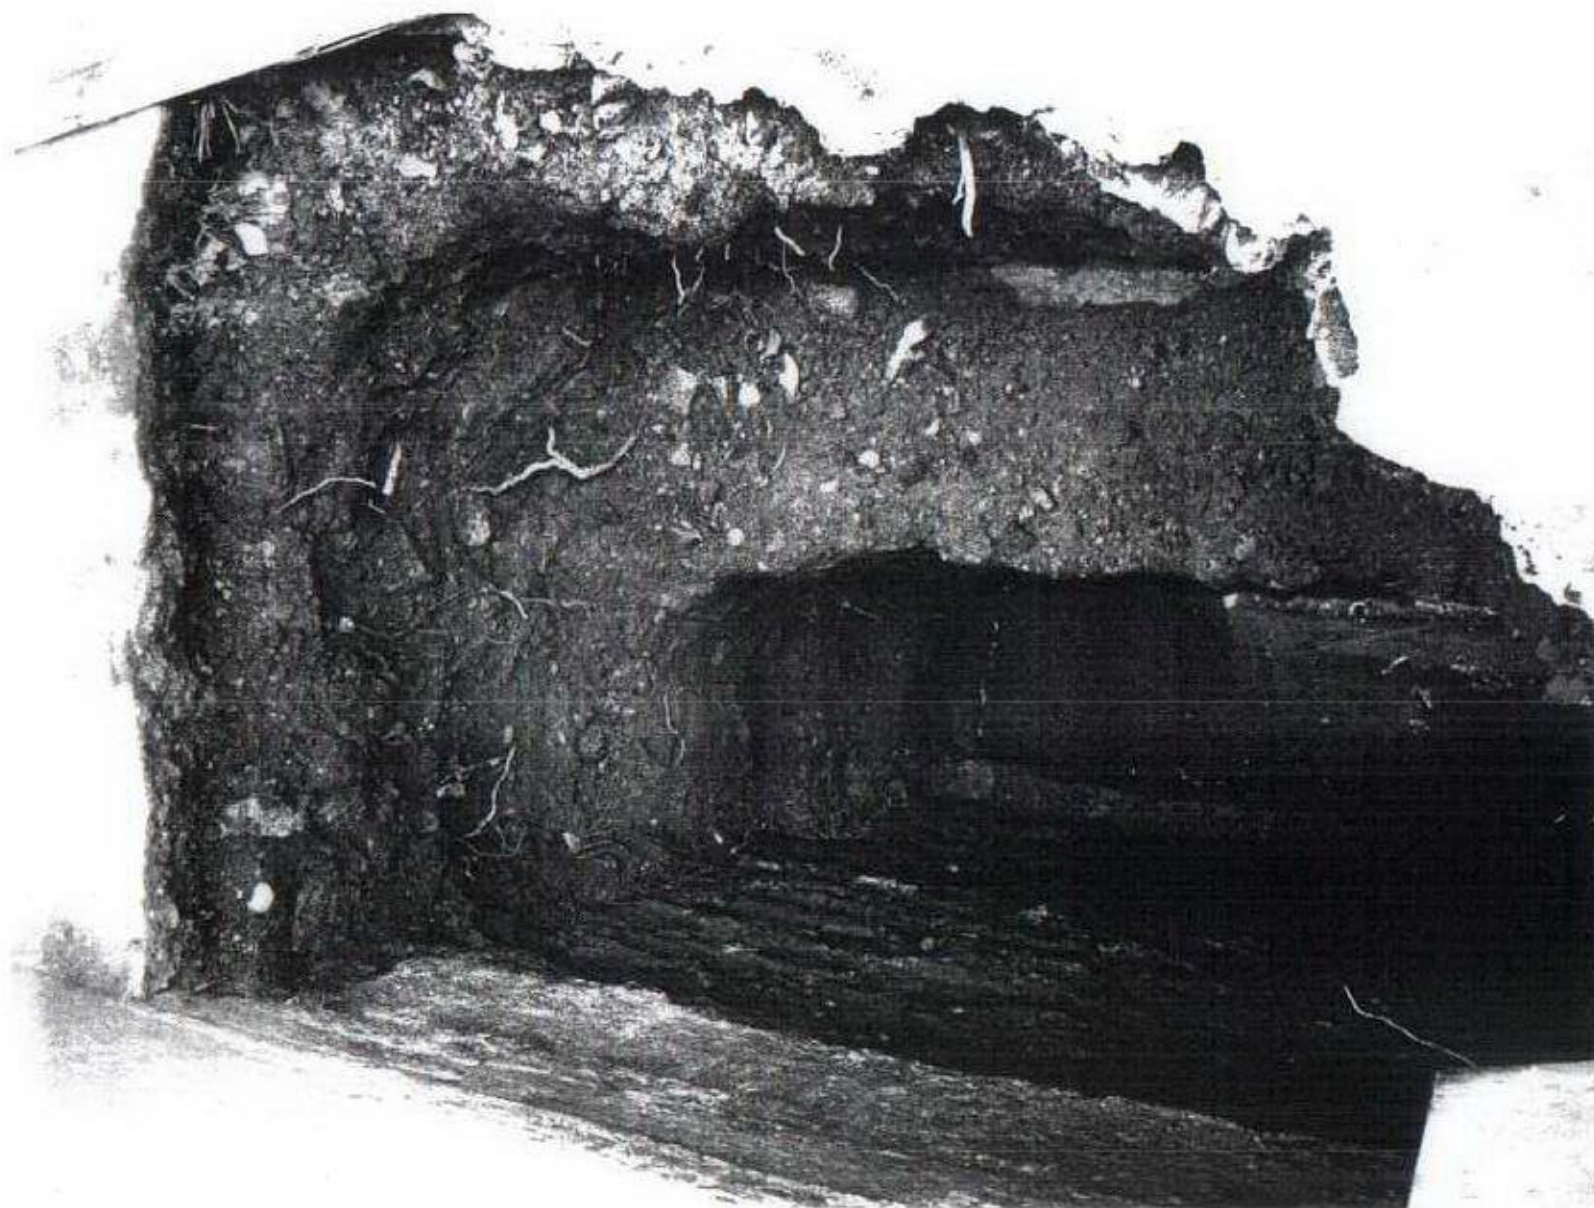
PHOTO 1.1

- 1.1 Excavation revealing the rear wall and footing at a depth of approx 1.5m at +34.07.
- 1.2 Single stepped footing. Wall of 9" roughly laid soft reds and flettons in lime mortar, built overhead.
- 1.3 Water table (probably road rain leakage water) is at level of footing approx +33.86 (i.e. at level of u/s of main room floor slab) see photos 1.1 – 1.4.

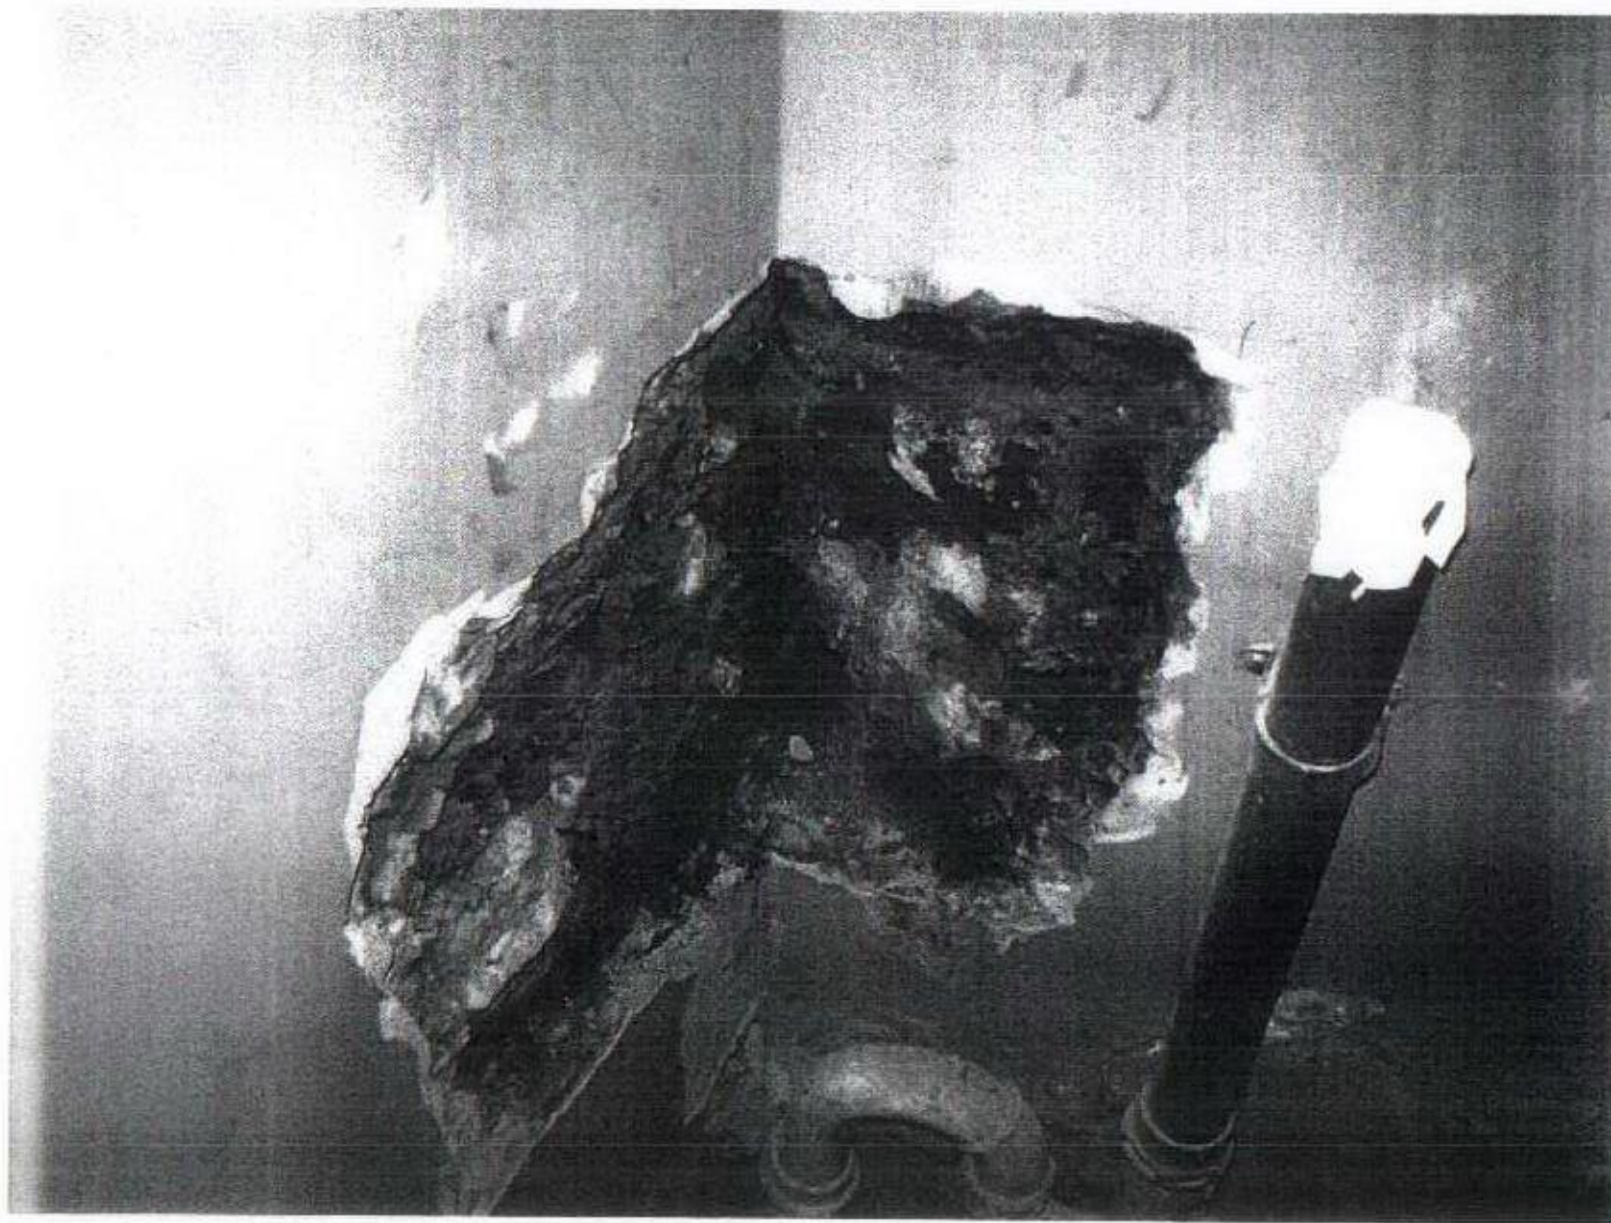
PHOTO 2.1

- 2.1 In the west room (photo 2.1) lime plaster direct brickwork (see above).
- 2.2 In the east bathroom (photo 2.2) carlite bonding on 100mm blockwork (dividing partition across one room) built in 1984 in cement mortar jointing. No damp membrane against the outer wall.

NOTE: There is no internal water proofing/tanking on the walls. The inner skin of brickwork is fairfaced showing that the 9" wall was built from inside. Damp is drawn across into the block wall as there is no vertical DPC.

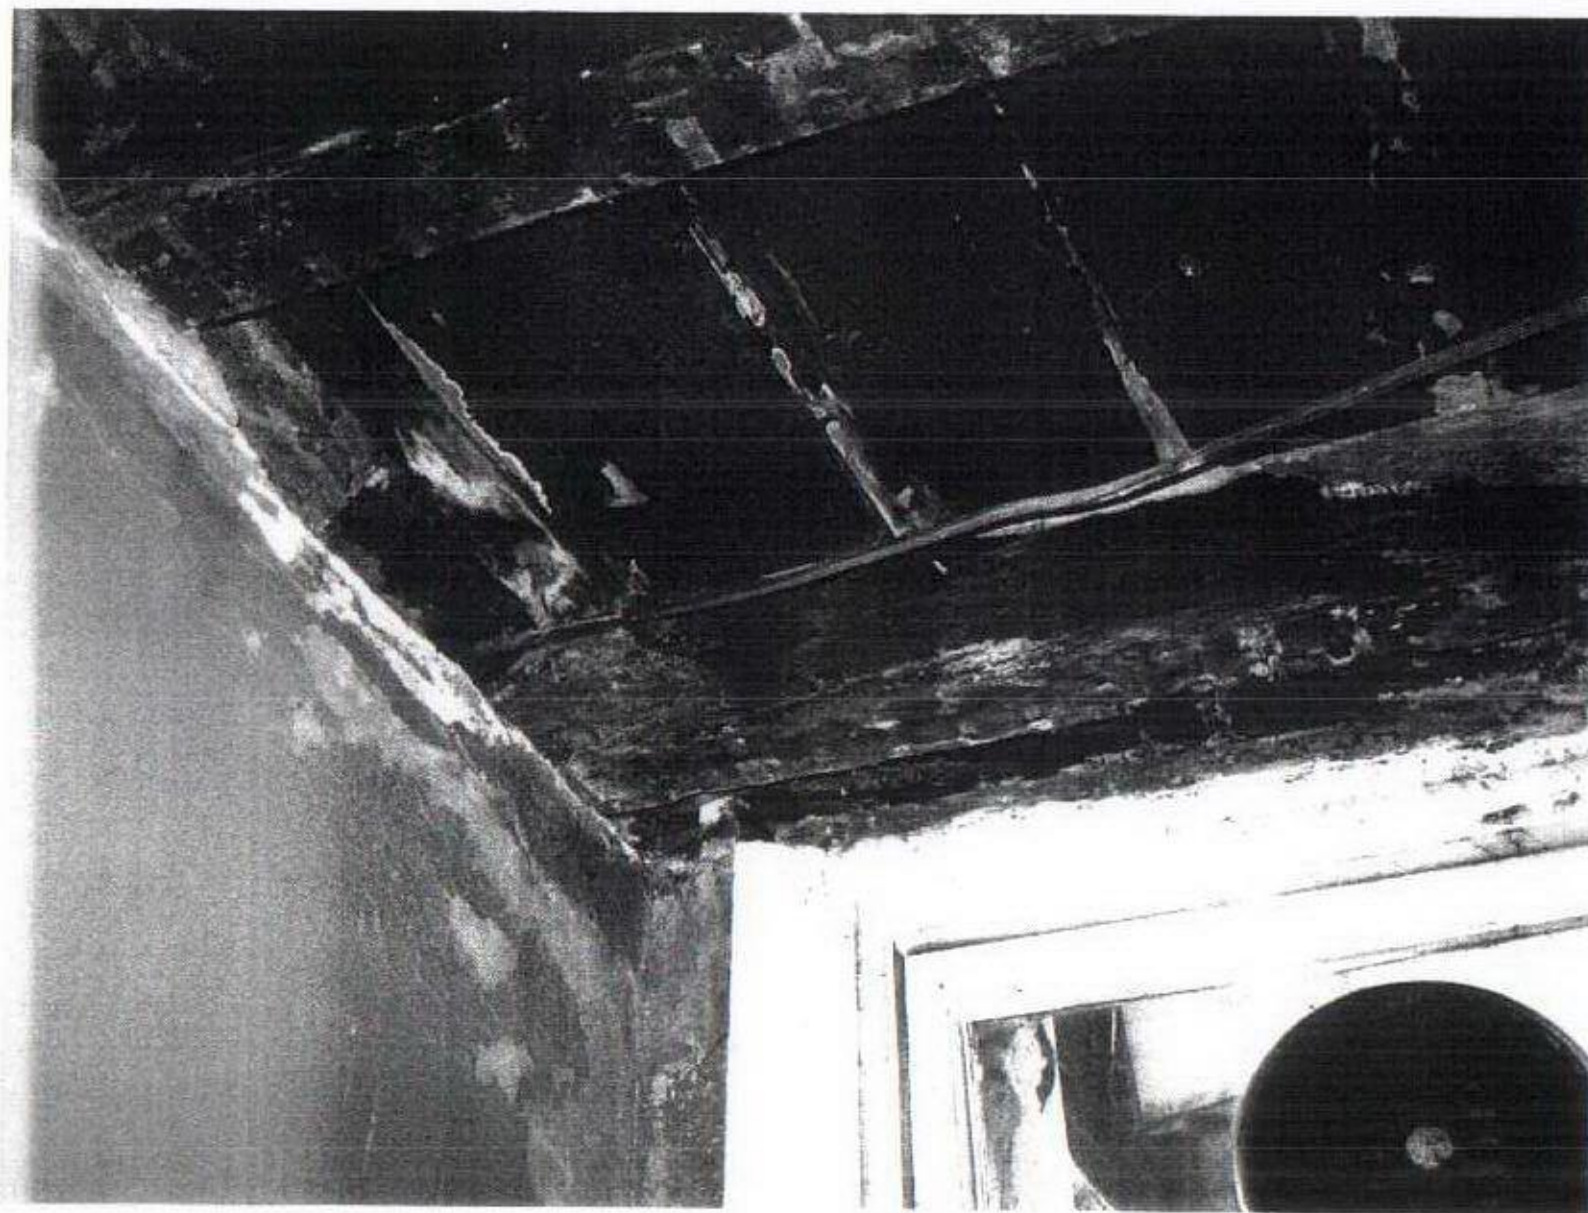
PHOTO 3.1

- 3.1 In the west room. 2" square joists spanning north/south ends housed in the walls. Timber is damp. Probably condensation and also leaks from bathroom over.

NOTE: The joists are very thin. It may be that there was once a roof and not a floor until the additional storey was built over. The date of the basement extension must be after 1880 on the lathe type.

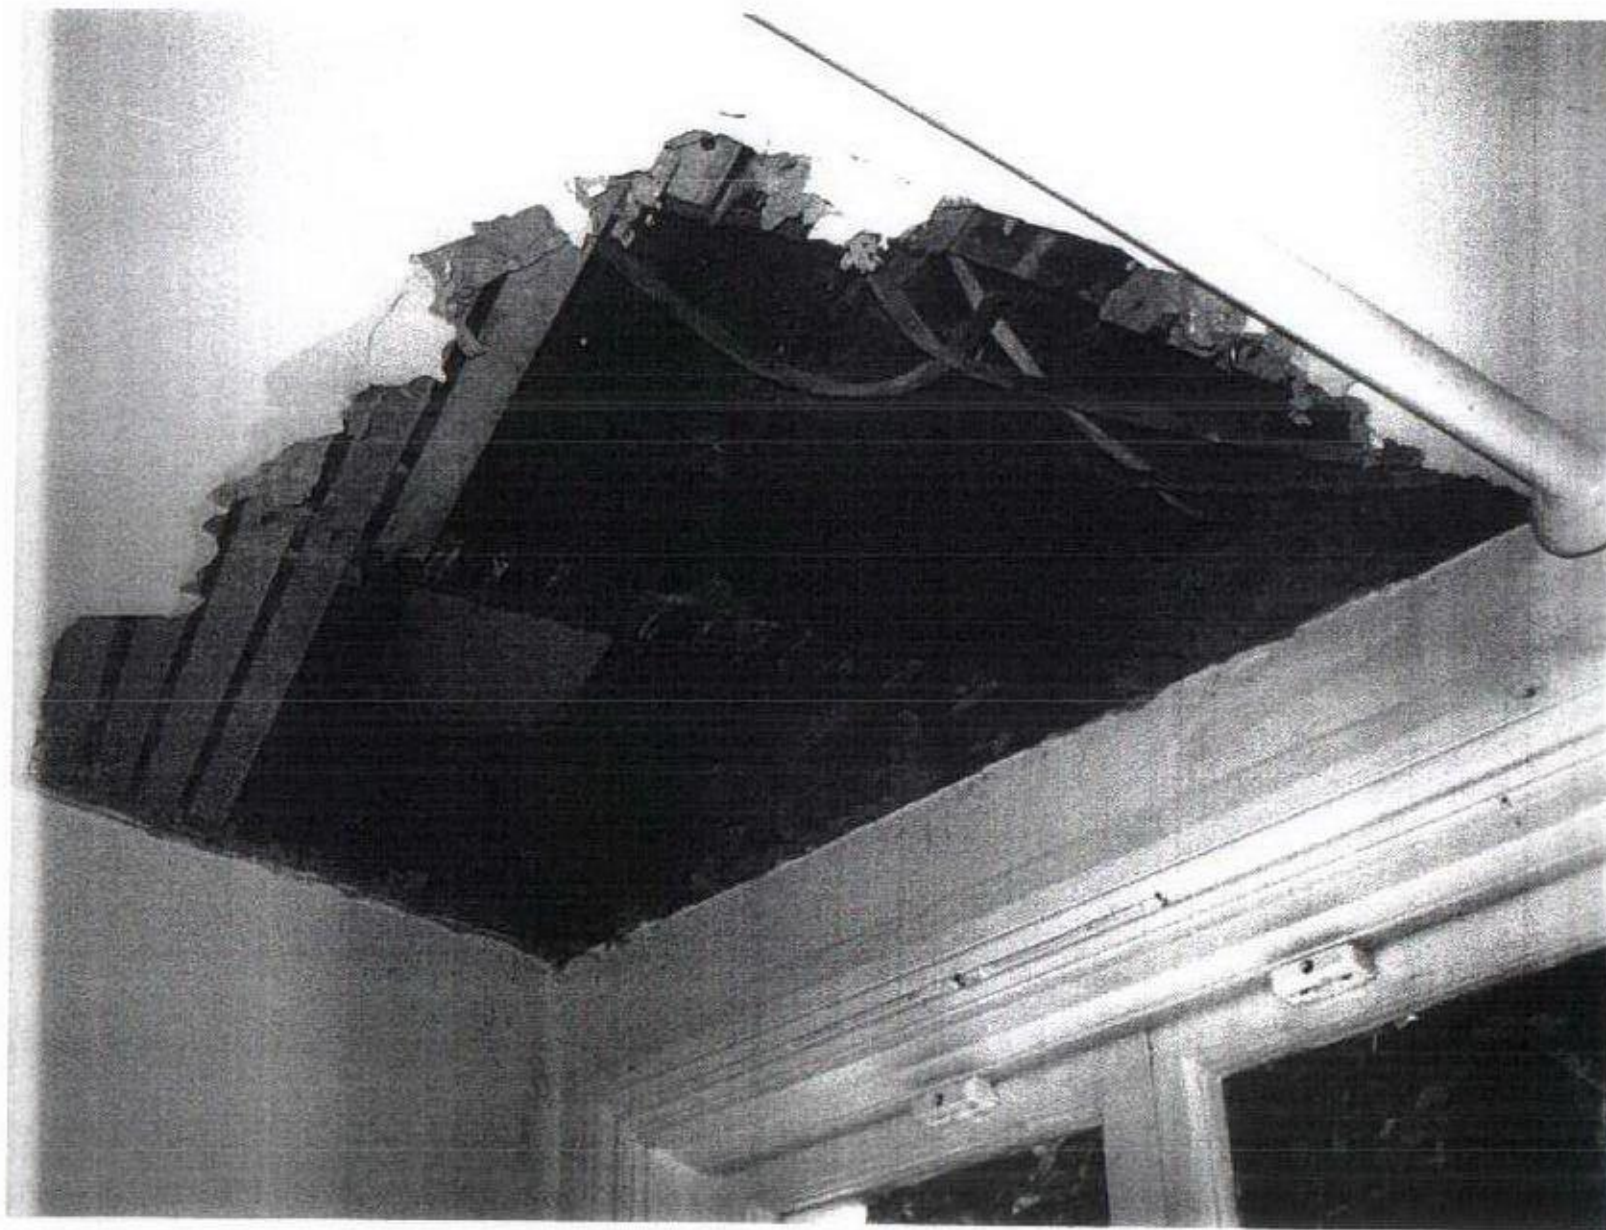
PHOTO 3.2

3.2 In the east room 2" square joists – all as above. Machine sawn lathe and plaster to both ceilings.

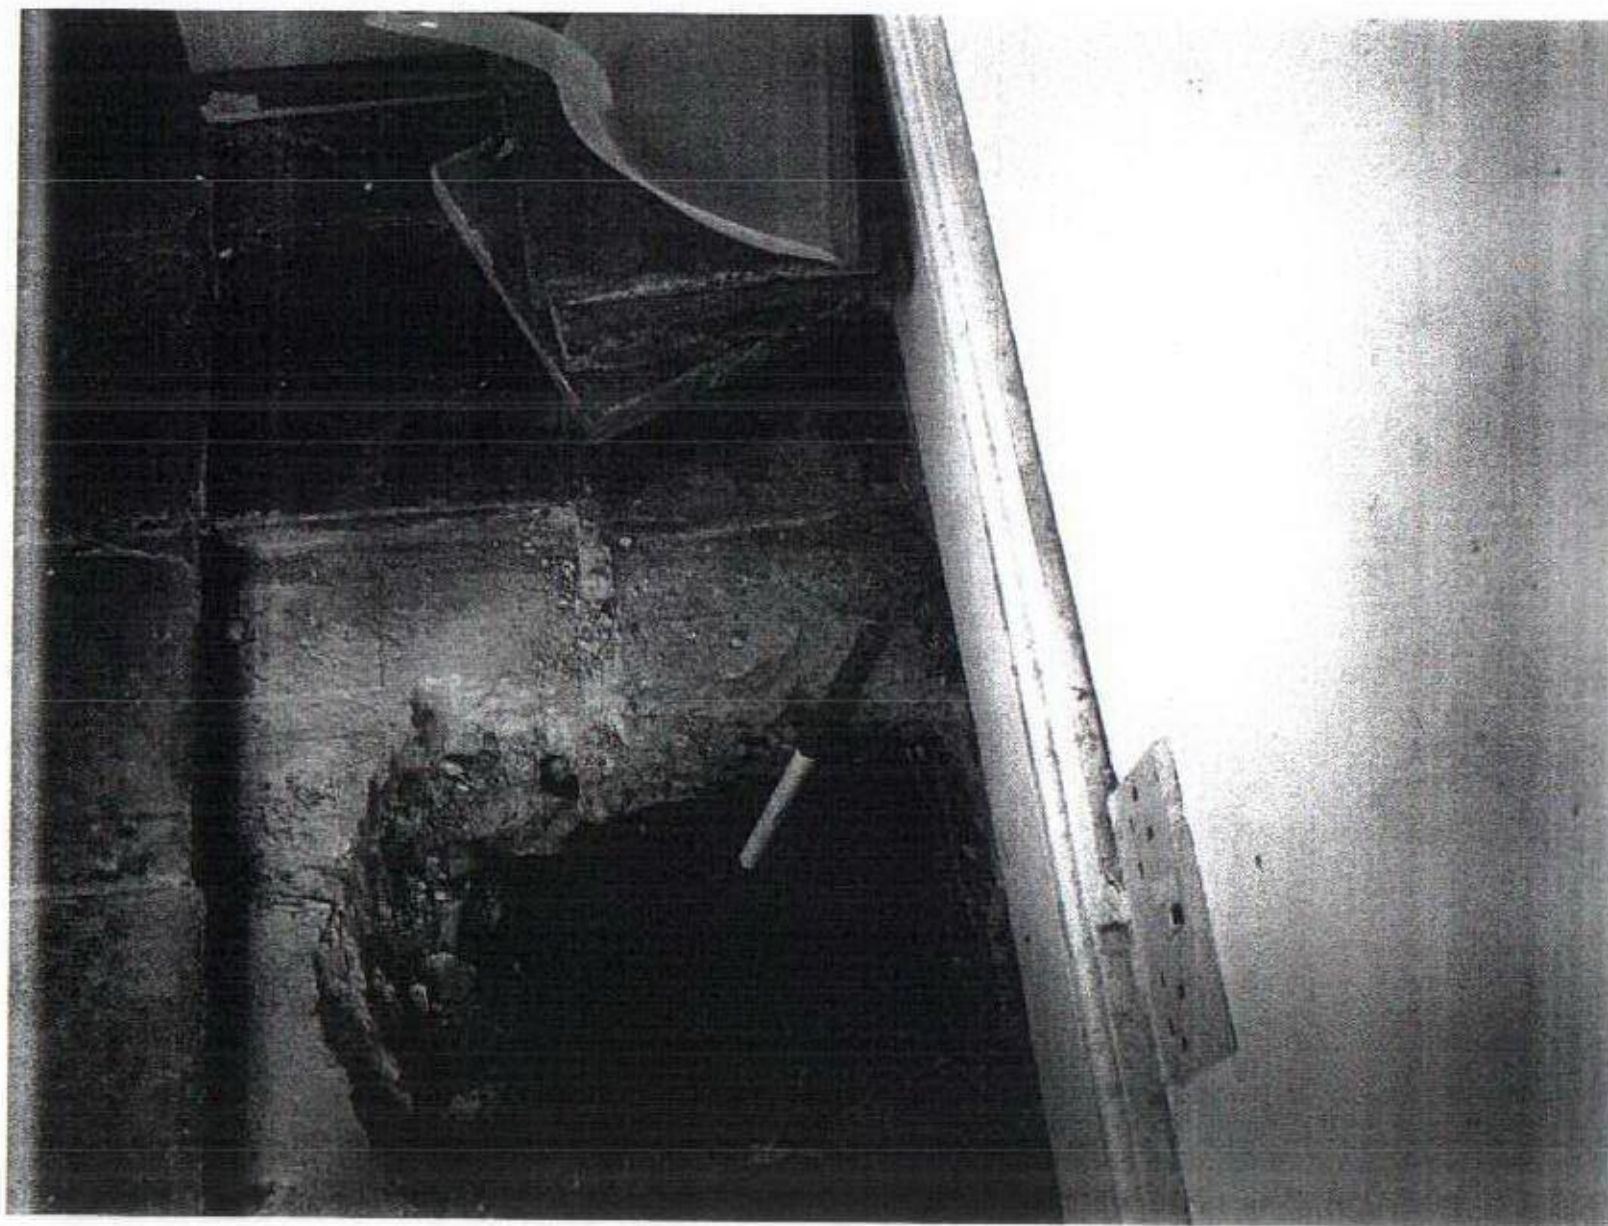
PHOTO 4.1

4.1 In the dining room. The slab is concrete and the finish is 50mm clay 'quarry' tiles. The base slab is 100mm thick with a DPC of 500g polythene and a topping of 50mm concrete. There is no insulation below the slab. Photo 4.1 and 4.2.

NOTE: The slab DPM does not dress up the walls and is therefore not continuous with the wall water proofing. This accounts for the damp in the walls.

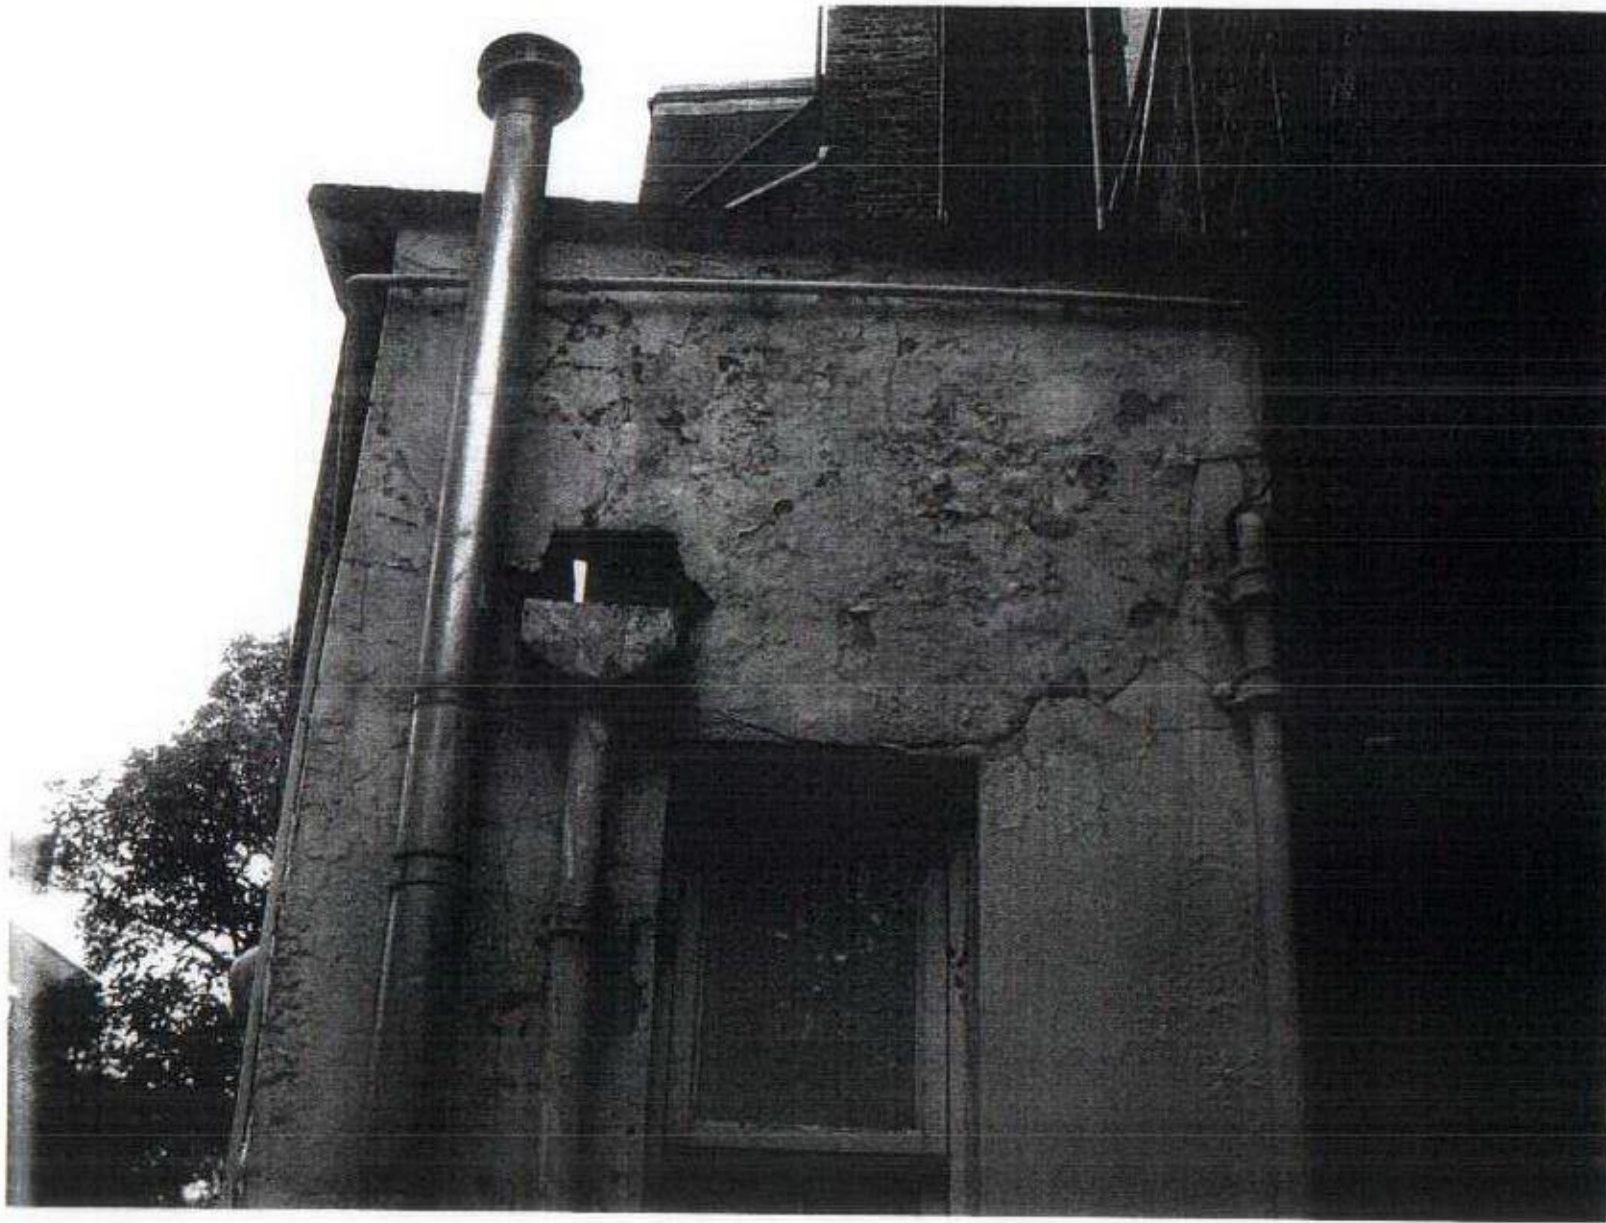
PHOTO 5

This extension is probably a built-on scullery of 1860 date constructed by cutting the rising ground away and building from inside over head – hence the rough brickwork. Subsequent metering of Berkley Road and public drainage have made the very poor construction vulnerable to damp penetration and structural movement (see photo 5).

- These walls must be made waterproof by adequate tanking. In the case of the rear extension this, ideally, means rebuilding the extension together with a retaining tanking wall holding back the garden earth.
- The rear extension render shown on photo 5 is detaching from its brick backing and cracking indicates that movement caused by inadequate construction of roof and retaining wall at basement level are causing unacceptably large structural movement.
