57-60 Lincoln's Inn Fields – Leaning Garden Walls

We visited site with you on 23.4.09 and made a visual inspection of the two leaning walls. The weather was warm, calm and dry. The following report is based upon that inspection and our subsequent structural calculations of the stability of the walls. The report is presented to you and the client in accordance with the terms of our letter 21.4.09.

Date: 24.4.09	Project No: 124463/6	Page: SK1.	Rev:
--	---------------	----------------------	------------	------

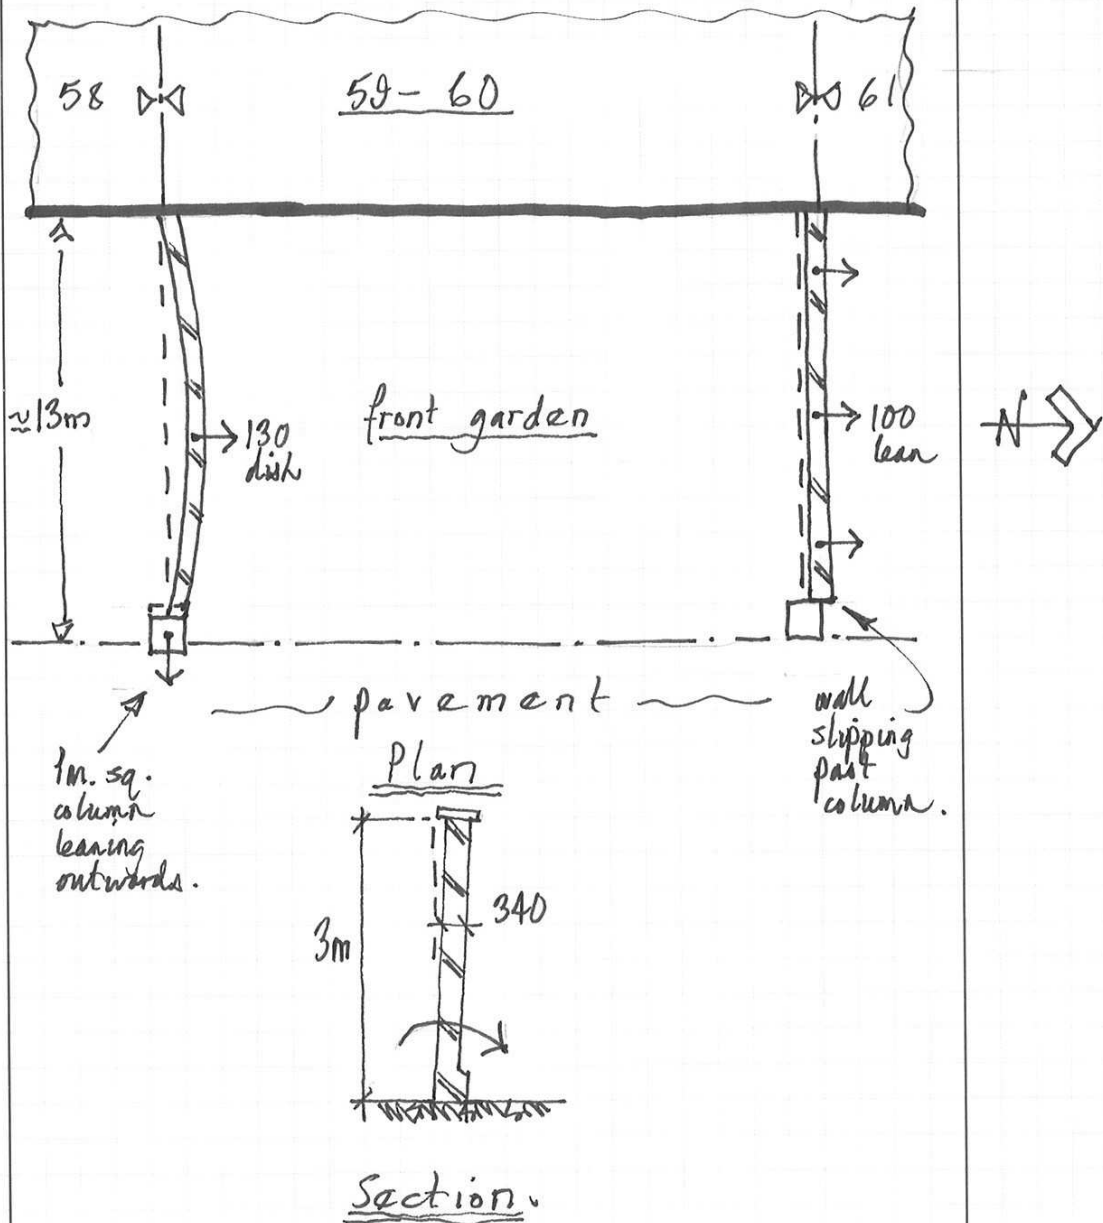
The two walls are each approximately 3m high by 13m long by 340mm thick, with 105 thick piers at 3m centres. The walls run between the front elevation of 59-60, and 1m square columns at their free ends.

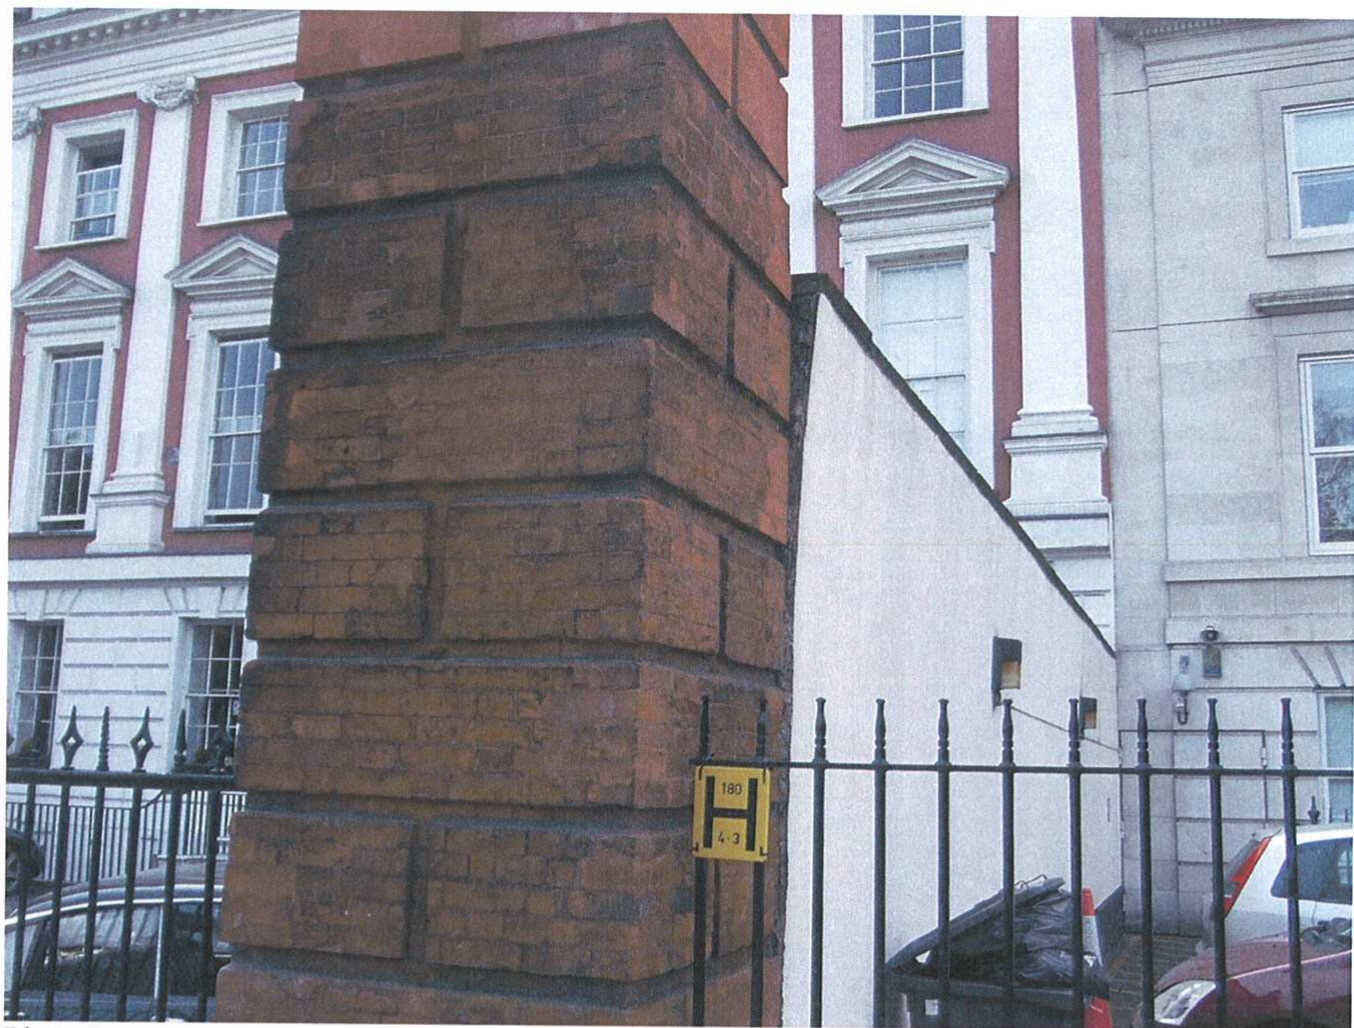
Photo 3

The walls are constructed with London Stock bricks set in lime mortar, with ribbon repointing in cement mortar. Both walls are leaning to the north. The southernmost wall is dished at its midrun (130mm), and the northernmost wall leans along most of its length (100mm). See photos 3 and 4.

As both walls lean to the north, cyclical thermal and moisture movement combined with sulphate attack are the likely causes. These causes will continue, so the walls will continue to distort until they get blown over by the wind one day.

If the walls were plumb they would have a 50% safety margin against collapse under design wind loads, to BS. 6399 Part 2. That margin has been reduced to about 7% by the current distortion. Whilst 50% is a normal safety margin, 7% is not, so the distortion of the walls has eroded their safety margin unacceptably close to failure. It will only take another 11mm of lean (half inch) to erode the safety margin completely.

1. Rebuild the walls, on new foundations (provisional), and provide dowelled movement joints at the wall ends to accommodate future longitudinal reversible movement.

2. Butress the existing walls at midrun, and tie the northernmost wall to its terminal column, and the front wall of 59-60 (provisional).

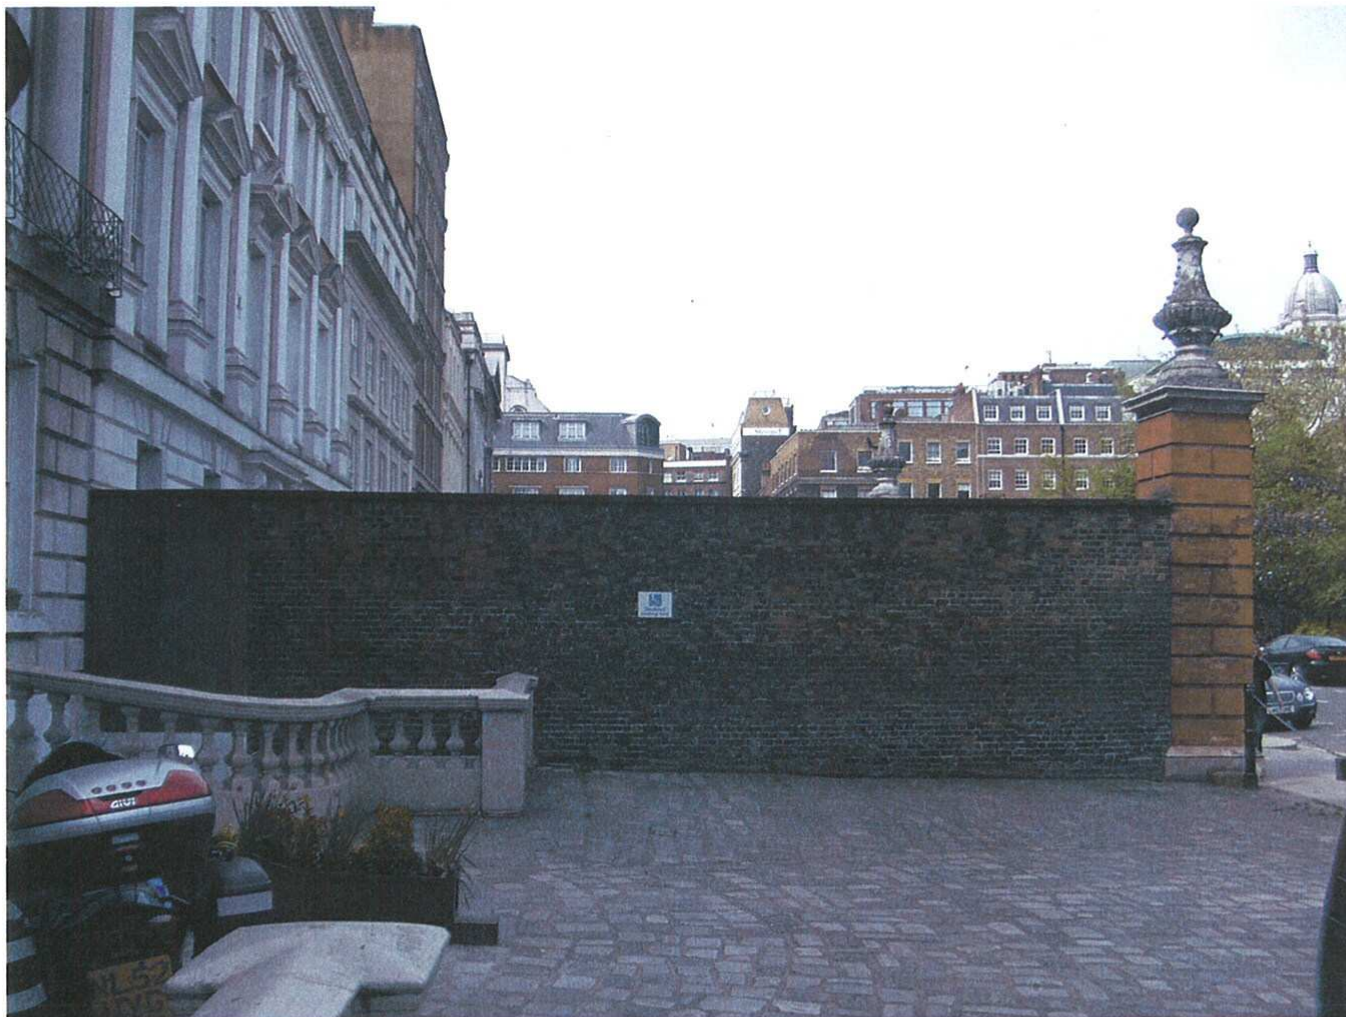
Photo 5

Apart from the walls, the leaning column (see photos 5 and 6) needs to be monitored quarterly for a year to check for any progressive displacement.
