## PLANNING AND LISTED BUILDING APPLICATION 57 – 60 LINCOLN'S INN FIELDS, YARD WALL REBUILDING WORKS SUPPORTING PHOTOGRAPHS

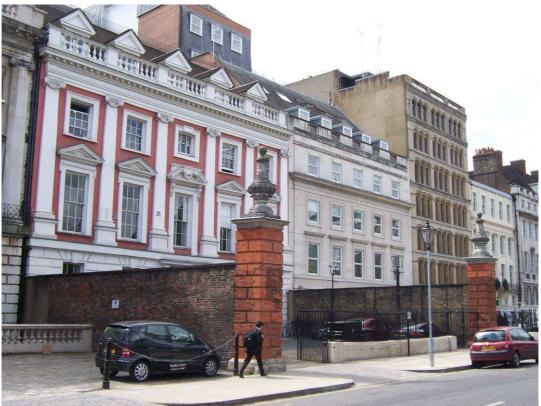
1. General view of the walls within the front yard of 59-60 LIF. Front piers are original, dividing walls are rebuilds.

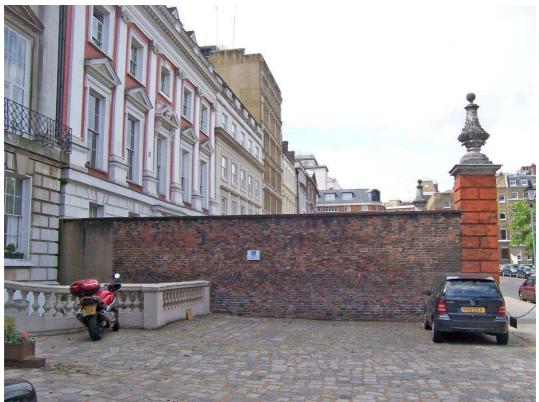
2. South wall, looking north. Note it is unclear whether the red brickwork is original, however it is older than the late c.19<sup>th</sup> buff brickwork that exists elsewhere. Render to the lhs is a younger application.

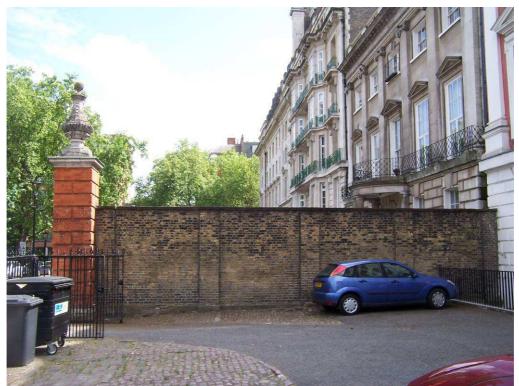
3. South wall, looking south. Note the buff stock bricks date from the rebuilding during the late c.19<sup>th</sup>.

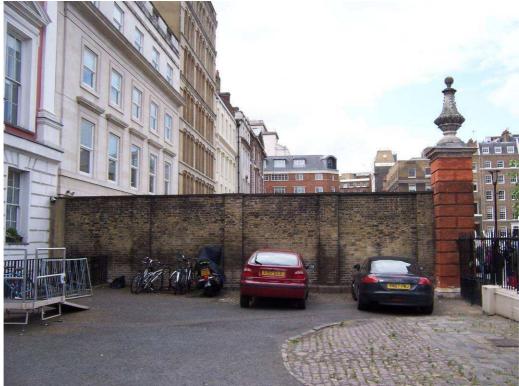
4. North wall, looking north. Note the buff stock bricks date from the rebuilding during the late  $c.19^{th}$ .

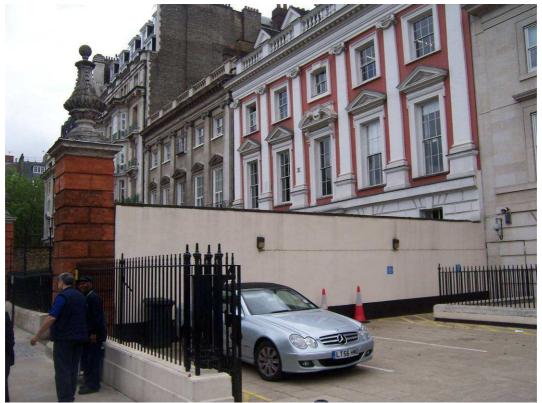
5. North wall, looking south. Note the render and decorations are modern, undertaken without authorisation by the neighbours to the north.

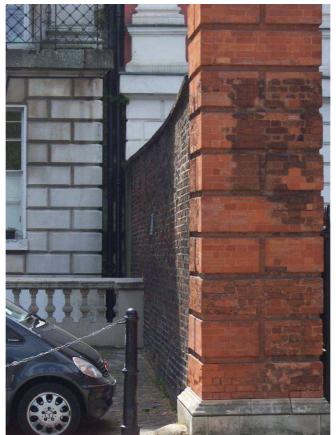
6. Bowing and leaning of the south wall.

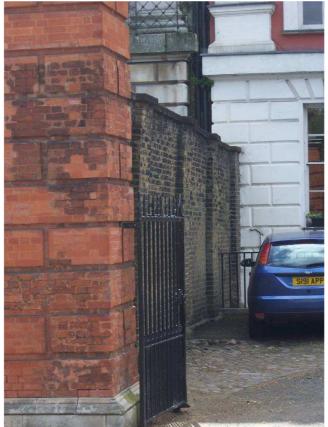
7. Bowing and leaning of the south wall.

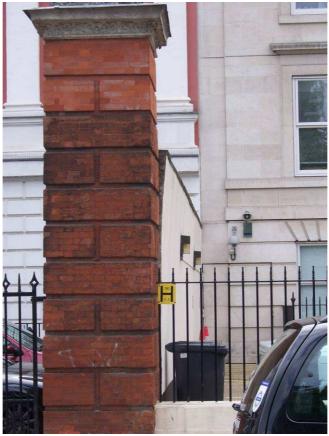
8. Leaning of the north wall.

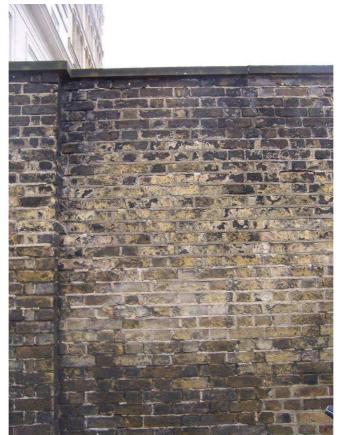
9. Buff stock brickwork to the north wall and to the north face of the south wall.

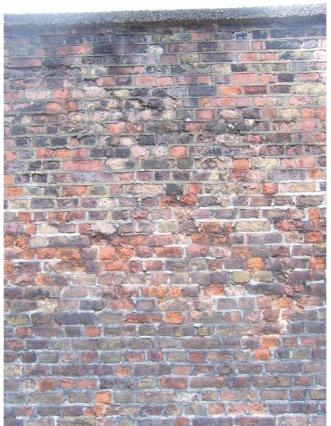
10. Mixed, mainly soft red, brickwork to the south face of the south wall.

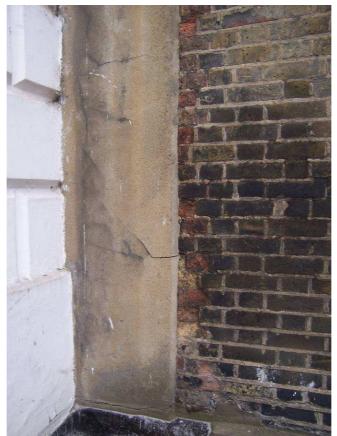
11. Evidential remains of older red brickwork at the abutment to the north wall.

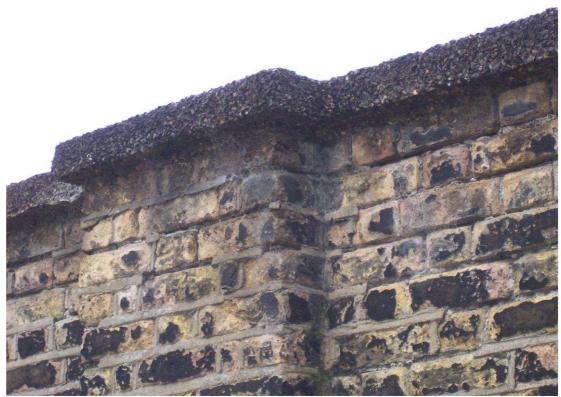
12. Current copings: Inadequate roughcast concrete, with insufficient overhangs, no drip throat, no weathering slopes (flat top) and no dpc.

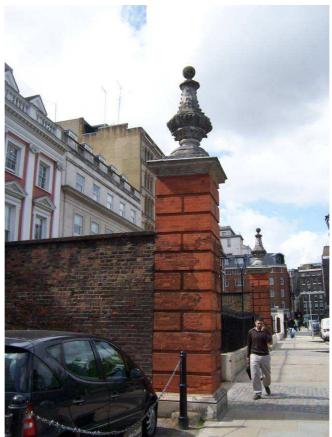
13. Leaning south pier; foundations requiring investigation.

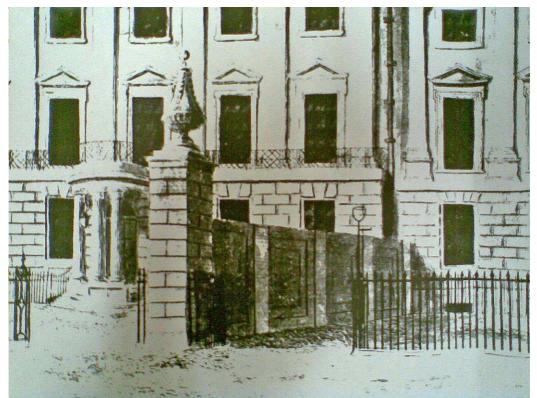
14. 1809 image of the north face of the south wall, showing previous recessed panel design of brickwork set between piers. Similar aesthetic treatment existed to the south face of the north wall. It is not clear whether similar treatment existed to the outer faces, although these were likely to have been flush faced brickwork (as per photo 2).
