BS5837:2005 Tree Survey Report, incorporating Arboricultural Implications Assessment and Method Statement

In support of an application for a docking station on the footway opposite:

The High Holborn Post office at 181 High Holborn WC1

Site Ref: 02/610230 Status: FINAL Date:11 May 2009

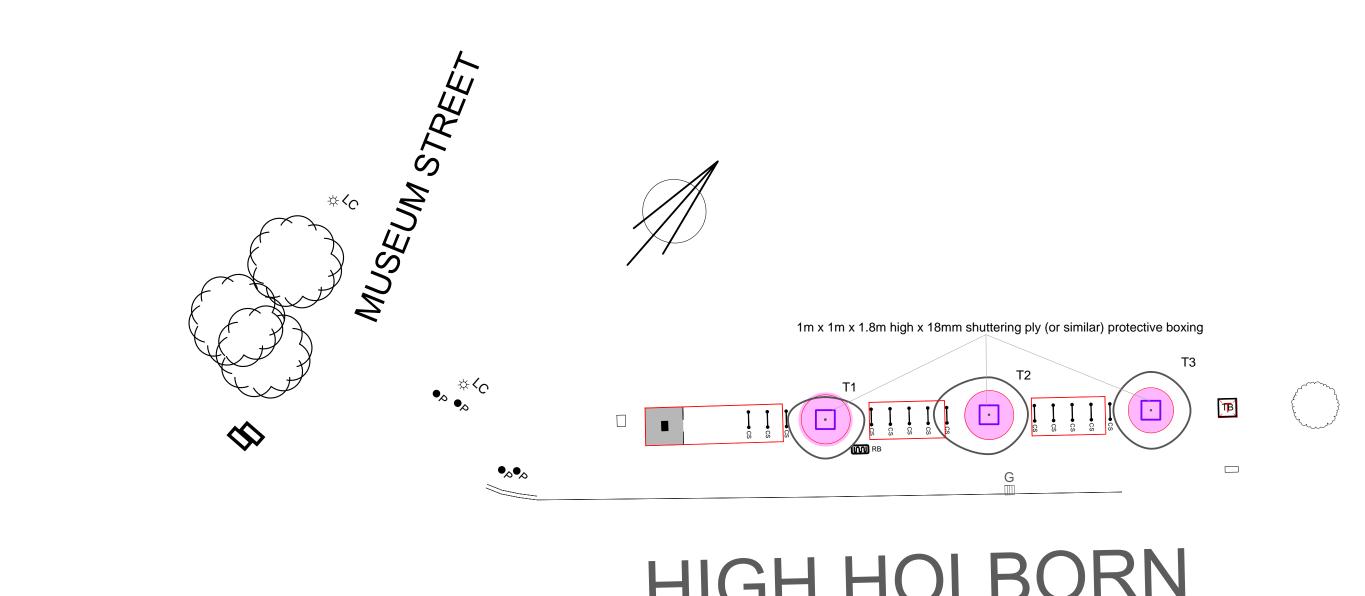
TREE **CONSTRAINTS** PLAN

The Tree Constraints Plan (Appendix 4) shows the location of T1-T3 in relation to the proposed development. The plan indicates that the proposed docking stations are located beyond the RPAs of all trees. As such, any excavation within the site is only likely to encounter minor roots and shall not have a significant detrimental impact on any trees.

Protective fencing is specified around T1-T3 to protect the stems and primary branches. The existing hard surfacing shall be retained over RPAs outside of the Site which shall provide sufficient protection for tree roots.
