BS5837:2005 Tree Survey Report,
incorporating
Arboricultural Implications Assessment
and Method Statement

**opposite 205 Eversholt Street (adjacent to the Mayford Estate)
NW1**

Site Ref: 02/610262
Status: FINAL
Date: 04 May 2009

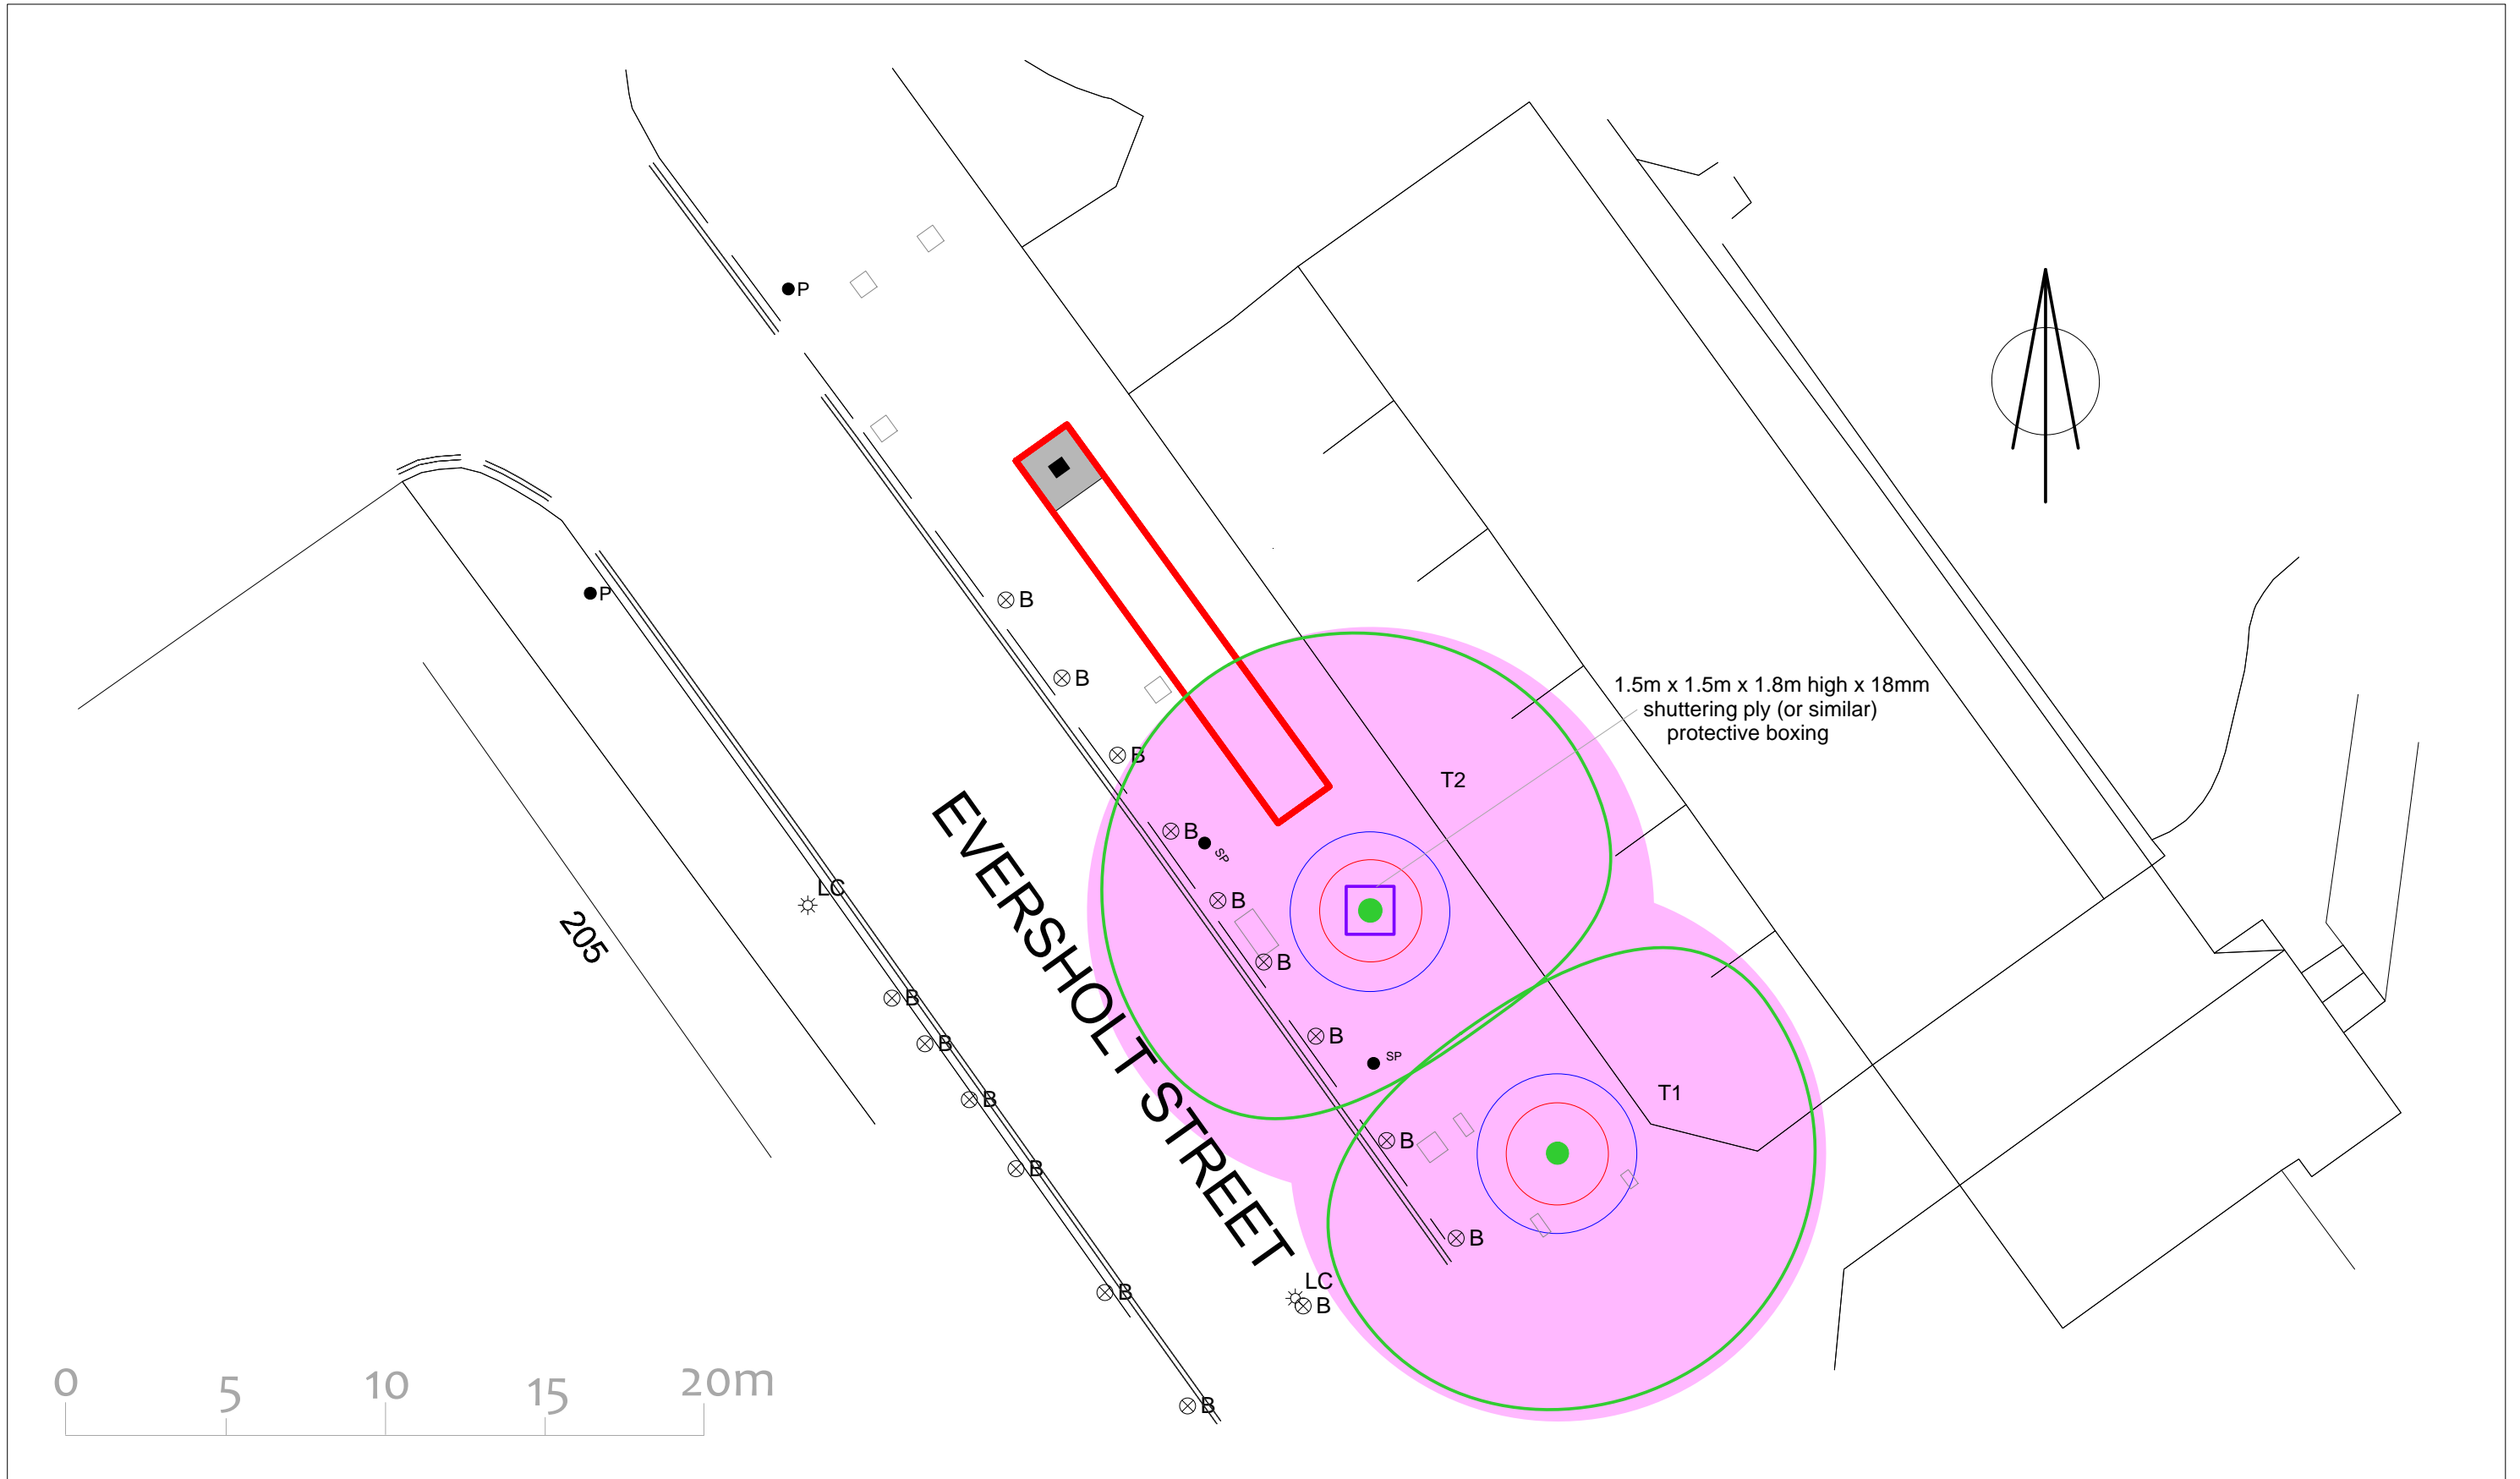
APPENDIX 4: TREE CONSTRAINTS PLAN

The Tree Constraints Plan (Appendix 4) shows the location of T1 and T2 in relation to the proposed development. The plan indicates that the proposed docking station is located within the RPA of T2. However the distance between the Site and this tree (approximately 3.5m) along with the radial alignment of the Site, means that relatively few significant roots are likely to be encountered when compared with the portion of the RPA which shall remain untouched. No structural roots are likely to be encountered so the stability of the tree shall be unaffected. A short term reduction in vigour may occur within the short term due to trenching operations. However, T2 is likely to make a full recovery within one or two growing seasons with no long term detrimental impact.

No construction exclusion zones are specified for T1 due to its distance from the site. Protective fencing is specified around T2 to protect the stem and primary branches. The existing hard surfacing shall be retained over RPAs which shall provide sufficient protection for tree roots.

The stem and primary branches of T2 shall require protecting before commencement of any construction activity (including ground preparation) and throughout the development process. A fencing solution shall be required which prevents access to the stems by all construction machinery, materials and personnel. Weldmesh panels or 18mm shuttering ply to a height of 1.8m should be positioned around the tree stems at a distance of no less than 0.75m from the stem centre. Such fencing shall need to be robust enough to withstand occasional knocks from construction machinery. The fencing should be secured to the ground using brackets or ground pins. Excavation to secure the fencing shall not be acceptable.
