BS5837:2005 Tree Survey Report, incorporating Arboricultural Implications Assessment and Method Statement

**58A & 58 G Hatton Garden
and 83 Clerkenwell Road
EC1**

Site Ref: 02/610223
Status: FINAL
Date: 13 May 2009

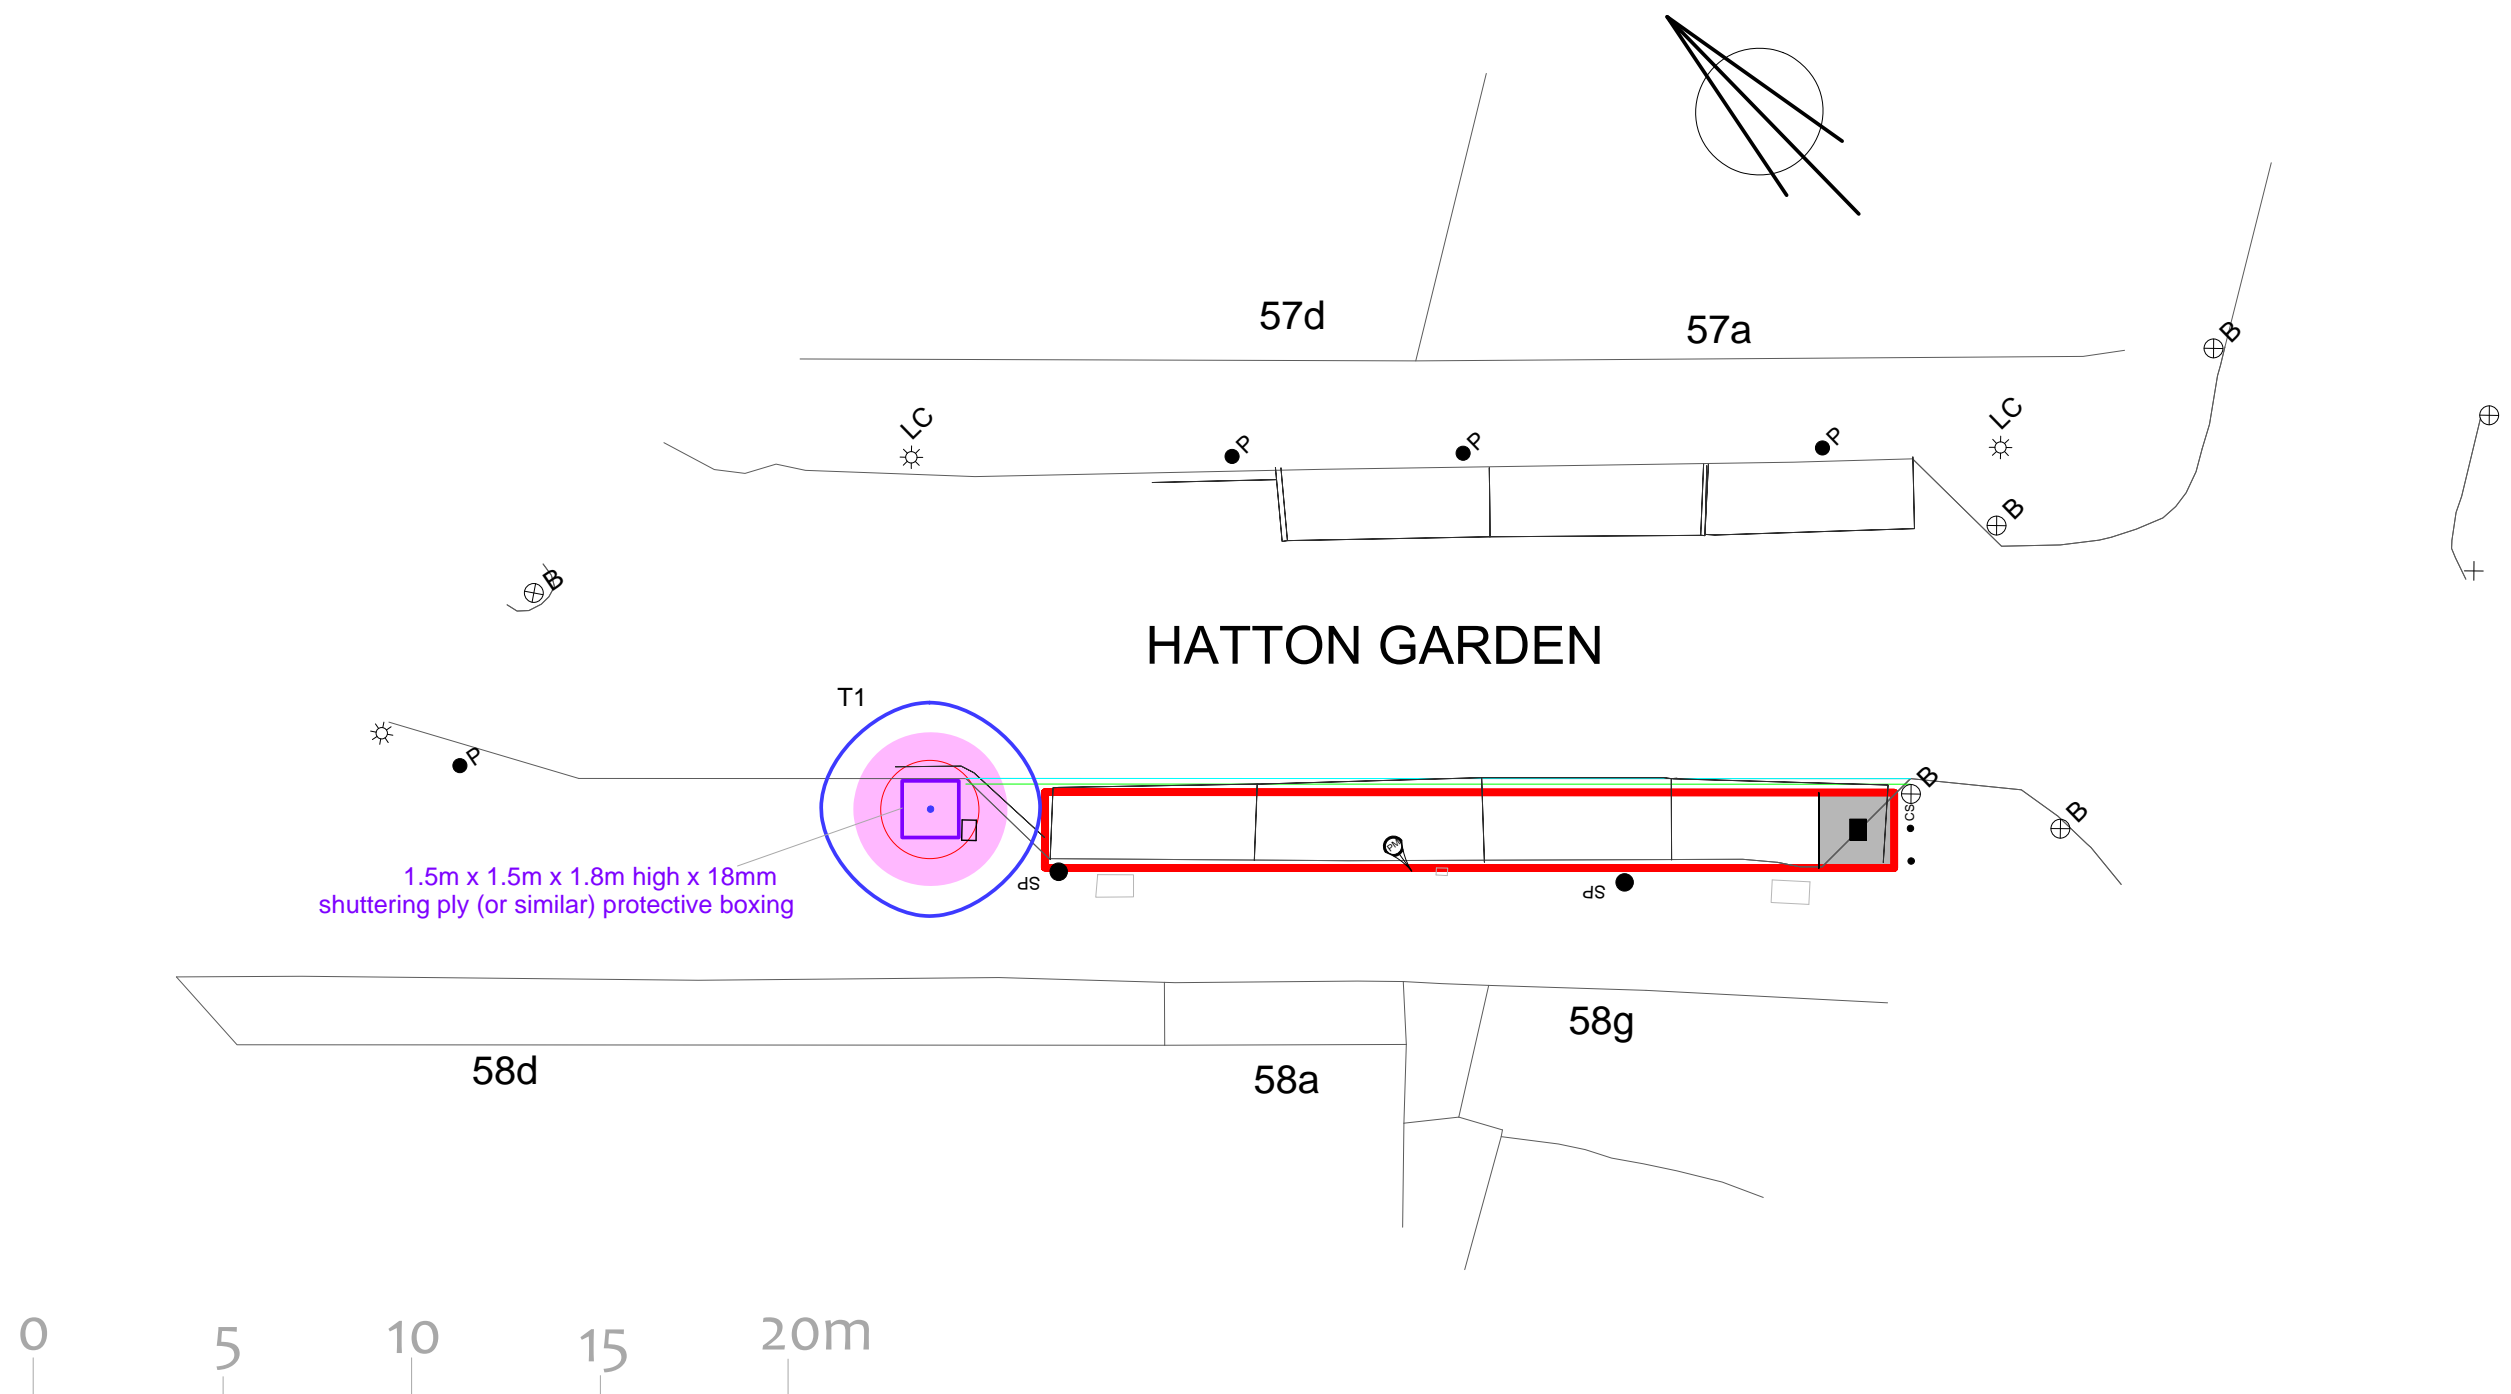
TREE
CONSTRAINTS
PLAN

The Site is located on the footway adjacent to 58A and 58G Hatton Garden and 83 Clerkenwell Road, EC1. There is one semi-mature tree to the north west of the docking station site. This represents the only tree surveyed in connection with the proposed development.

The Tree Constraints Plan (Appendix 4) shows the location of T1 in relation to the proposed development. The plan indicates that the proposed docking station is located just beyond the RPA of T1. As such, any excavation within the site is only likely to encounter minor roots and shall not have a significant detrimental impact on T1.

Protective fencing is specified around T1 to protect the stem and primary branches. The existing hard surfacing shall be retained over RPAs which shall provide sufficient protection for tree roots.

The stem and primary branches of T1 shall require protecting before commencement of any construction activity (including ground preparation) and throughout the development process. A fencing solution shall be required which prevents access to the stems by all construction machinery, materials and personnel. Weldmesh panels or 18mm shuttering ply to a height of 1.8m should be positioned around the tree stems at a distance of no less than 0.75 from the stem centre. This fencing shall need to be robust enough to withstand occasional knocks from construction machinery. The fencing should be secured to the ground using brackets or ground pins. Excavation to secure the fencing shall not be acceptable.
