**BS5837:2005 Tree Survey Report,
incorporating
Arboricultural Implications Assessment
and Method Statement**

**Tavistock Place (opposite 1 Wakefield Street)
WC1**

Site Ref: 02/610254
Status: FINAL
Date: 13 May 2009

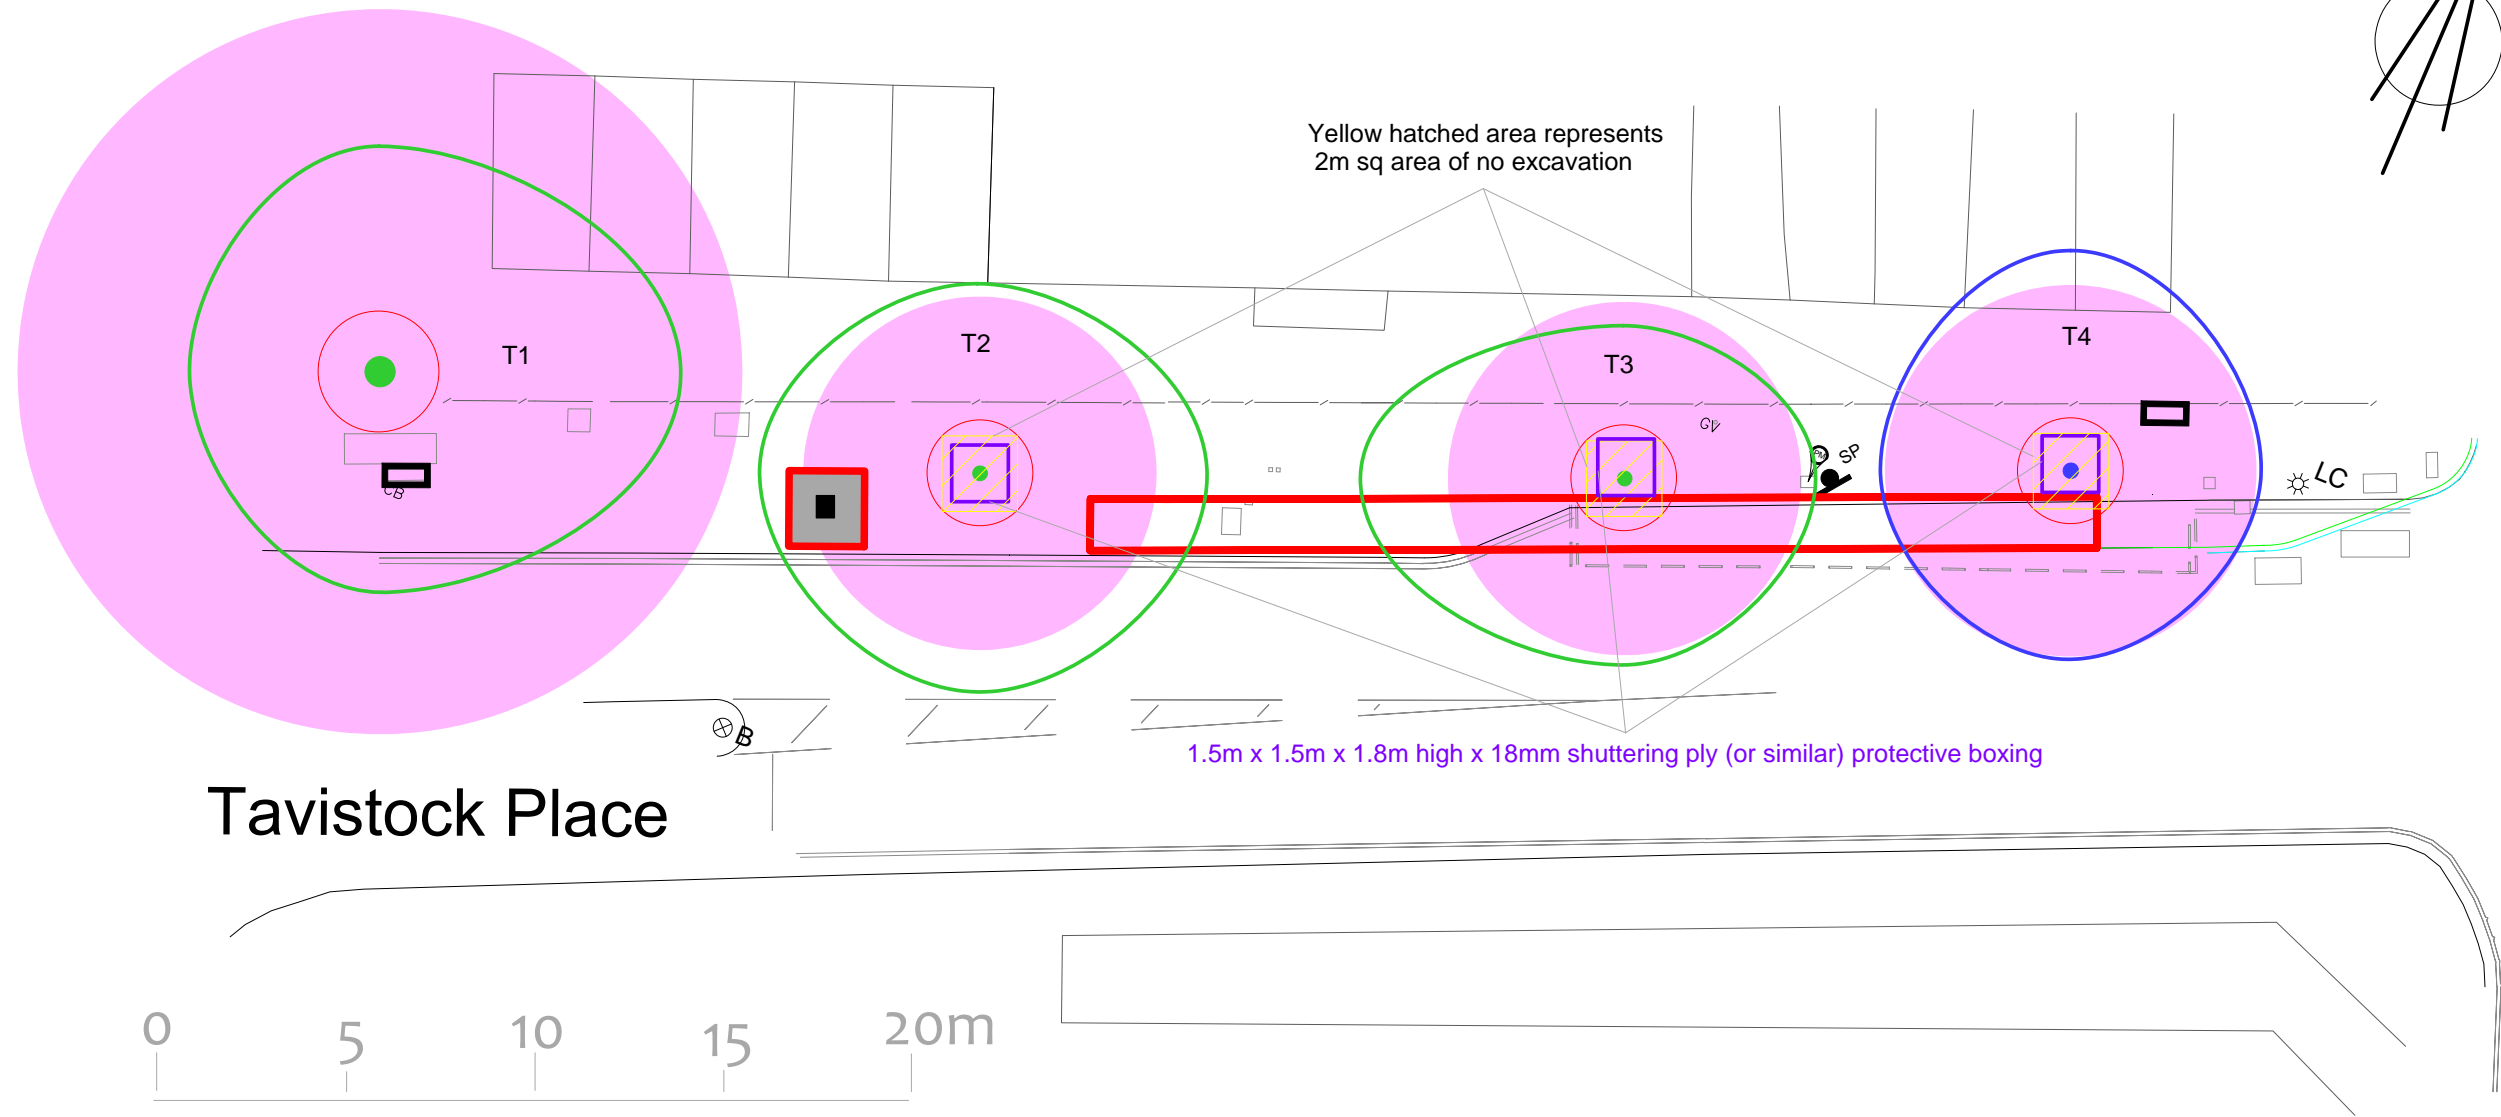
Title
 TREE CONSTRAINTS PLAN

The Tree Constraints Plan (Appendix 4) shows the location of T1-T4 in relation to the proposed development. The plan indicates that the proposed docking station is located within the RPAs of T2-T4. In order to minimise the impacts of excavation the docking station is to be installed without excavation within 2m of any tree. Given the existing kerb, hostile conditions beneath the carriageway, and recent construction of that part of the footway within the Site, any excavation within the remainder of the site is not likely to have a long term impact on the health of any trees.

No construction exclusion zones are specified for T1 due to its distance from the site and location on third party land. Protective fencing is specified around T2-T4 to protect the stem and primary branches. The existing hard surfacing outside of the Site shall be retained over RPAs which shall provide sufficient protection for tree roots.

The stem and primary branches of T2 - T4 shall require protecting before commencement of any construction activity (including ground preparation) and throughout the development process. A fencing solution shall be required which prevents access to the stems by all construction machinery, materials and personnel. Weldmesh panels or 18mm shuttering ply to a height of 1.8m should be positioned around the tree stems at a distance of no less than 0.75m from the stem centre. Such fencing shall need to be robust enough to withstand occasional knocks from construction machinery. The fencing should be secured to the ground using brackets or ground pins. Excavation to secure the fencing shall not be acceptable.
