Application for tree works: works to trees subject to a tree preservation order (TPO) and/or notification of proposed works to trees in a conservation area.
Town and Country Planning Act 1990

**Re: Tree Related Subsidence at 10 Torriano Cottages, Torriano Avenue, NW5 2TA
Notice under s.211 of the Town and Country Planning Act 1990 of intent to
Fell one False Acacia tree (T1) at 9 Torriano Cottages, Torriano Avenue, NW5 2TA**

INSURANCE CLAIM

**FACTUAL REPORT
OF
INVESTIGATION**

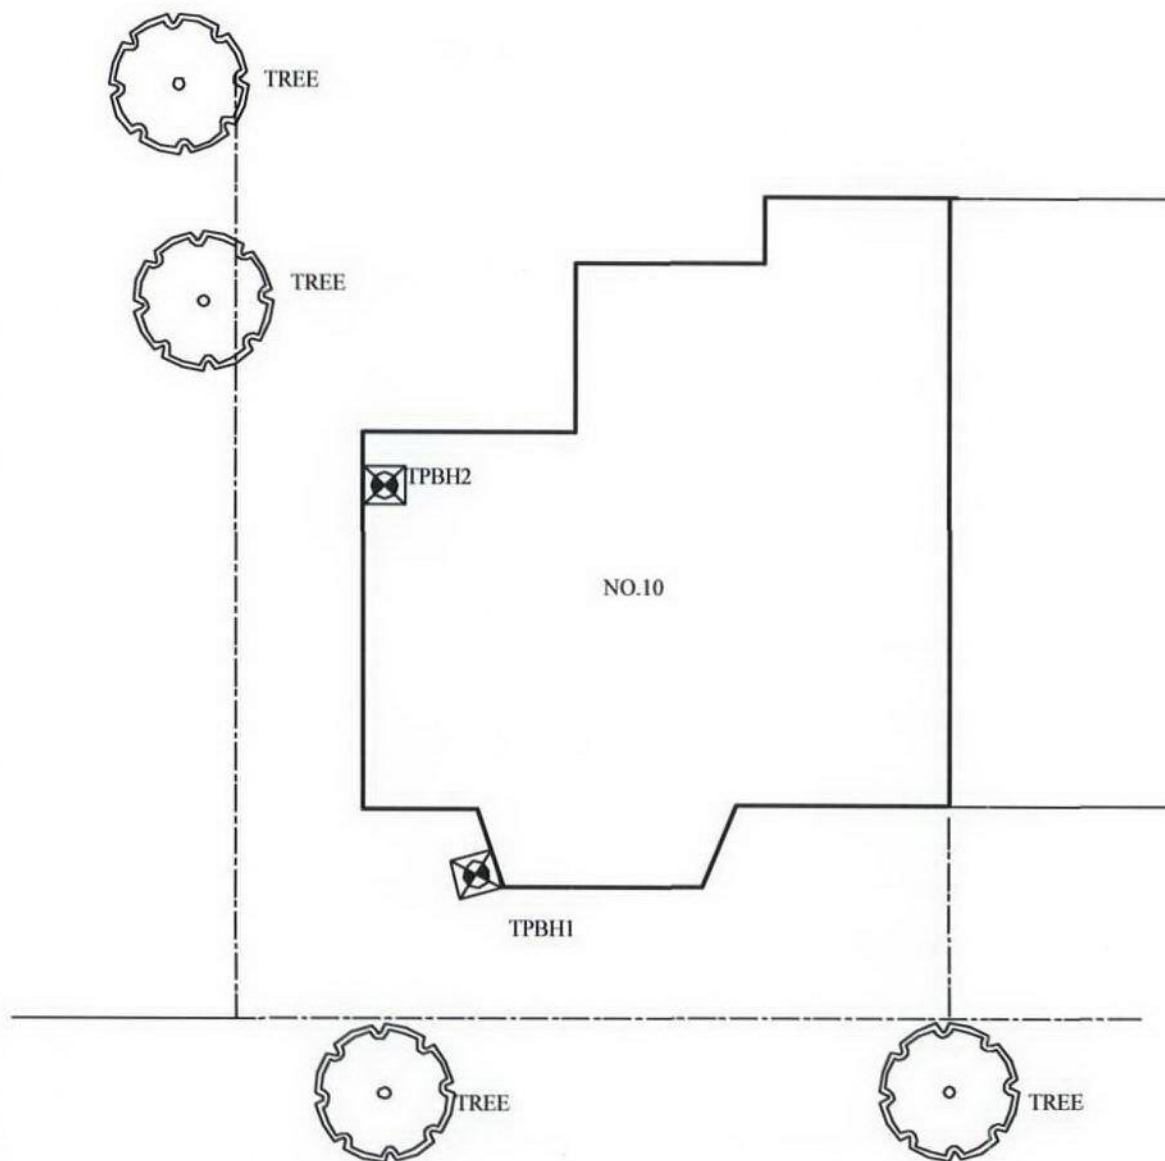
Investigation Layout Plan

ON SITE TREE IDENTIFICATION FOR GUIDANCE ONLY. NOT AUTHENTICATED.

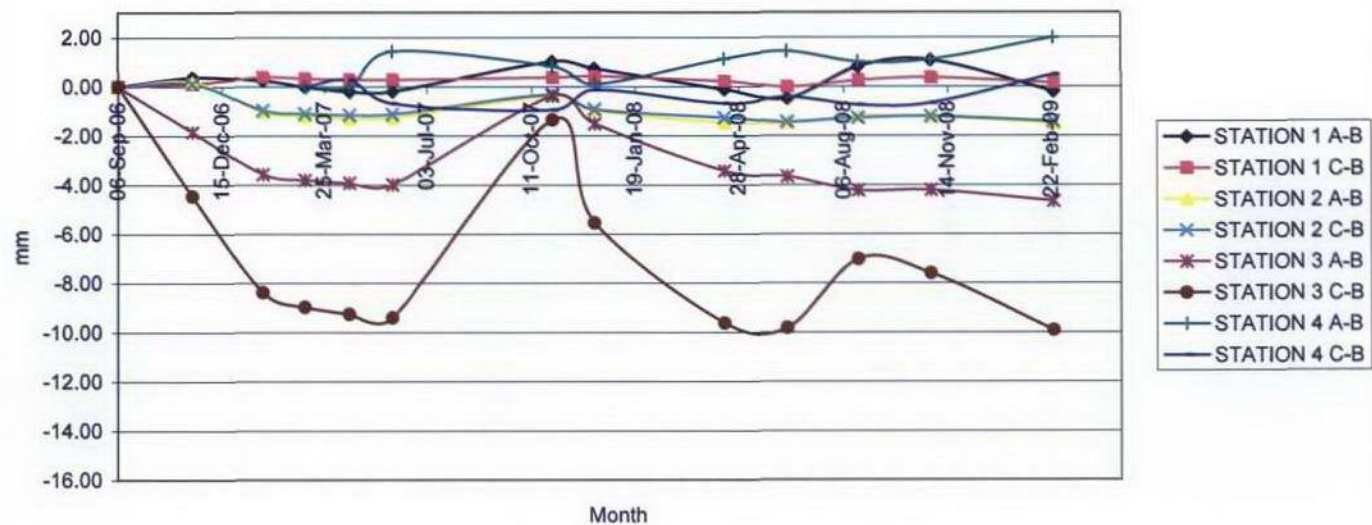
Crack Monitoring undertaken for the period 06 September 2006 to 24 February 2009 demonstrates a pattern of movement, which could only be consistent with a vegetation related subsidence.

VARIATION IN CRACK WIDTH SINCE FIRST READING															
MONTH		06-Sep-06	16-Nov-06	24-Jan-07	06-Mar-07	18-Apr-07	30-May-07	31-Oct-07	11-Dec-07	14-Apr-08	13-Jun-08	20-Aug-08	29-Oct-08	24-Feb-09	
STATION 1	A-B	0.00	0.37	0.25	-0.01	-0.21	-0.20	1.03	0.74	-0.12	-0.48	0.80	1.07	-0.21	
	C-B	0.00	0.12	0.38	0.32	0.28	0.28	0.37	0.43	0.21	-0.02	0.25	0.35	0.14	
STATION 2	A-B	0.00	0.20	-1.05	-1.20	-1.31	-1.27	-0.38	-0.98	-1.47	-1.49	-1.24	-1.23	-1.52

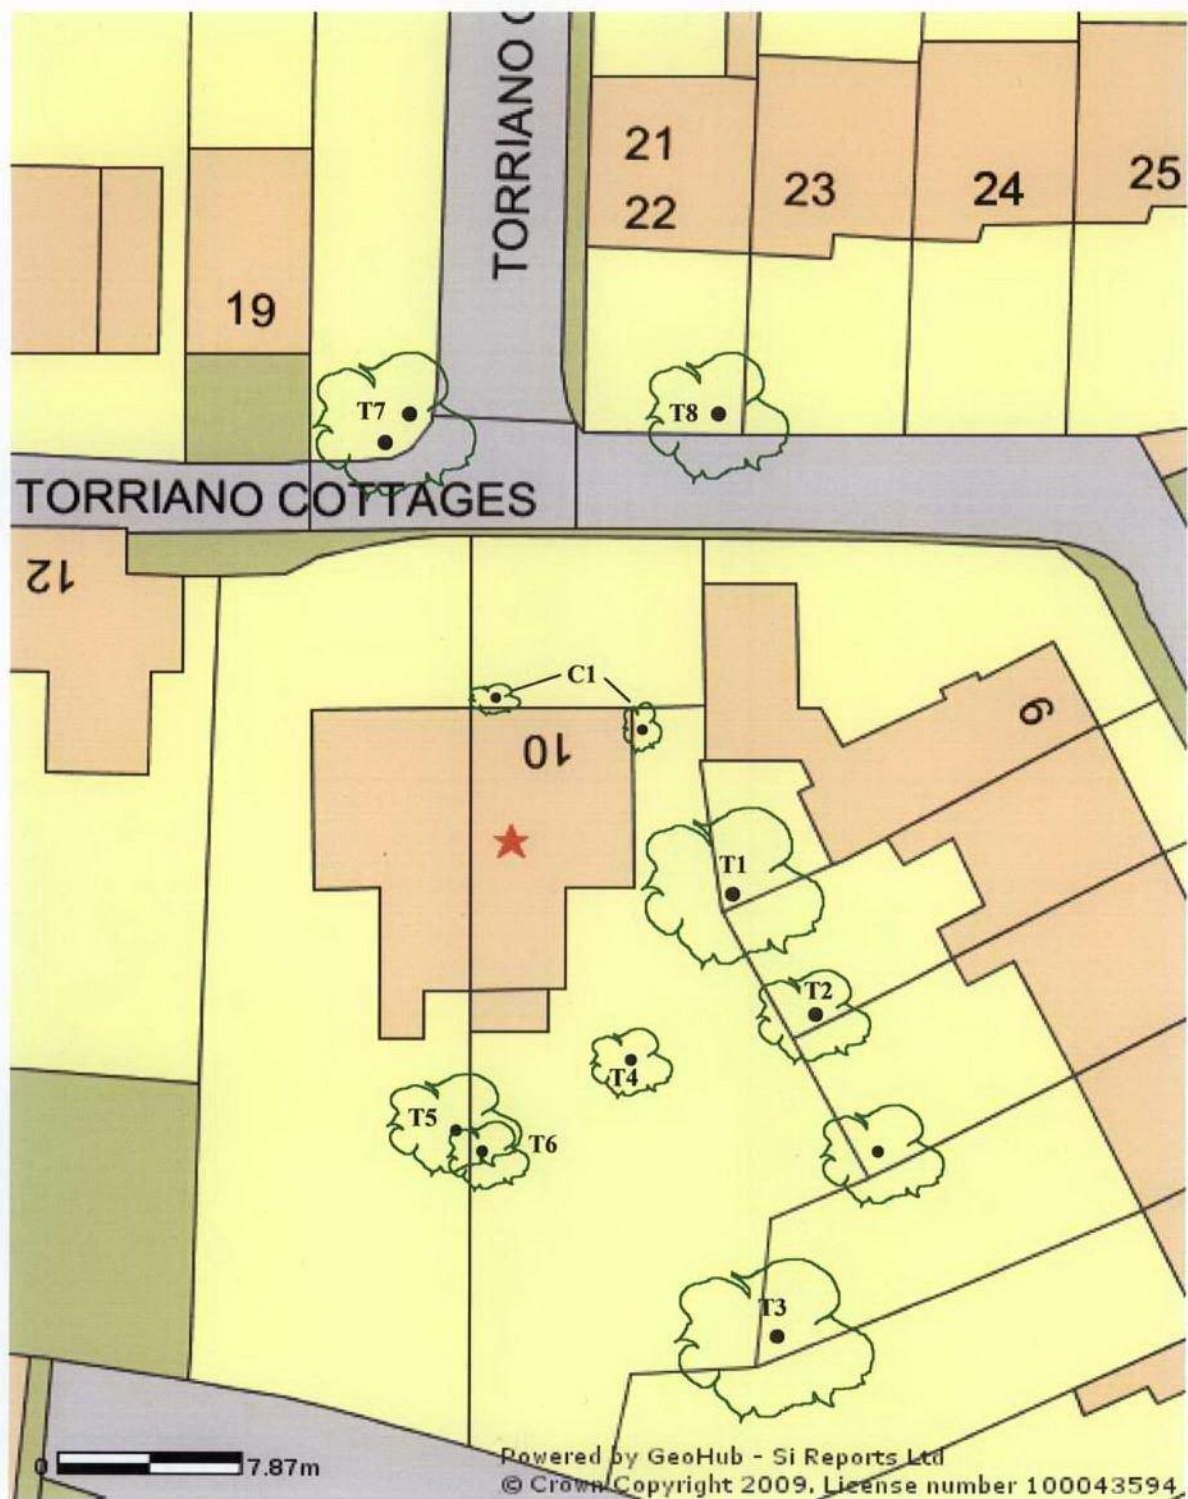
Title: 10 Torriano Cottages	Scale: N T S

Regarding the Leguminosae roots recovered, given the size, species and proximity to Trial Pit 2, I consider that these roots emanated from either C1 Wisteria or T1 False Acacia. However, on close inspection of the Crack Width monitoring results it is clear that movement is more 'defined' at the rear left corner of the insured property (station 3 c-b). As such this is more consistent with T1 than C1 and therefore I consider the Leguminosae roots most likely emanated from False Acacia T1.

Therefore it is my opinion that the continued damage to the front of the insured property is as a result of T7 Sycamore and T8 Sycamore and damage to the rear left corner as a result of False Acacia T1.

(NB: This plan identifies the trees considered within the covering report and may not be a comprehensive record of site features.)

In order to mitigate current damage and allow soils beneath the property to recover to a position such that an effective engineering repair solution can be implemented we recommend that T7 Sycamore and T8 Sycamore (current Tree Preservation Order Application submitted) and False Acacia T1 be removed entirely.
