DETAIL SHOWING THE JUNCTION OF THE SIDE EXTENSION AND THE MAIN HOUSE

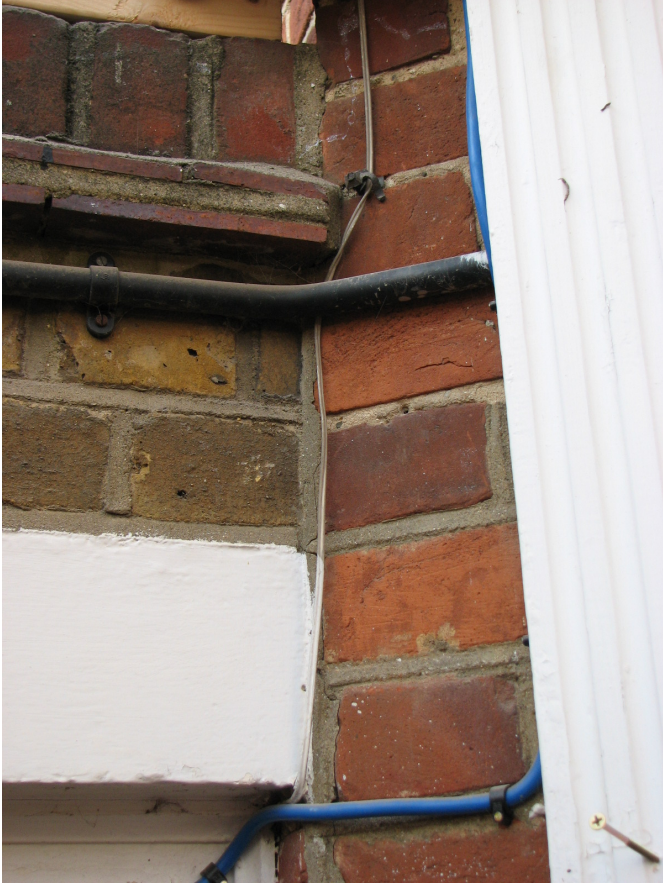
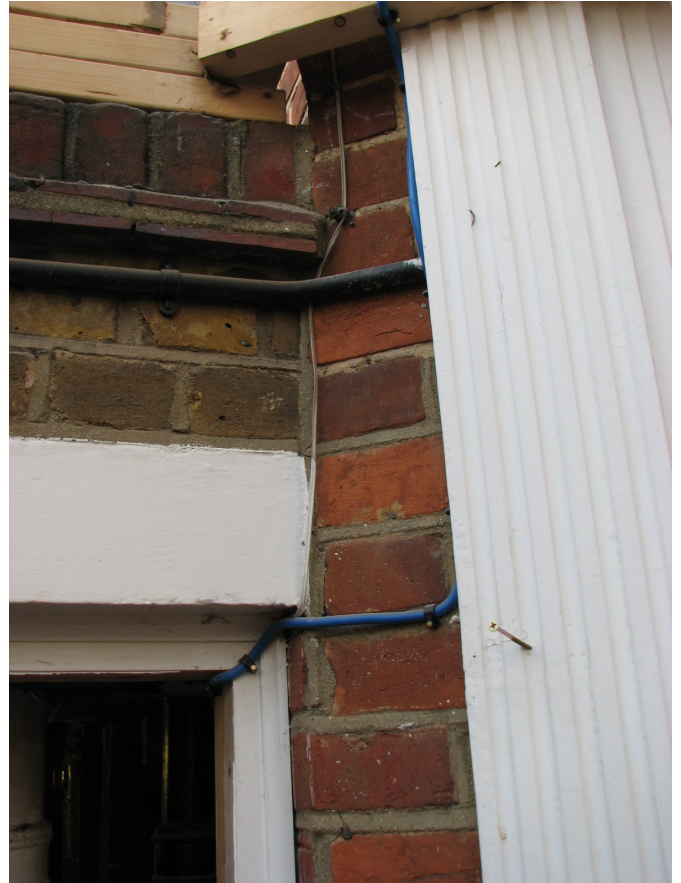
Existing ground floor extension abutts the feature red bricks with a vertical joint. It is not bonded to the main house and hides the return brick.

The 2 courses of creasing tiles is particular poor detail.

All this could be improved by setting back the side extension wall by 450mm as the suggested planning revision.
