Description	By	Date	
Client			
Linda & Carl Johnson			
Project			
St. Georges Terrace			
Title			
Existing & Proposed Front Elevation			
Drawing No.		Revision	
97 / 10 -615			
Scale	Date	Drawn	Checked
1:50@A1	13 11 97	SMP	
1:100@A3

Description	By	Date	
Client			
Linda & Carl Johnson			
Project			
St. Georges Terrace			
Title			
Existing section AA			
Drawing No.		Revision	
97 / 10 -610			
Scale	Date	Drawn	Checked
1:50@A1	13 11 97	SMP	
1:100@A3

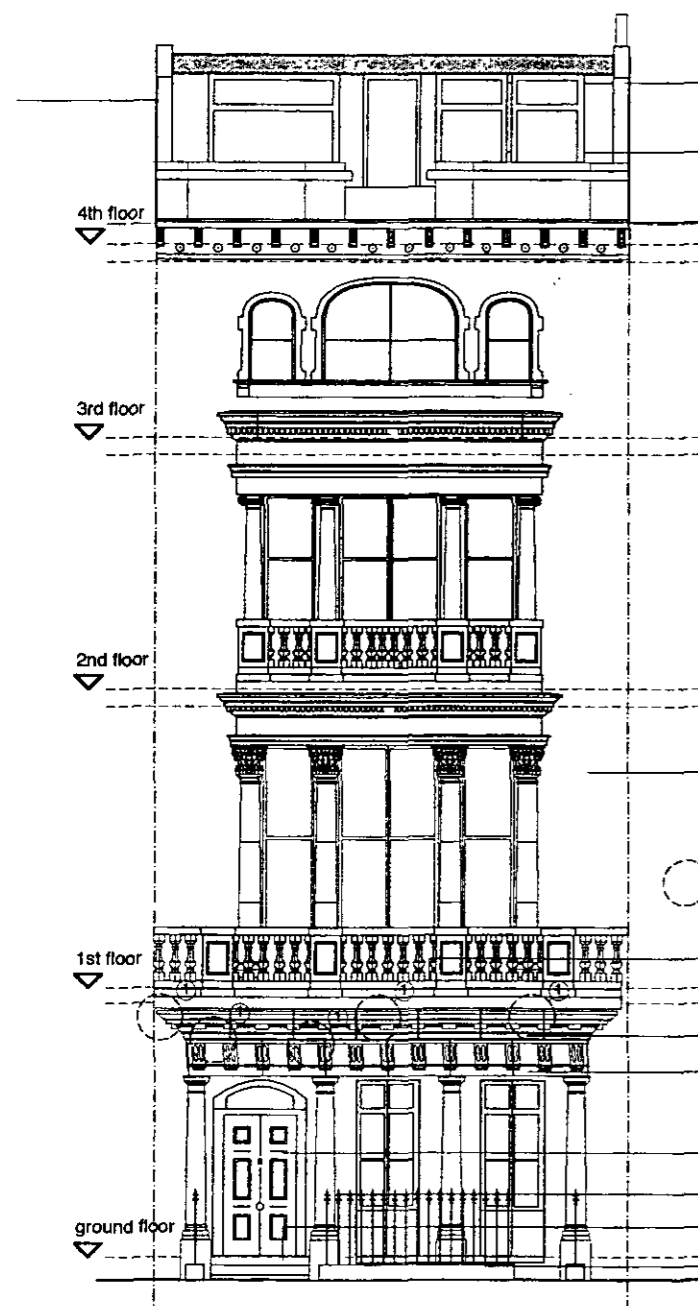
EXISTING

- main asphalt roof
- softwood framed casement windows
- rendered parapet
- 4th floor
- 60% decorative stucco to upper cornice to be replaced & repaired
- fair faced brickwork to upper levels with stucco rendered decorative surrounds to windows openings and main roof parapet
- 3rd floor
- 2nd floor
- fair faced brickwork
- stucco render at base of elevation + decorative features to be repaired - cracking and spalling to be treated provide new paint finish
- 1st floor
- projecting stone balcony surfaced in asphalt
- 80% rose details to underside of cornice missing stucco with paint finish
- existing stucco render to base of elevation
- timber door with paint finish
- iron railings
- stone steps leading to entrance
- cantilevered stone balcony at ground floor level
- ground floor
