ARBORICULTURAL IMPLICATIONS ASSESSMENT FOR PROPOSED REDEVELOPMENT

NOS. 1-7 MILL LANE
LONDON
NW6

Our ref: J 38.54
22nd July 2008

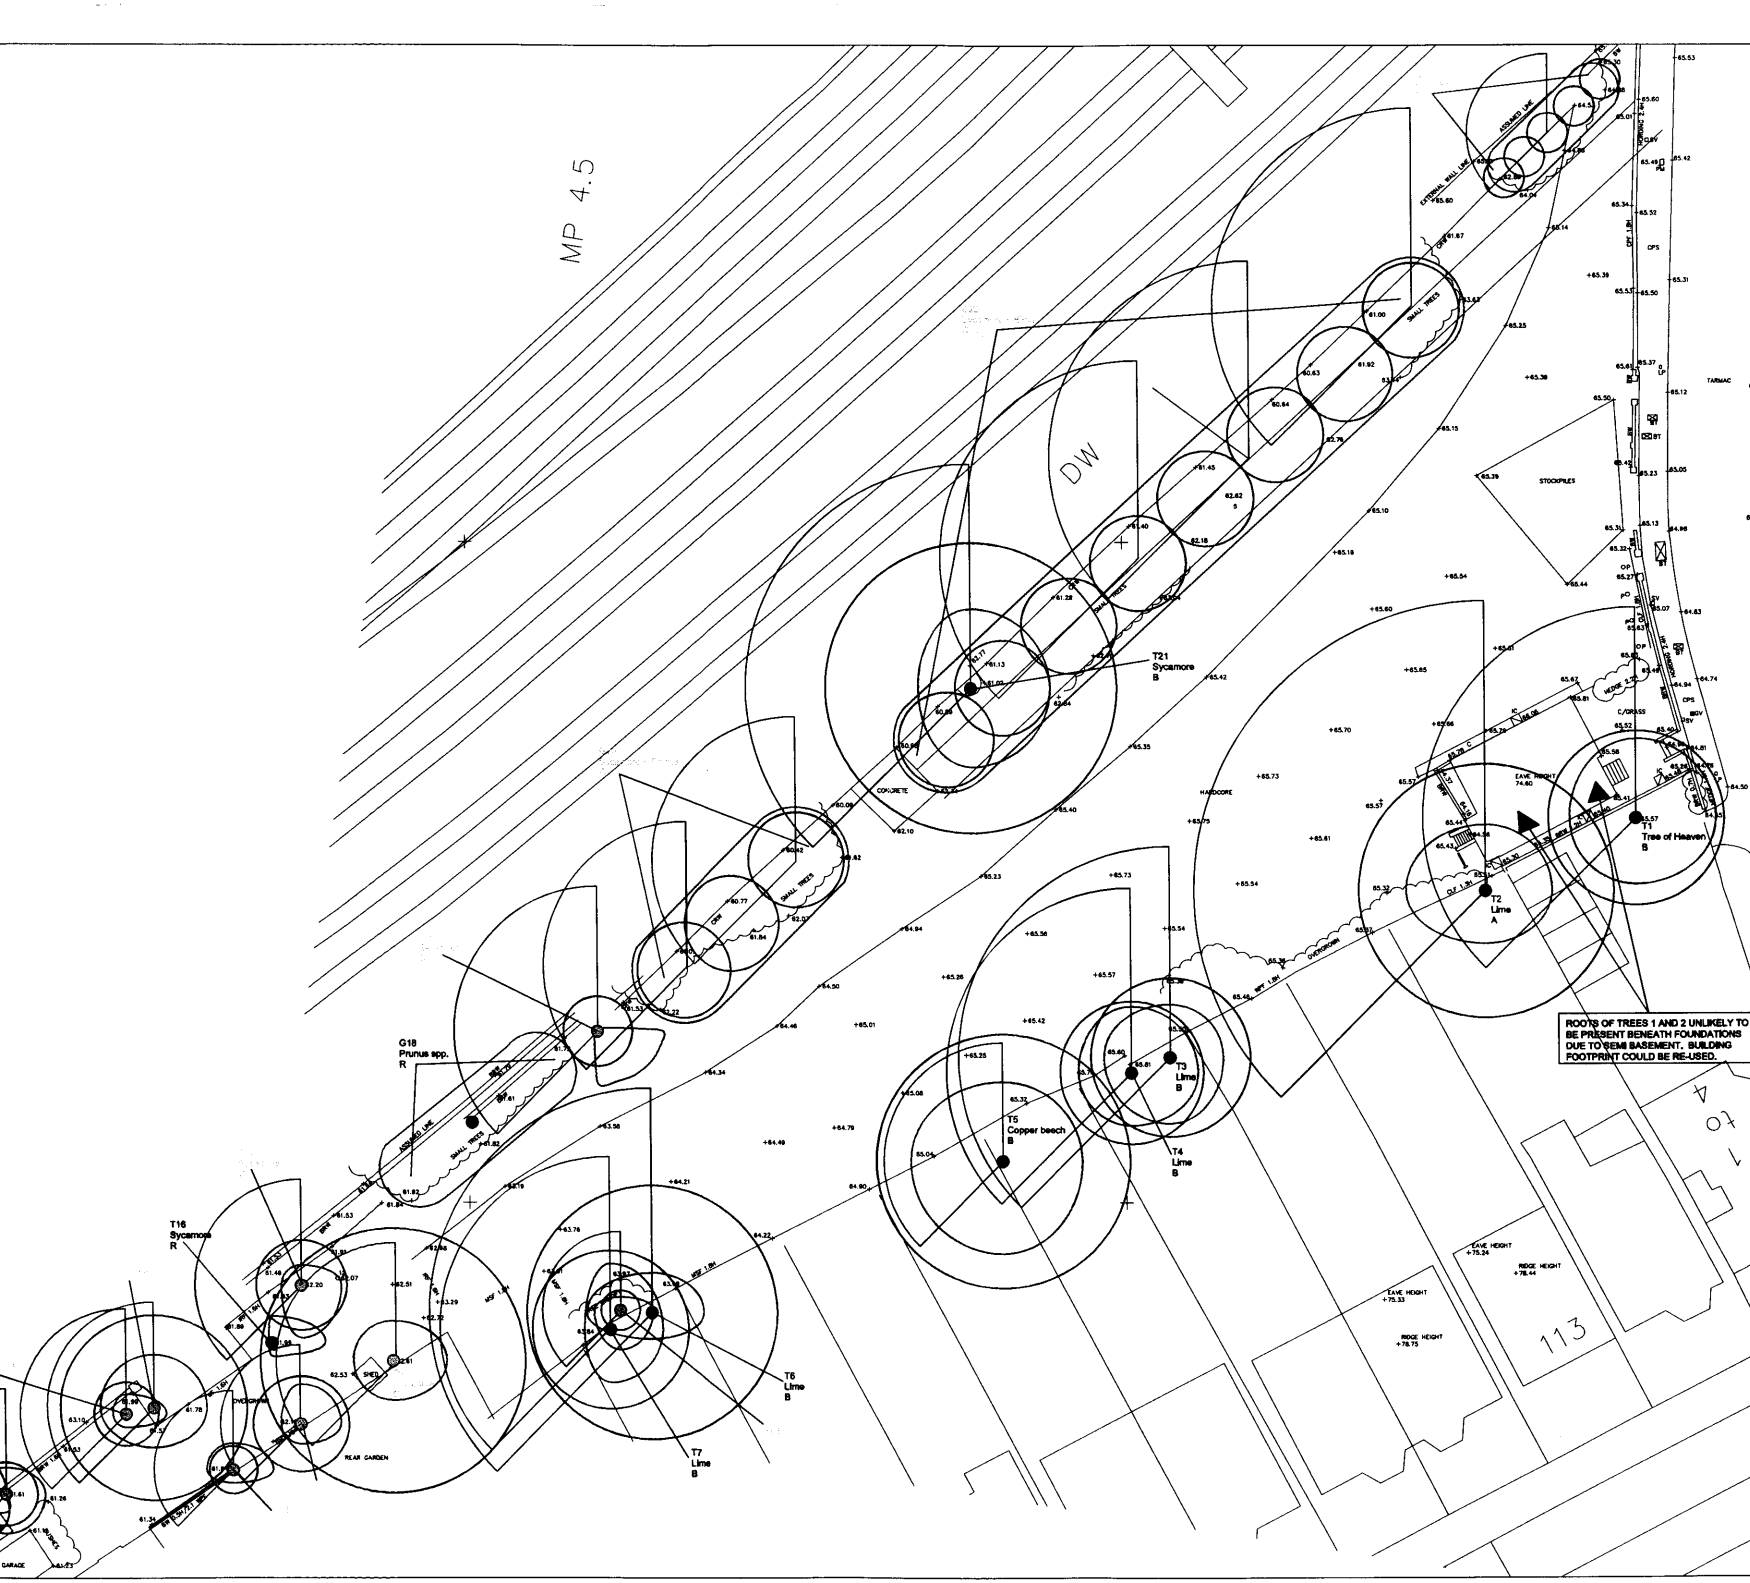
TREE CONSTRAINTS PLAN

ROOTS OF TREES 1 AND 2 UNLIKELY TO BE PRESENT BENEATH FOUNDATIONS DUE TO REAR BASEMENT. BUILDING FOOTPRINT COULD BE RE-USED.

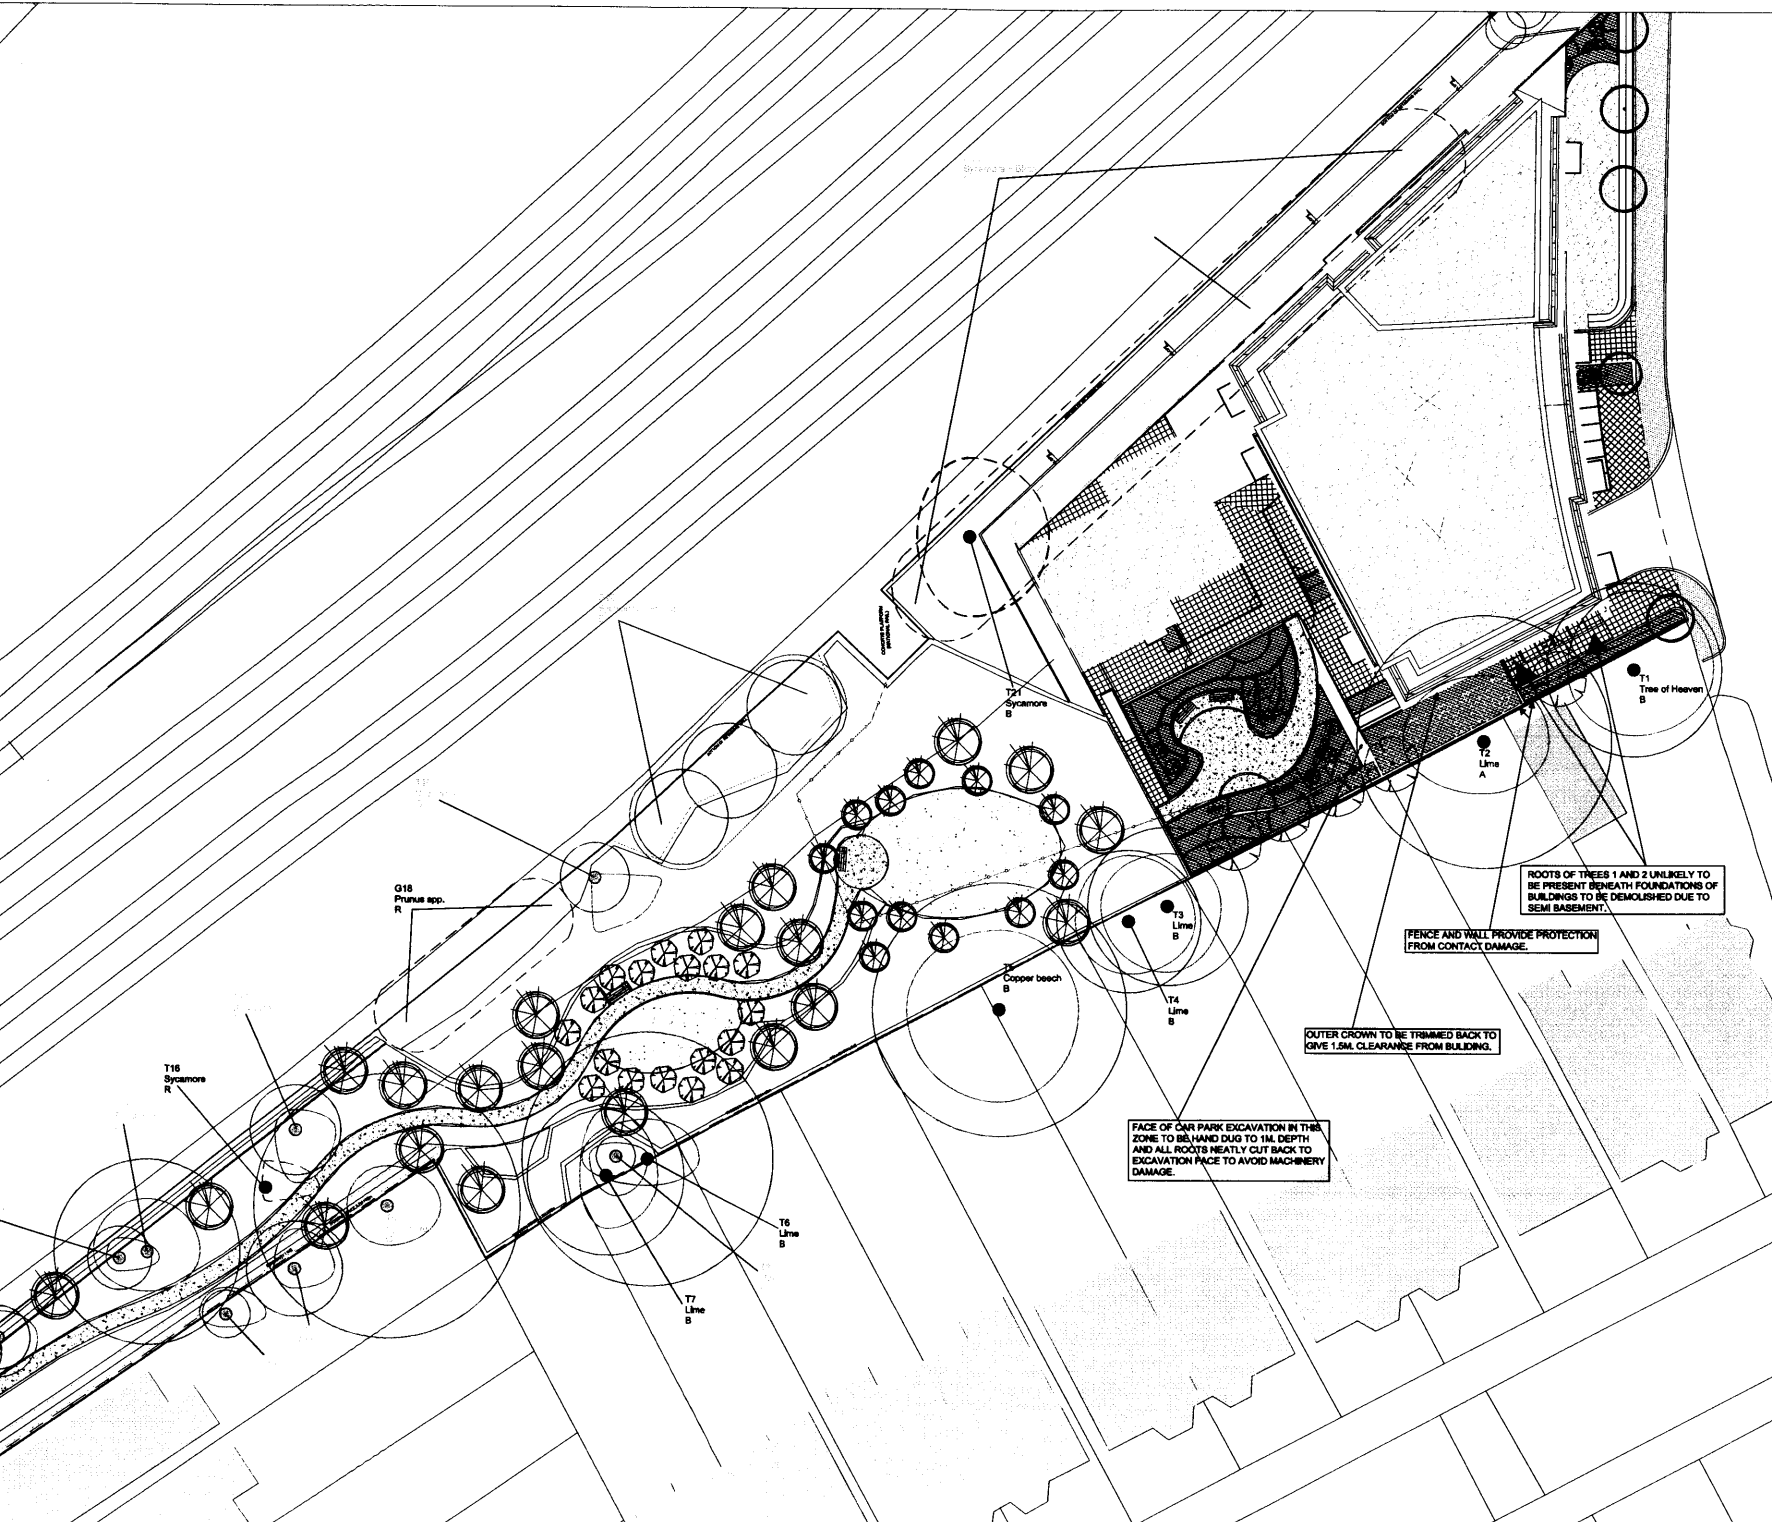
TREE PROTECTION PLAN

ROOTS OF TREES 1 AND 2 UNLIKELY TO BE PRESENT BENEATH FOUNDATIONS OF BUILDINGS TO BE DEMOLISHED DUE TO SEMI BASEMENT.

FENCE AND WALL PROVIDE PROTECTION FROM CONTACT DAMAGE.

OUTER CROWN TO BE TRIMMED BACK TO GIVE 1.5M. CLEARANCE FROM BUILDING.

FACE OF CAR PARK EXCAVATION IN THIS ZONE TO BE HAND DUG TO 1M. DEPTH AND ALL ROOTS NEATLY CUT BACK TO EXCAVATION FACE TO AVOID MACHINERY DAMAGE.
