TREE SURVEY and ARBORICULTURAL METHOD STATEMENT

A report to accompany a Planning Application for
development on land at 86 Canfield Gardens, London, NW6
3EE

Report by Dr Martin Dobson

7 November 2007

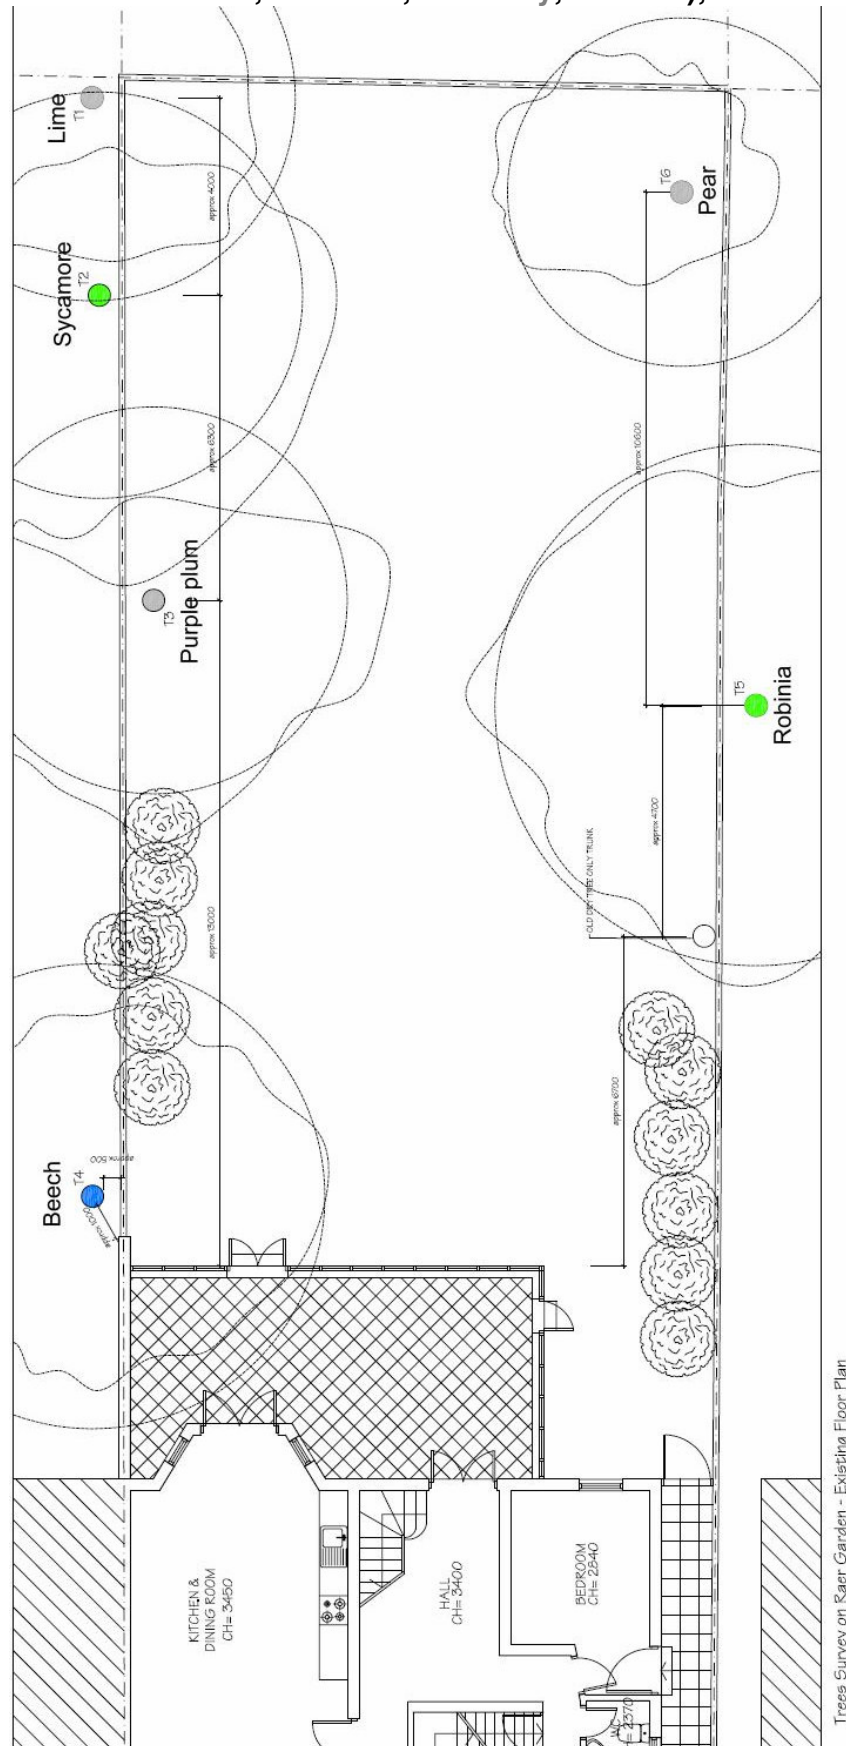
APPENDIX MD2

- 2.2 The site survey drawing appended at **MD2** shows the positions of the surveyed trees and gives a reasonable indication of the comparative branch spreads of the trees. The drawing has been colour coded as follows:

- 3.1 To the rear of 86 Canfield Gardens there is a modest sized garden mostly laid to lawn with some trees and shrubs at the edges near to the boundary with properties to the left and right. T1 is a mid-aged Lime in the rear garden of 88 Canfield Gardens which is in good condition other than a large wound at the base which is becoming decayed. The tree does not pose an unreasonable danger at present but as decay progresses it will become dangerous and therefore

its condition should be monitored. Due to its limited safe useful life the tree has been given a C grading. T2 is a large mid-aged Sycamore also in the rear garden of 88 Canfield Gardens which is in good condition. It casts substantial shade over the garden which will only worsen as the tree gets larger. It is suggested that the tree be reduced by about 30% to contain its size. Because of its significant contribution to the landscape the tree has been given an A grading. T3 is a modest sized Purple plum which provides interest within the garden, but otherwise is of little amenity value. It has therefore been given a C grading. T4 is a young Beech which is located within the rear garden of No. 88 and very close to the rear conservatory of No. 86. It has been pruned in the past to control its size and this treatment may need to be repeated from time to time. Due to its close proximity to the building it is not advisable to allow the tree to reach its full potential size and therefore since it will need regular maintenance it has been given a B grading. T5 is a Robinia (False acacia) which is a substantial mid-aged tree of good form. It has been given an A grading. T6 is a mid-aged Pear in fair condition, but since Pears are reasonably short-lived and this particular one does not have good form it has been given a C grading.

Site survey drawing showing tree numbers and BS5837 colour codes (A – Green, B – Blue, C – Grey, R - Red),

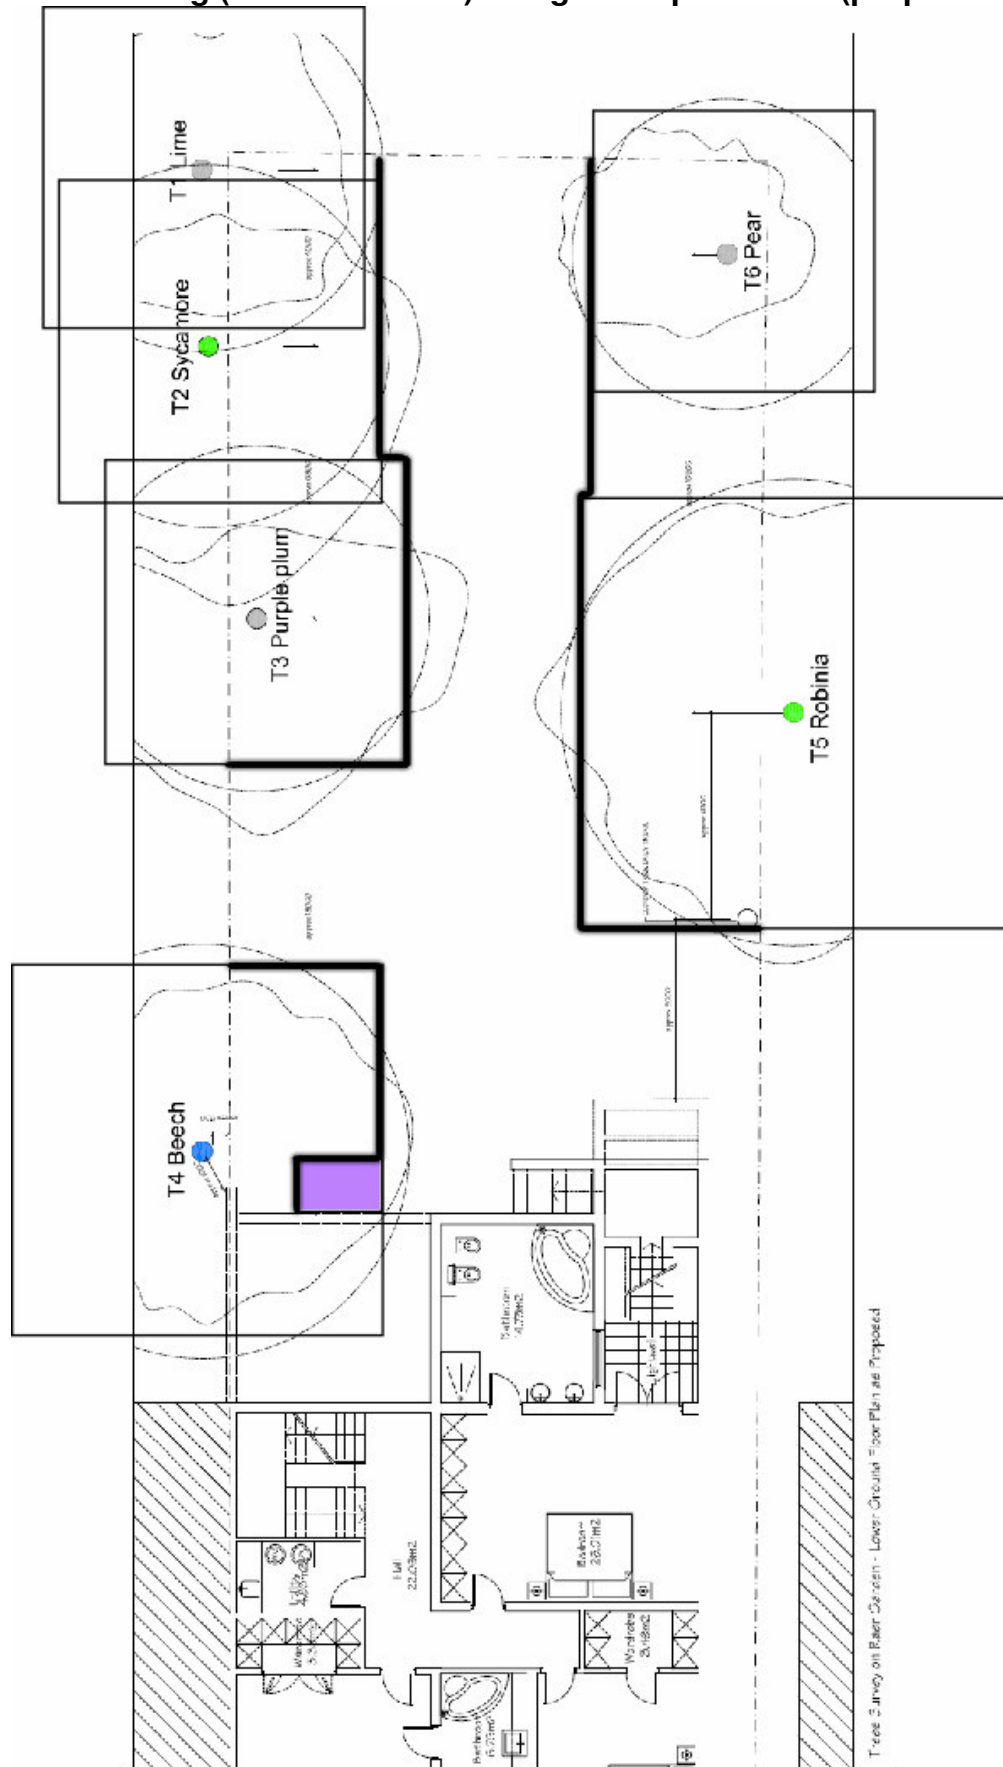
APPENDIX MD3

- 2.3 The information gathered from the survey has allowed a suitable root protection area to be calculated for each tree and the details of these are given below (**MD3** and **MD4**).

Proposed new layout and positions of root protection zones (thin black lines), protective fencing (thick black line) and ground protection (purple shading)

- 4.6 In one position only (adjacent to the doorway to the rear conservatory – shown on the plan shaded purple) fencing will be replaced by ground protection in the form of a raised timber walkway on ground bearing beams placed above existing ground level.

- 5.1 The sequence of events on site is described below and methods necessary to avoid damage to tree roots and/or branches are detailed.
- 5.2 Before any construction work takes place on site the protective fencing and ground protection will be installed in the positions shown at **MD3**. This will be approved and checked by a competent arboriculturist.
- 5.3 Once tree protection is in place then excavation and construction can begin. Fencing should not be taken down under any circumstances during construction unless with the express approval of the Council.
- 5.4 Once construction has demonstrably finished (to the satisfaction of a competent arboriculturist) the fencing and ground protection may be removed in order to allow any final landscaping to be undertaken. Landscaping should not involve any changes in soil levels or the digging of any trenches.
