QUINQUENNIAL INSPECTION REPORT

THE SWISS CHURCH
ENDELL STREET, LONDON

Date of Inspection: 16th August 2007

QUINQUENNIAL INSPECTION REPORT 2007

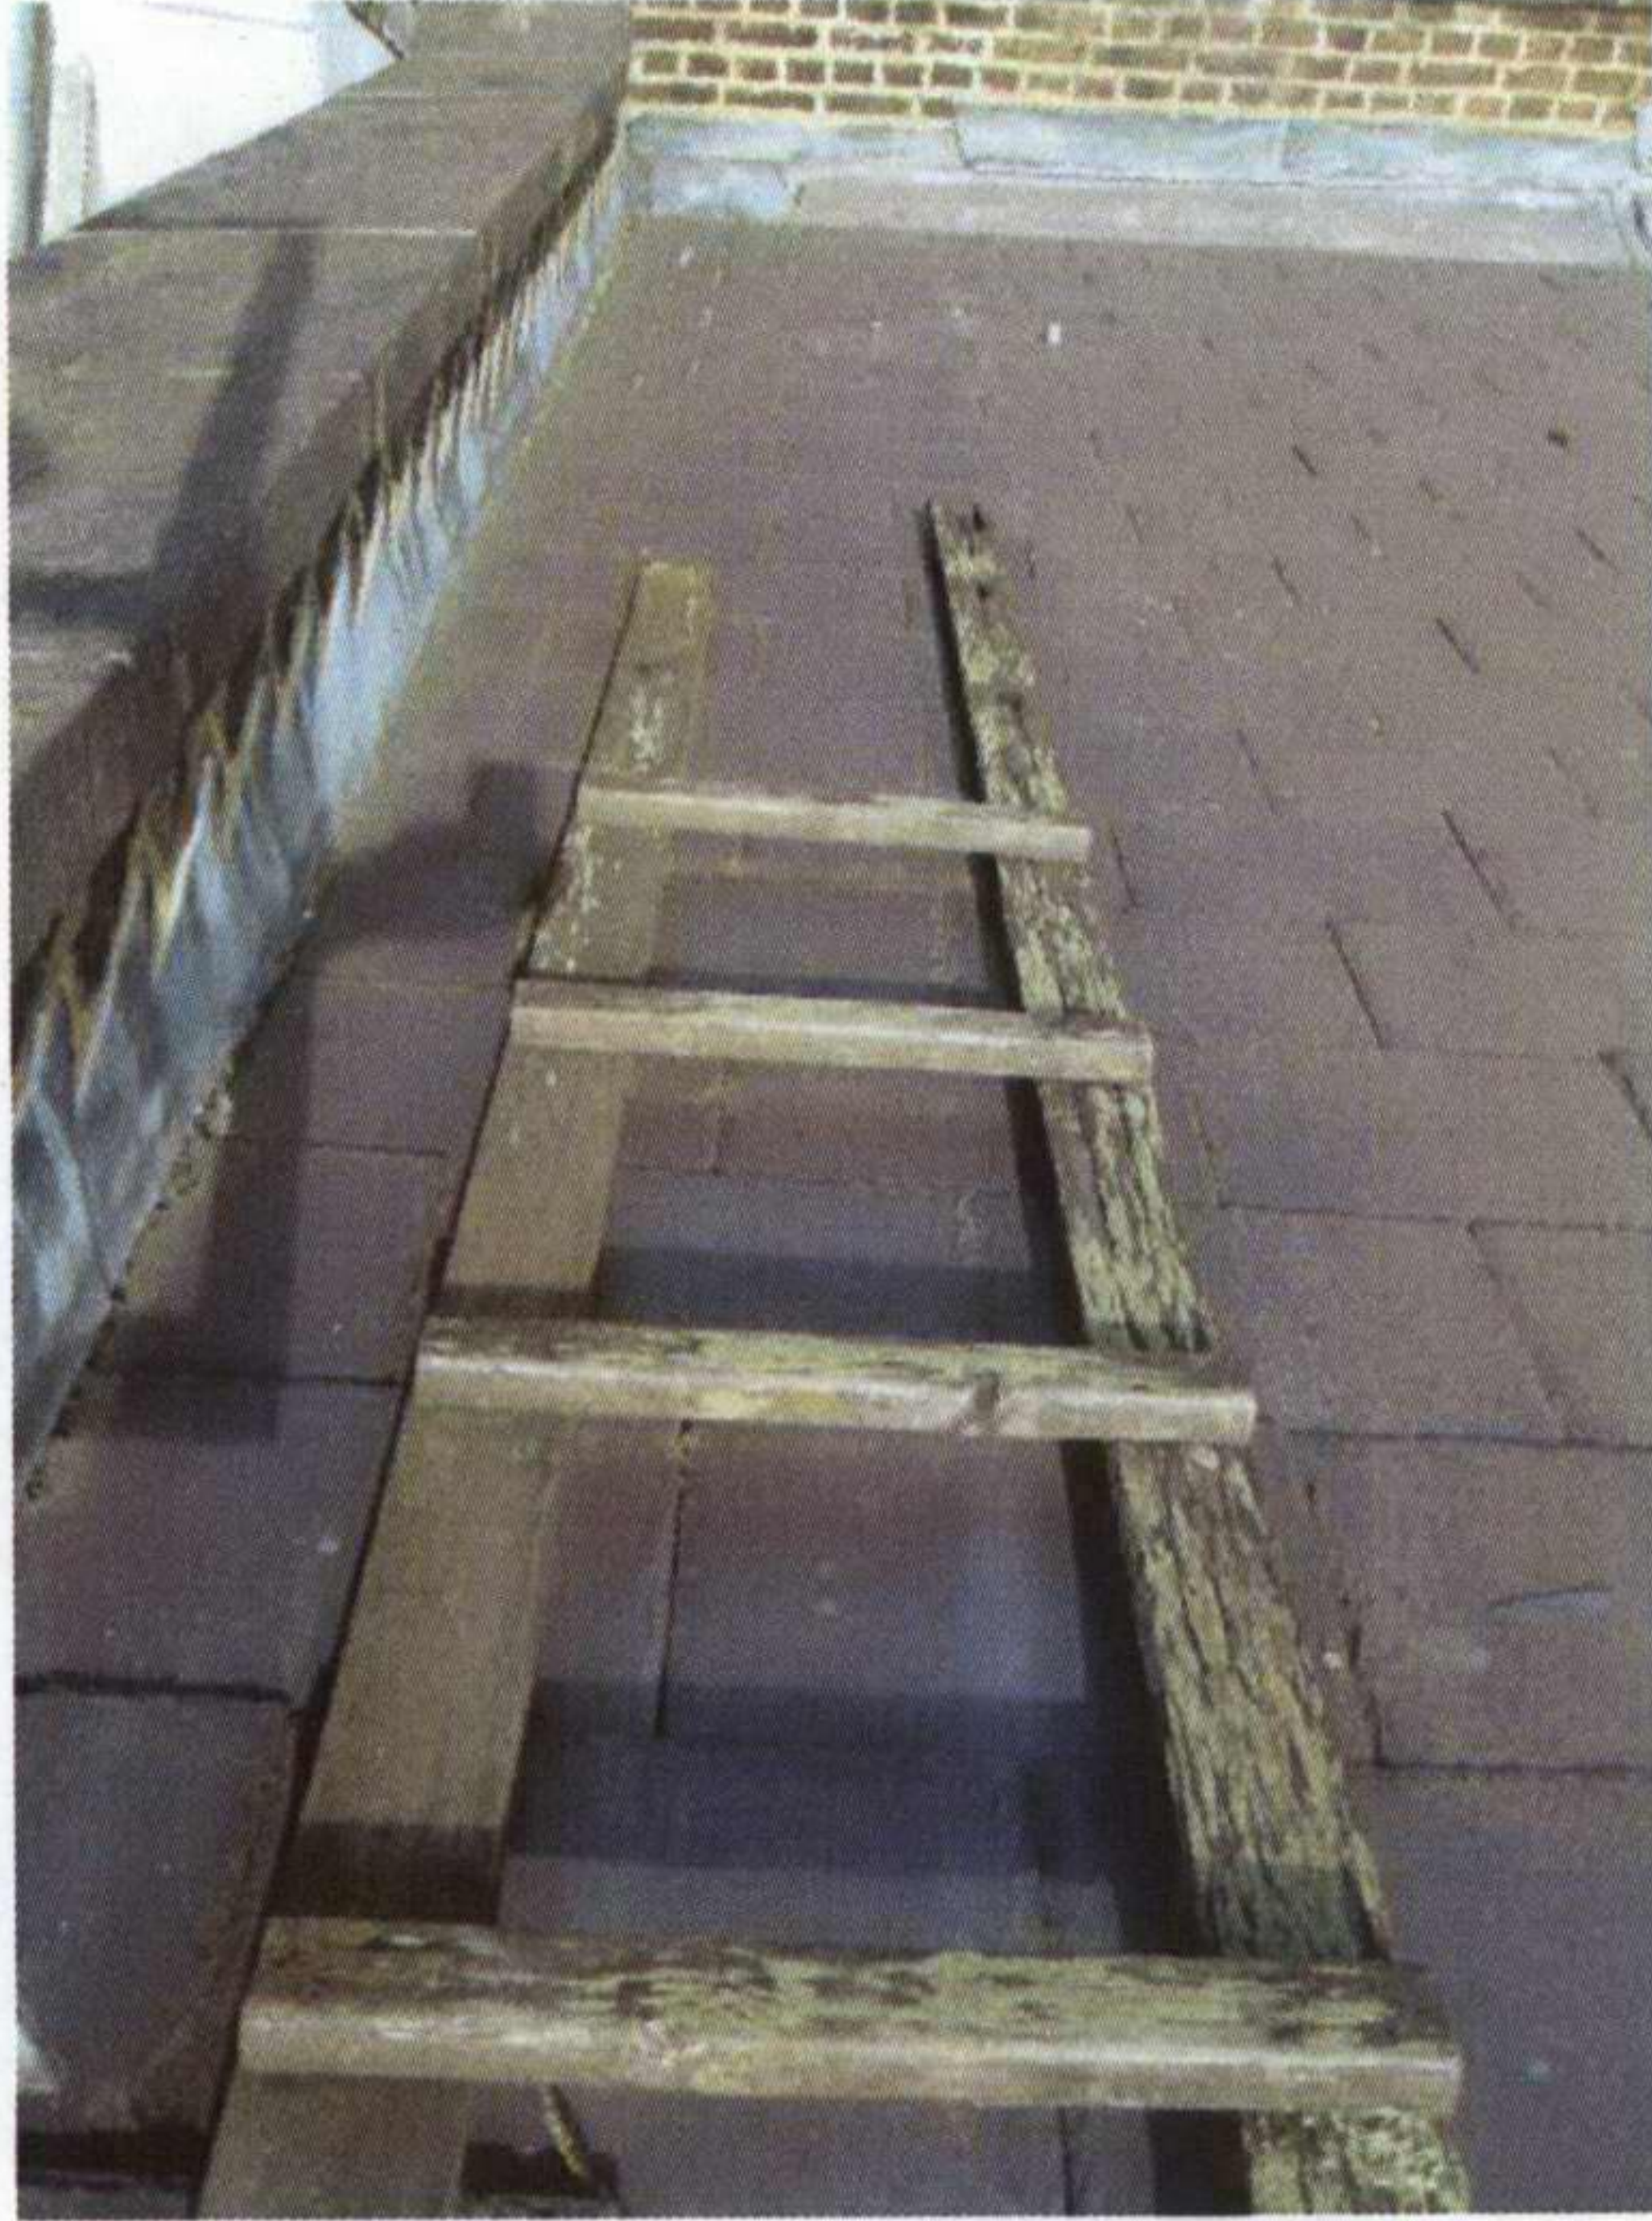
3.1 The roof is accessed via a sloping wooden ladder from the ground floor storage area to the first floor storage, thence by a vertical metal ladder thence by another sloping ladder up through a roof light, with vertical wall ladders leading onto successive heights of roofing. The ladder takes up space and could be set at a higher pitch in order to maximise space at ground level. The ladder itself is in sound order. Other ladders are securely fixed and in sound order.

Consider repositioning ladder

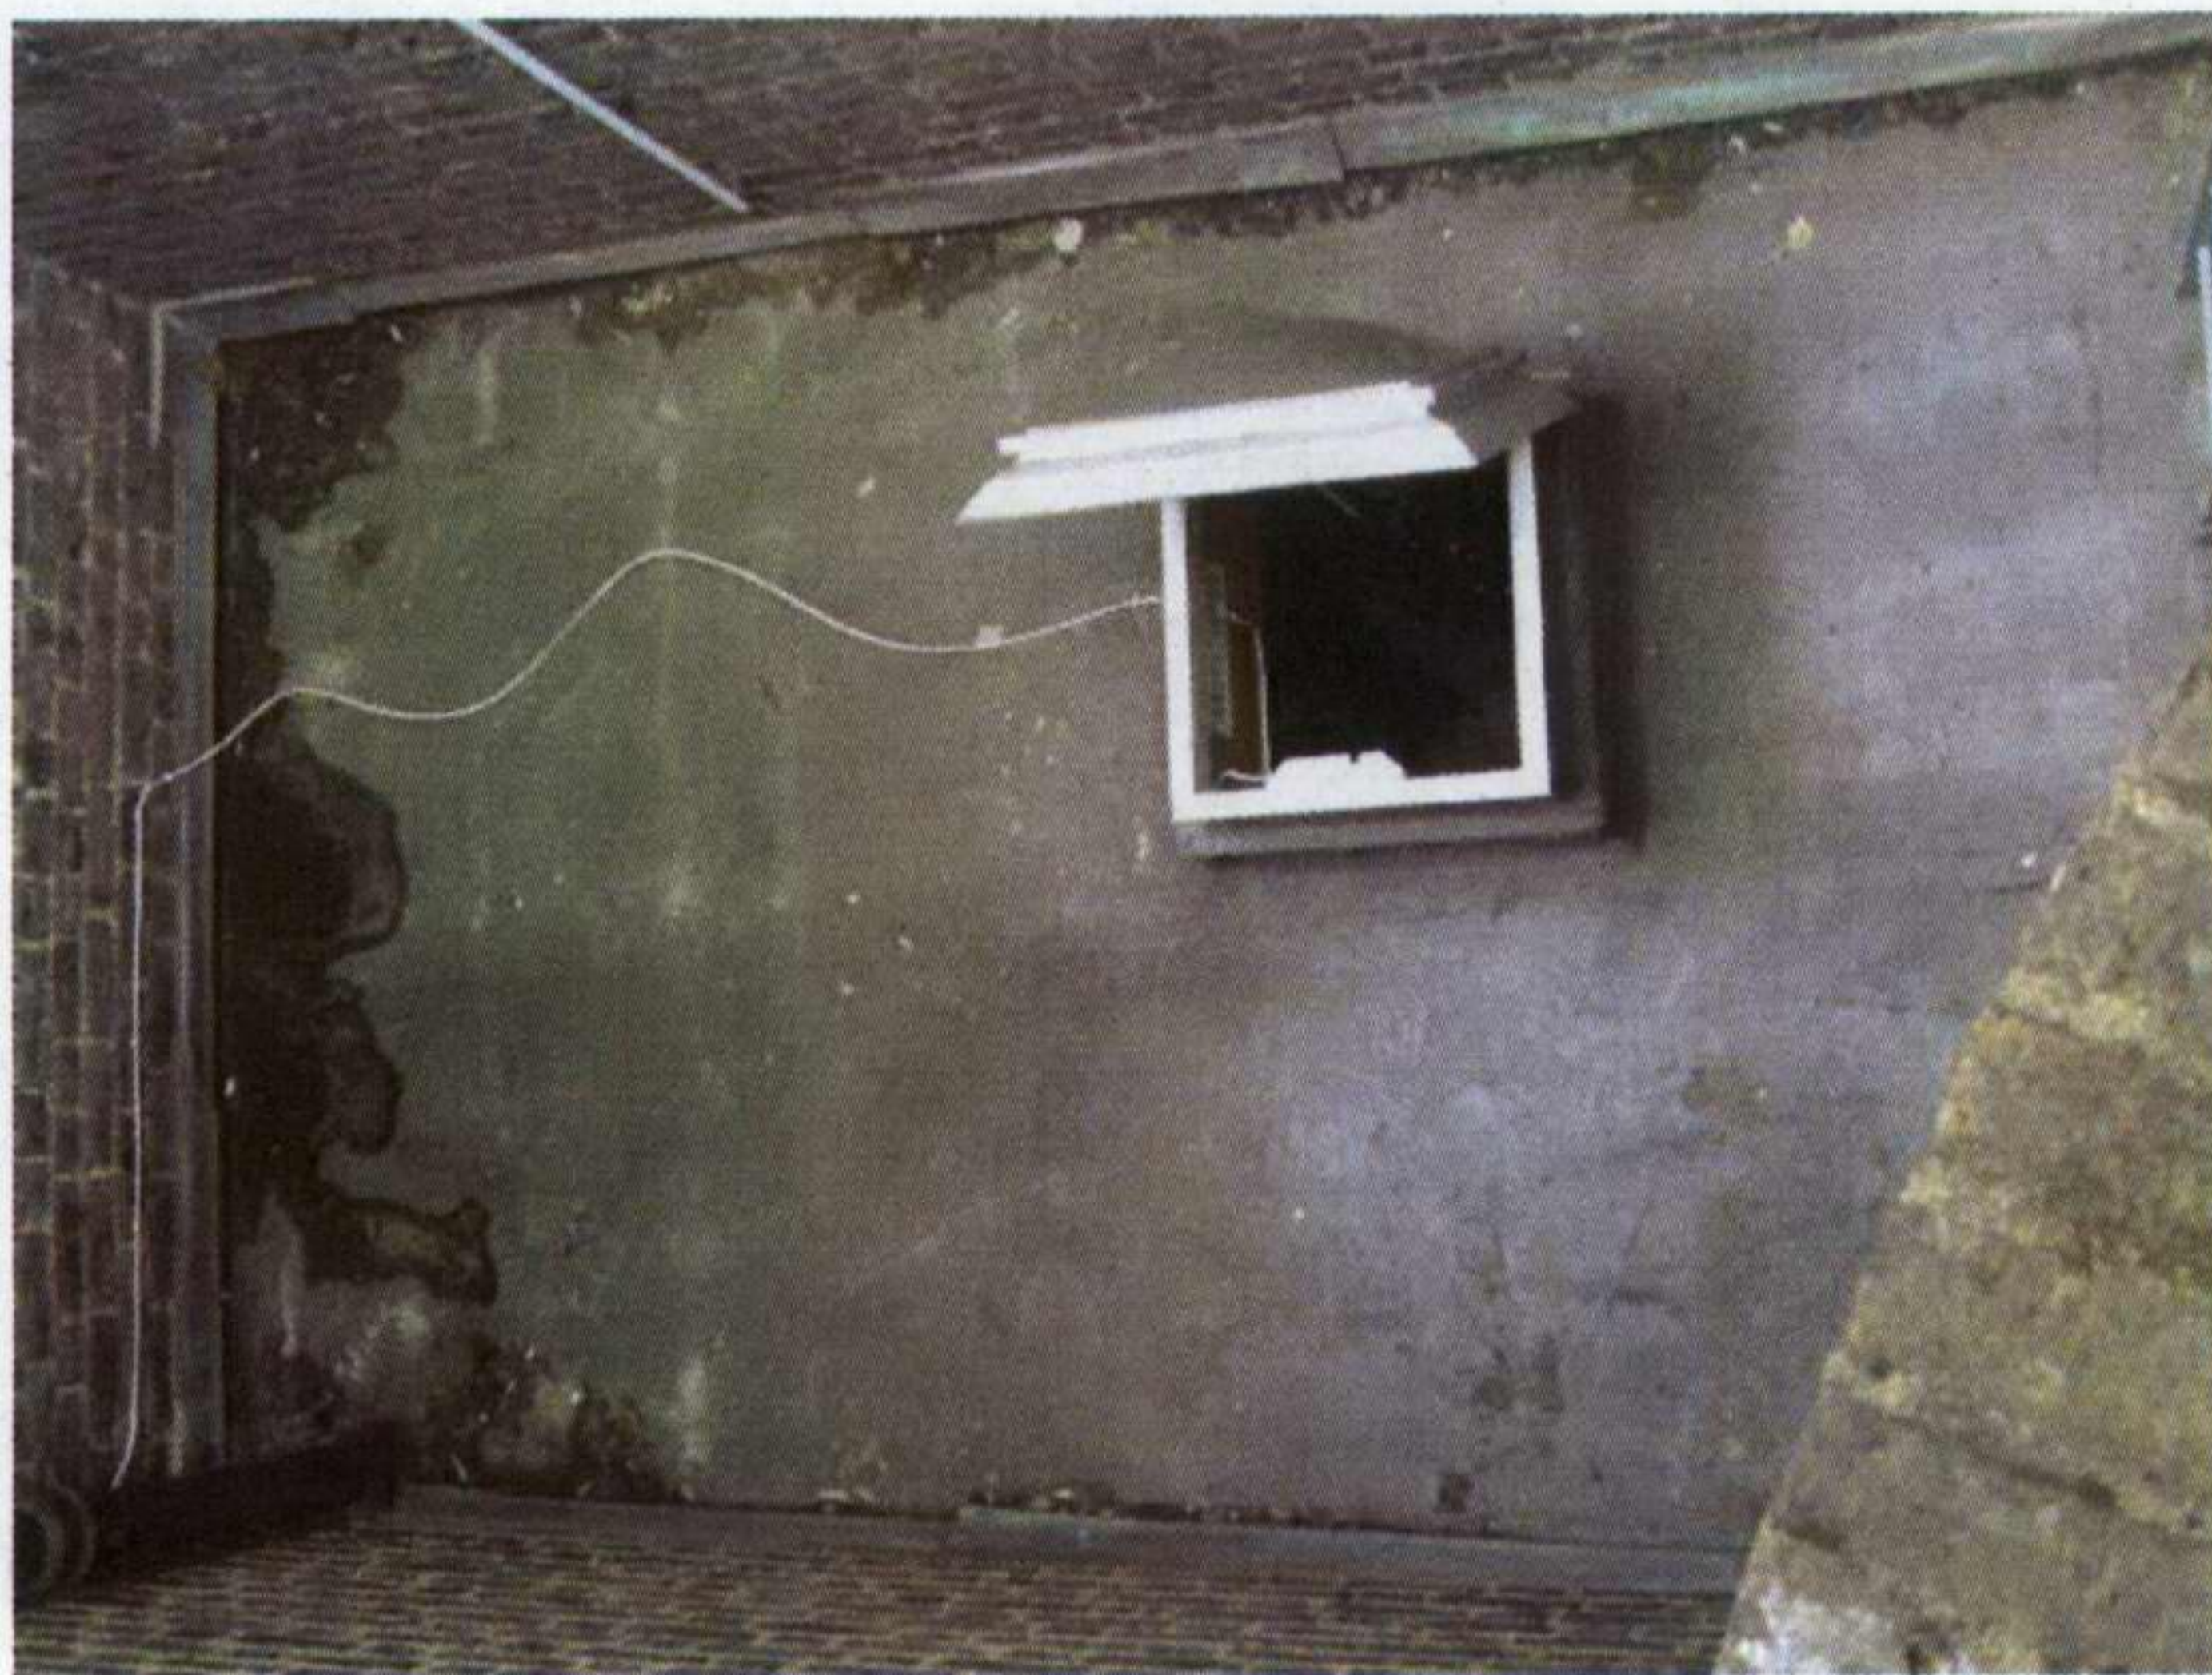
- 3.2 **Lower roof over storage area:** a high spec bituminous felt finish, with copper flashings weathering the roof to the walls. The upper side of the roof finishes are sound, and the evidence of staining on the underside appears therefore to relate to an earlier roof finish. No significant defects noted.

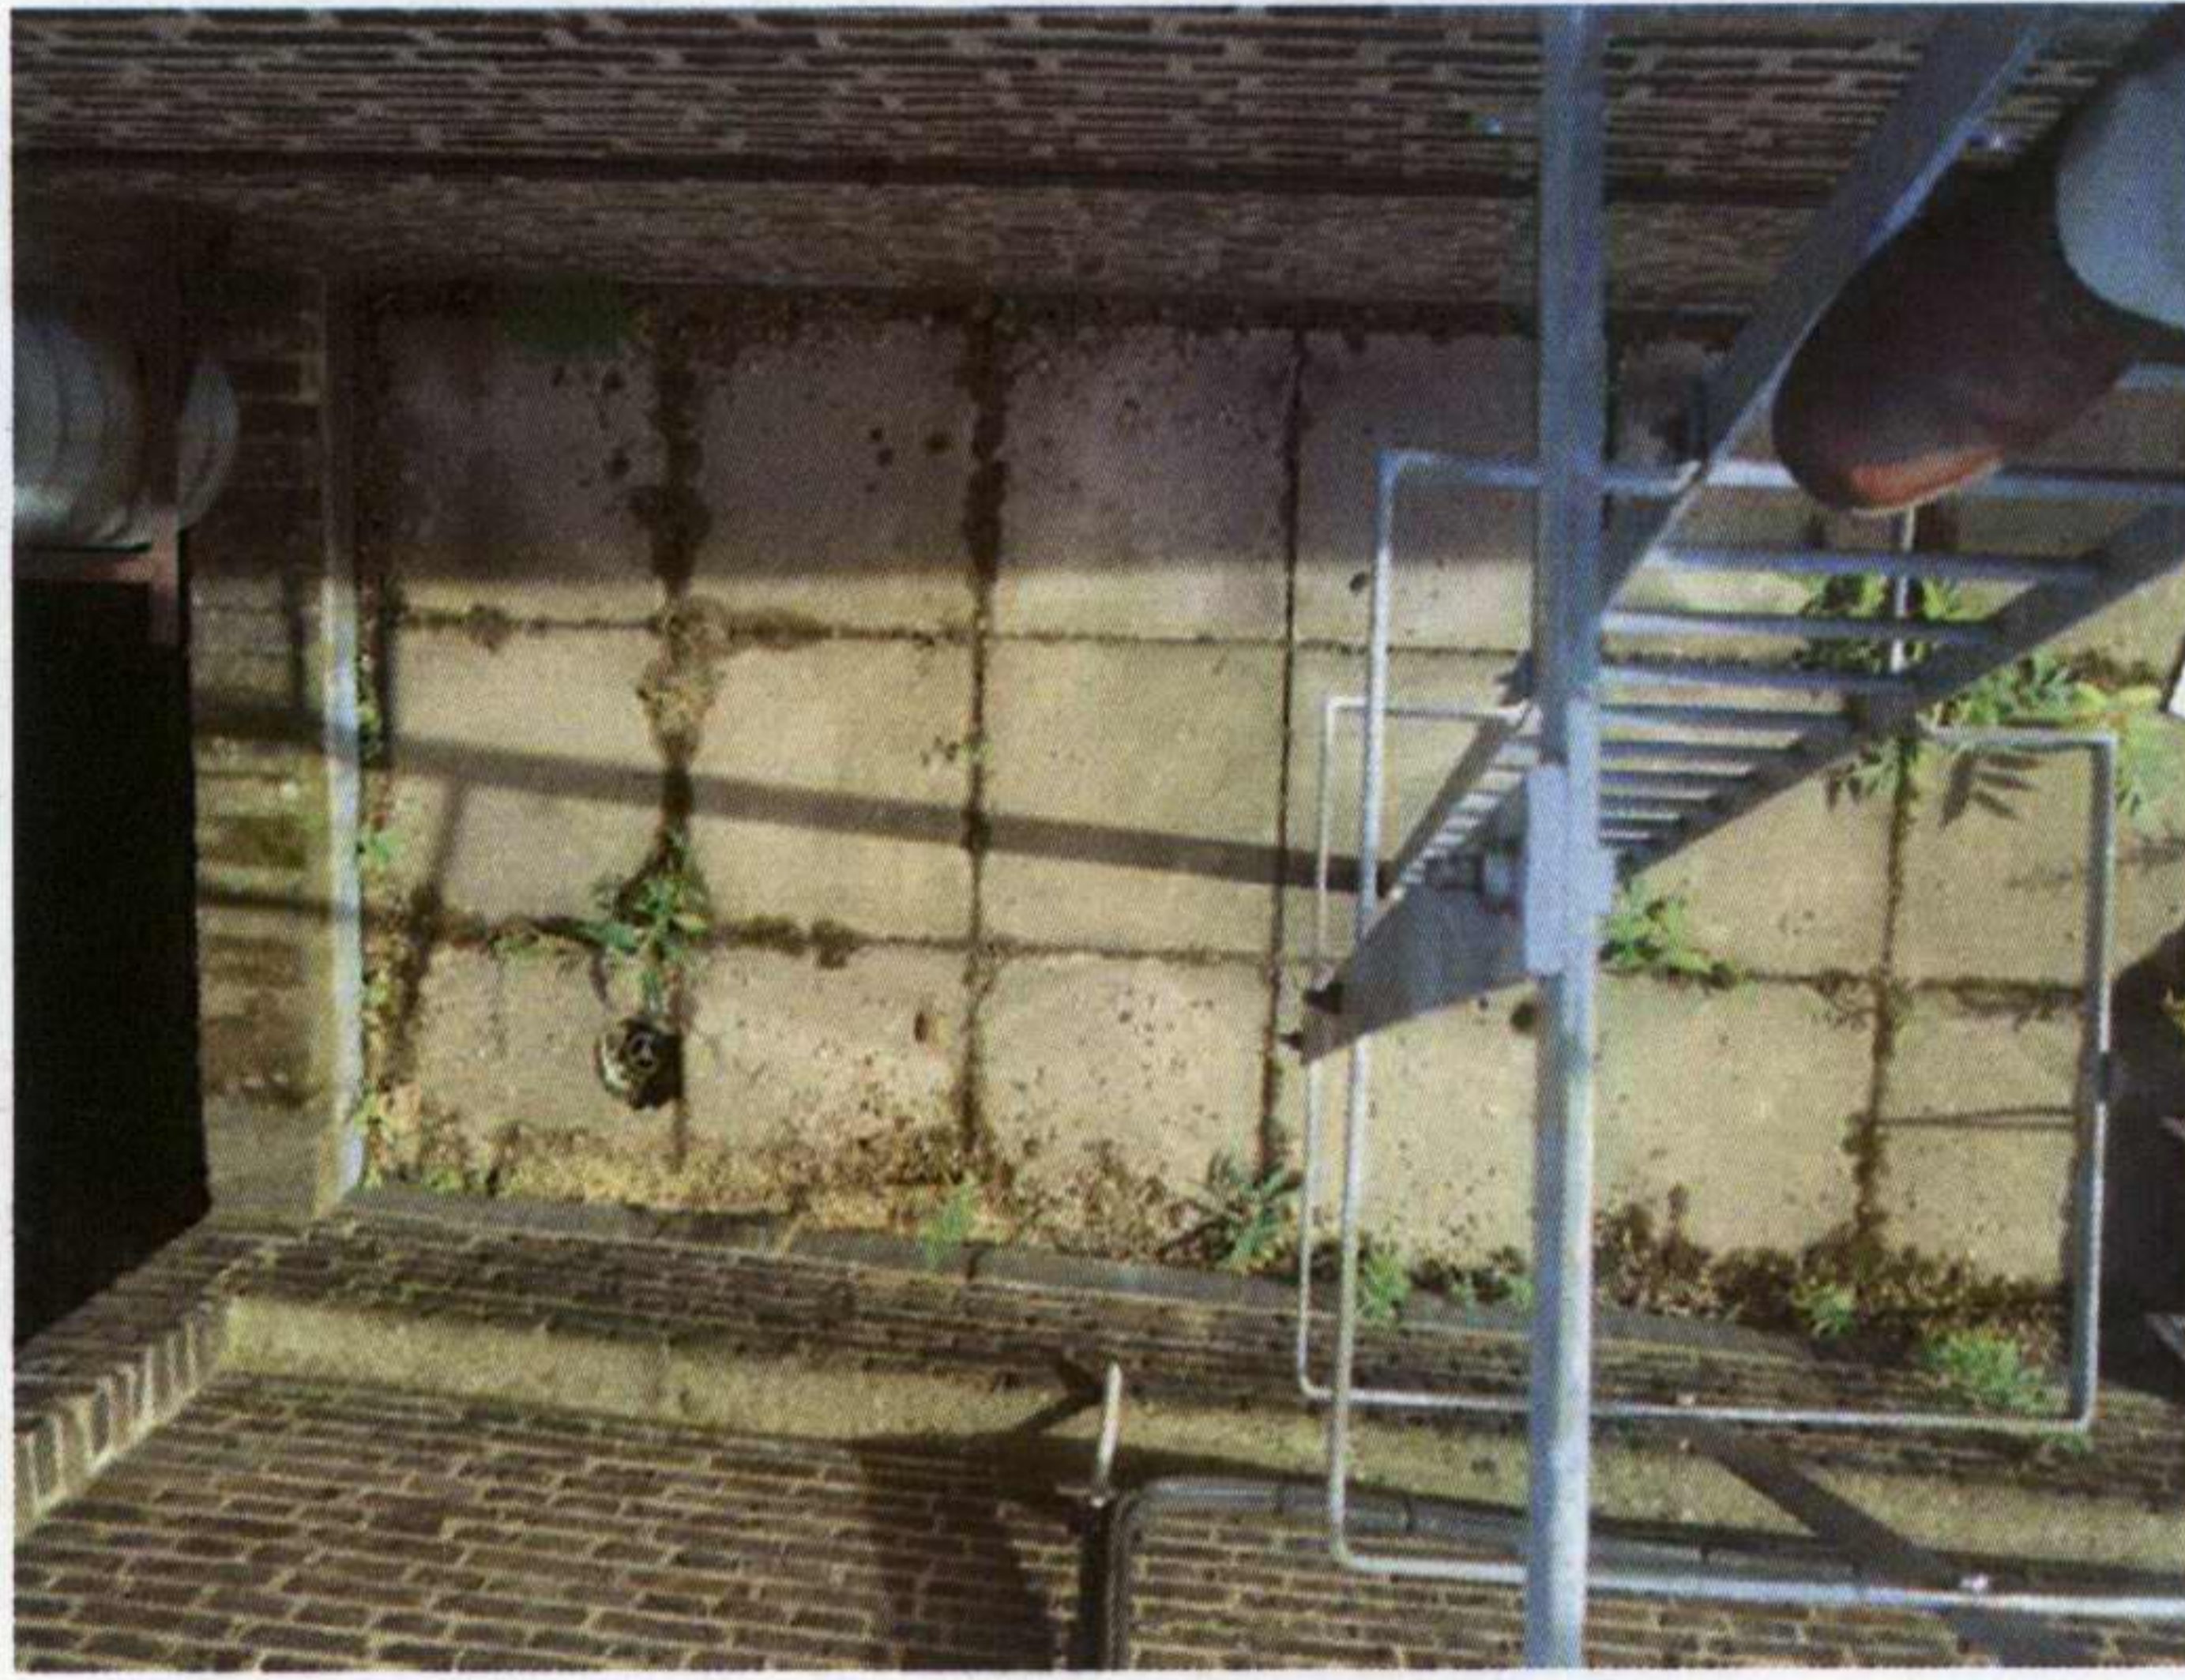
3.3 **Roof over apse end:** concrete slabs over insulation over bituminous felt finish ('inverted' roof detailing). There is shingle between the slabs, and this is supporting plant growth and weeds which need to be removed. No other defects noted at this level.

Remove weed growth

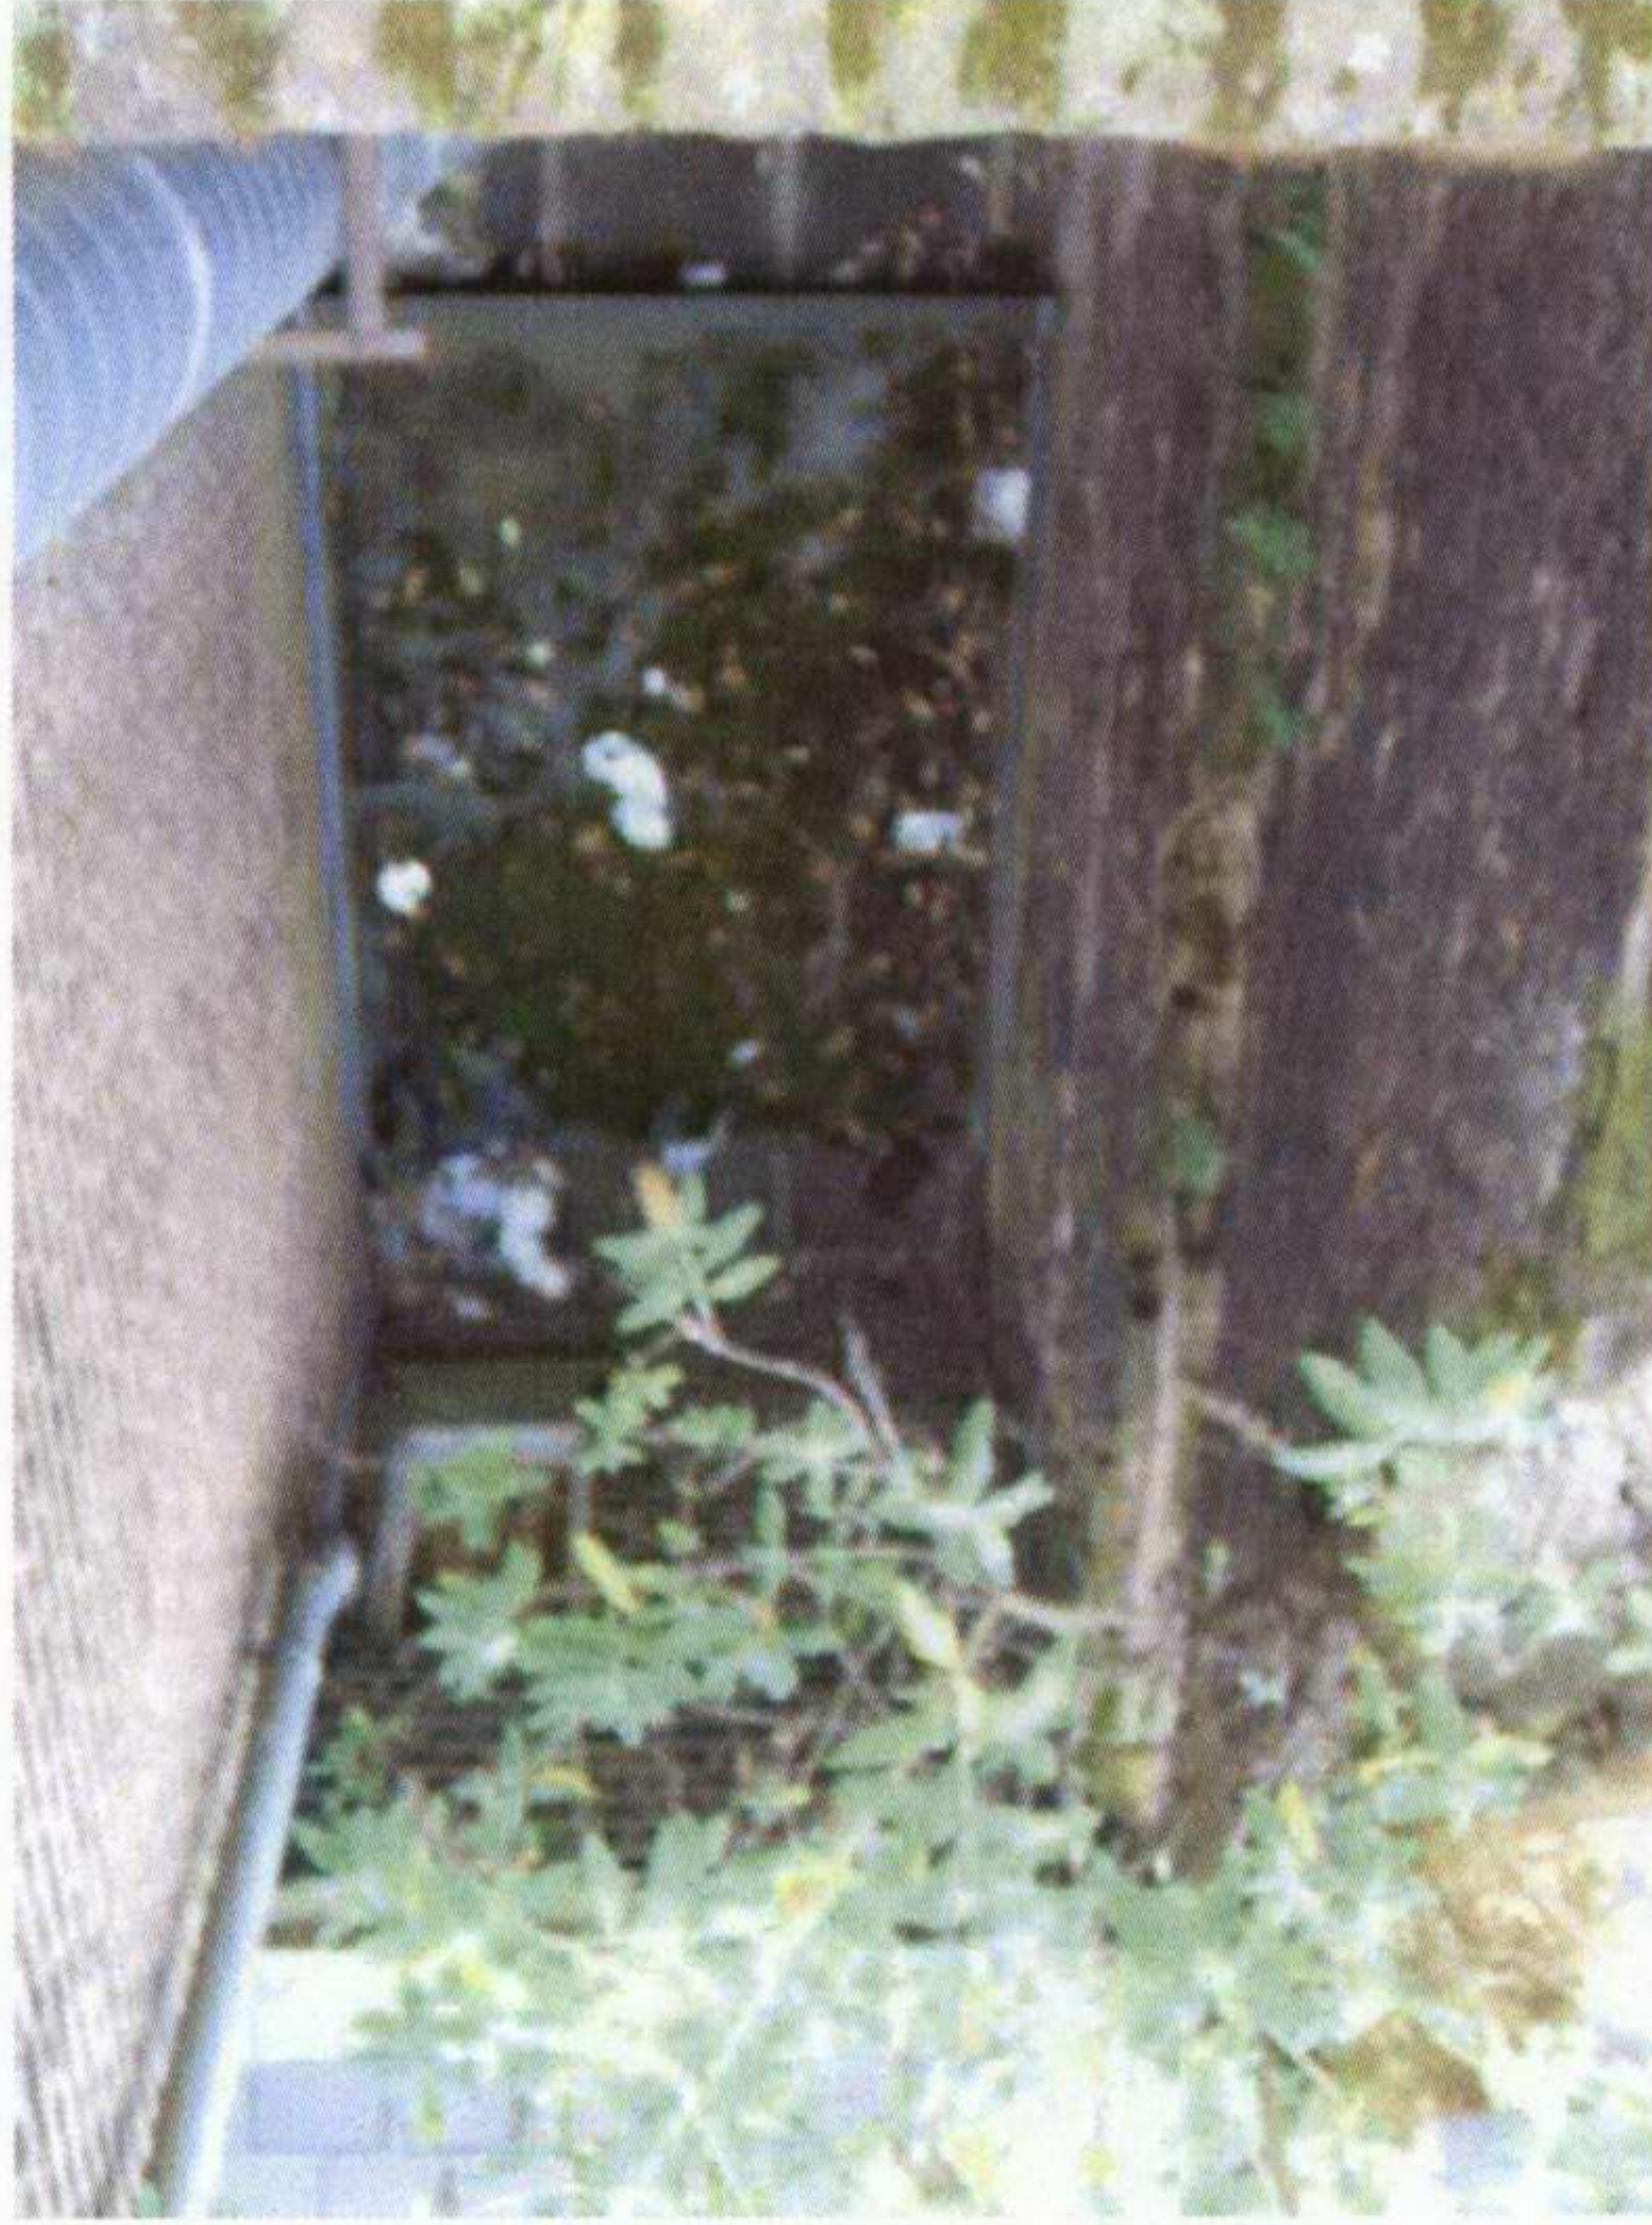
3.4 **Lower roof over boiler room:** galvanised meshing to the sides, with bituminous felt finish with flashings of copper or bituminous felt gets difficult to assess from upper level. No significant defects noted.

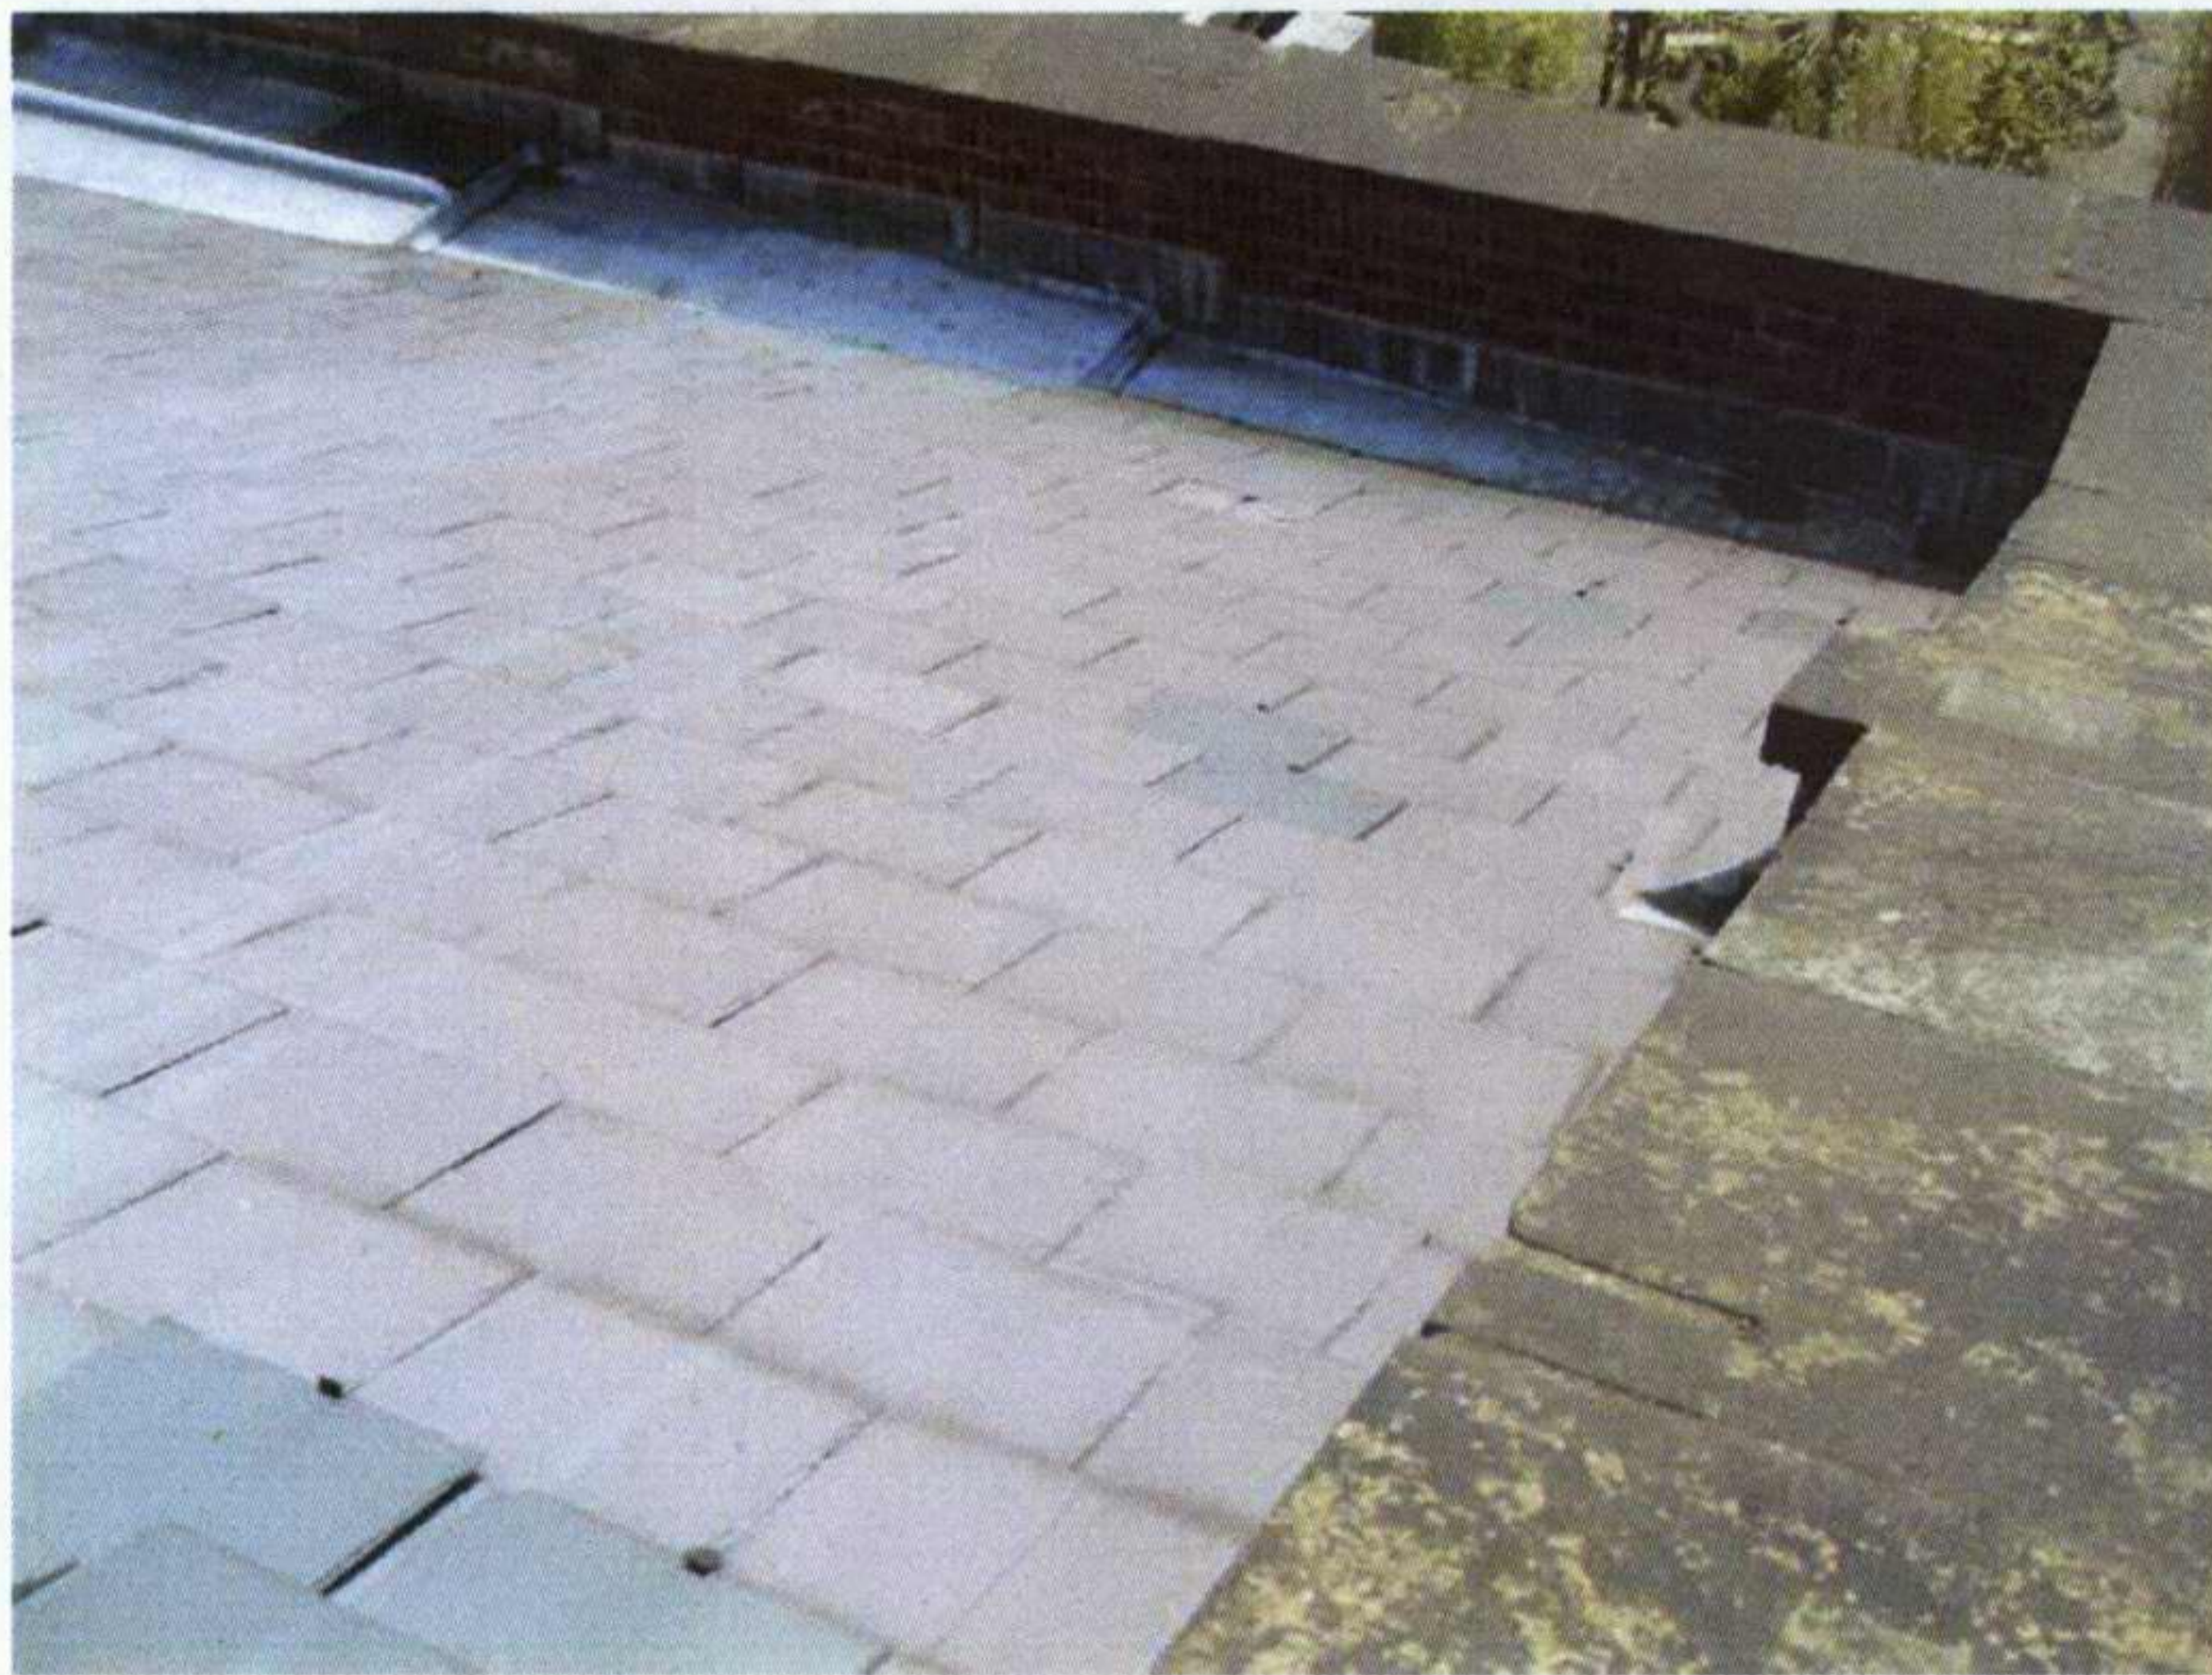
- 3.5 **Main roof over worship area:** a Welsh slate roof, some of the slates secured by lead 'tingles', but mainly in reasonable order. We counted eight slates on the north slope and four slates on the south slope which are broken or have slipped and need to be resecured in order to maintain weather tightness.

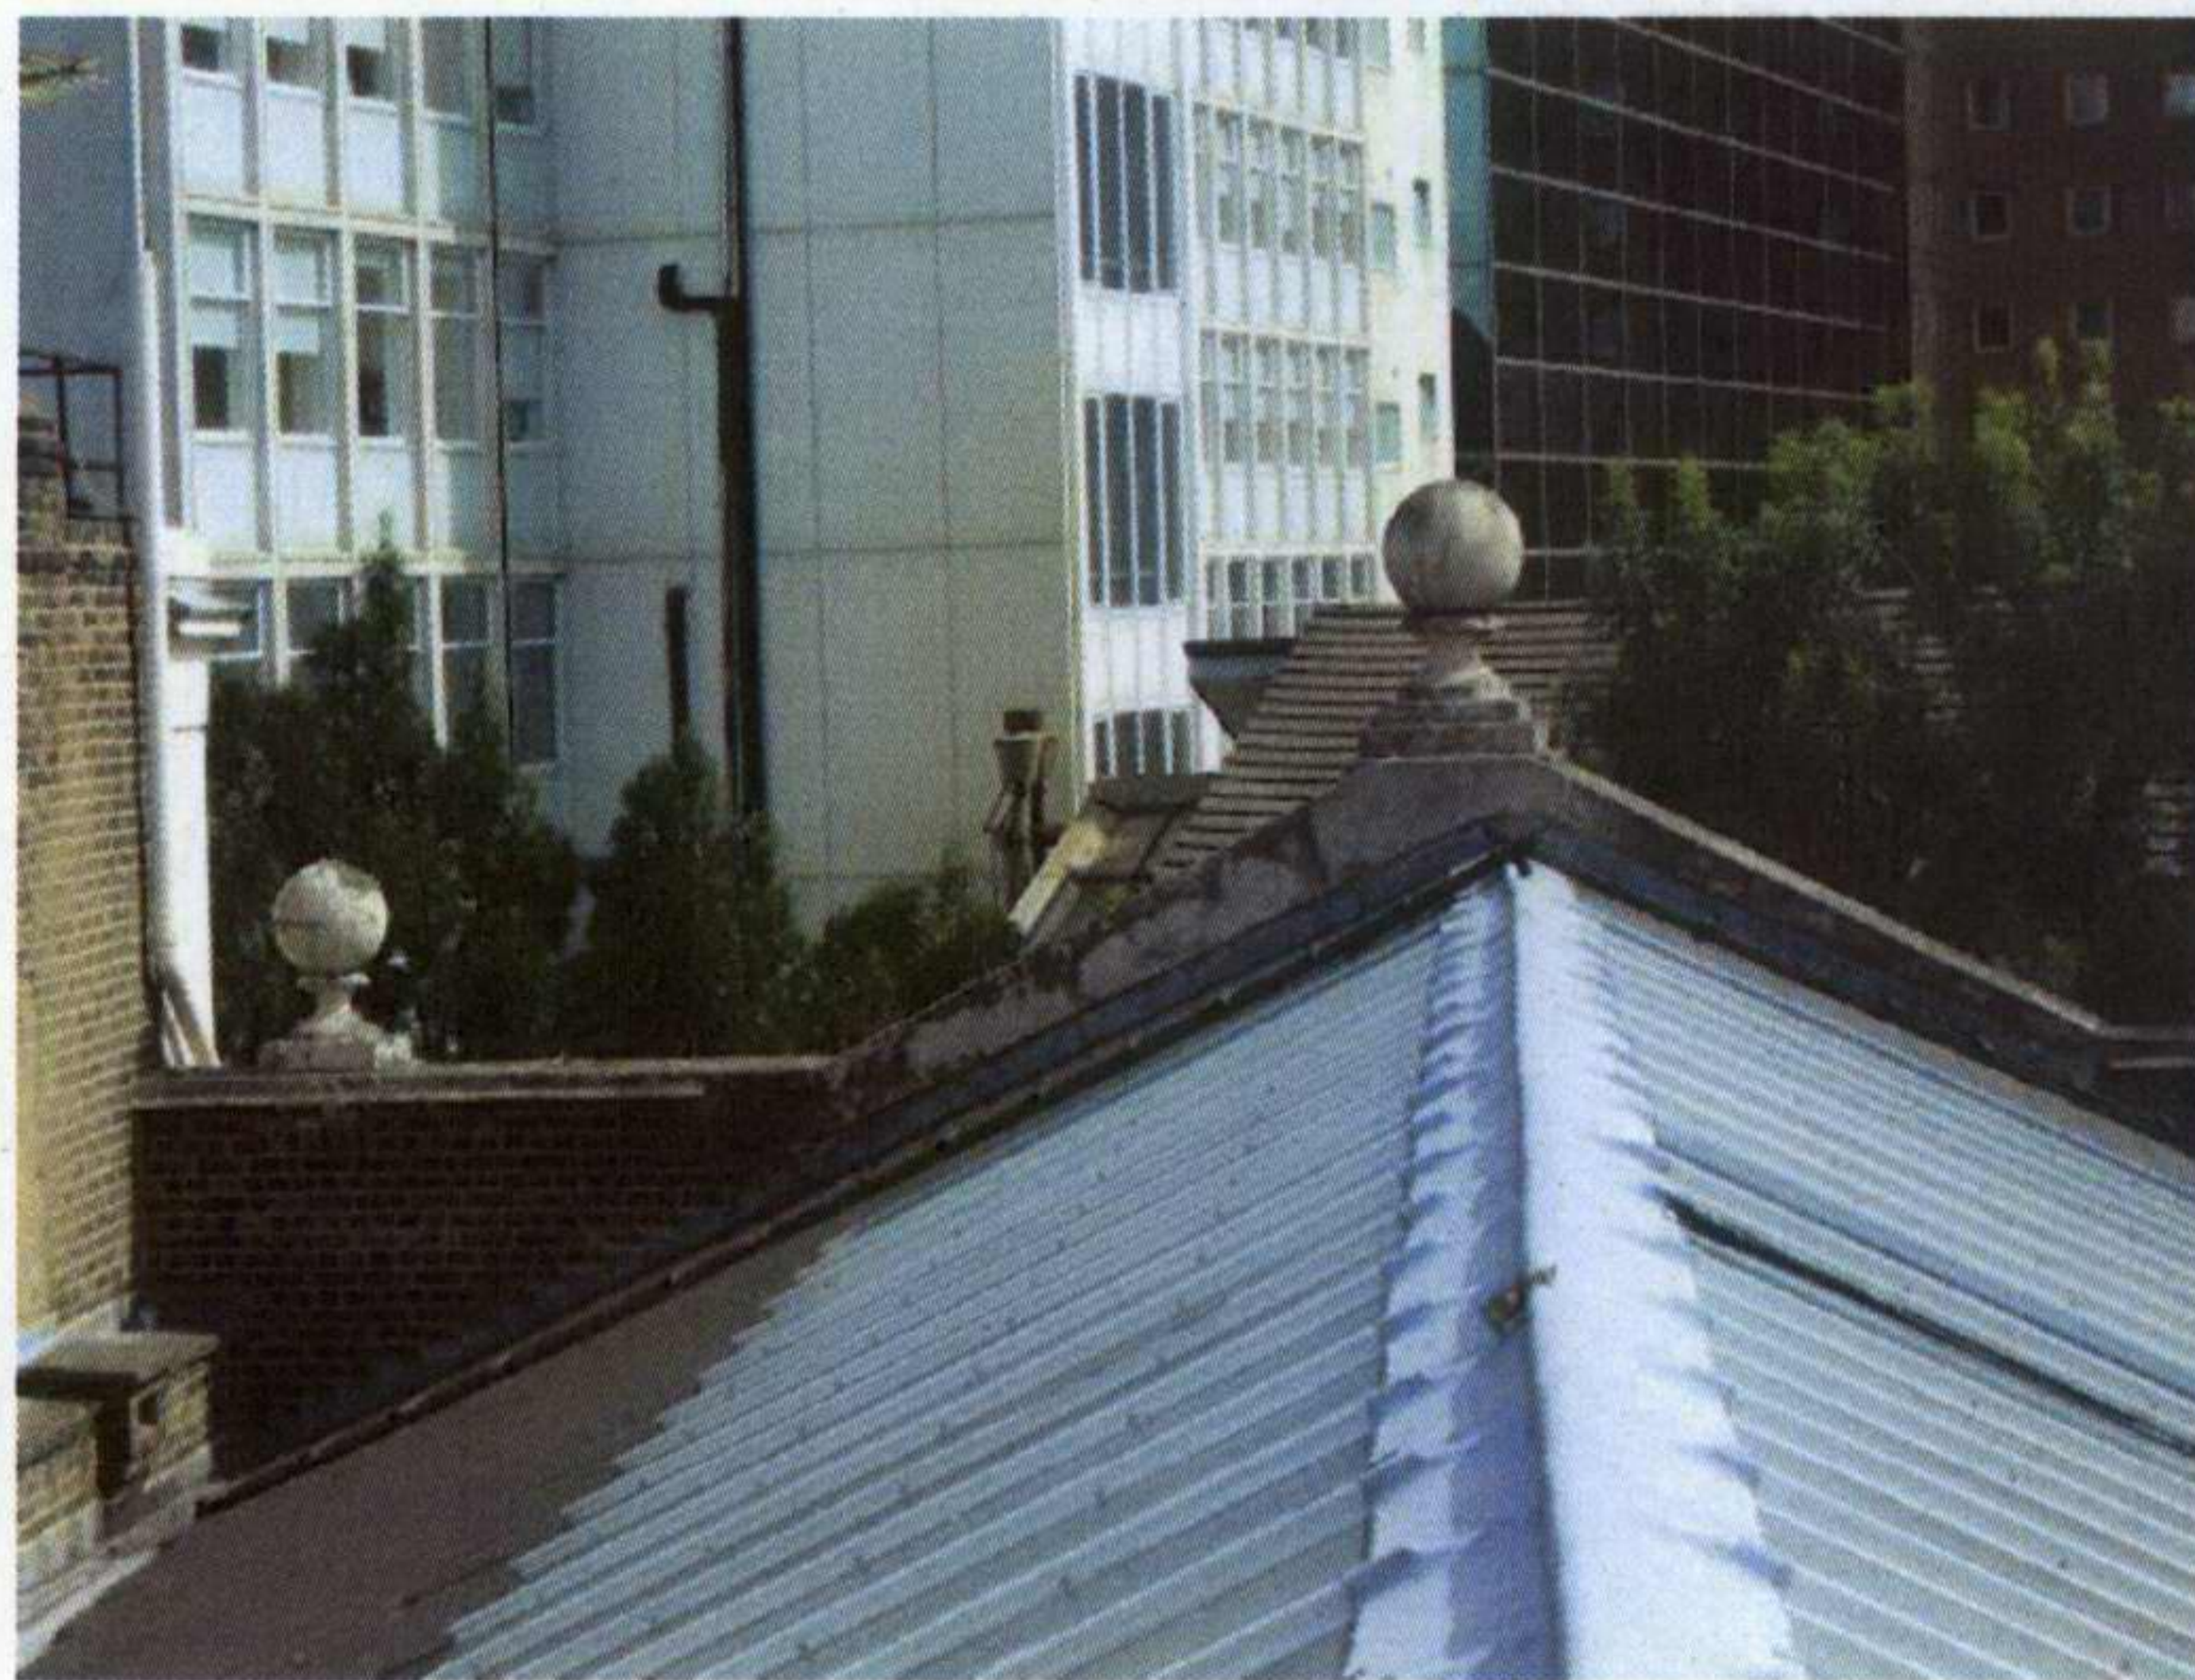
- 3.6 **Roof light:** a simple aluminium roof light, with a single skin of glass, resting just above the slate line. This appears to have been installed after 1988, and to have been subsequently repaired using a proprietary self adhesive metal finish such as flashband, applied to the twelfth bar from the east end, cracking in glass suggest these maybe overfixed. We note that there is no natural 'trickle' ventilation through the roof light, and apparently no ability to open roof lights to improve the ventilation. In the short term there is no evidence of water penetration from beneath, but the heat loss through the roof light and the risk of condensation caused by the form of heating suggests that consideration should be given to replacement of this with a more appropriate form of glazing, possibly double glazed solar reflective panels, with either controlled or trickle vent ventilation.
