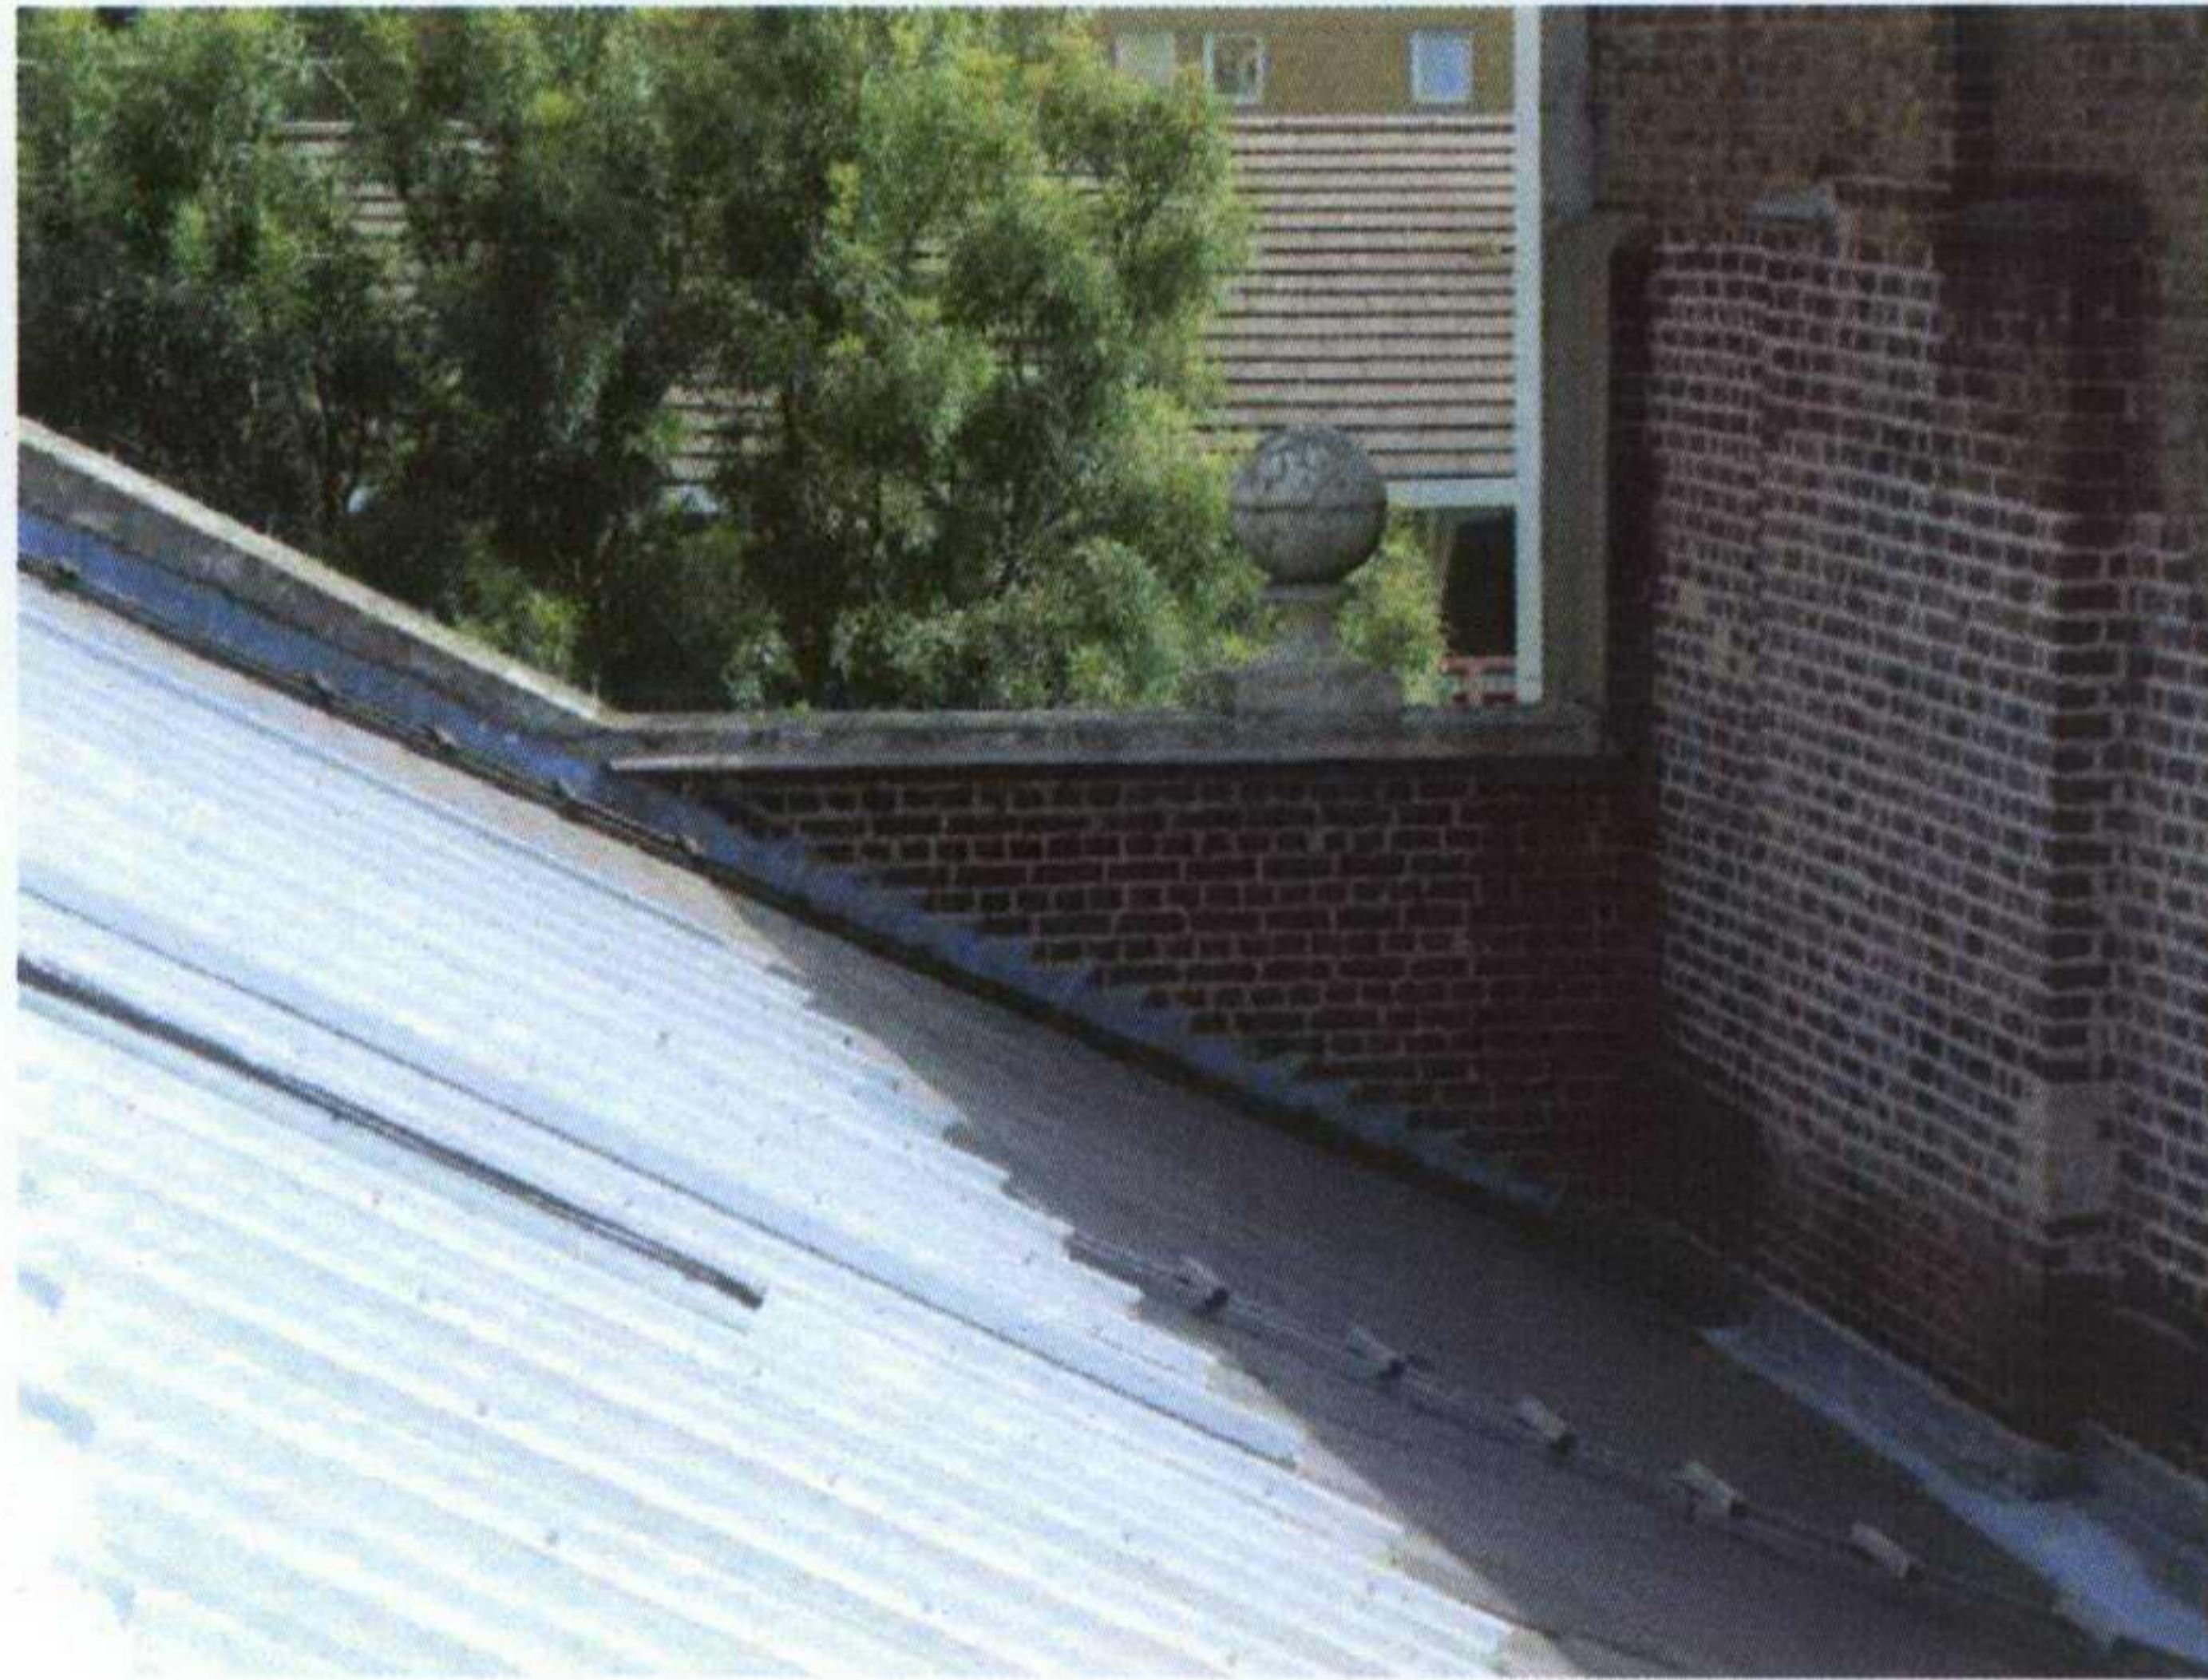
- 3.8 **South gutter:** a comparatively new and reasonably detailed lead gutter, but with the gutter board showing from the underside suggesting that there may be inadequate ventilation to the void below the gutter level. This needs to be checked by further inspection. This would involve opening up of the plaster from the underside to check, and perhaps incorporating appropriate ventilation through the western wall, this will allow further inspection and opening up.

Incorporate new ventilation below the gutter area.

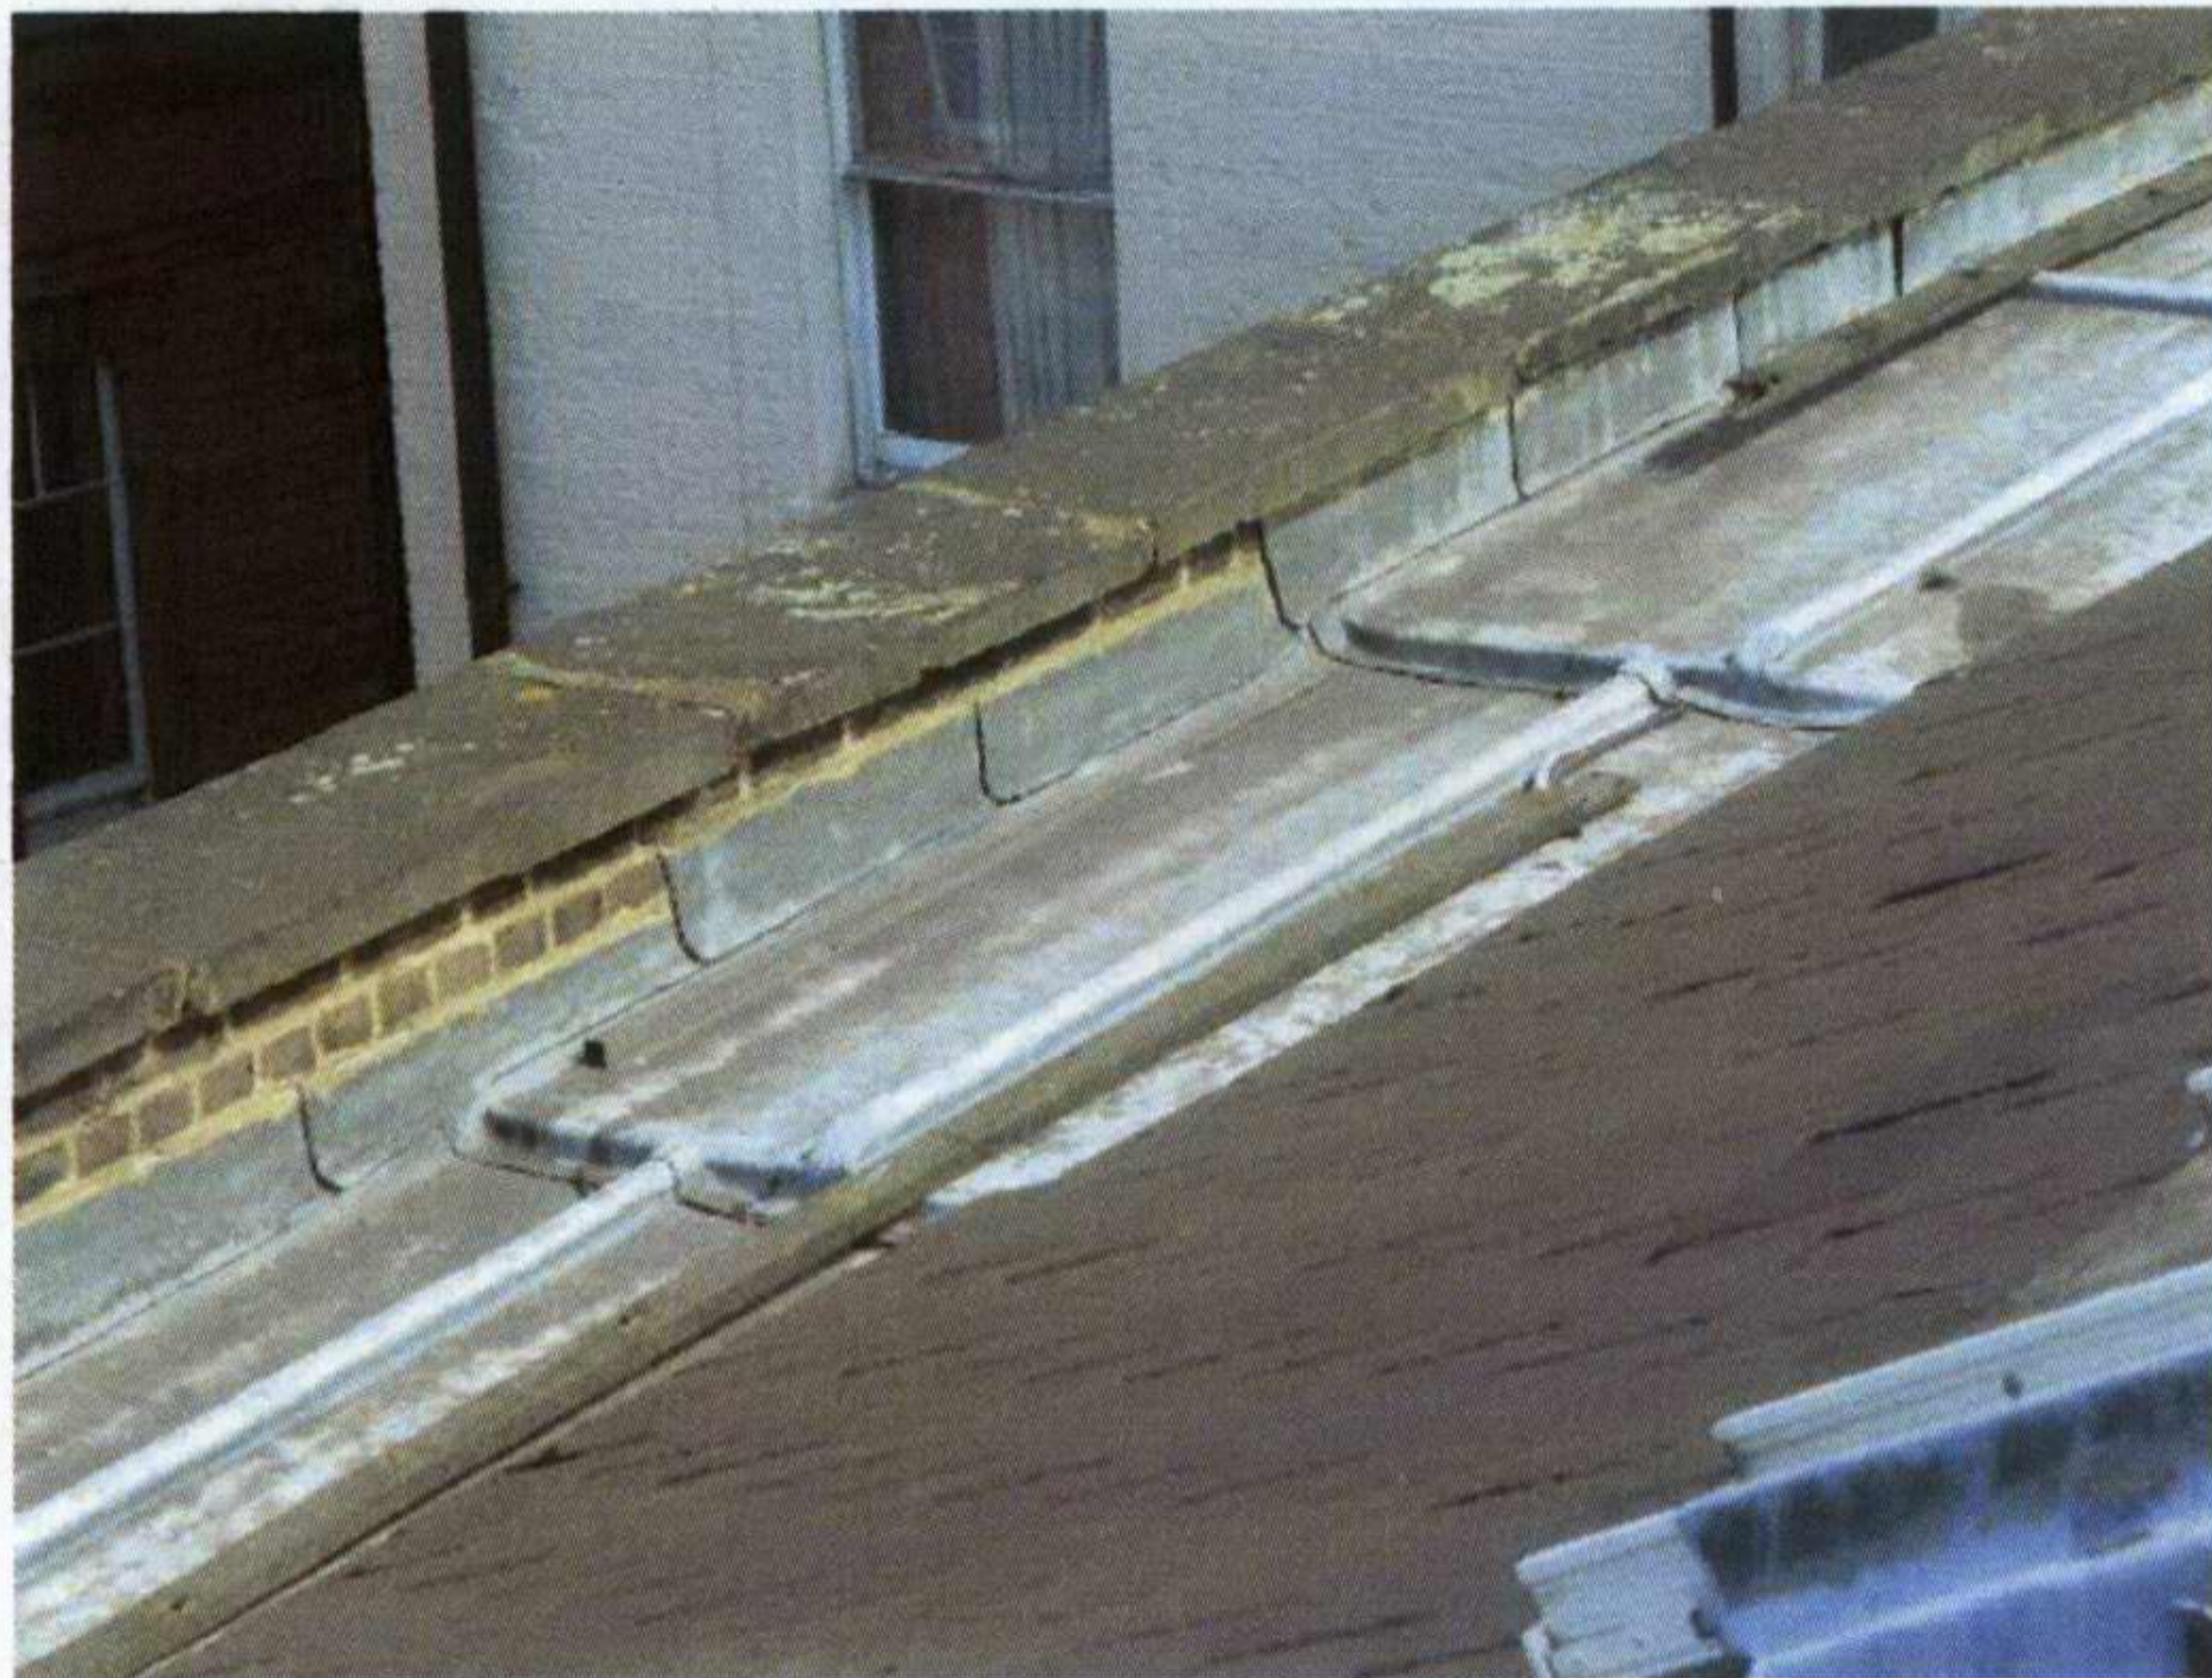
- 3.11 **Flashings to the upstand parapet walls:** these are in worse condition than on the south (they do get more sun), and the flashing chase along the whole length has split out from the brickwork. The flashing itself has become detached from the brickwork half way along, and the chase needs to be reformed along its entire length to a more satisfactory detail.

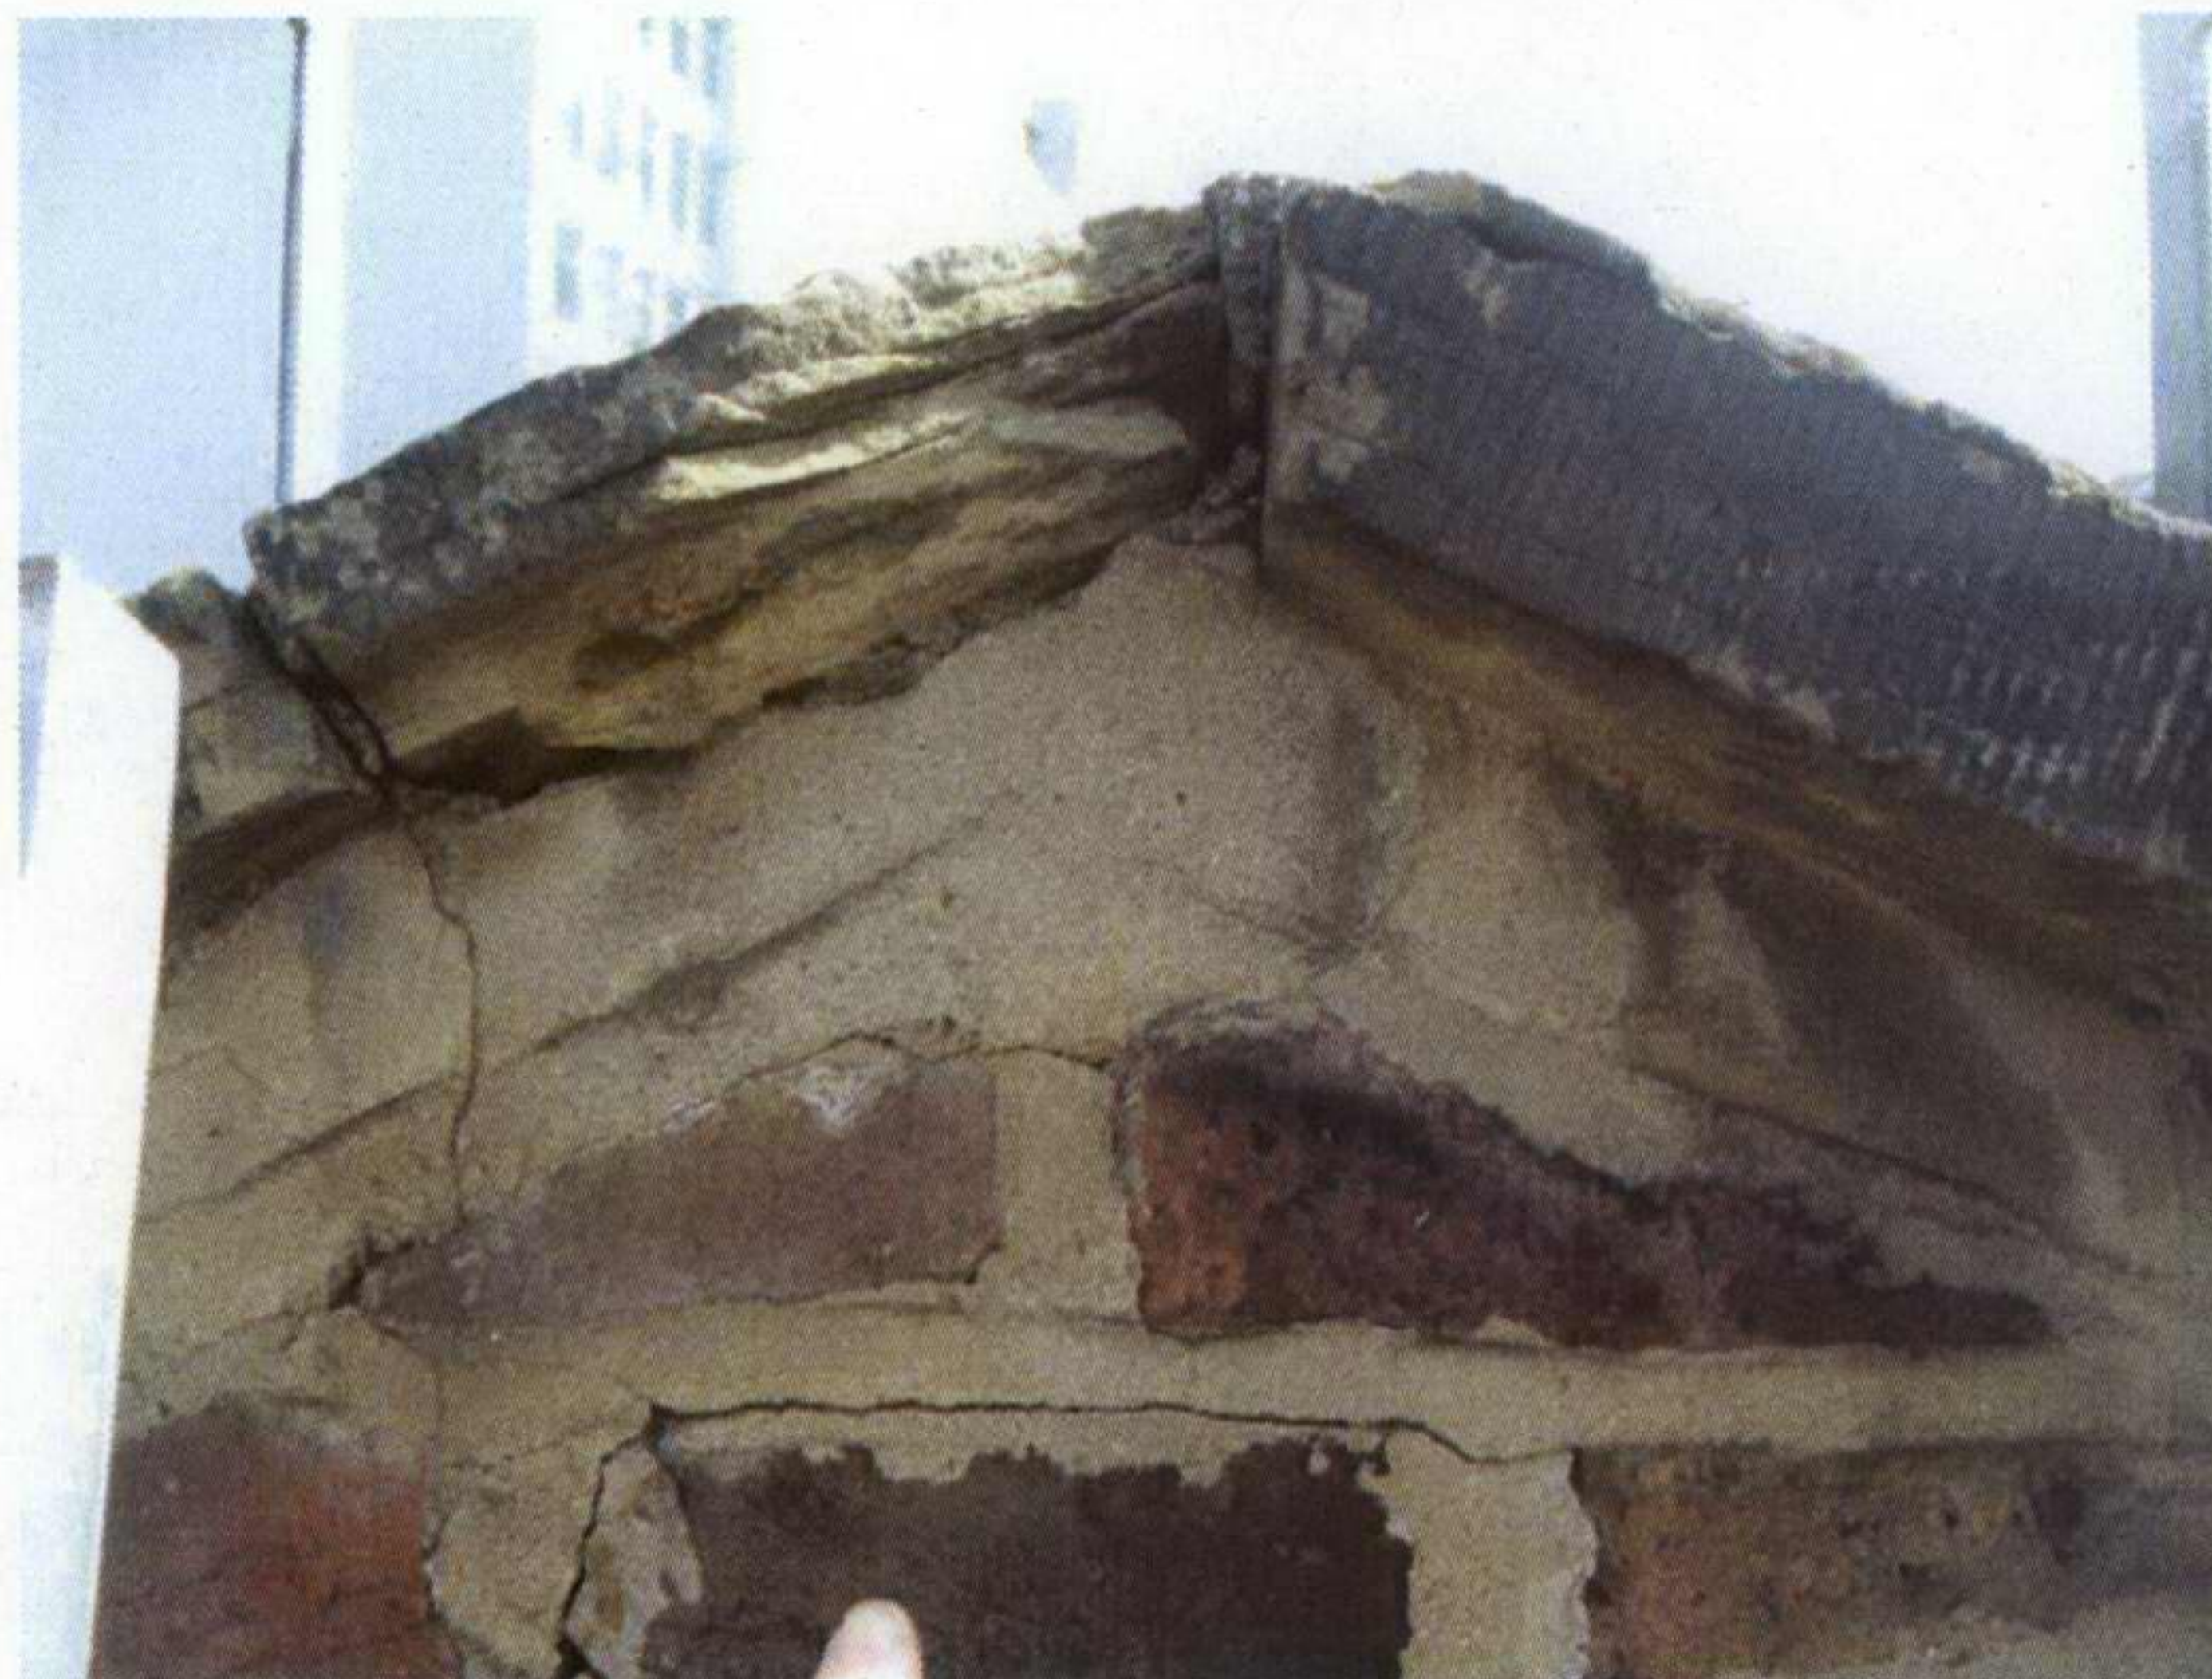
3.14 **West upstand:** the upper stones on the western upstand need to be consolidated, and minor repointing is required in the upper parts.

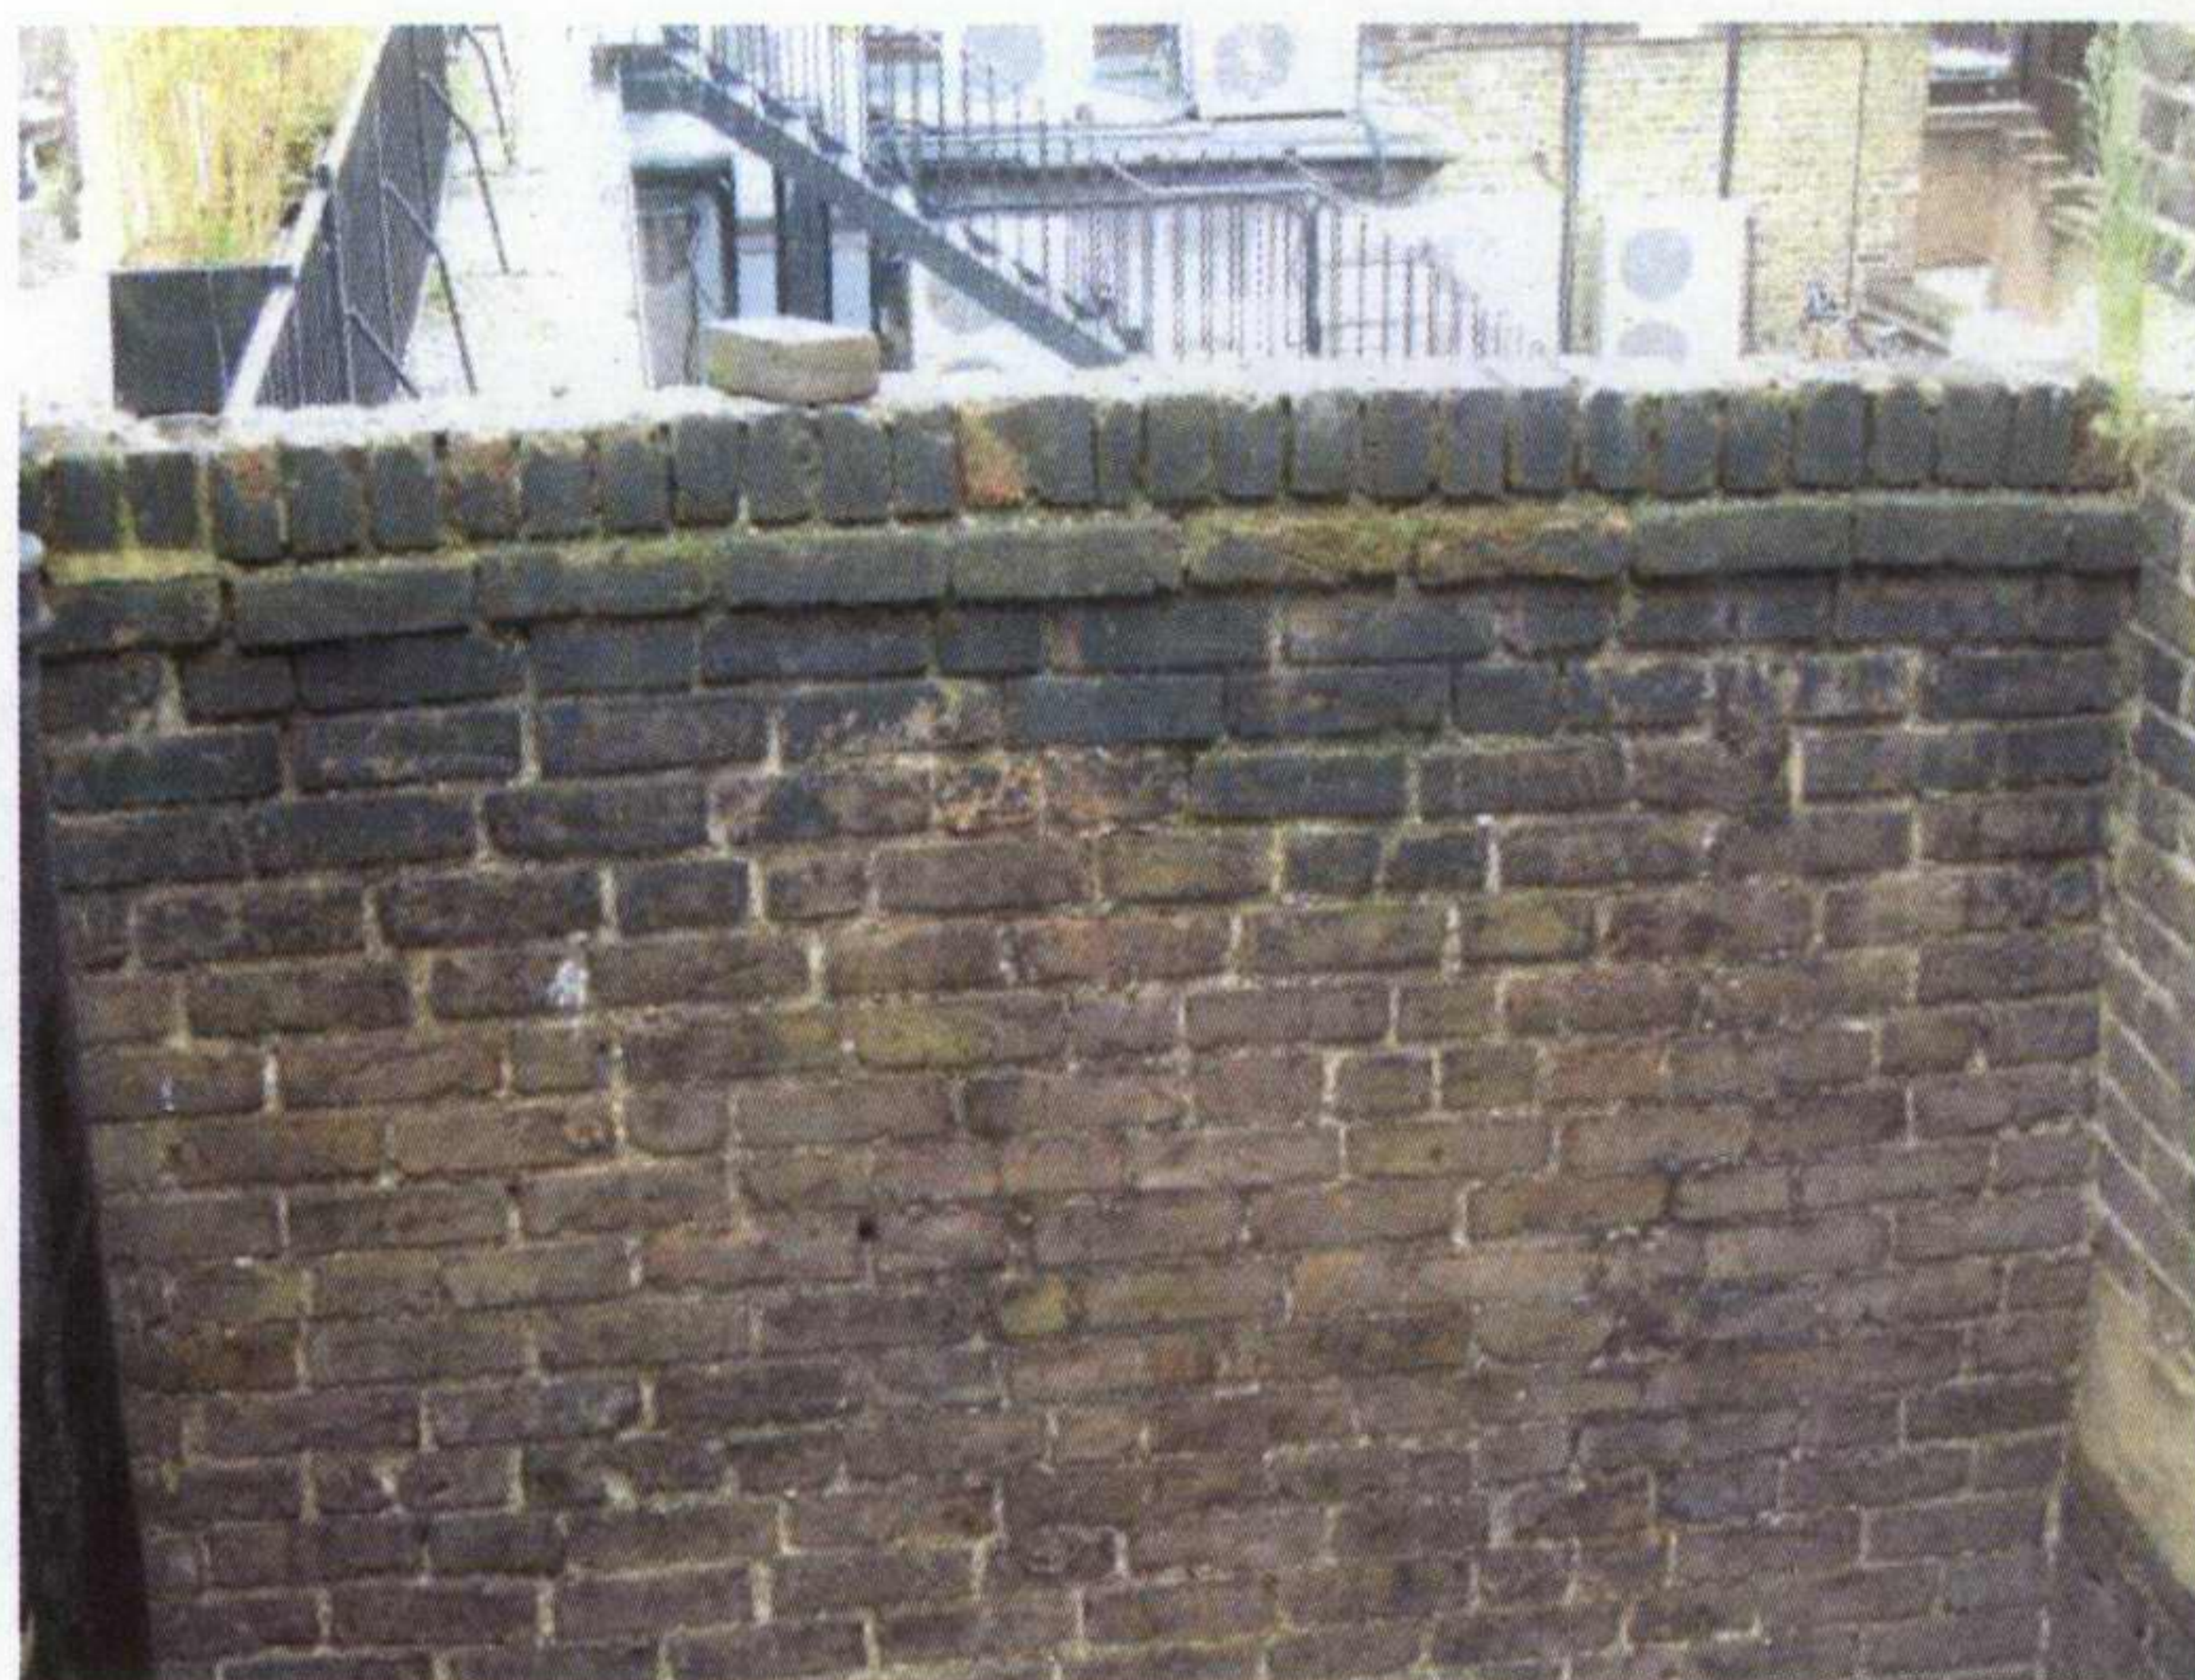
4.2 **South wall over storage areas:** generally reasonably well pointed in the lower parts, but open in the top part and the upper 750mm requires rebuilding. The brick on edge capping over this has sprung upwards due to lack of adequate movement joints, and possibly also buried ironwork, and this needs to be reset over. Access is awkward and party wall issues will relate.

General repairs to the top of wall

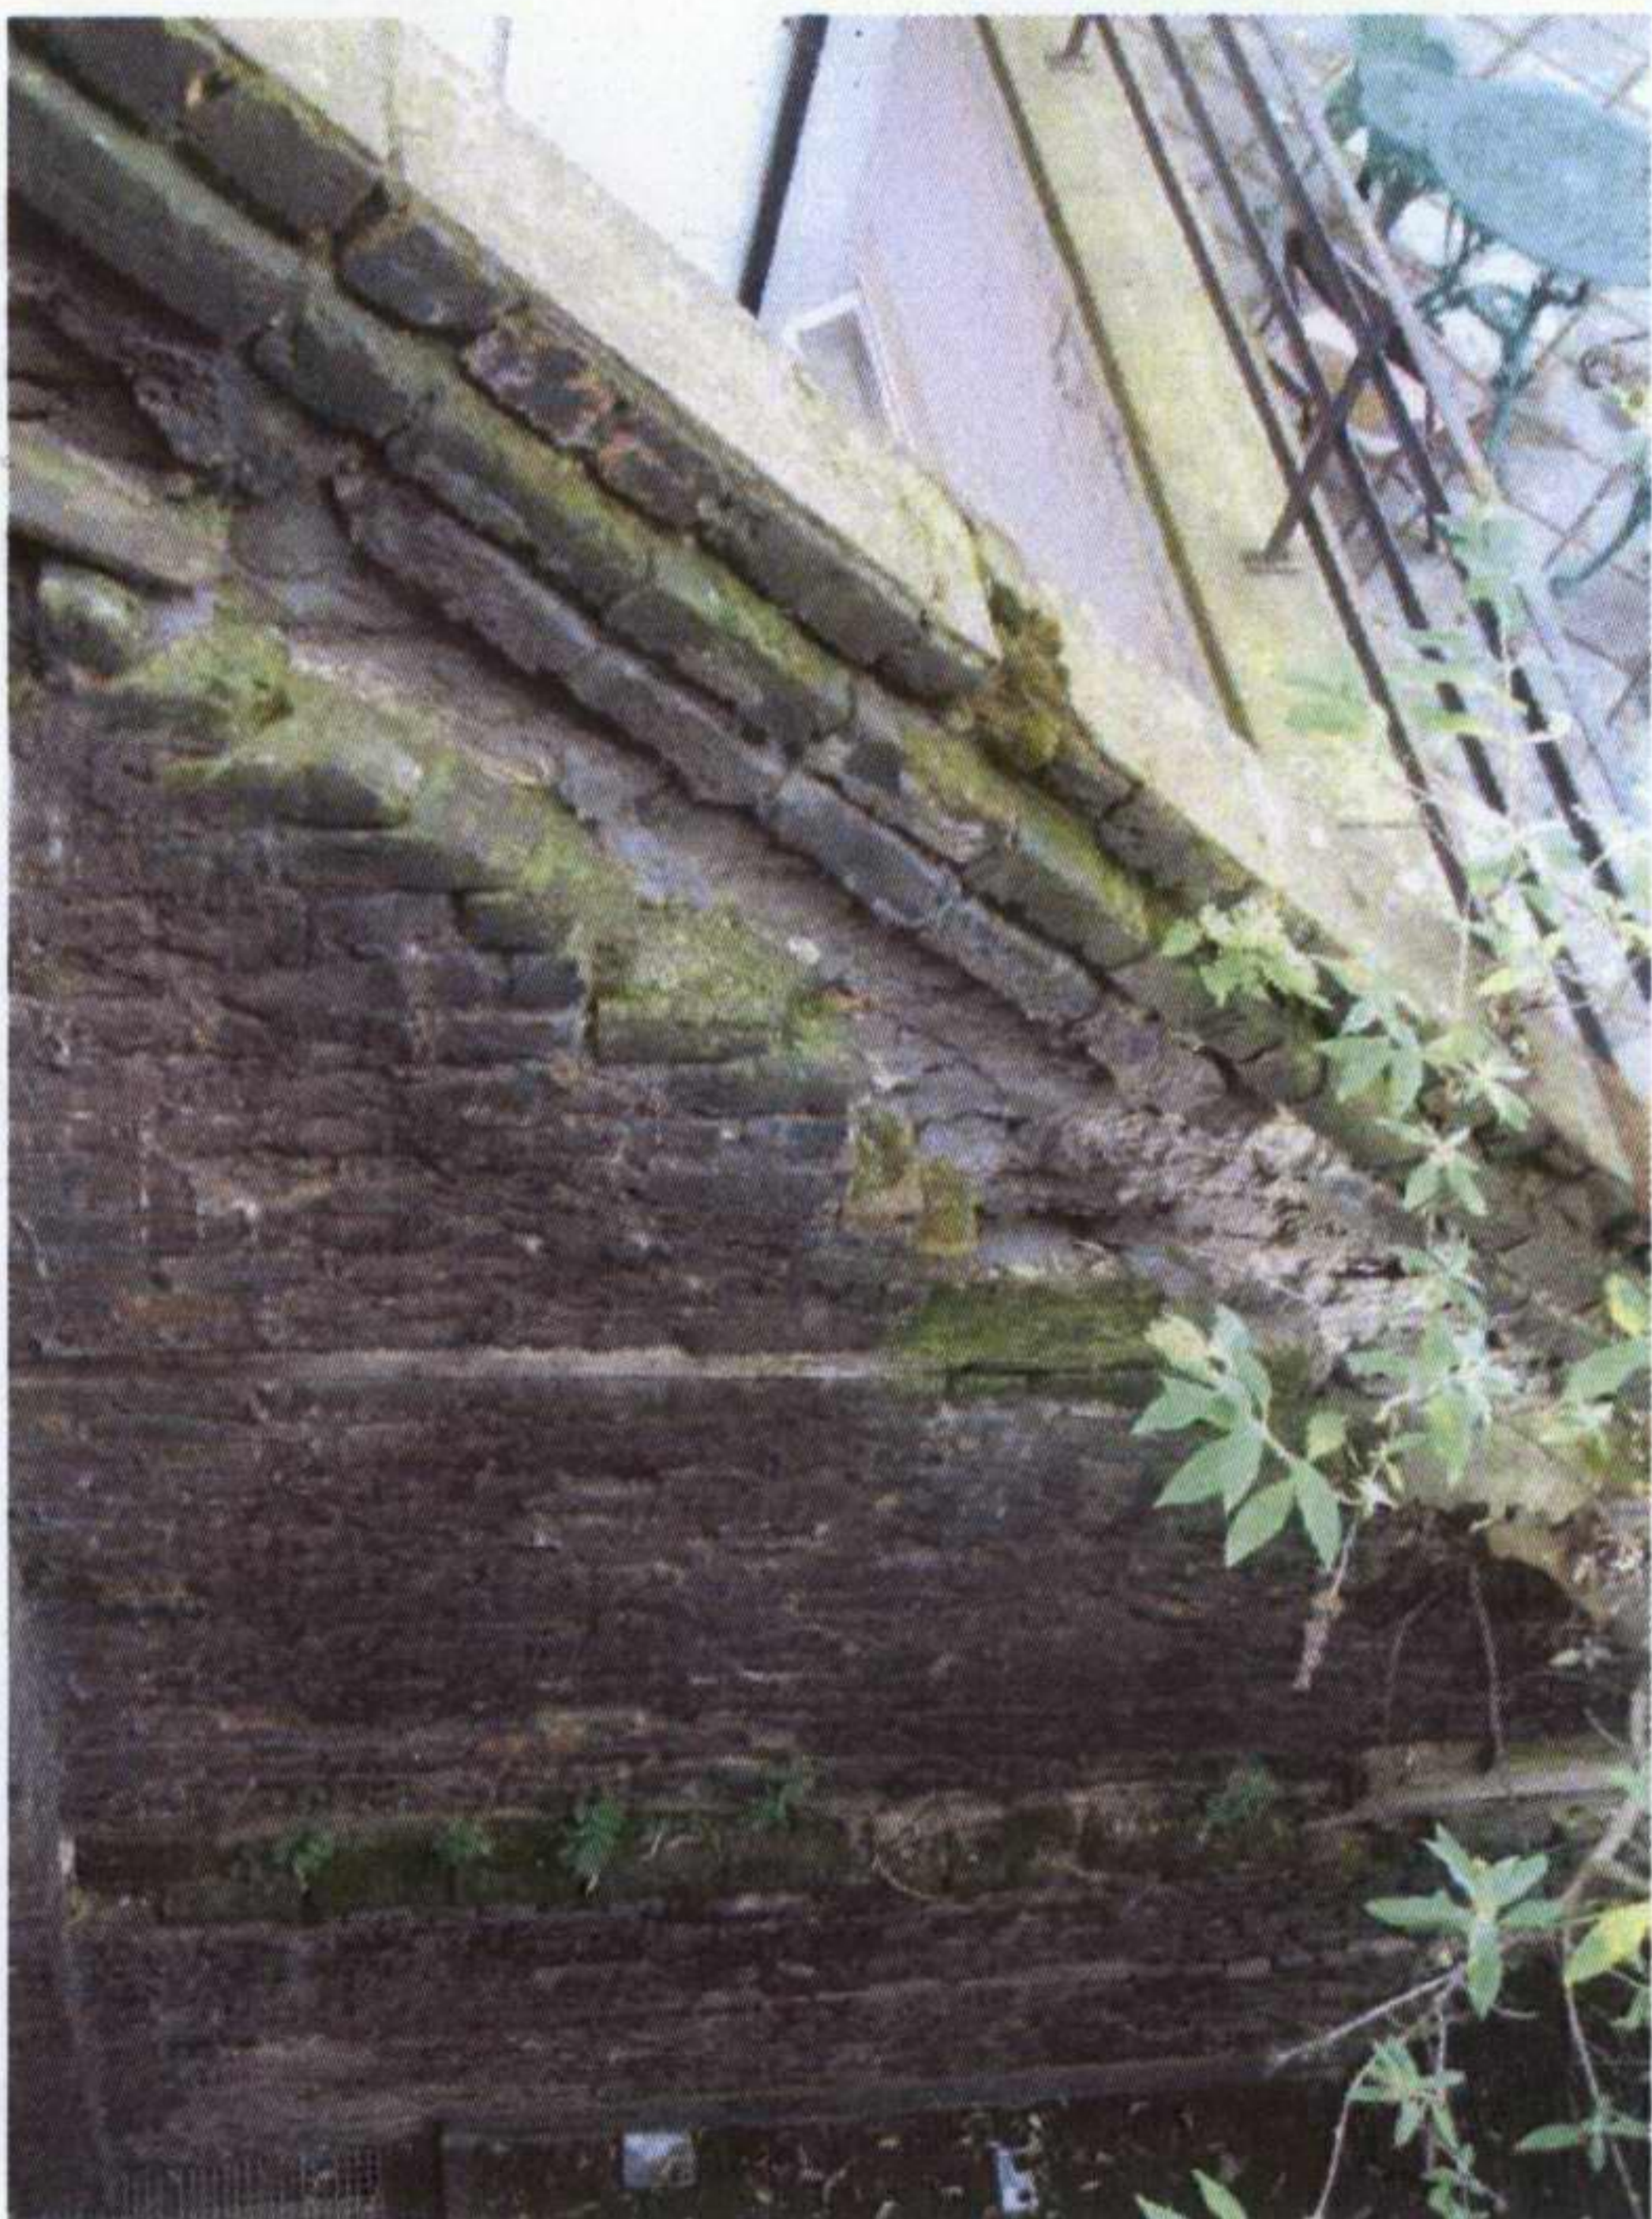
PRIORITY	BUDGET COSTS
	B/F	37,750
4.4	West wall over the boiler room: this is in a very poor condition, and in the past has suffered collapse from the upper sections of the weathering as such that the wall is now vulnerable to the weather and the rate of decay is increasing. Lacing timbers incorporated within the brick courses have decayed significantly, and there is a heavy growth of buddleia from the front of the wall. This is a party wall, and the east face of the wall in the adjoining owner's property appears to be in much better condition. The wall will require partial dismantling, the removal of the lacing timbers, reconstruction, a new capping, repointing and removal of the vegetable growth.

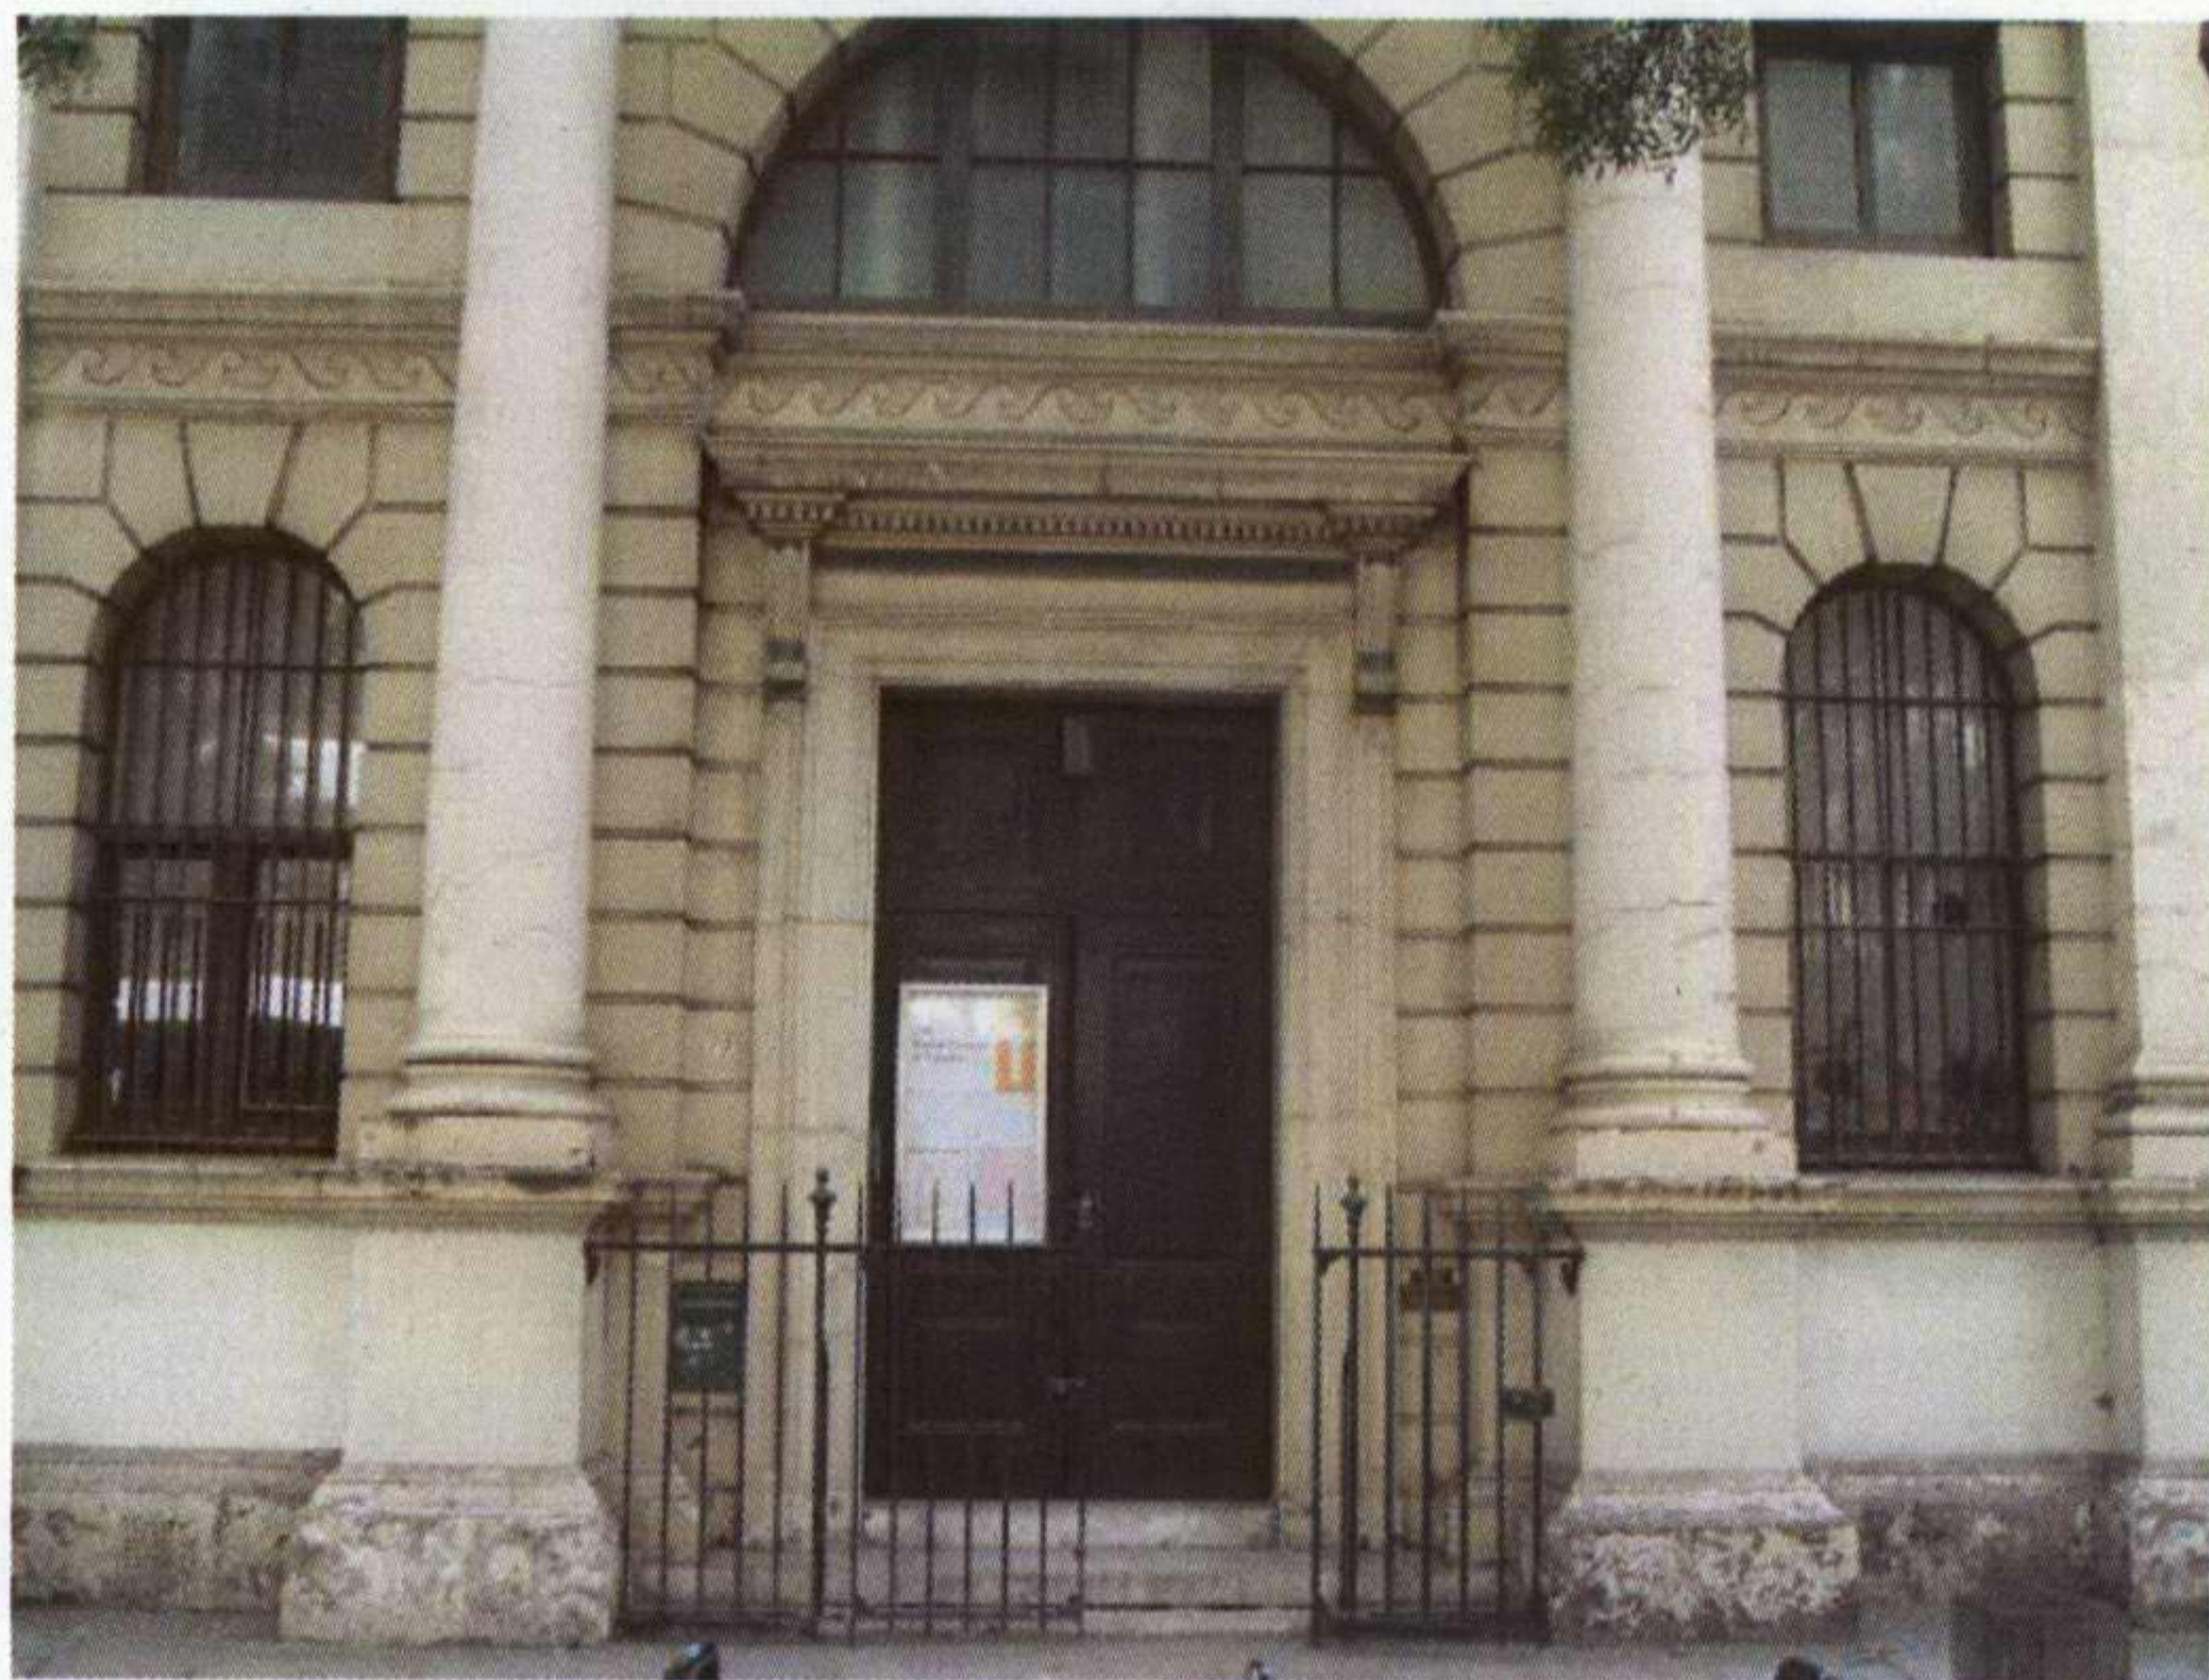
ITEM	B	*
4.8	Front façade: complex Palladian façade predominantly formed in stucco rendered brickwork. The elevation has been successively patch repaired particularly to the columns over the years, and subsequently redecorated with various types of paint. In recent years this has included an oil bound gloss paint. This has failed, bringing off under layers of paint forming blisters and cracks, due to the following weathering agencies.

- Trapped moisture, from higher levels including breaks in the capping to the top of the parapet, and also in the weathering courses, subsequently attempting to evaporate through the surface and causing blistering particularly under weathering courses in sheltered areas.
