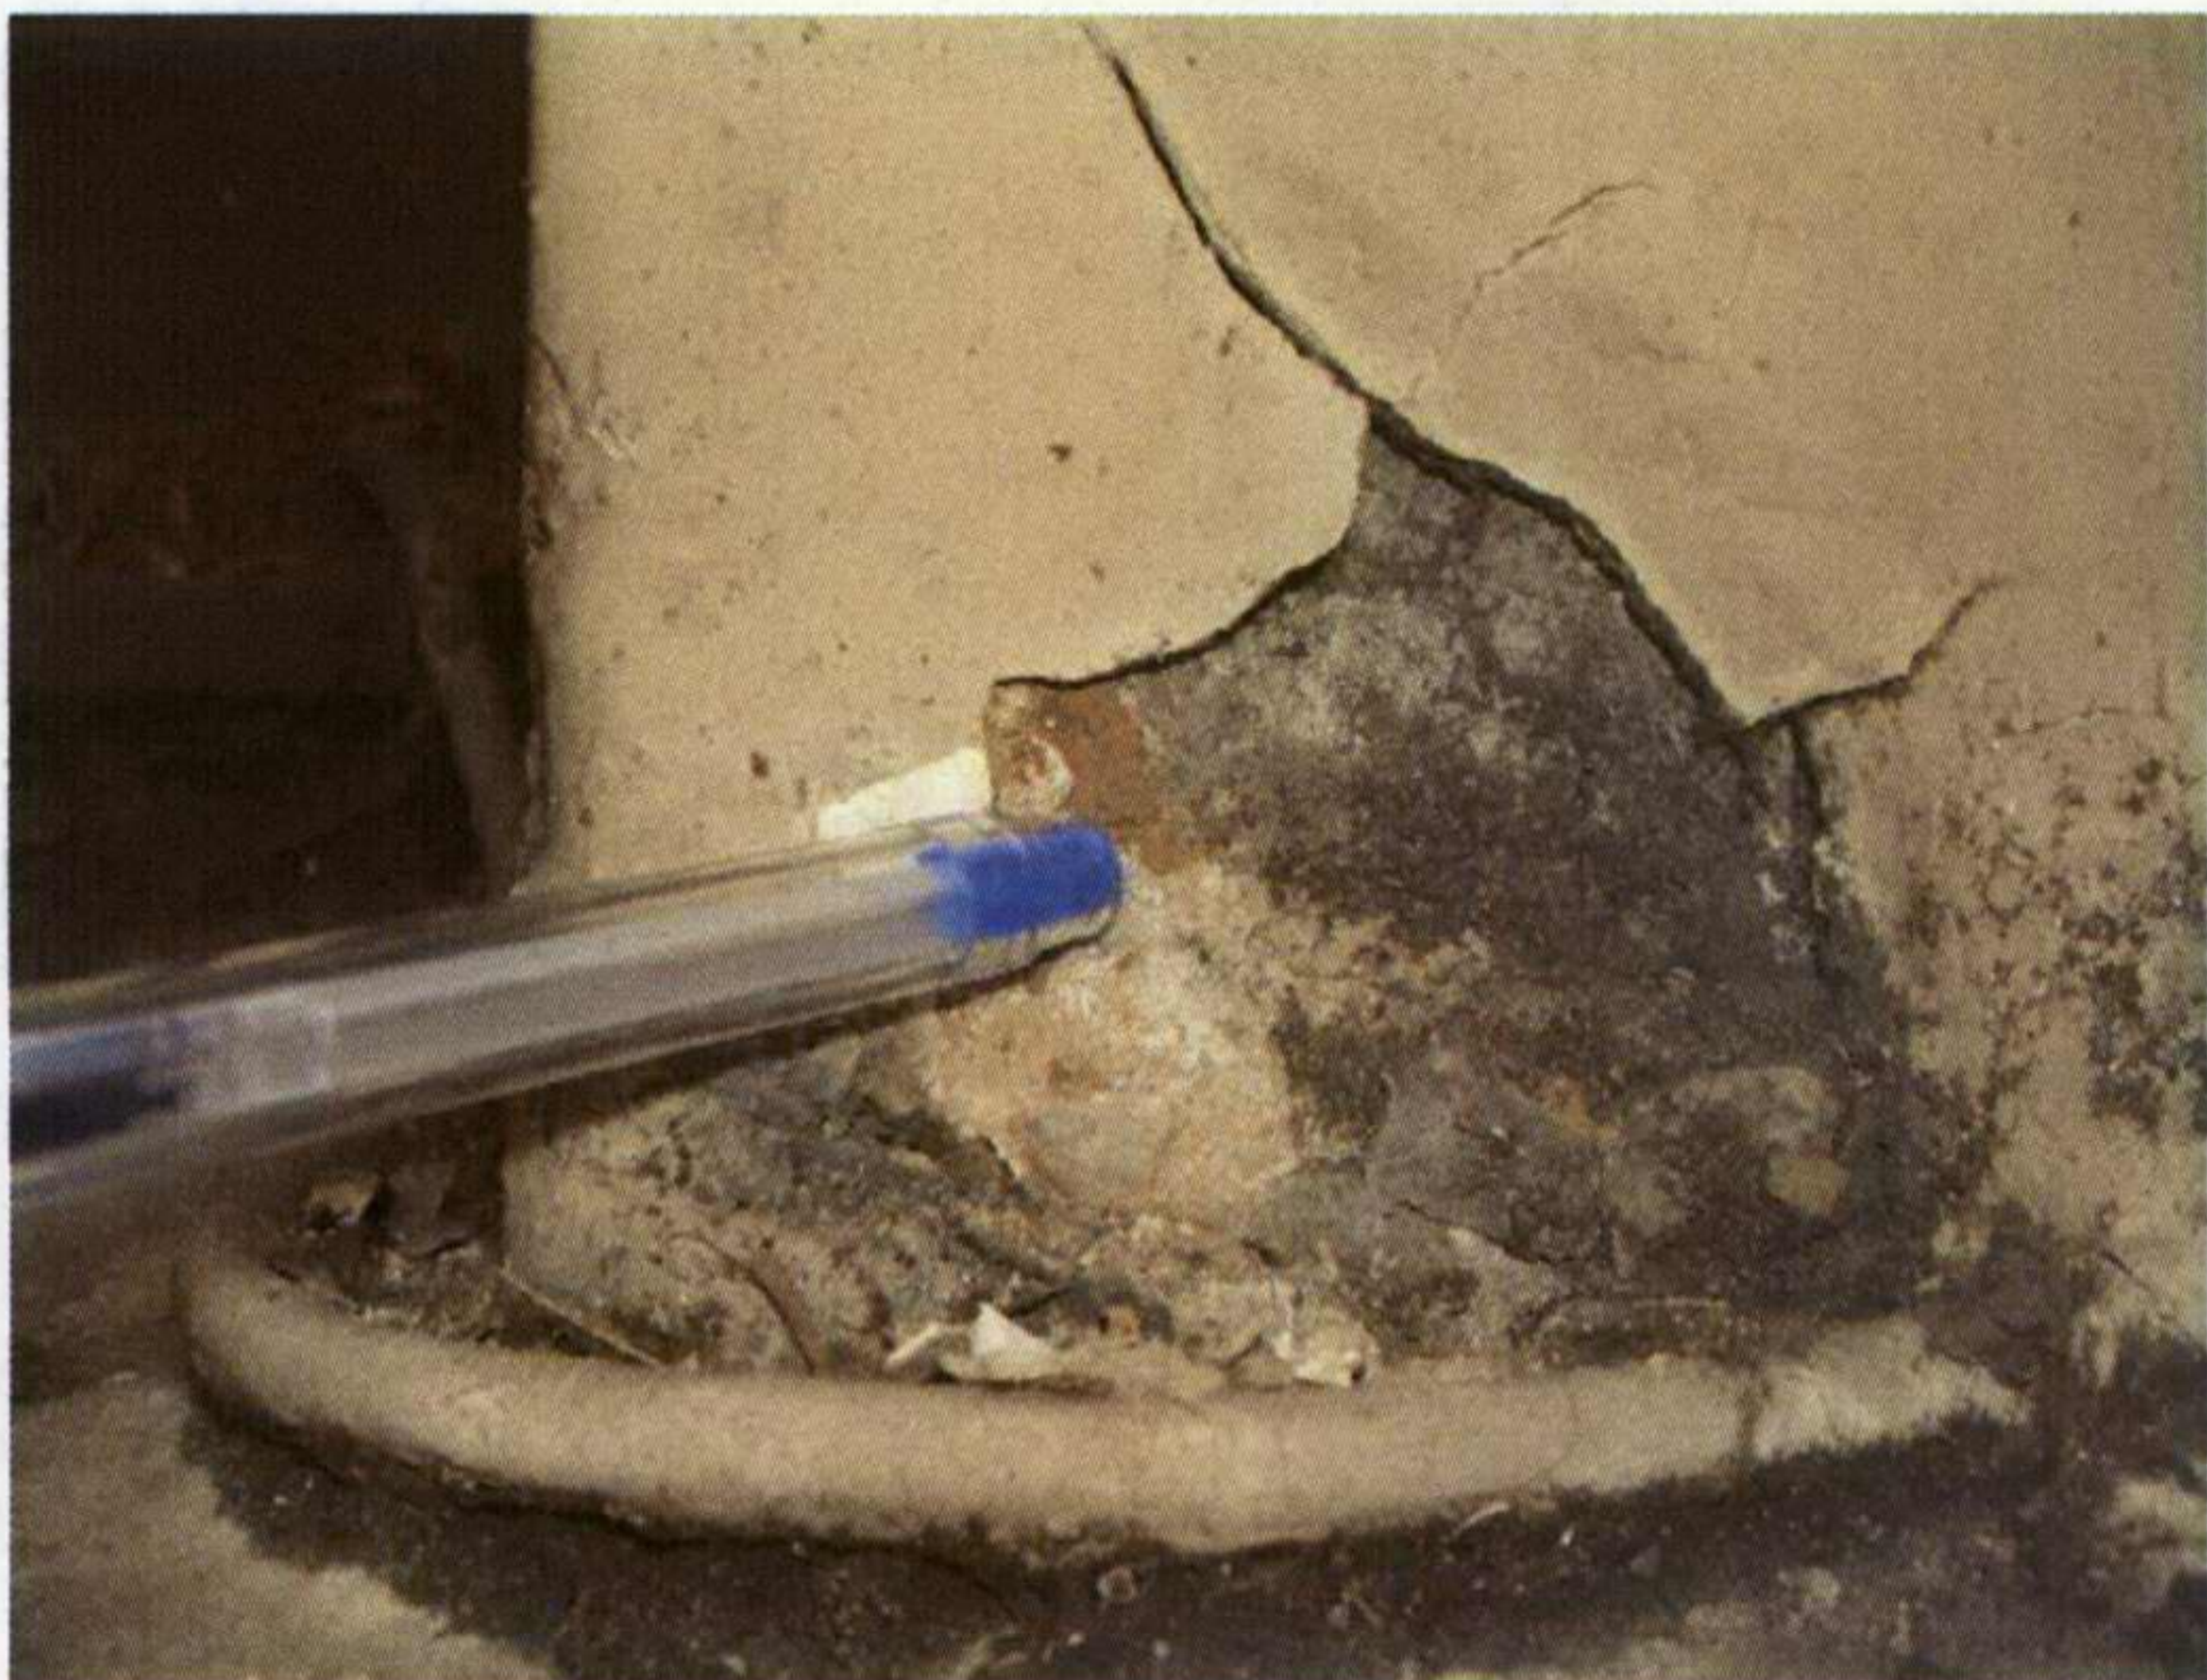
- Stresses in the surface tension of the newer paint films, which have caused a shrinking of the under layers causing these to become detached from the original stucco. This has been responsible for the forming of horizontal and crazy paving type cracks in the front elevation with the curling up of the paint film especially in the lower layers of Ashlar in the columns.
- Mechanical abrasion: particularly visible at low level and in the vicinity of the doorway.

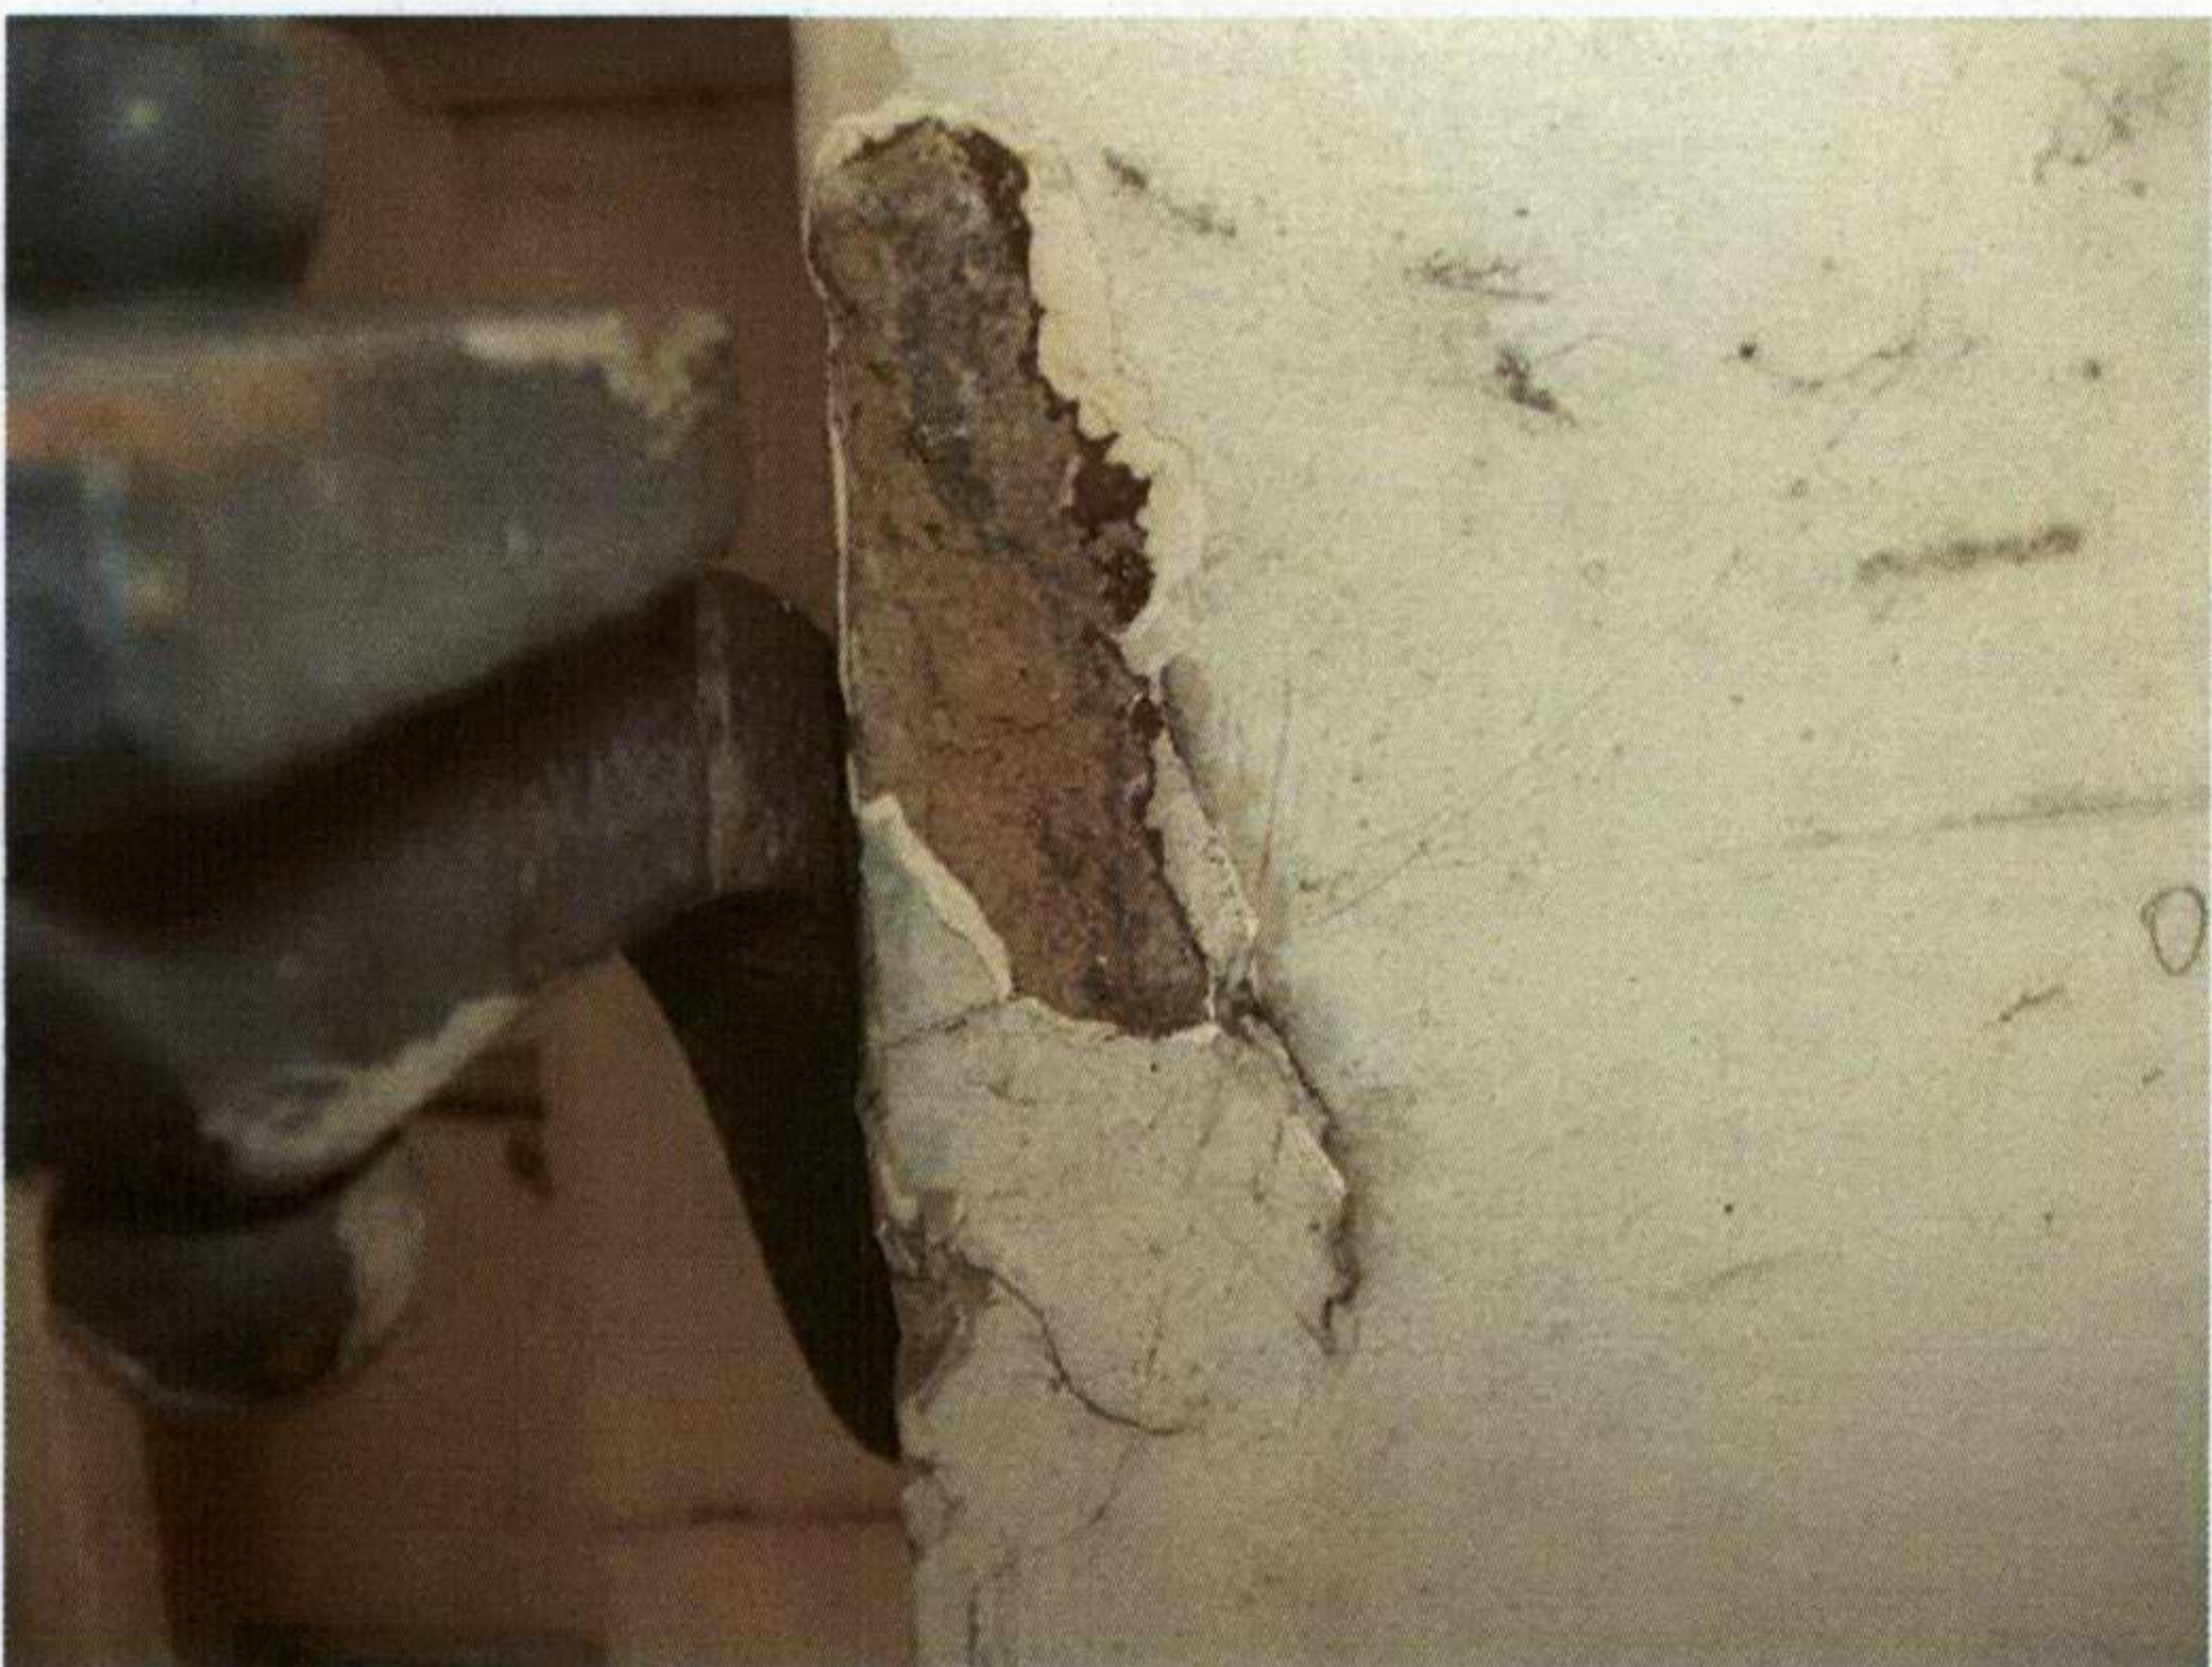
- Dampness evaporating from the ground: this is affecting the paintwork in the lower part of the property all the way along, and causing failure of the paint film to the column bases and lower drip courses.

In the light of this, and in the observation that the main weathering details and columns are primarily adversely affected, although the rusticated Ashlar work less so, we could justify the removal of the paint film in its entirety and to this end we have taken scrapes to analyse the paint layers to establish the nature of the original paint film and its colour. We refer you to the appendix relating to colour attached to this report.

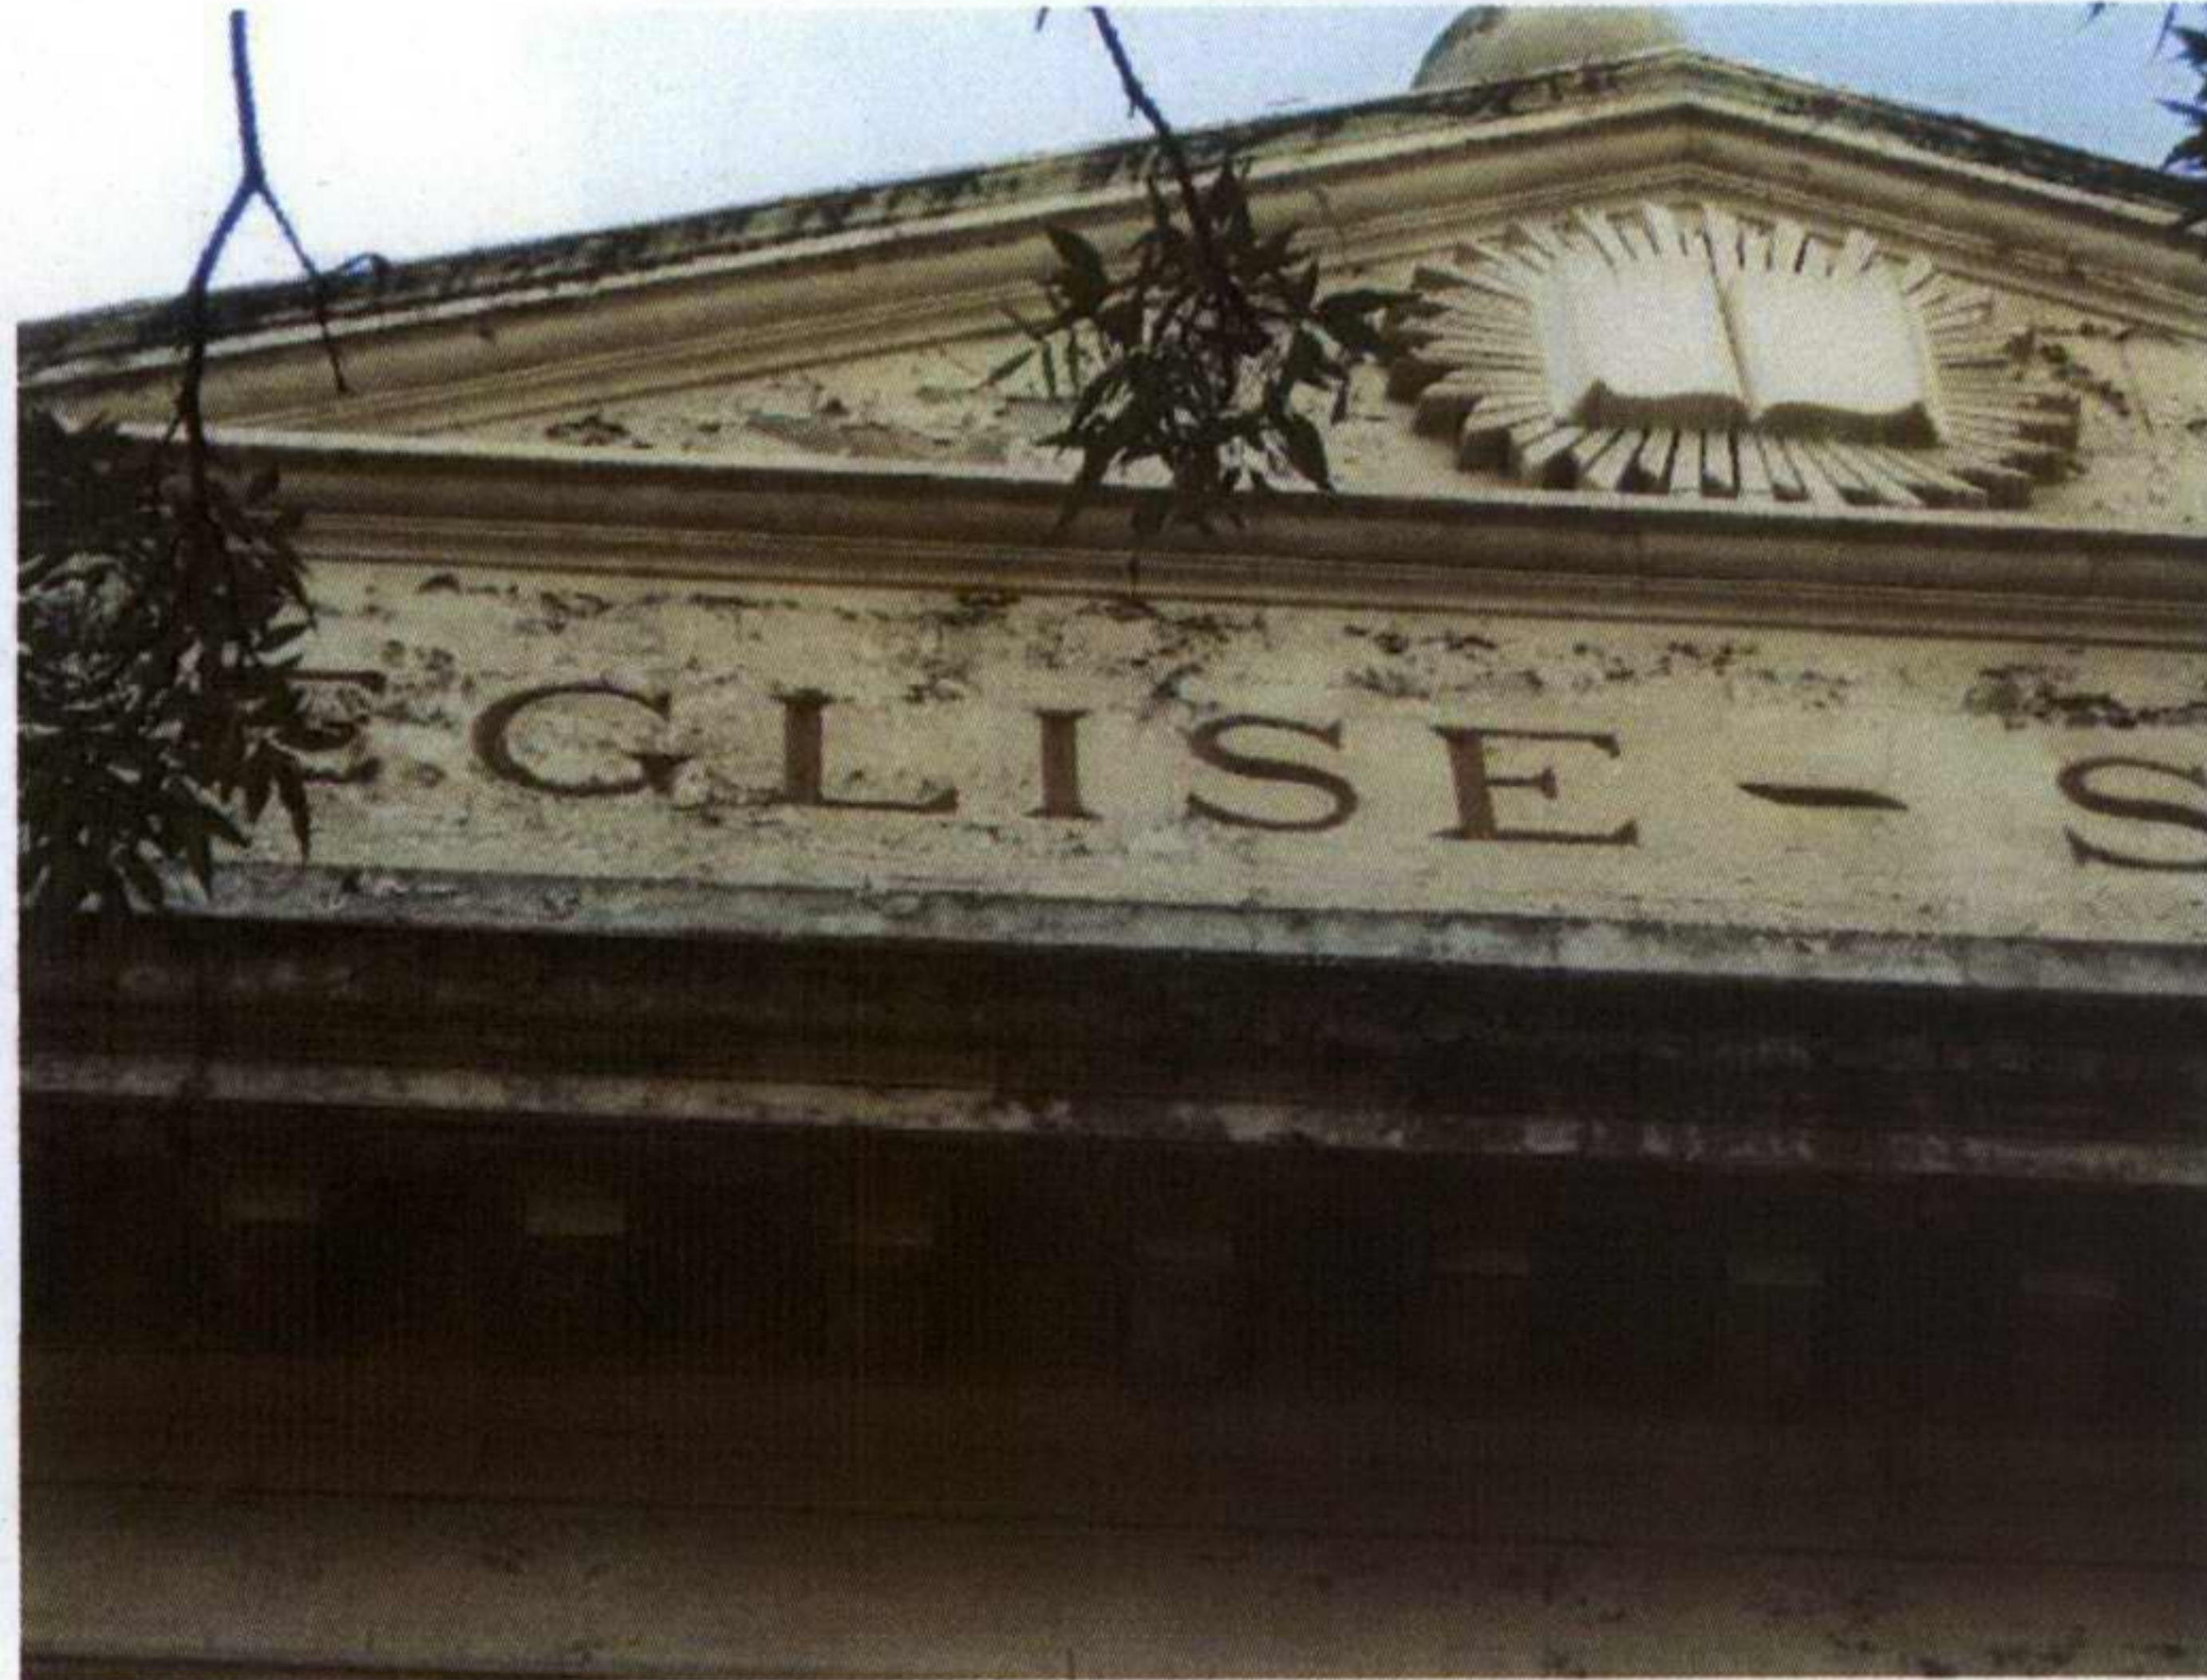
- **Lower frieze in the form of waves:** there are several bricks in the drip course over the left hand ground floor window, and similarly to a lesser extent over the right hand ground floor window. These both affect the rusticated Ashlar work. These should be wedged and filled.

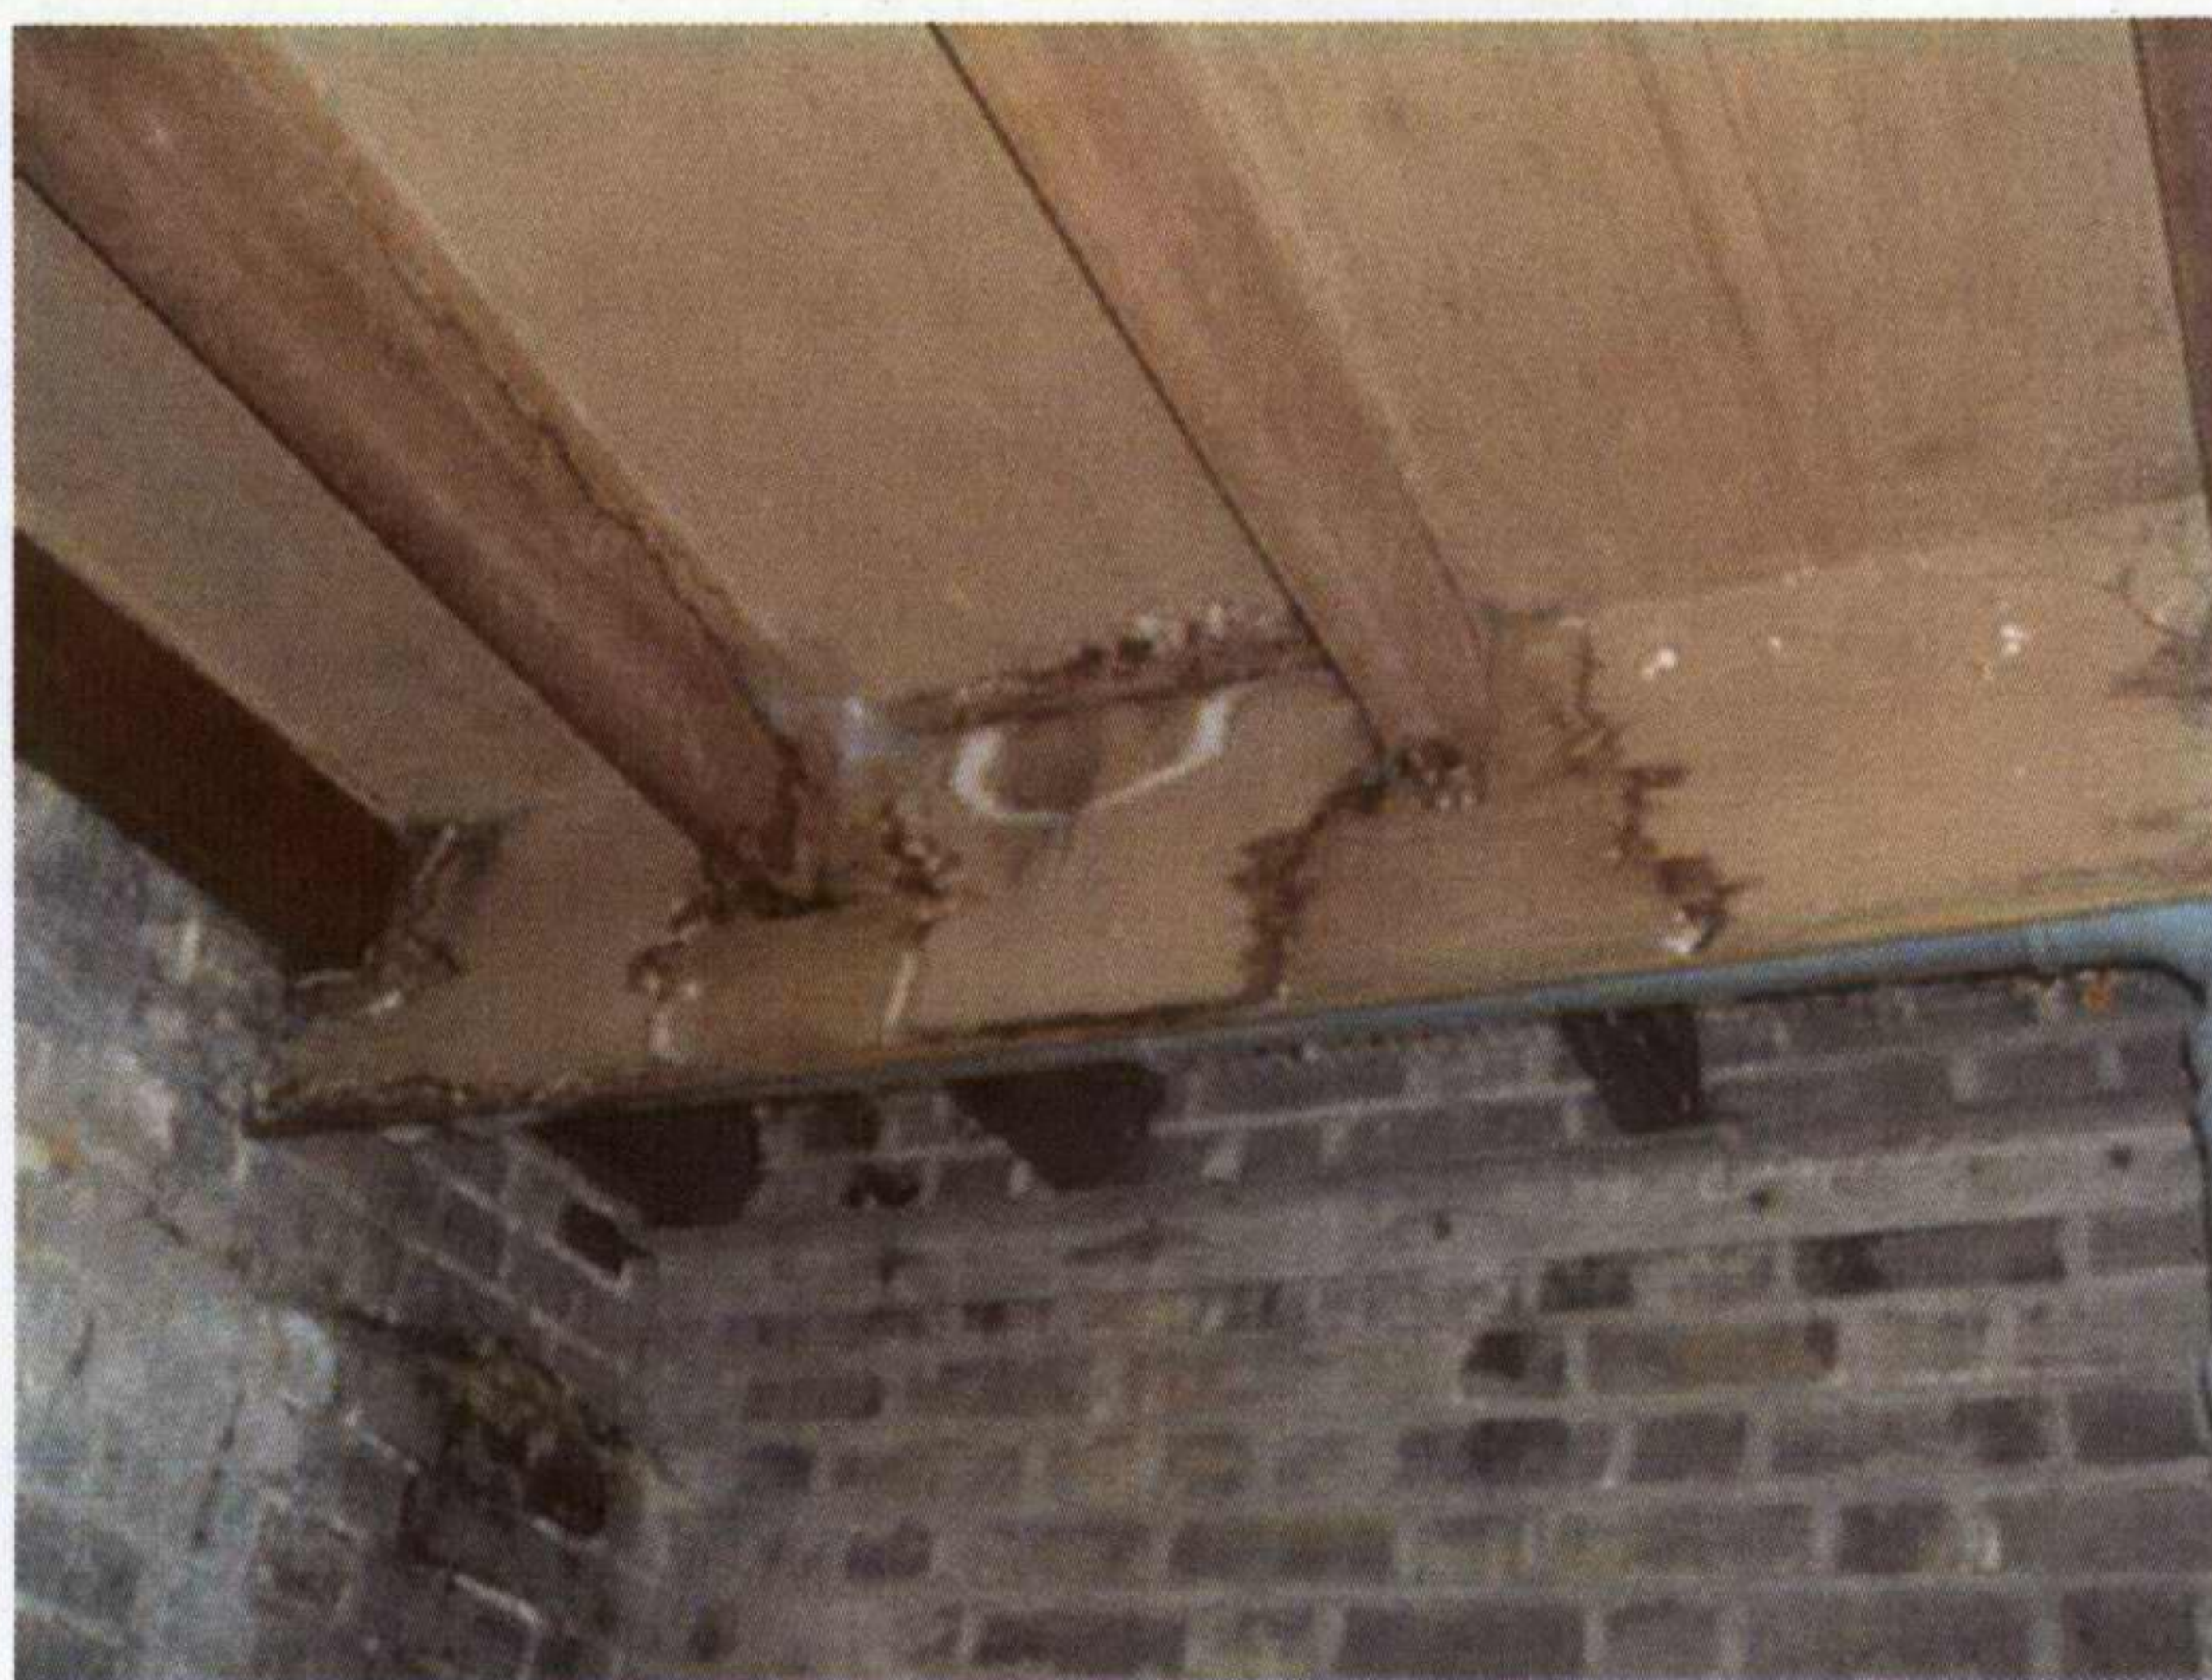
5.3 **Ground floor store/vestry:** a composition style floor with a vinyl finish, with plastered walls and a plastered ceiling, with no defects noted. There was very minor damage noted at the low level of the floor due to impact and abrasion and minor repairs are required, and evidence of old water penetration from roof above.

Repair walling
