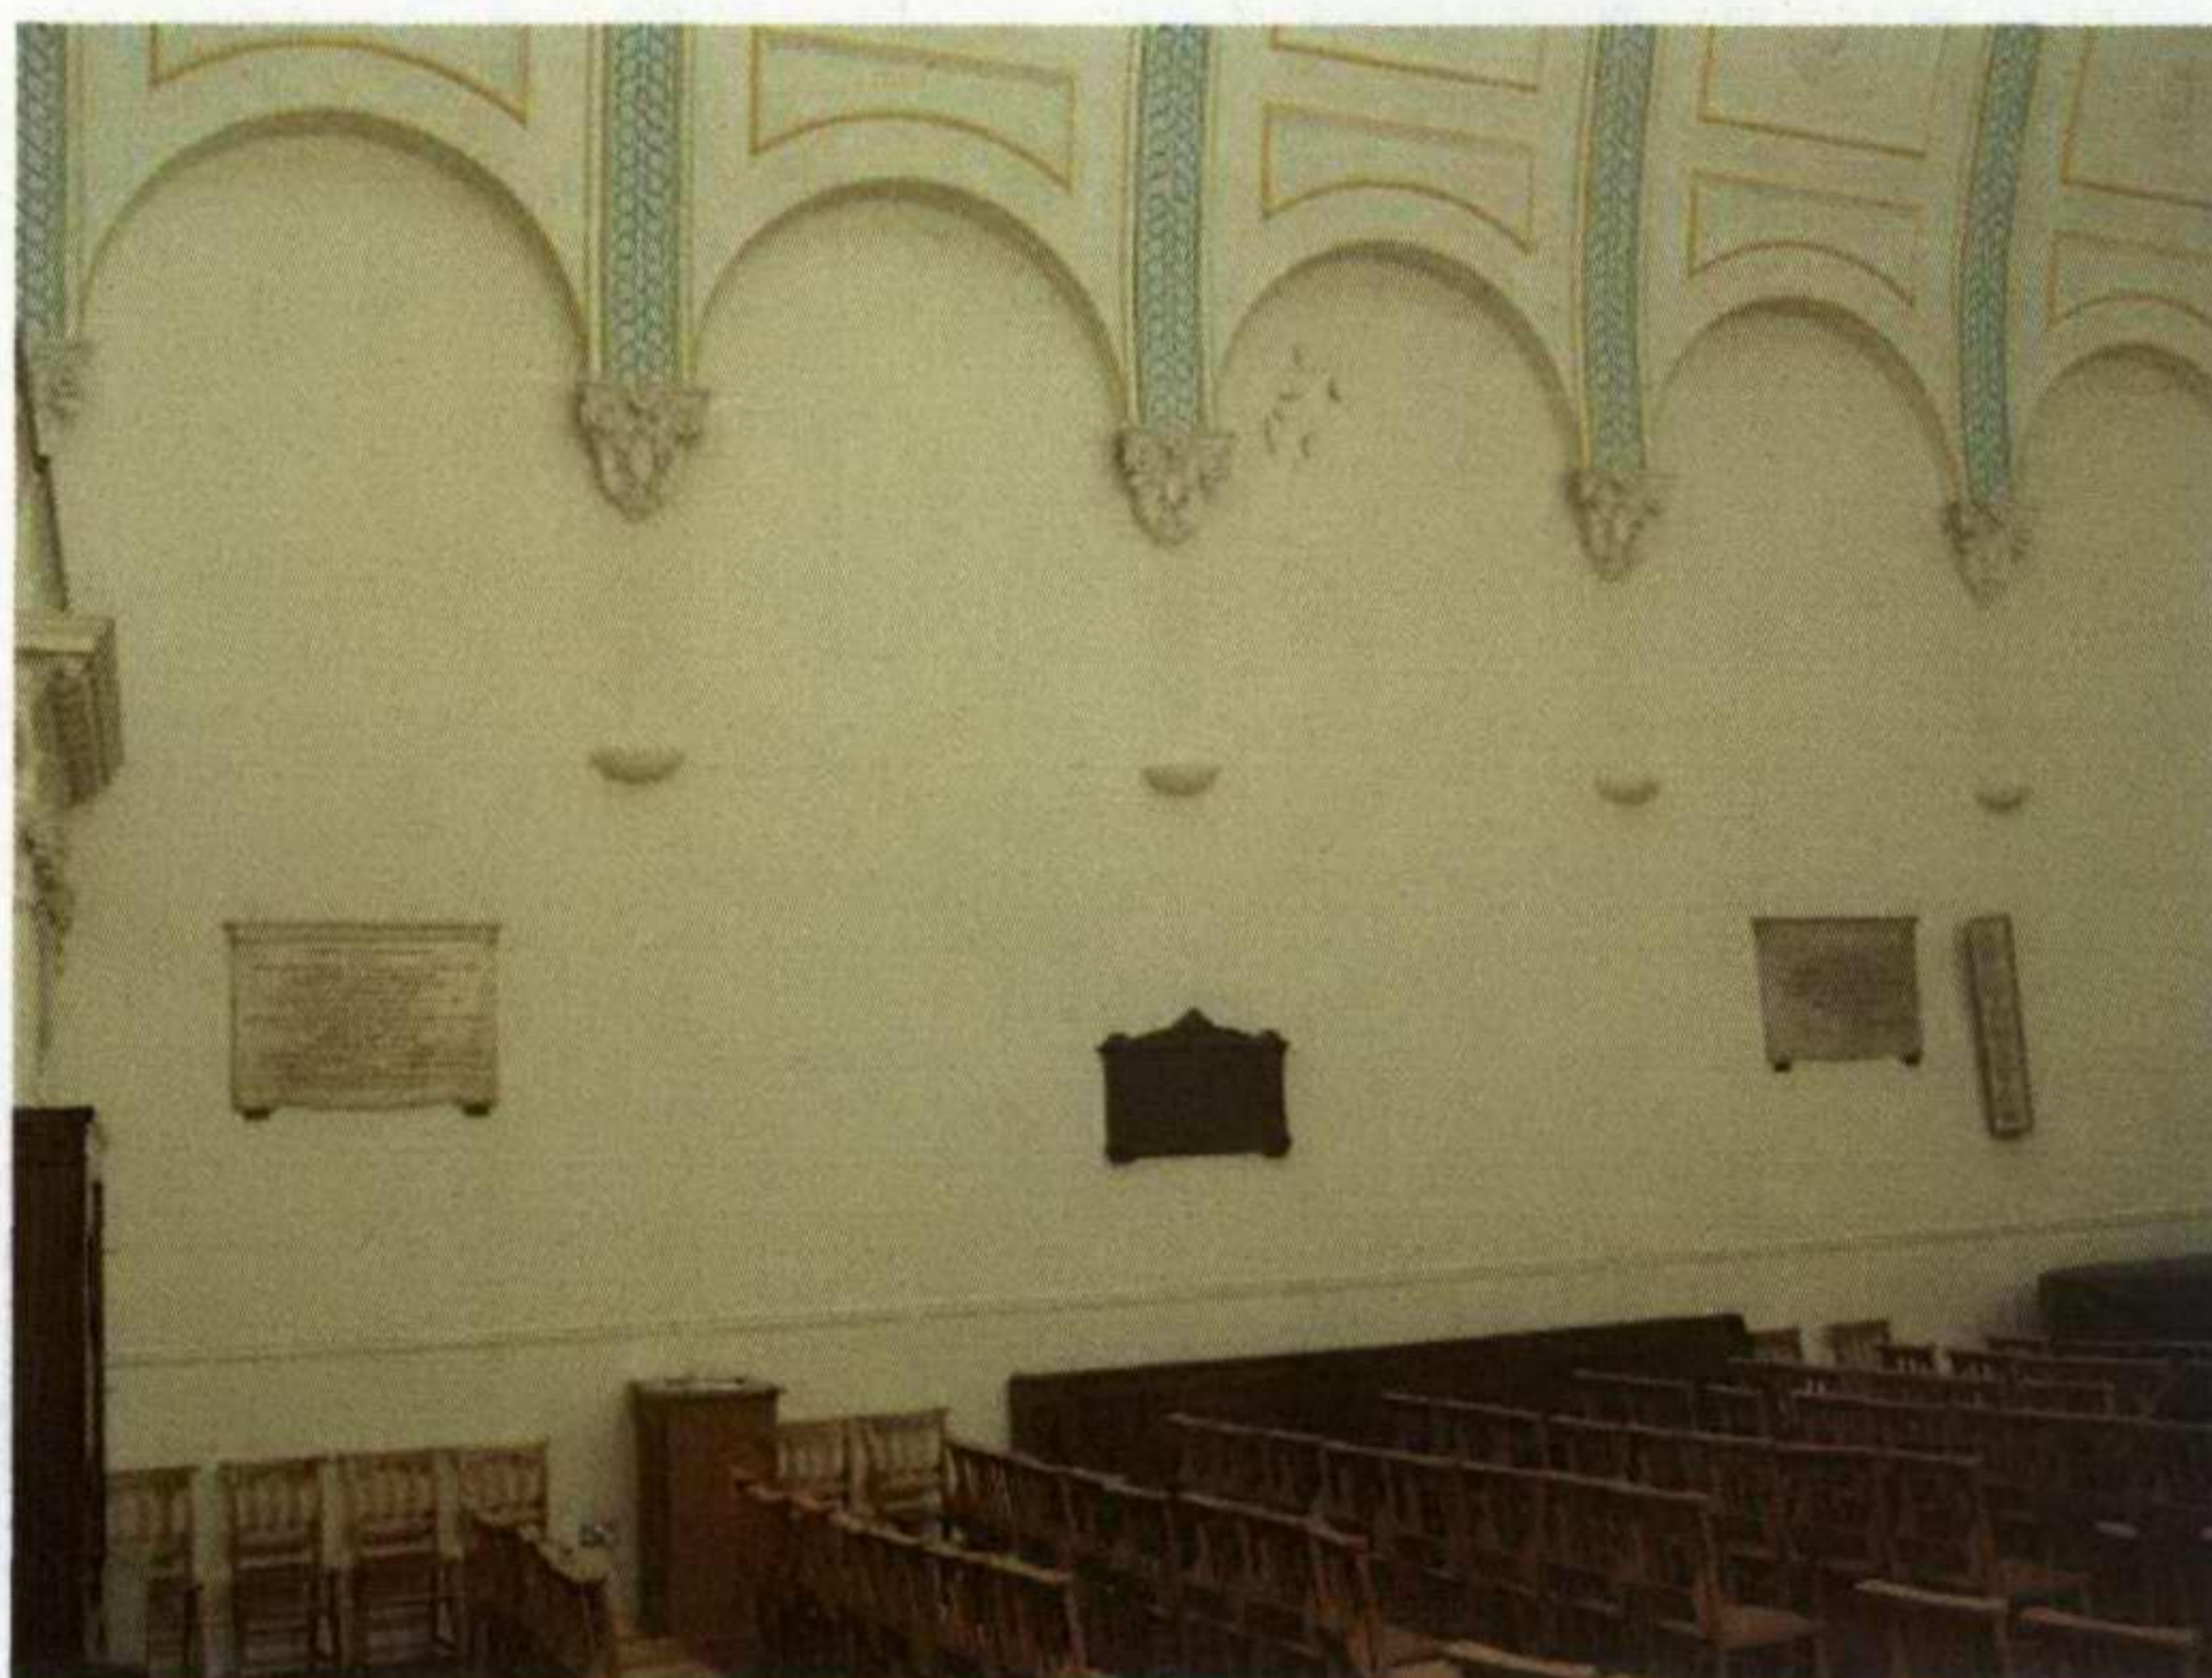
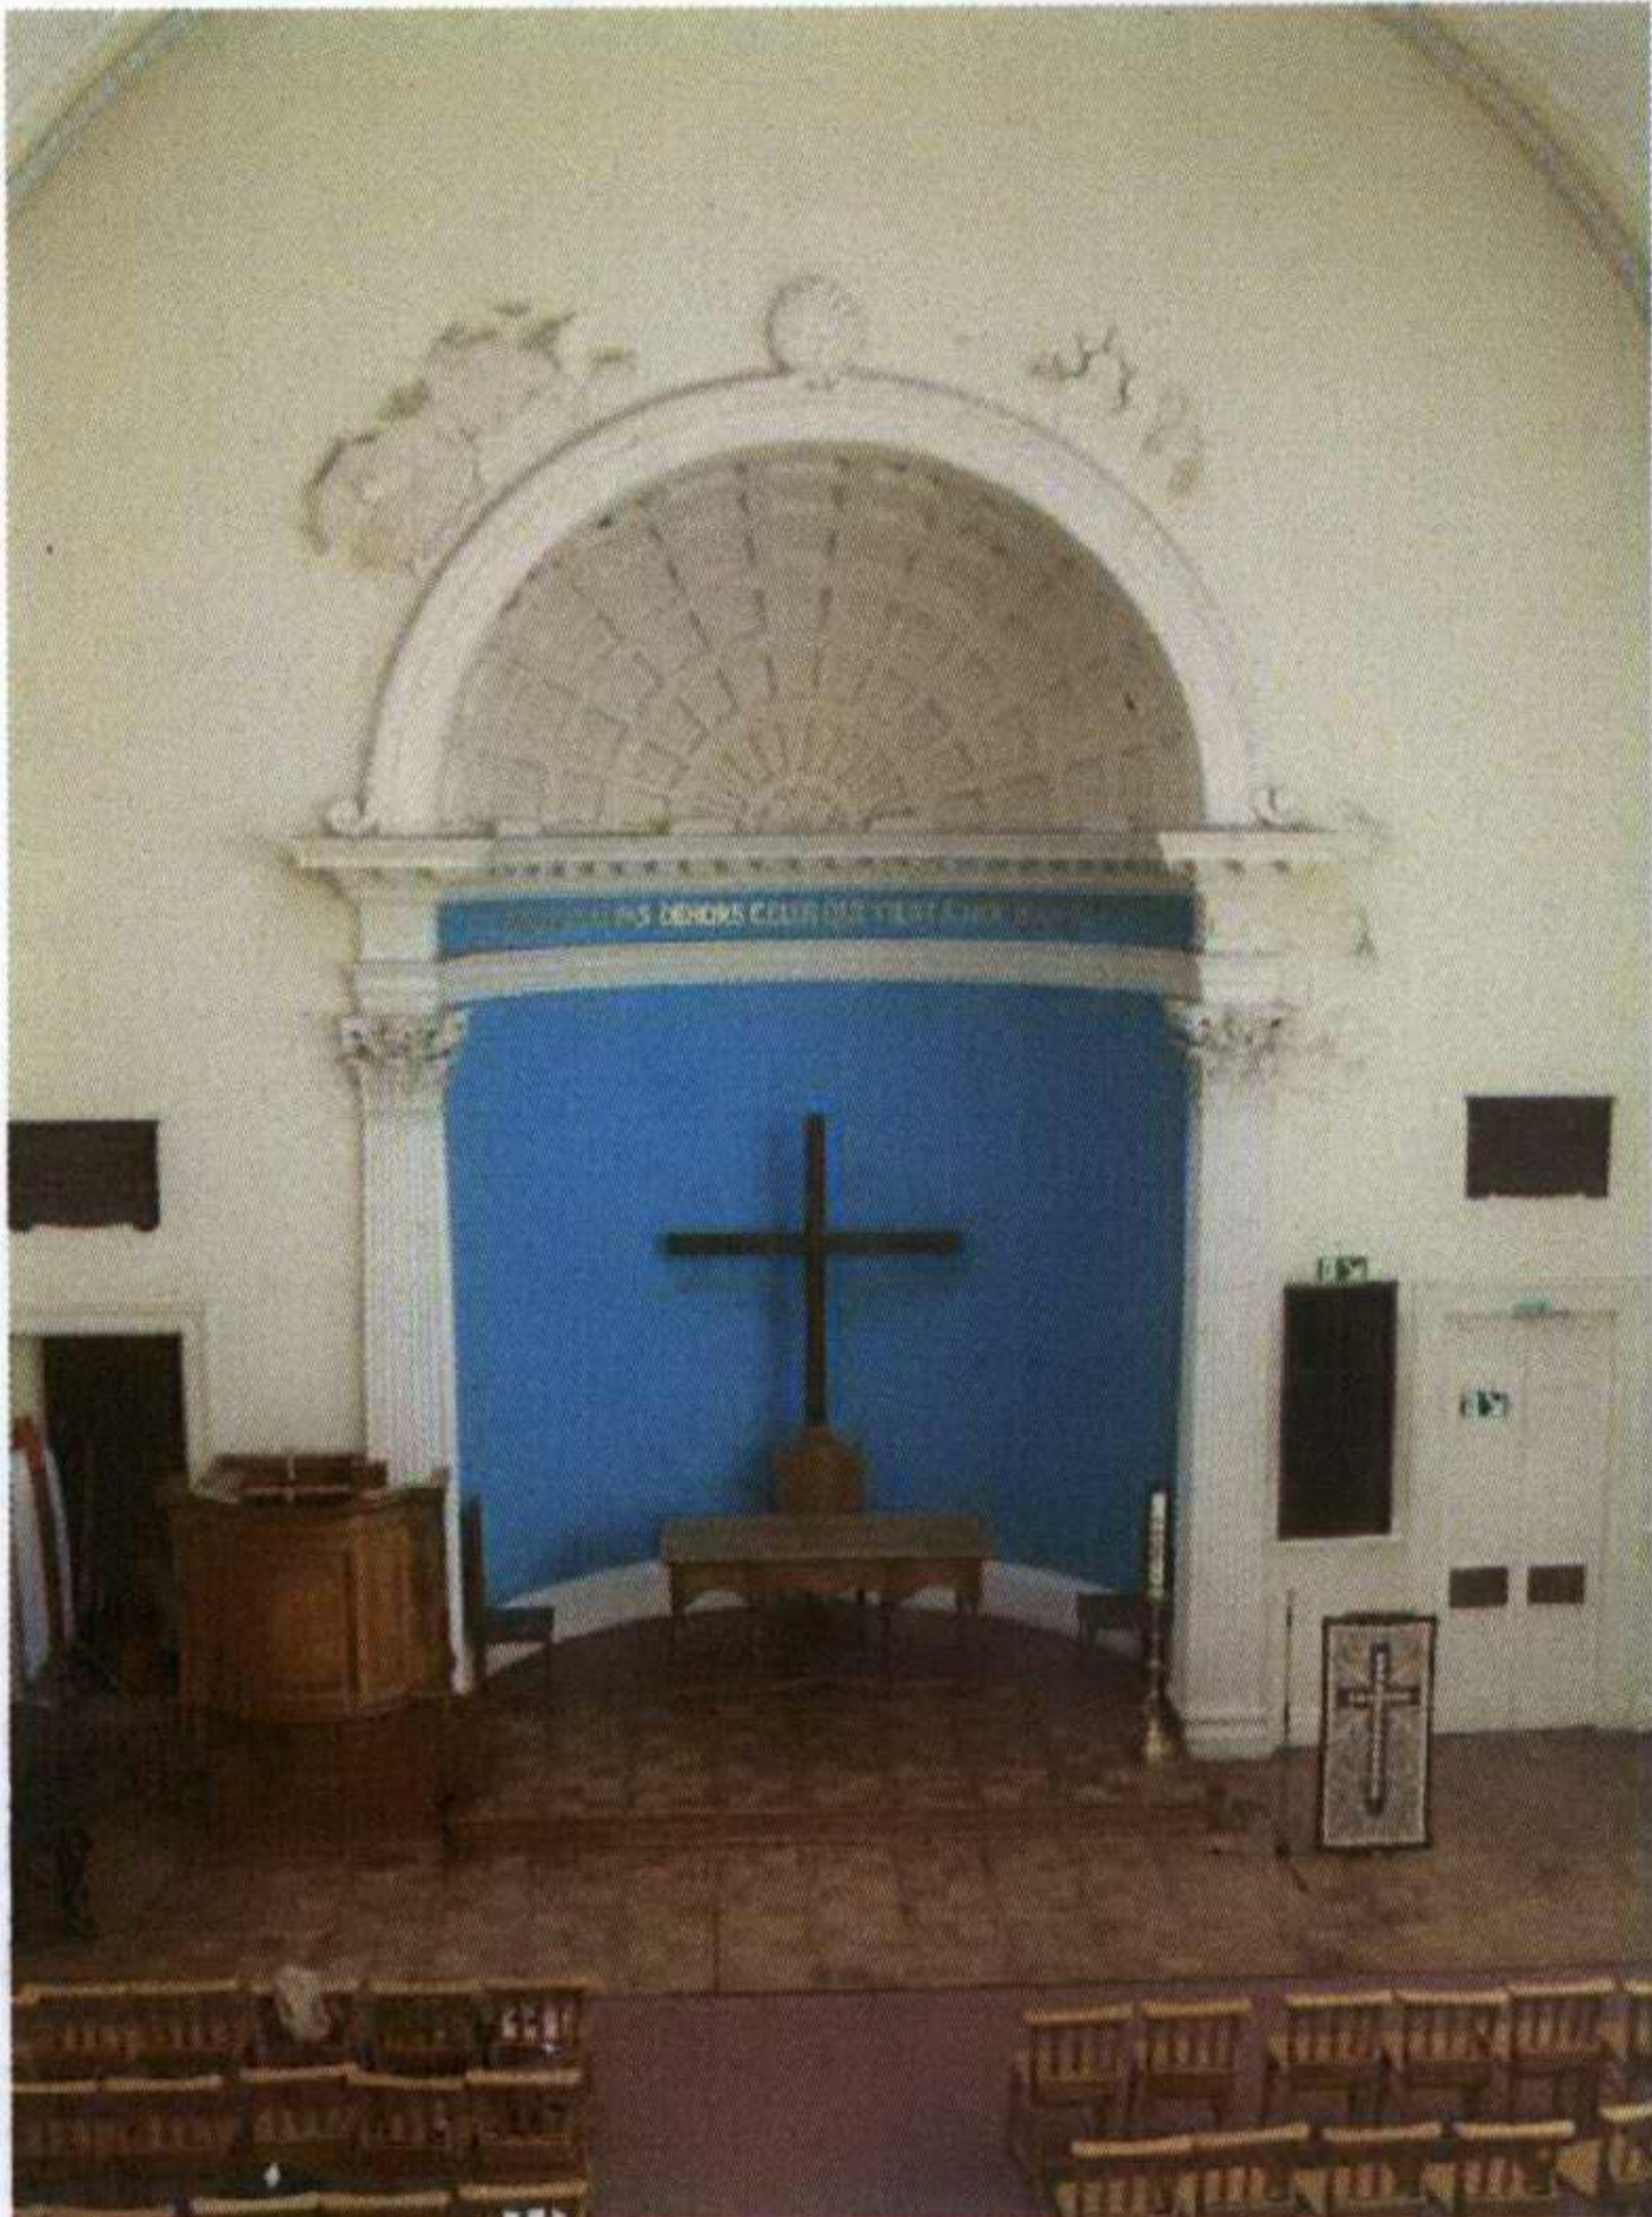
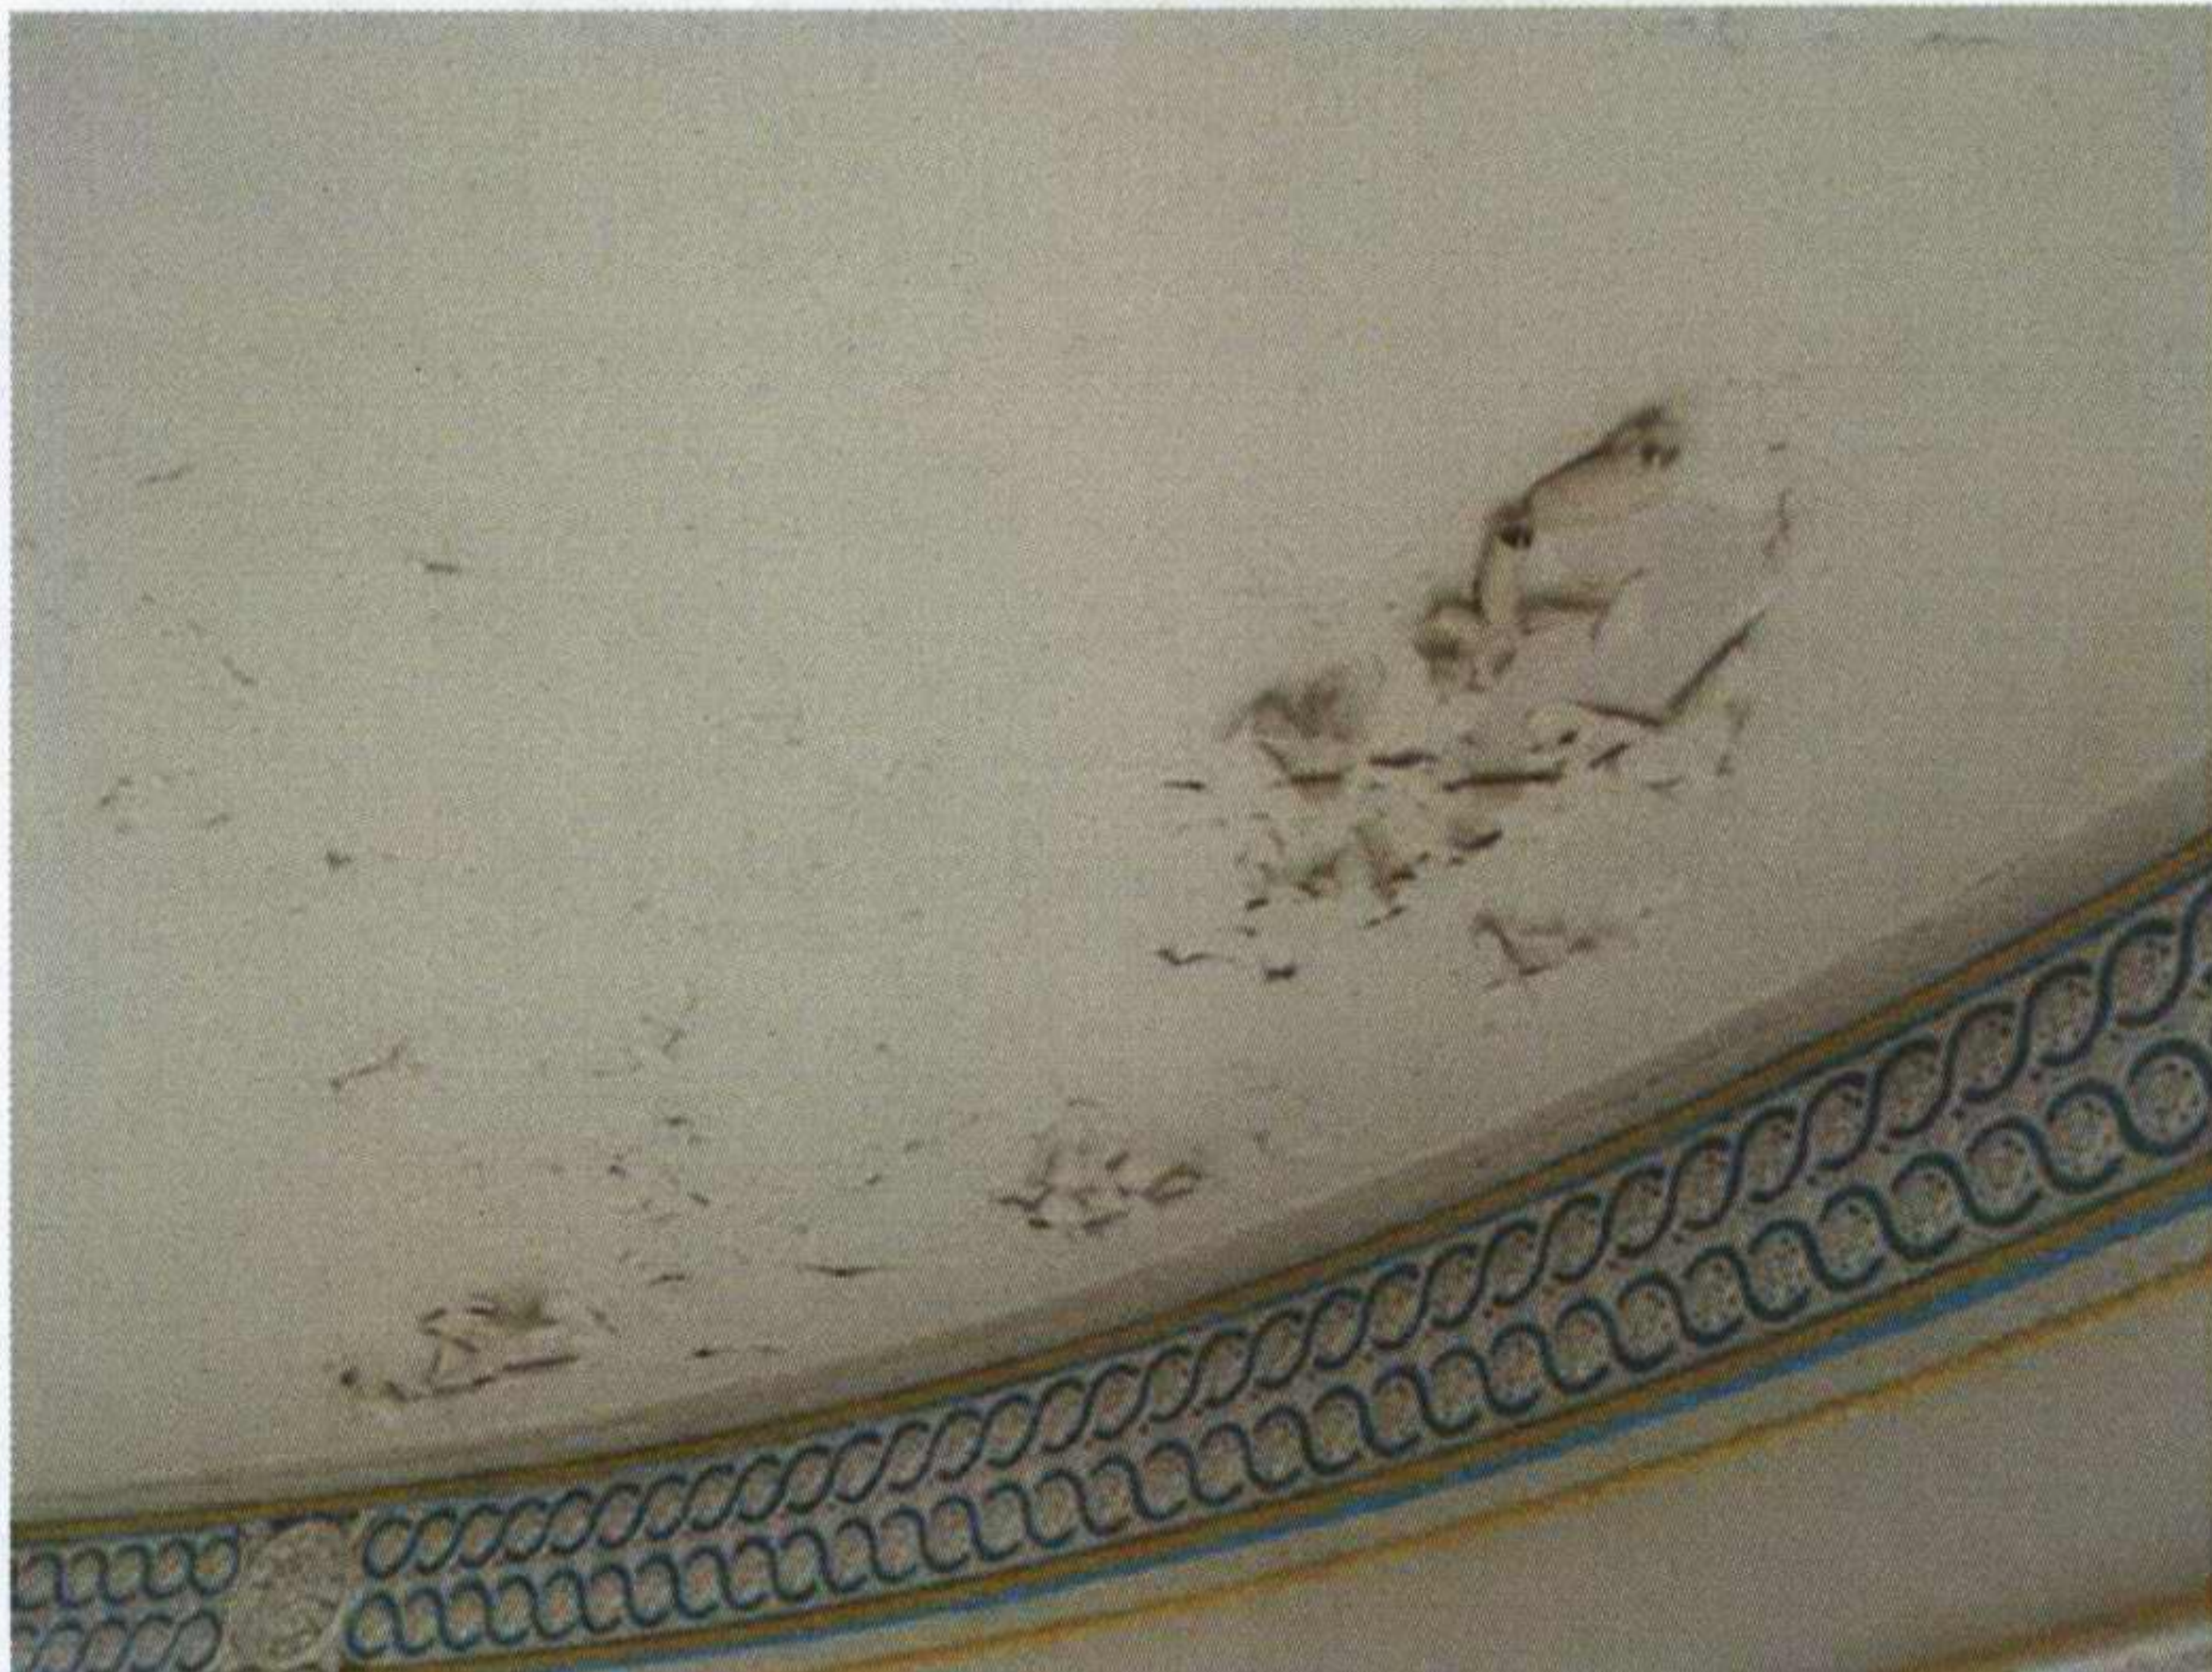
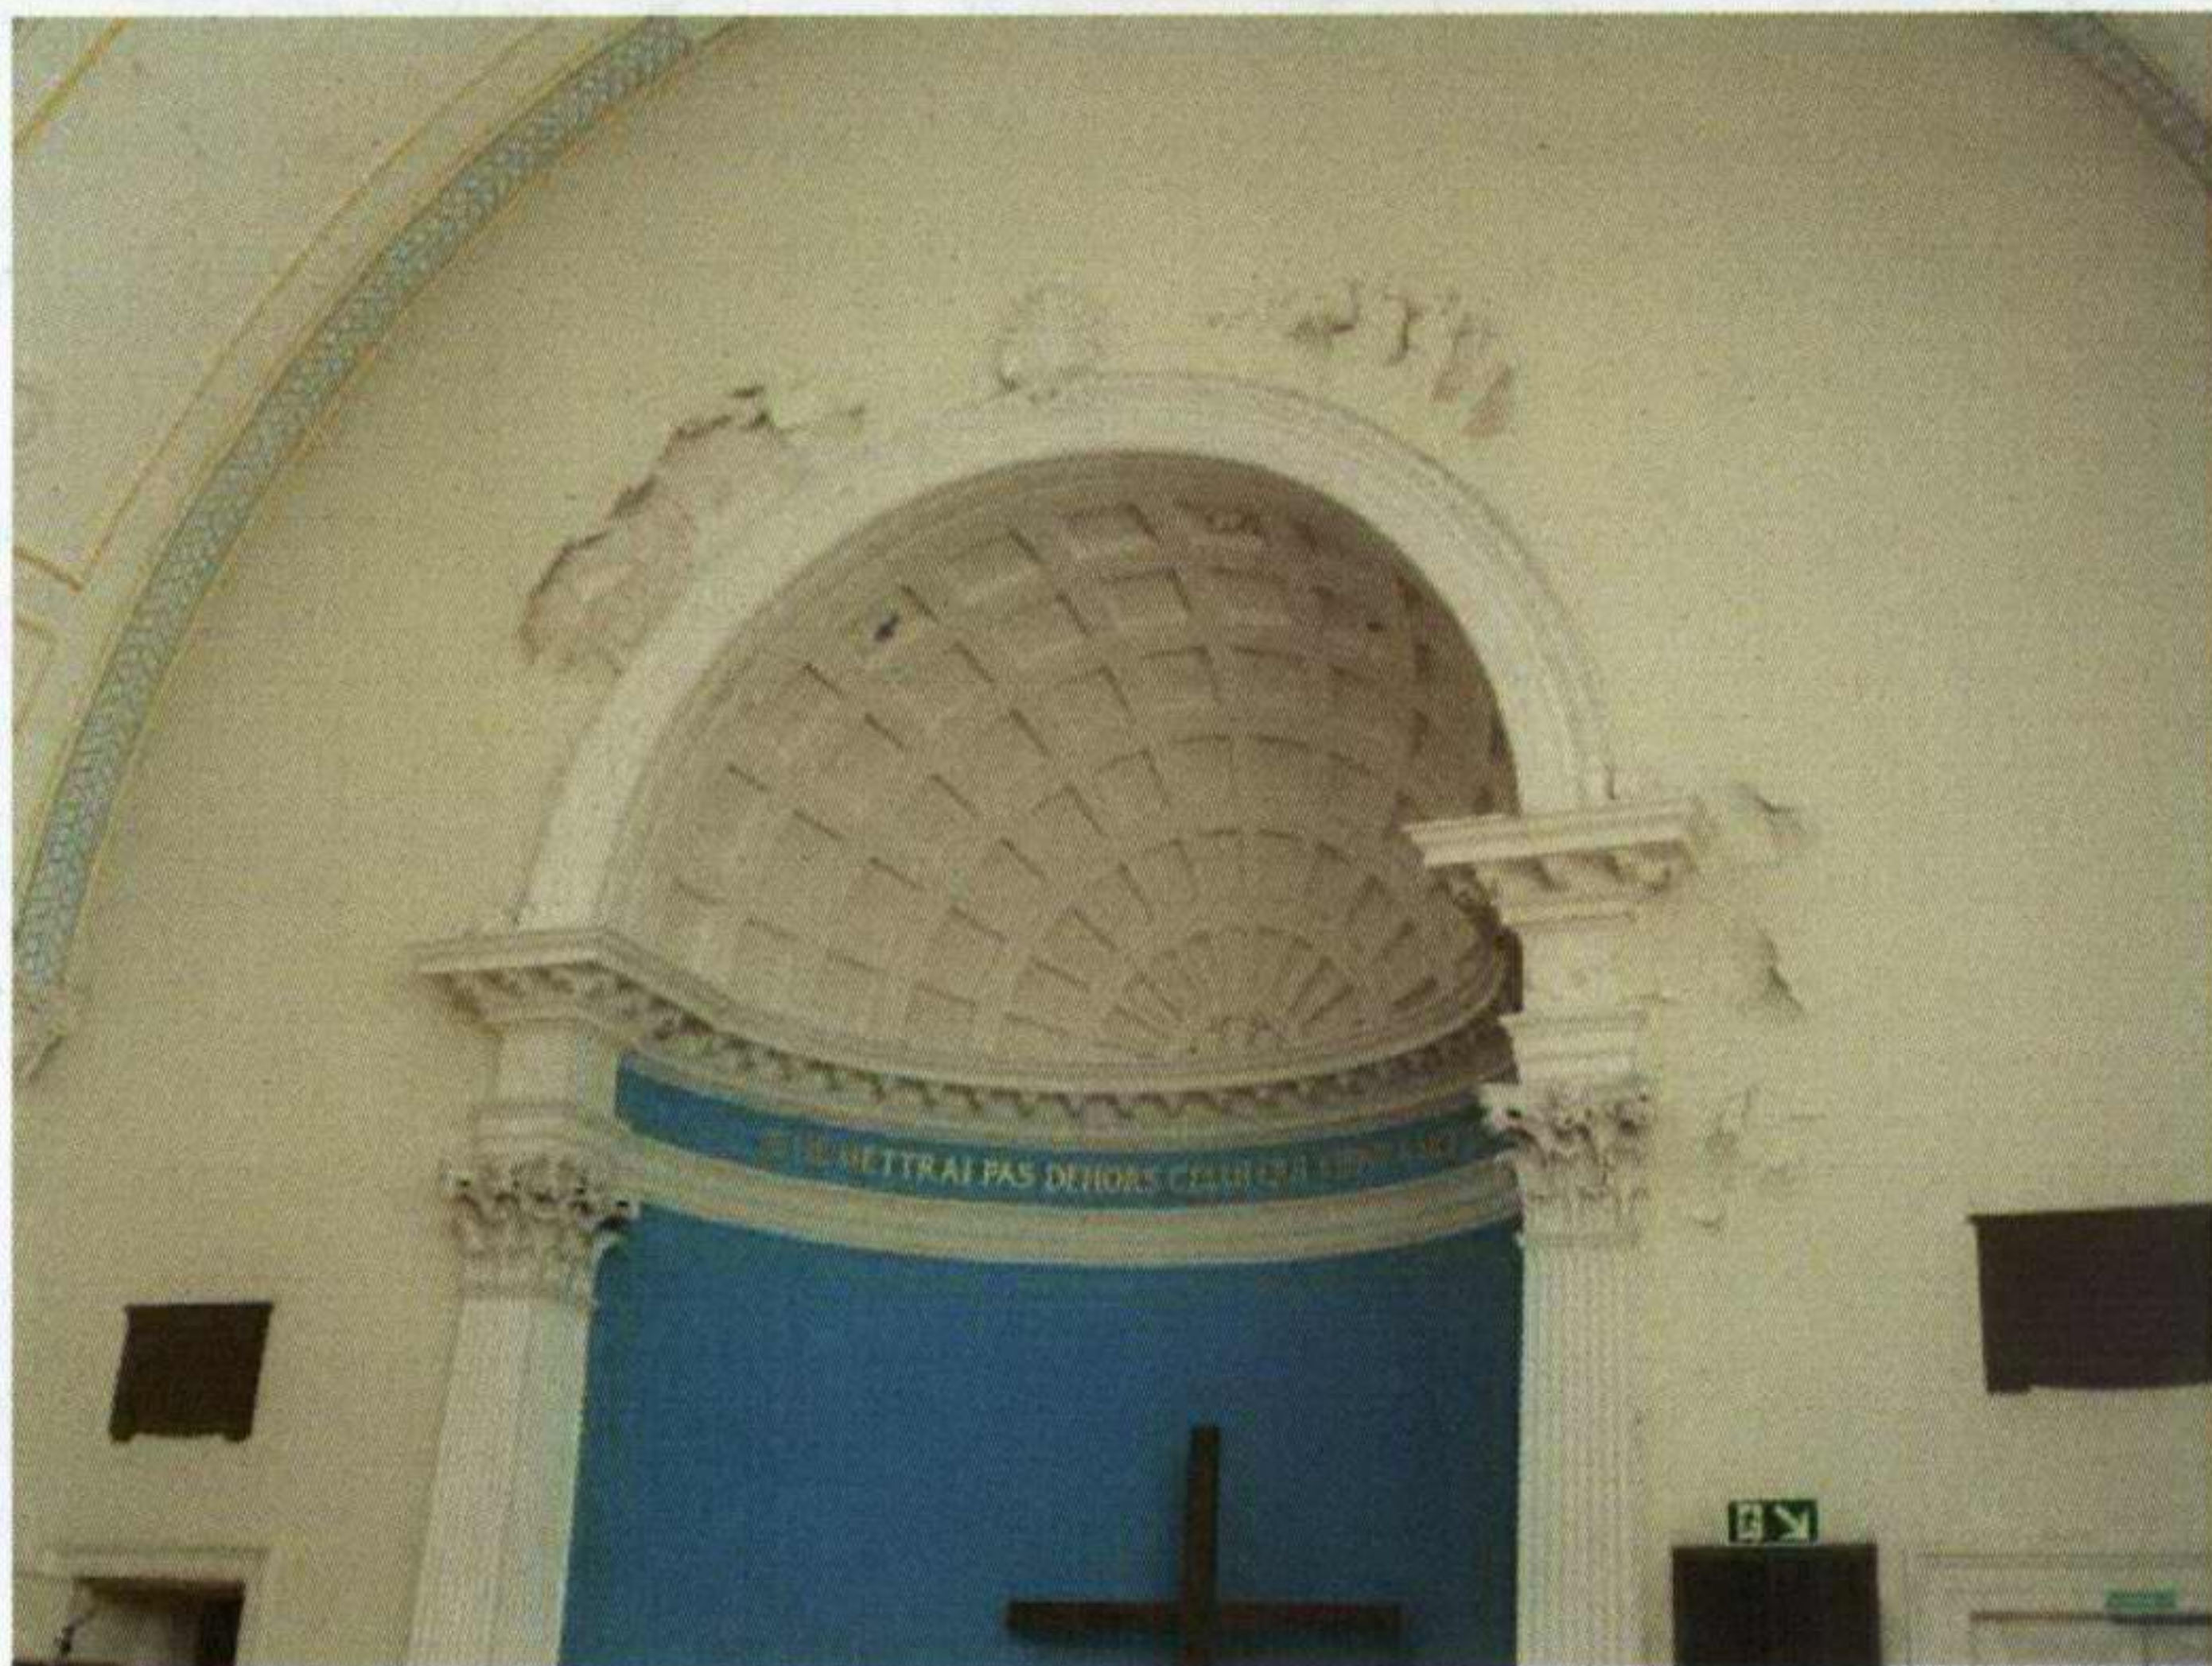
- 5.14 **Walling:** plastered and painted, with several overlapping series of cracks indicating failings to the plaster and to the paint finish visible on both sides. An initial analysis of the fracturing would seem to suggest incompatibility between the later paint finish and the original paint finish. We note that there is also a strong correlation between the incompatibility and defects present or past noted in the weatherings to the roof finish. On the north wall, paint is coming off in curls, with the pattern changing in the vicinity of the original inscription, which was presumably undertaken in oil based paints. At low level there is a different series of fractures in the paint film, and in the areas of this

paint failure, there is a general pattern of fine shrinkage cracks which could indicate either shrinkage in the original plaster due to drying shrinkage, or an incompatibility between under layers of the paint. We understand that the painting was done twice, with the second layer being redone after the first layer failed. Further specialist advice will need to be obtained to establish the precise nature of the failure, but in our opinion the main issues appear to be:

- Incompatibility of the paint finishes, and perhaps lack of adequate preparation of the original plasterwork. Especially in the apse and at low level in the main worship area.
- High humidity levels within the building (there is virtually no air movement other than that caused by the warm air central heating system when operated). Particularly affecting paintwork at high level over the gallery and in the apse.
- Presence of hygroscopic salts in the plaster following prolonged water penetration. This is particularly noticeable in the north wall.

In our opinion, all removal of the existing paint film will be required, including the paint film to the decorative plaster surfaces. This would be best undertaken using a poultice treatment, which is laborious but effective. It will then be possible to proceed with redecoration.

Remove paint film
