The Whitworth Co-Partnership  
18 Hatter Street  
Bury St Edmunds  
Suffolk IP33 1NE

## **THE CAREER OF GEORGE JOHN VULLIAMY (1817-1886) AND HOW THE SWISS CHURCH FITS**

### THE SWISS CHURCH

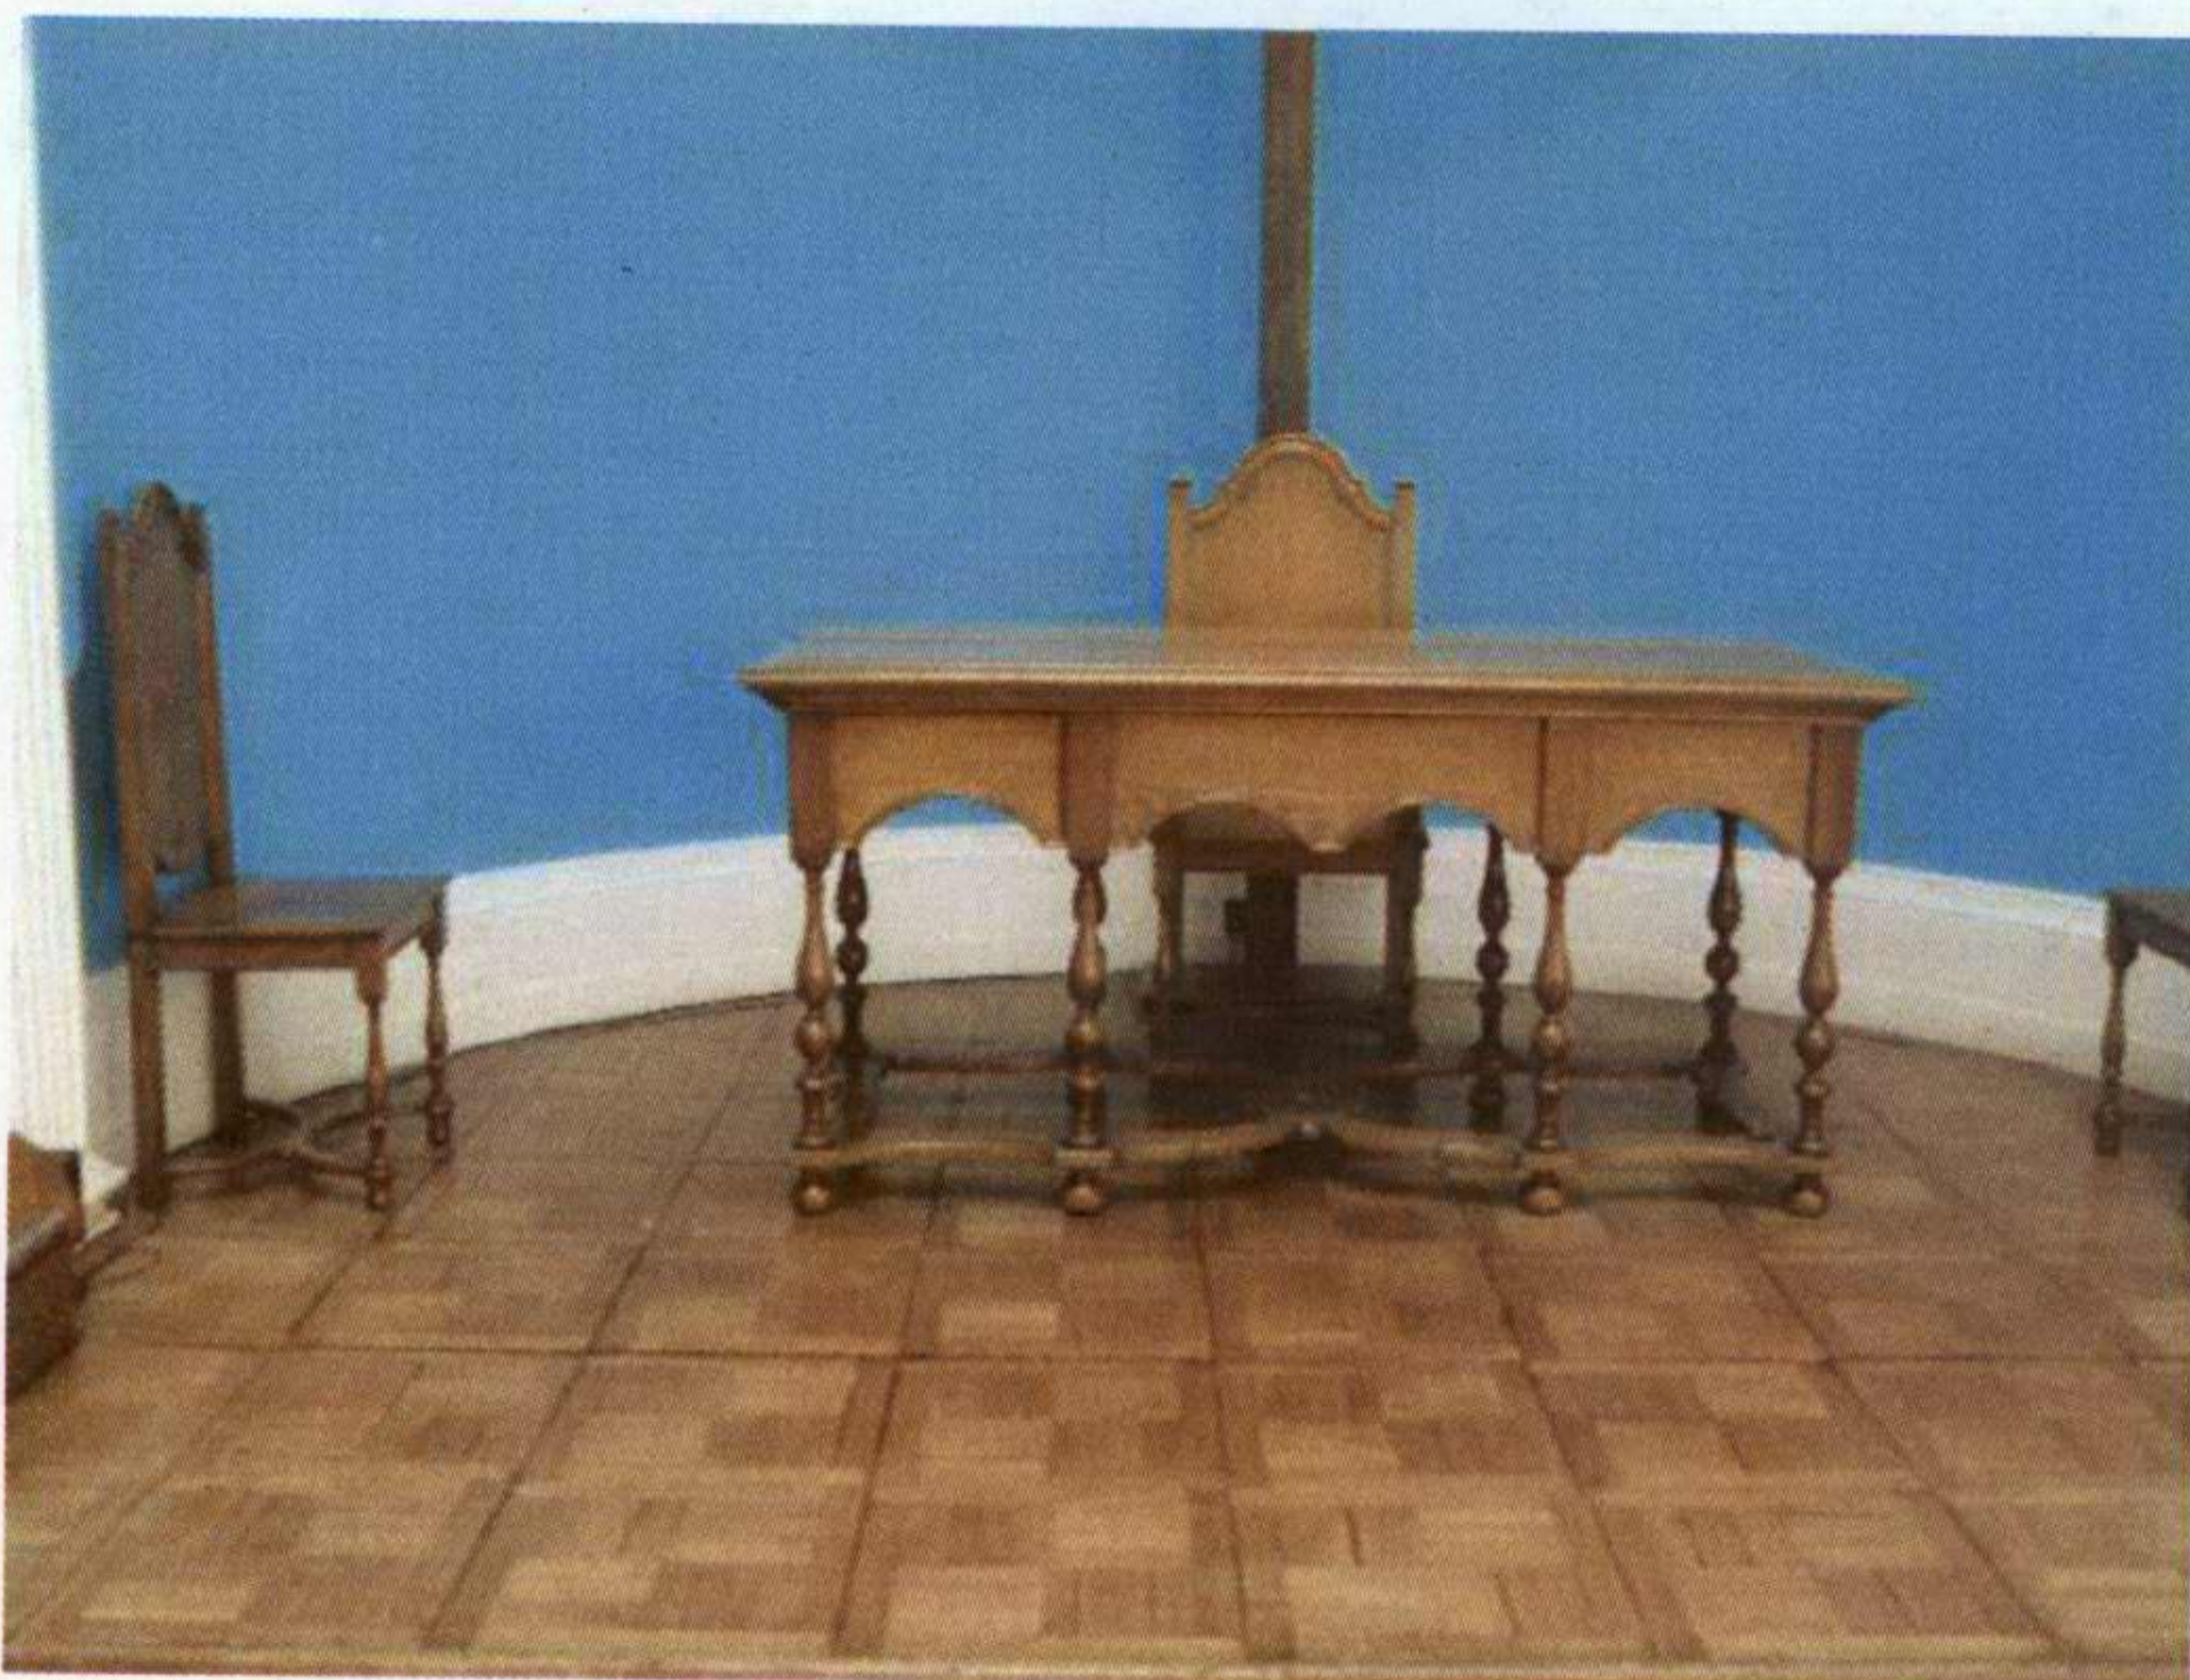
- In the apse: a table with three chairs.

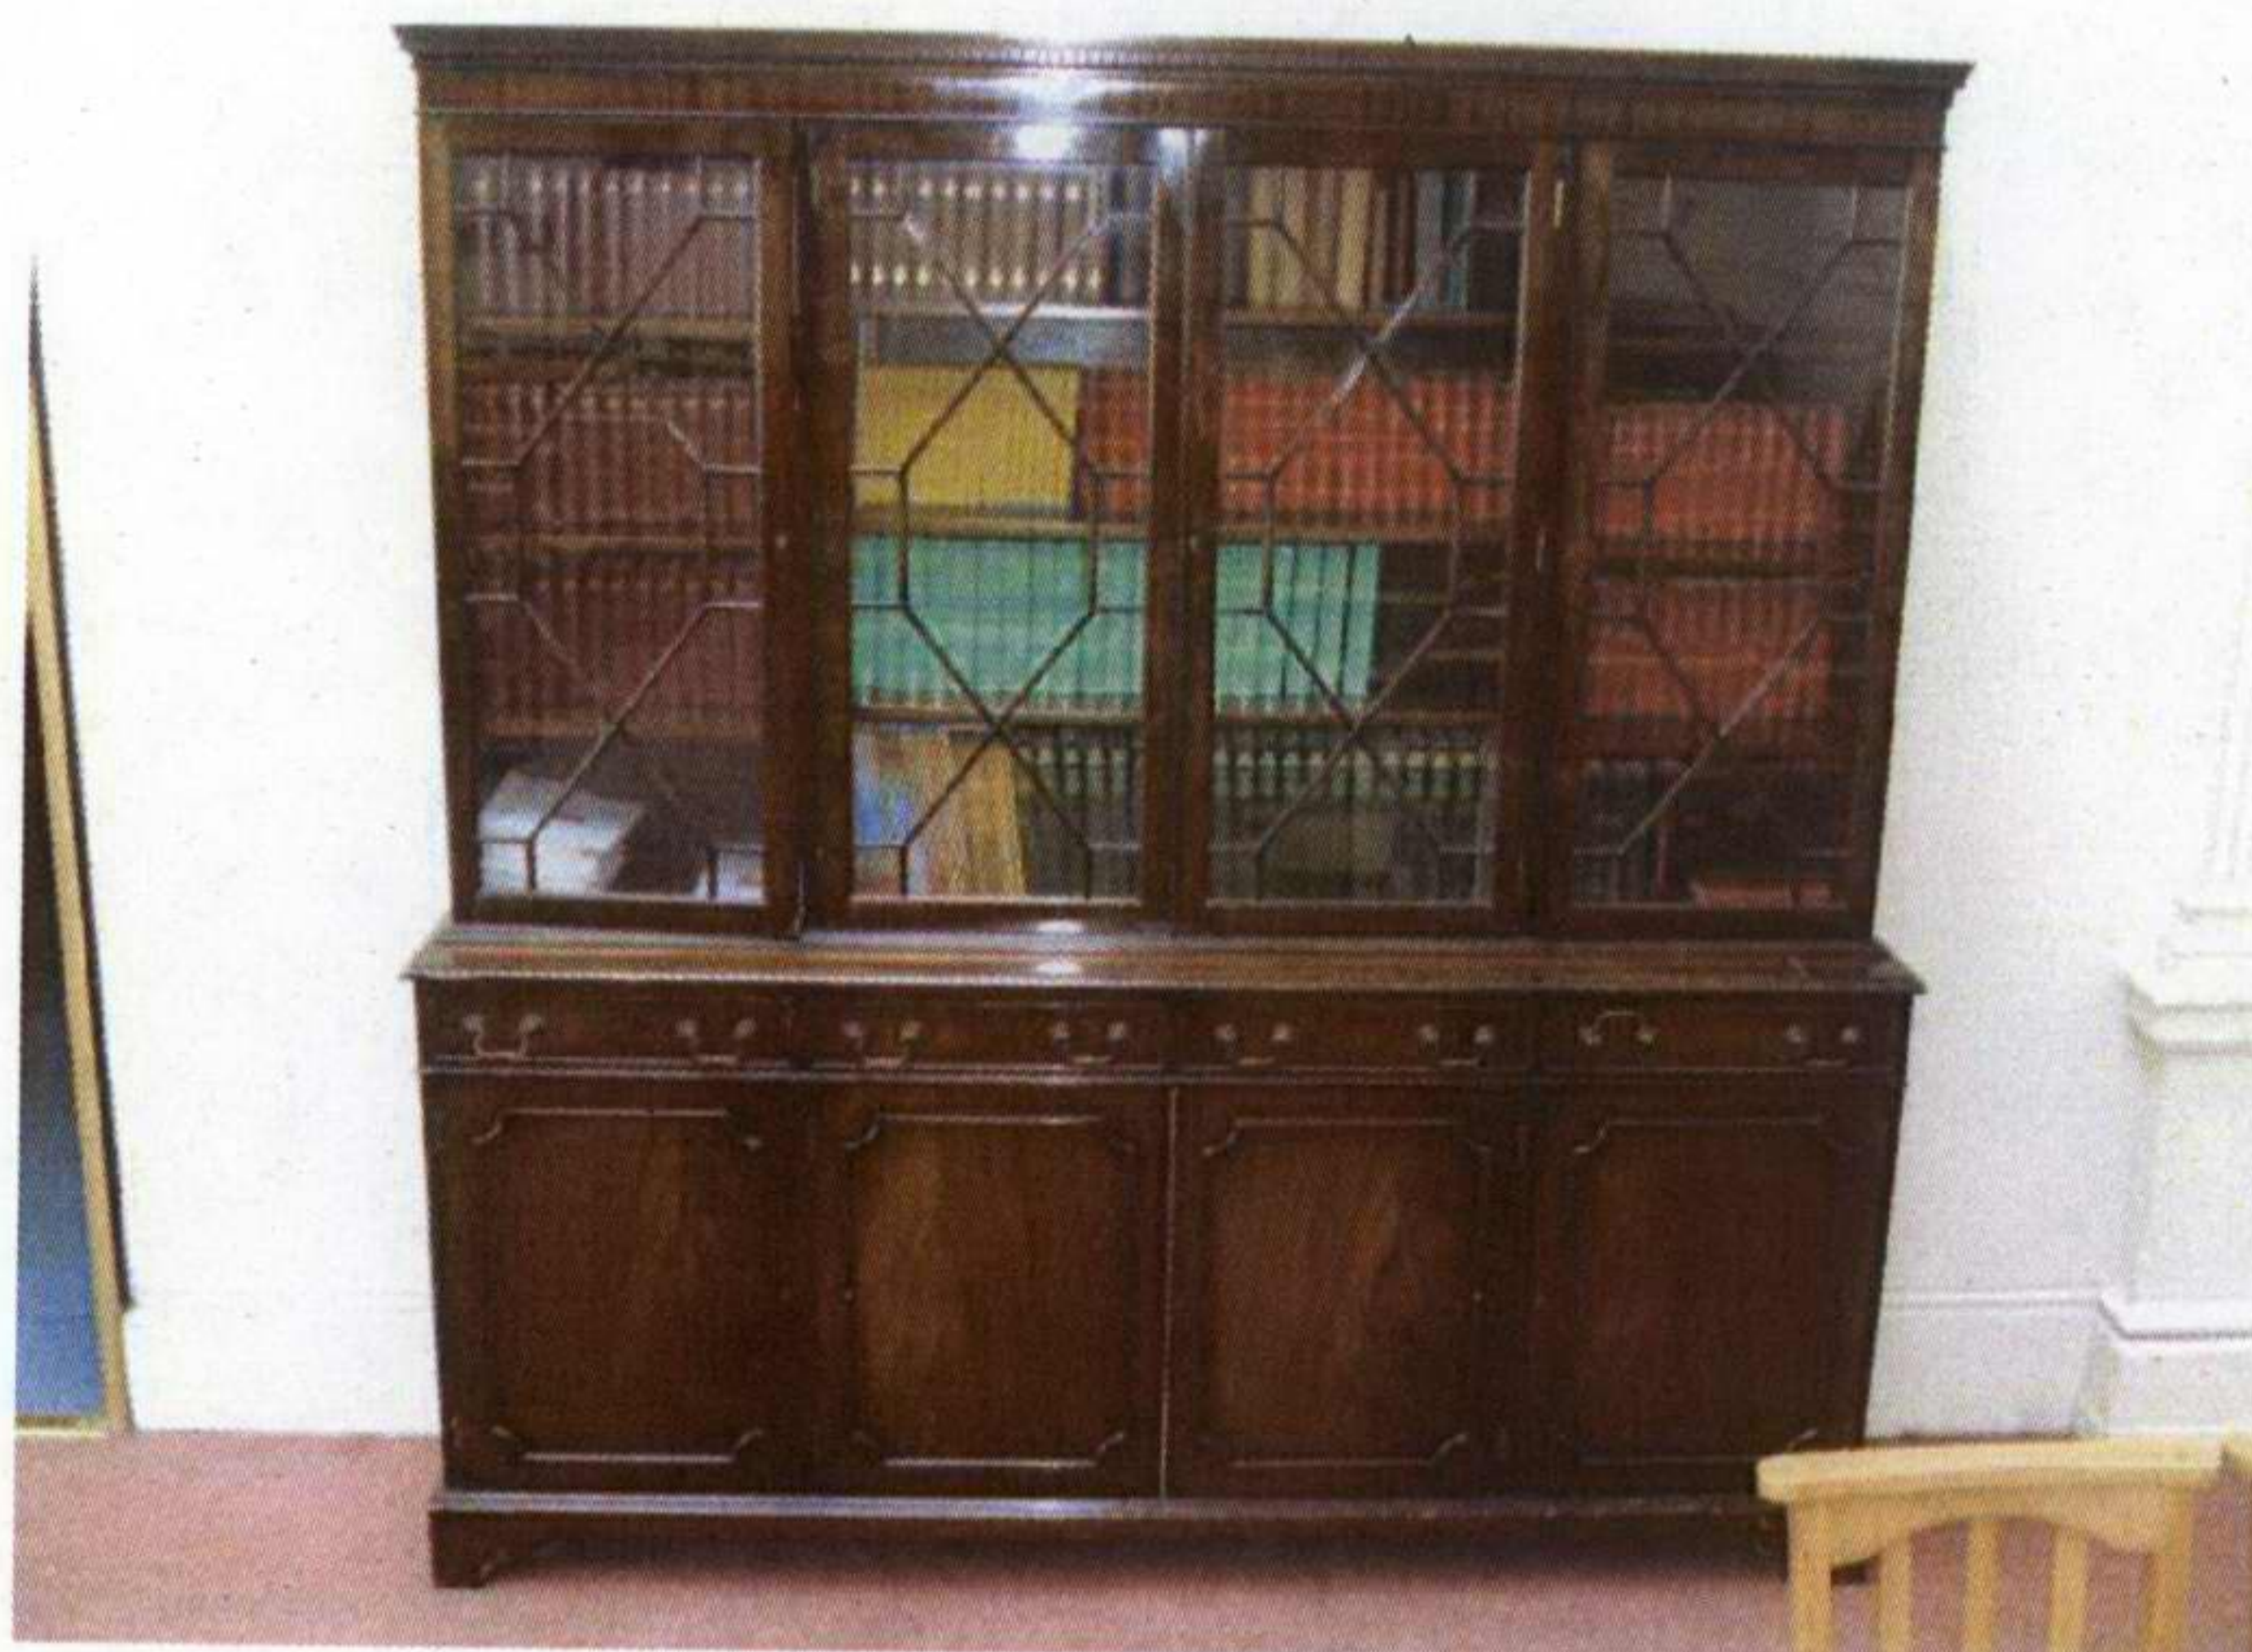
- In the main worship area: pulpit, in oak, Bernese style.
- On the east wall: bookcase with glass fronts.

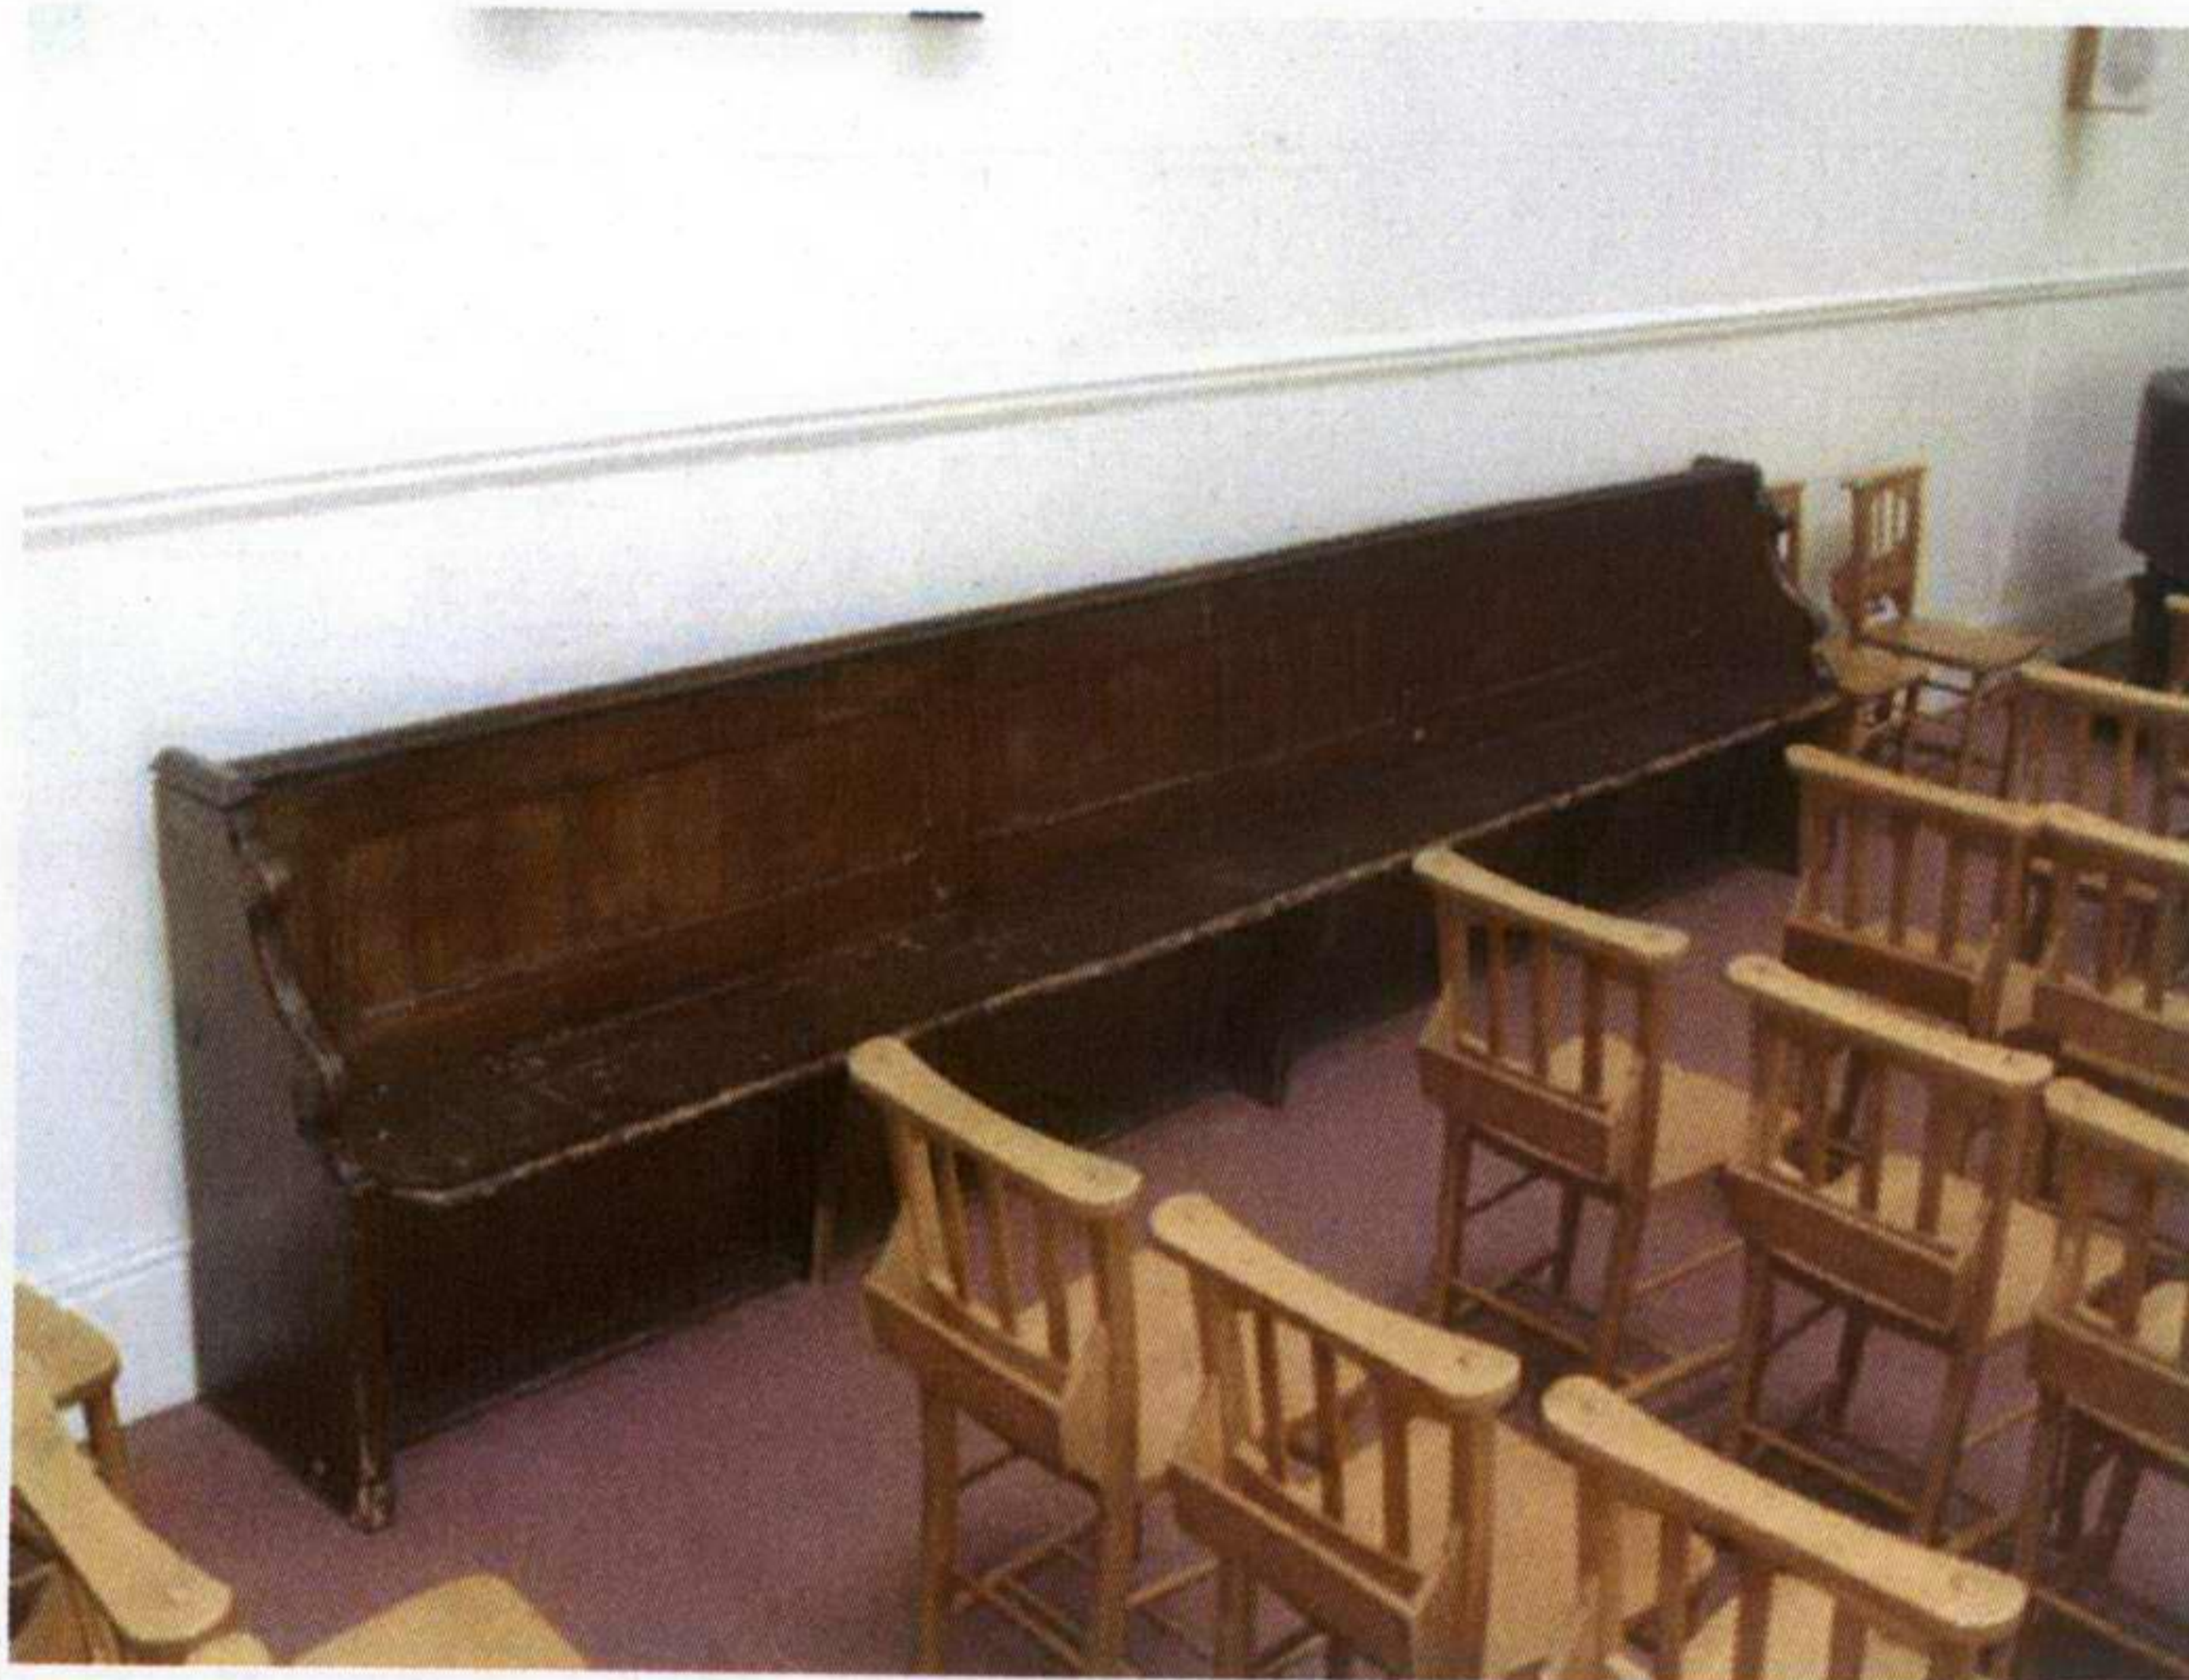
- South wall pew: has unstable legs, poor condition.

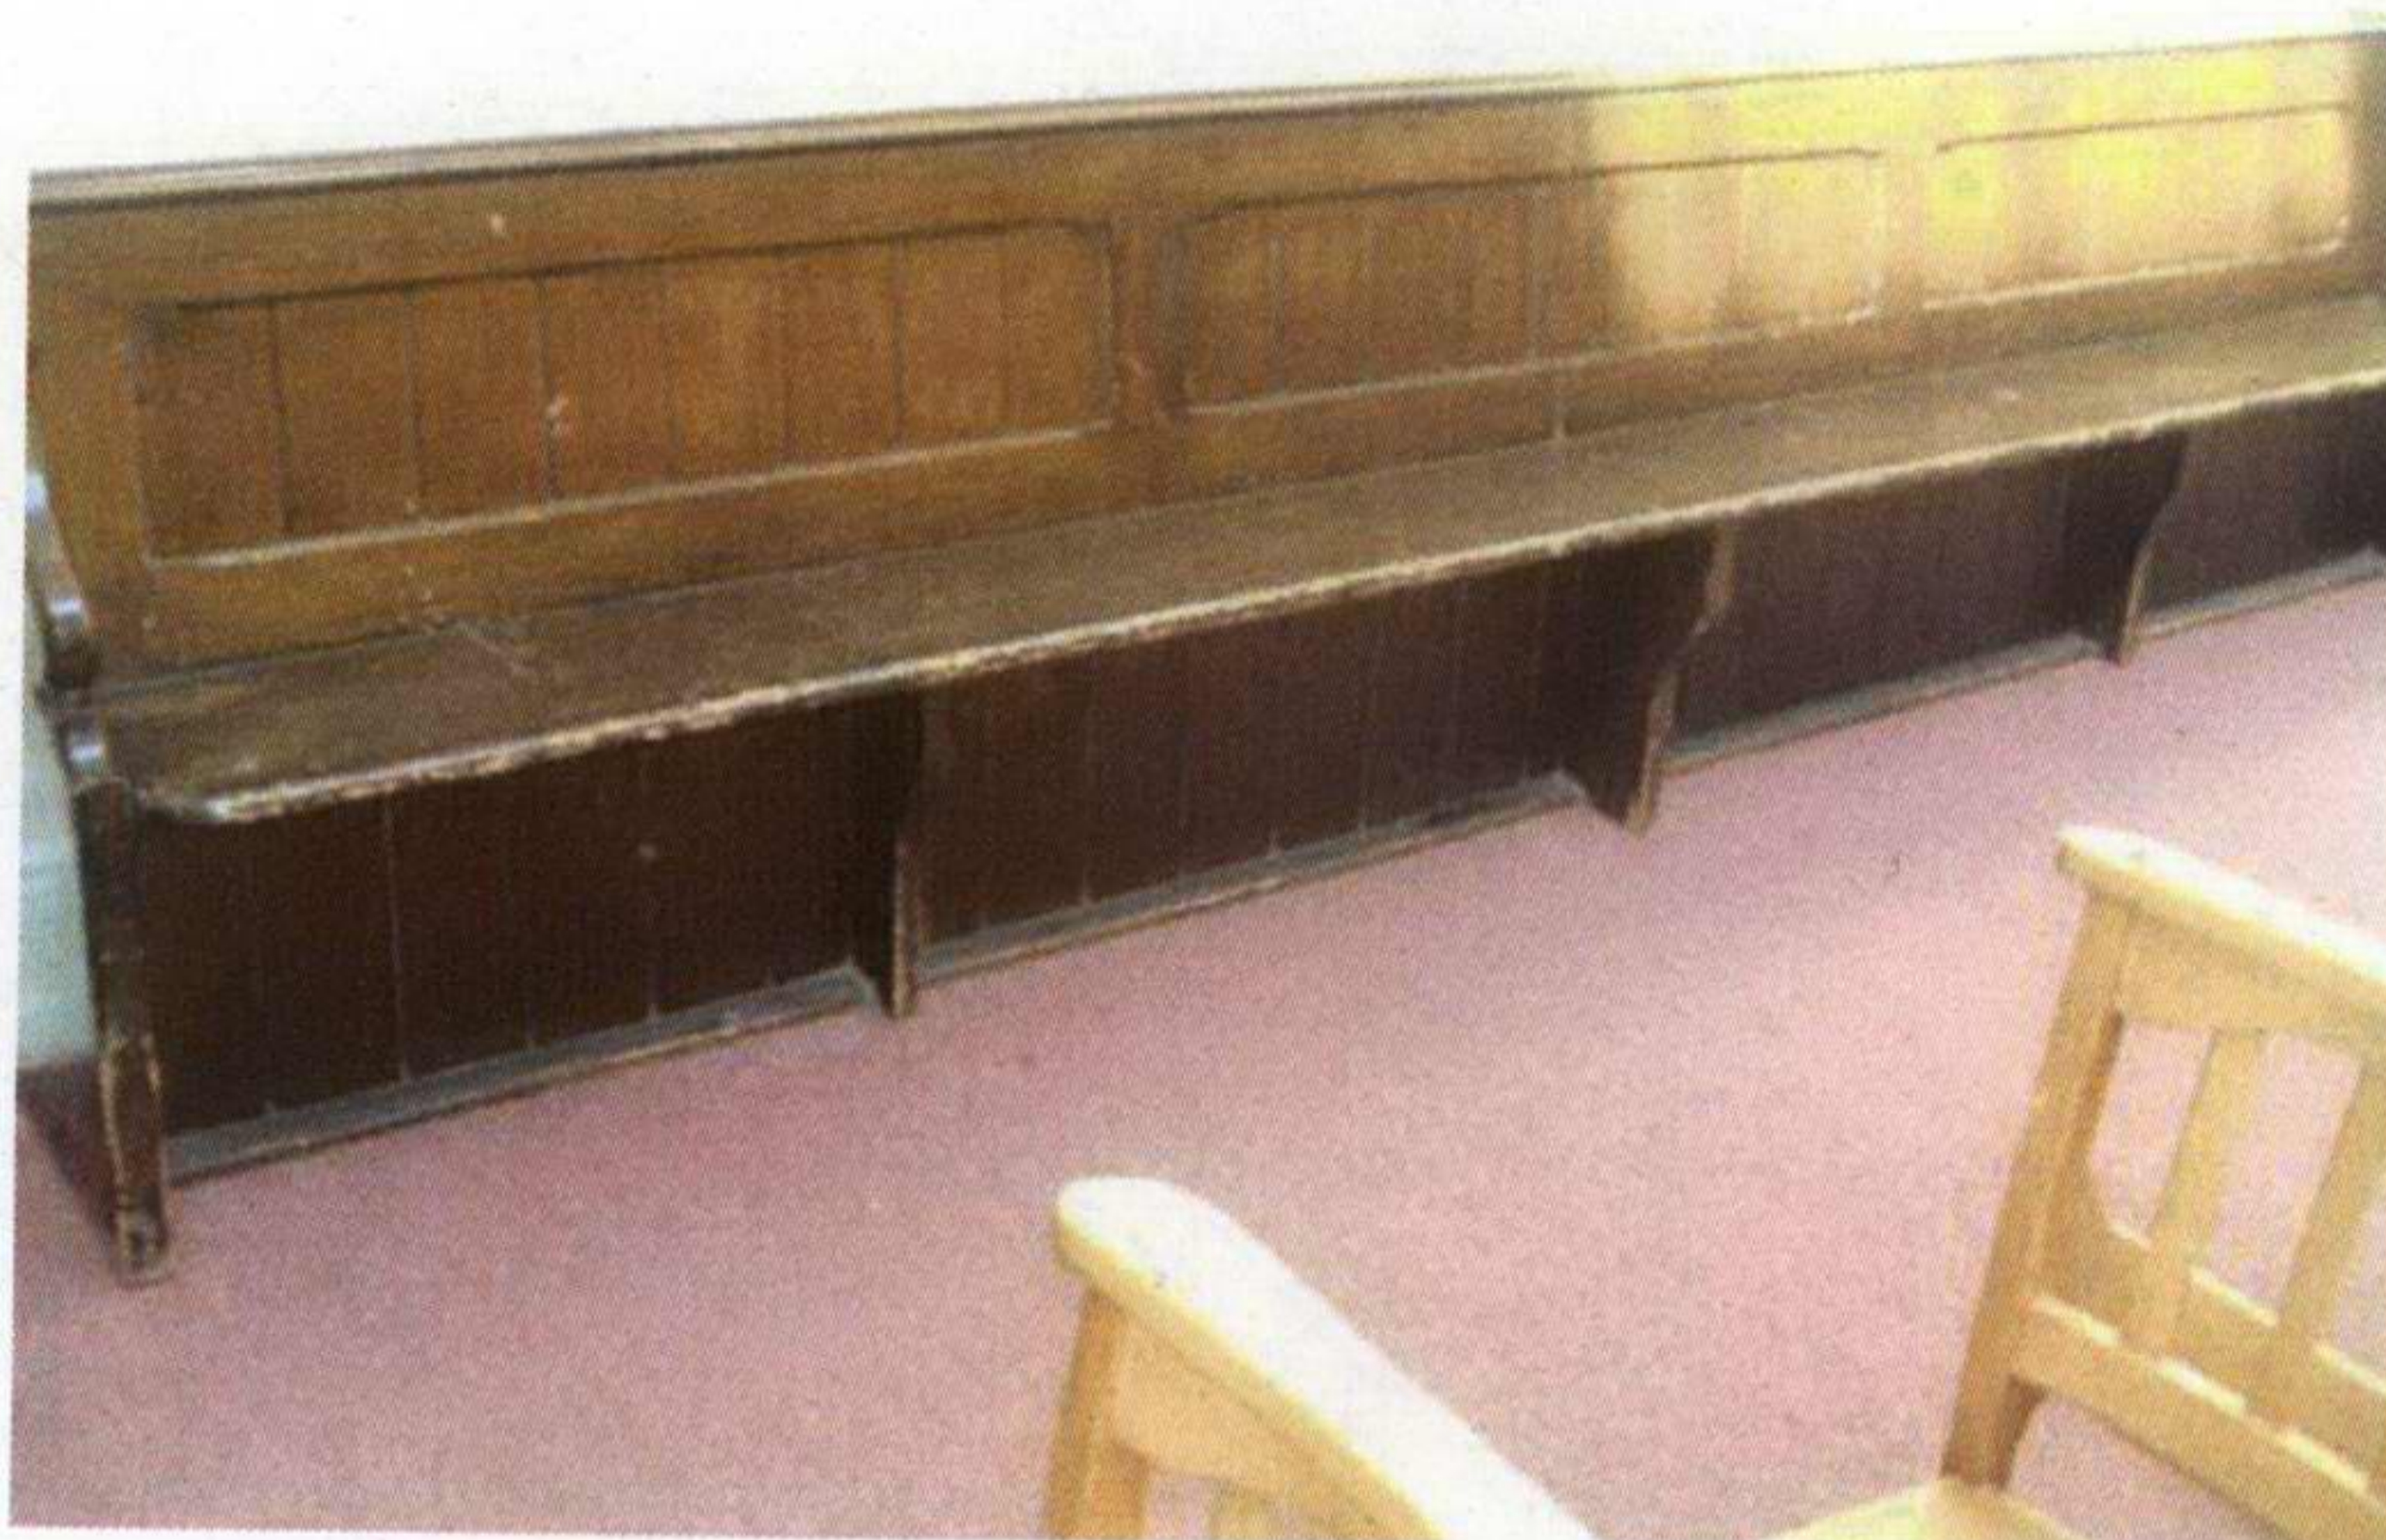
- North pew: less wear, no cracking, but again unstable.

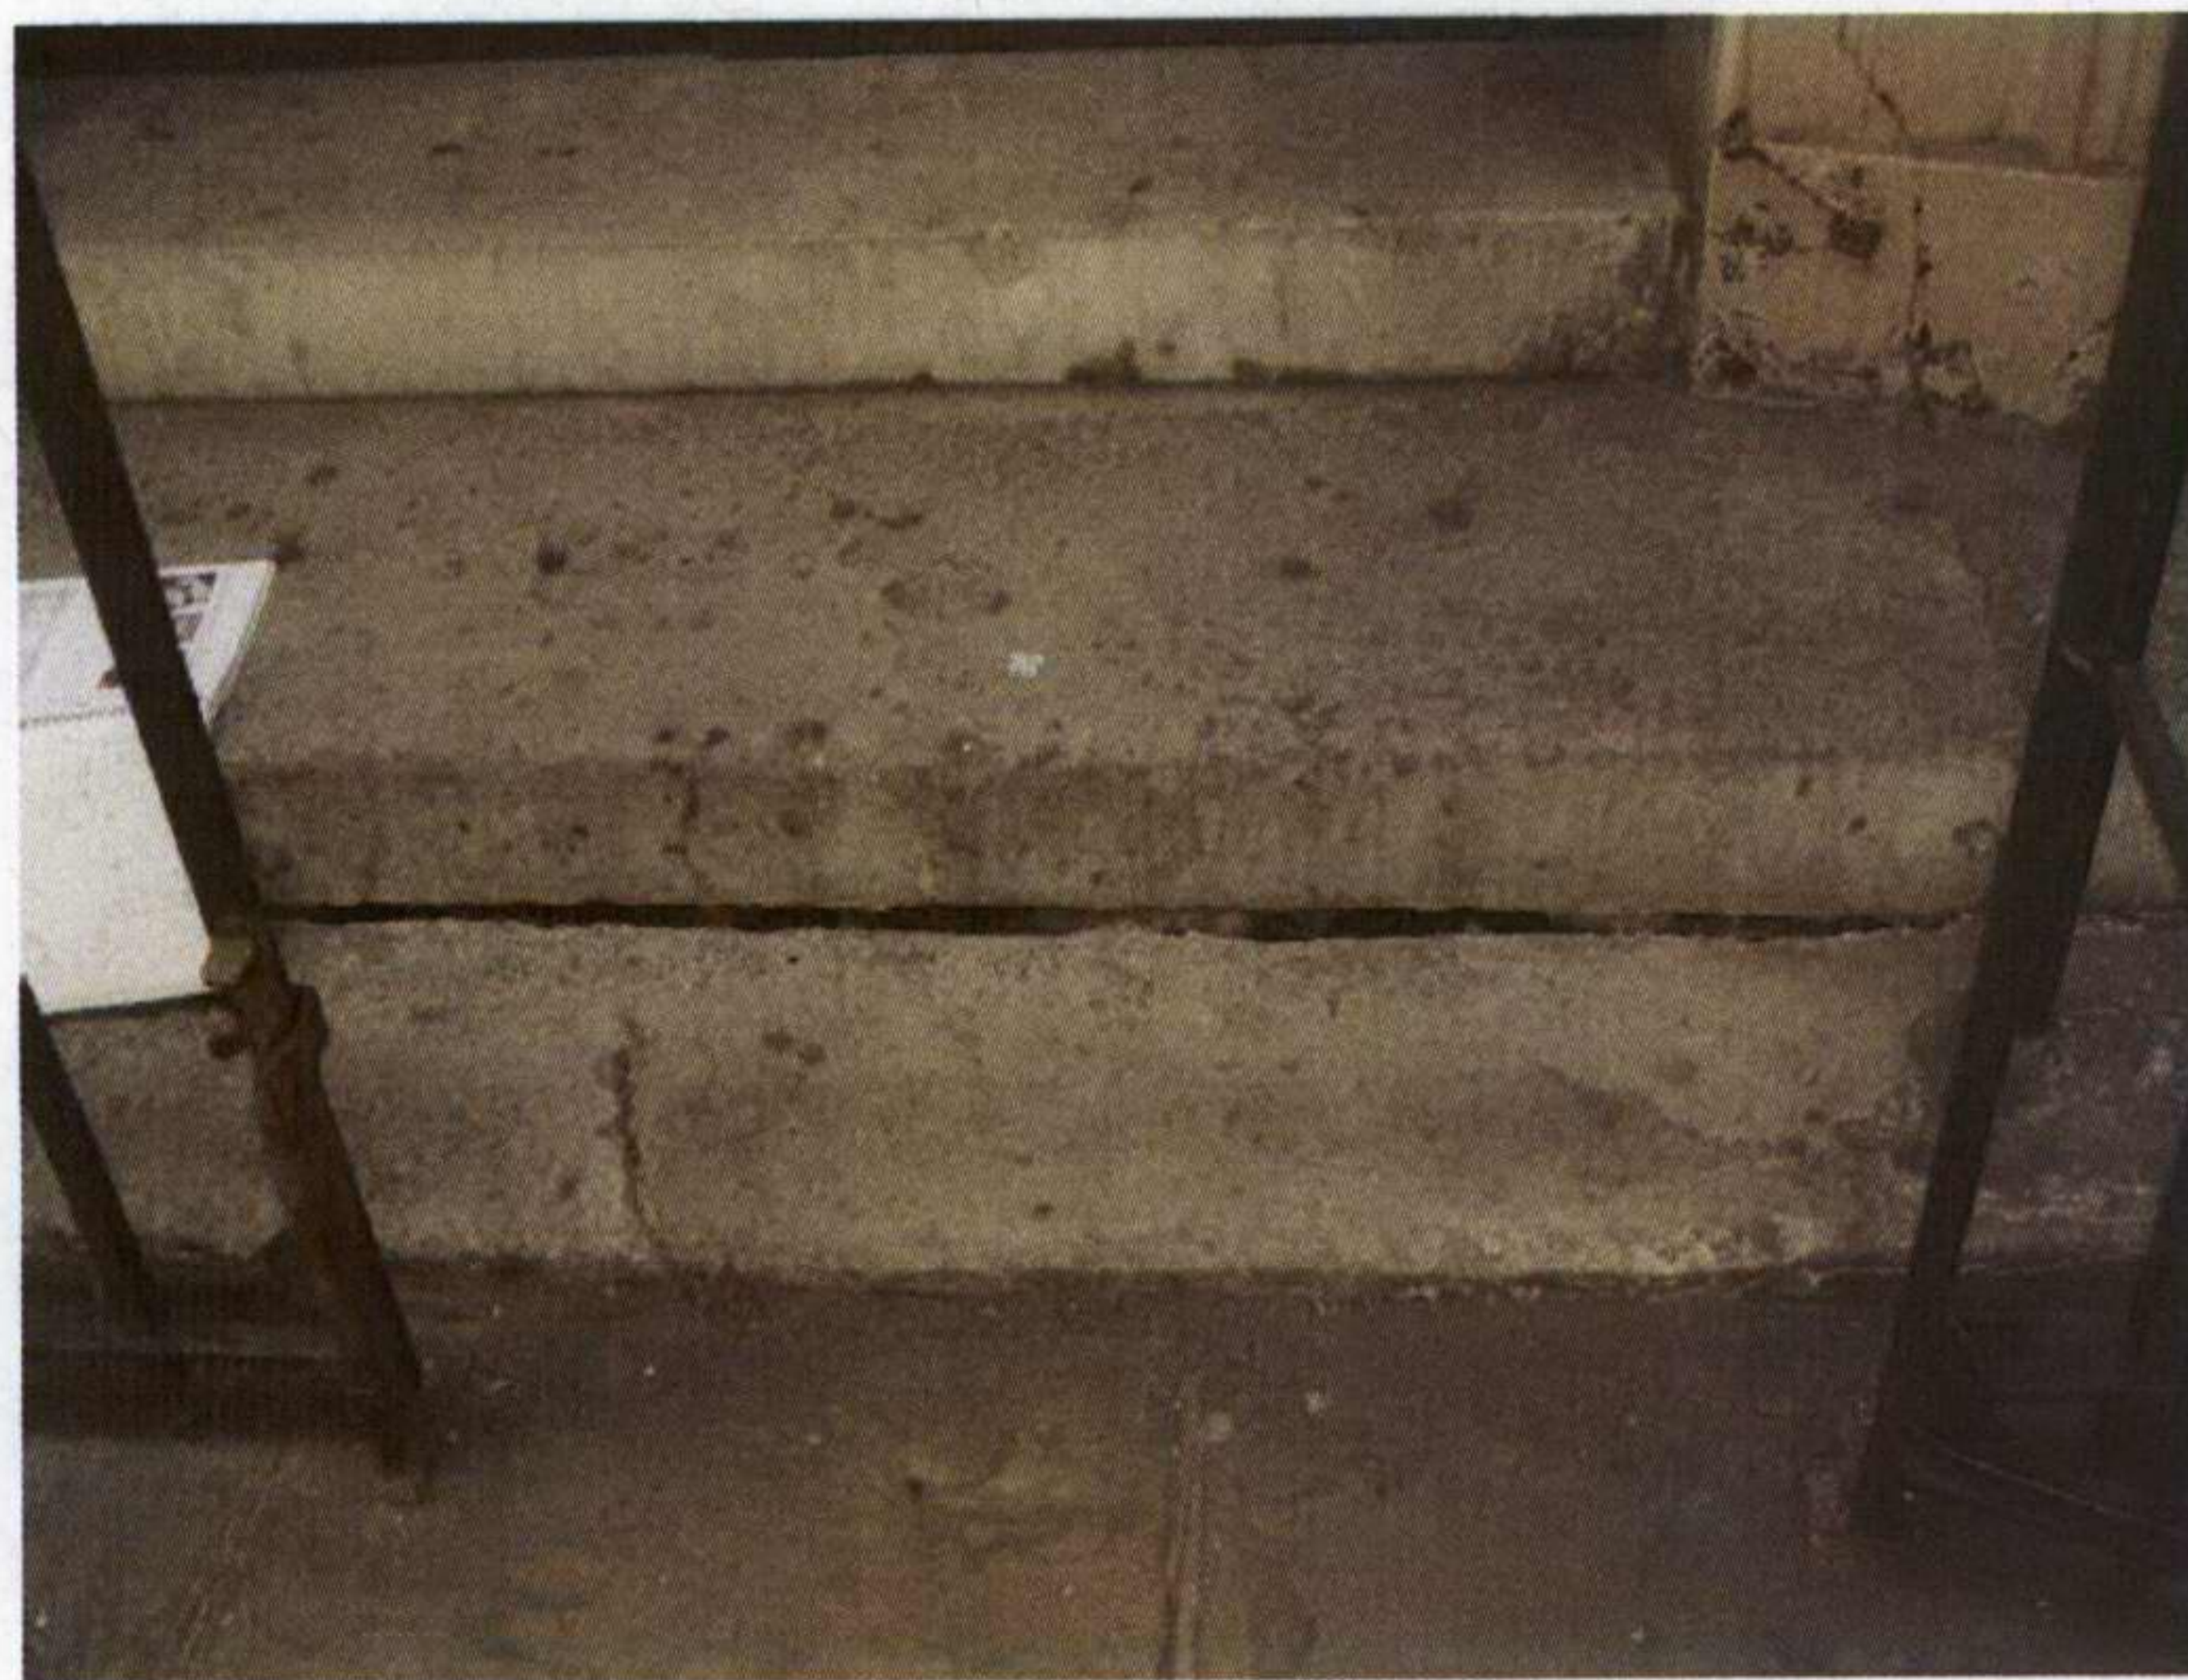
Handrails

necessary. In conjunction with this, it is appreciated that most access to the building will be during service times when the church is manned and ramp provision is not likely to be required for casual tourist use.
