Project **18 Church Row
Hampstead
NW3 6UP**

Subject **Design Statement for proposed alteration/ expansion of the doorway
between front and back room at first floor**

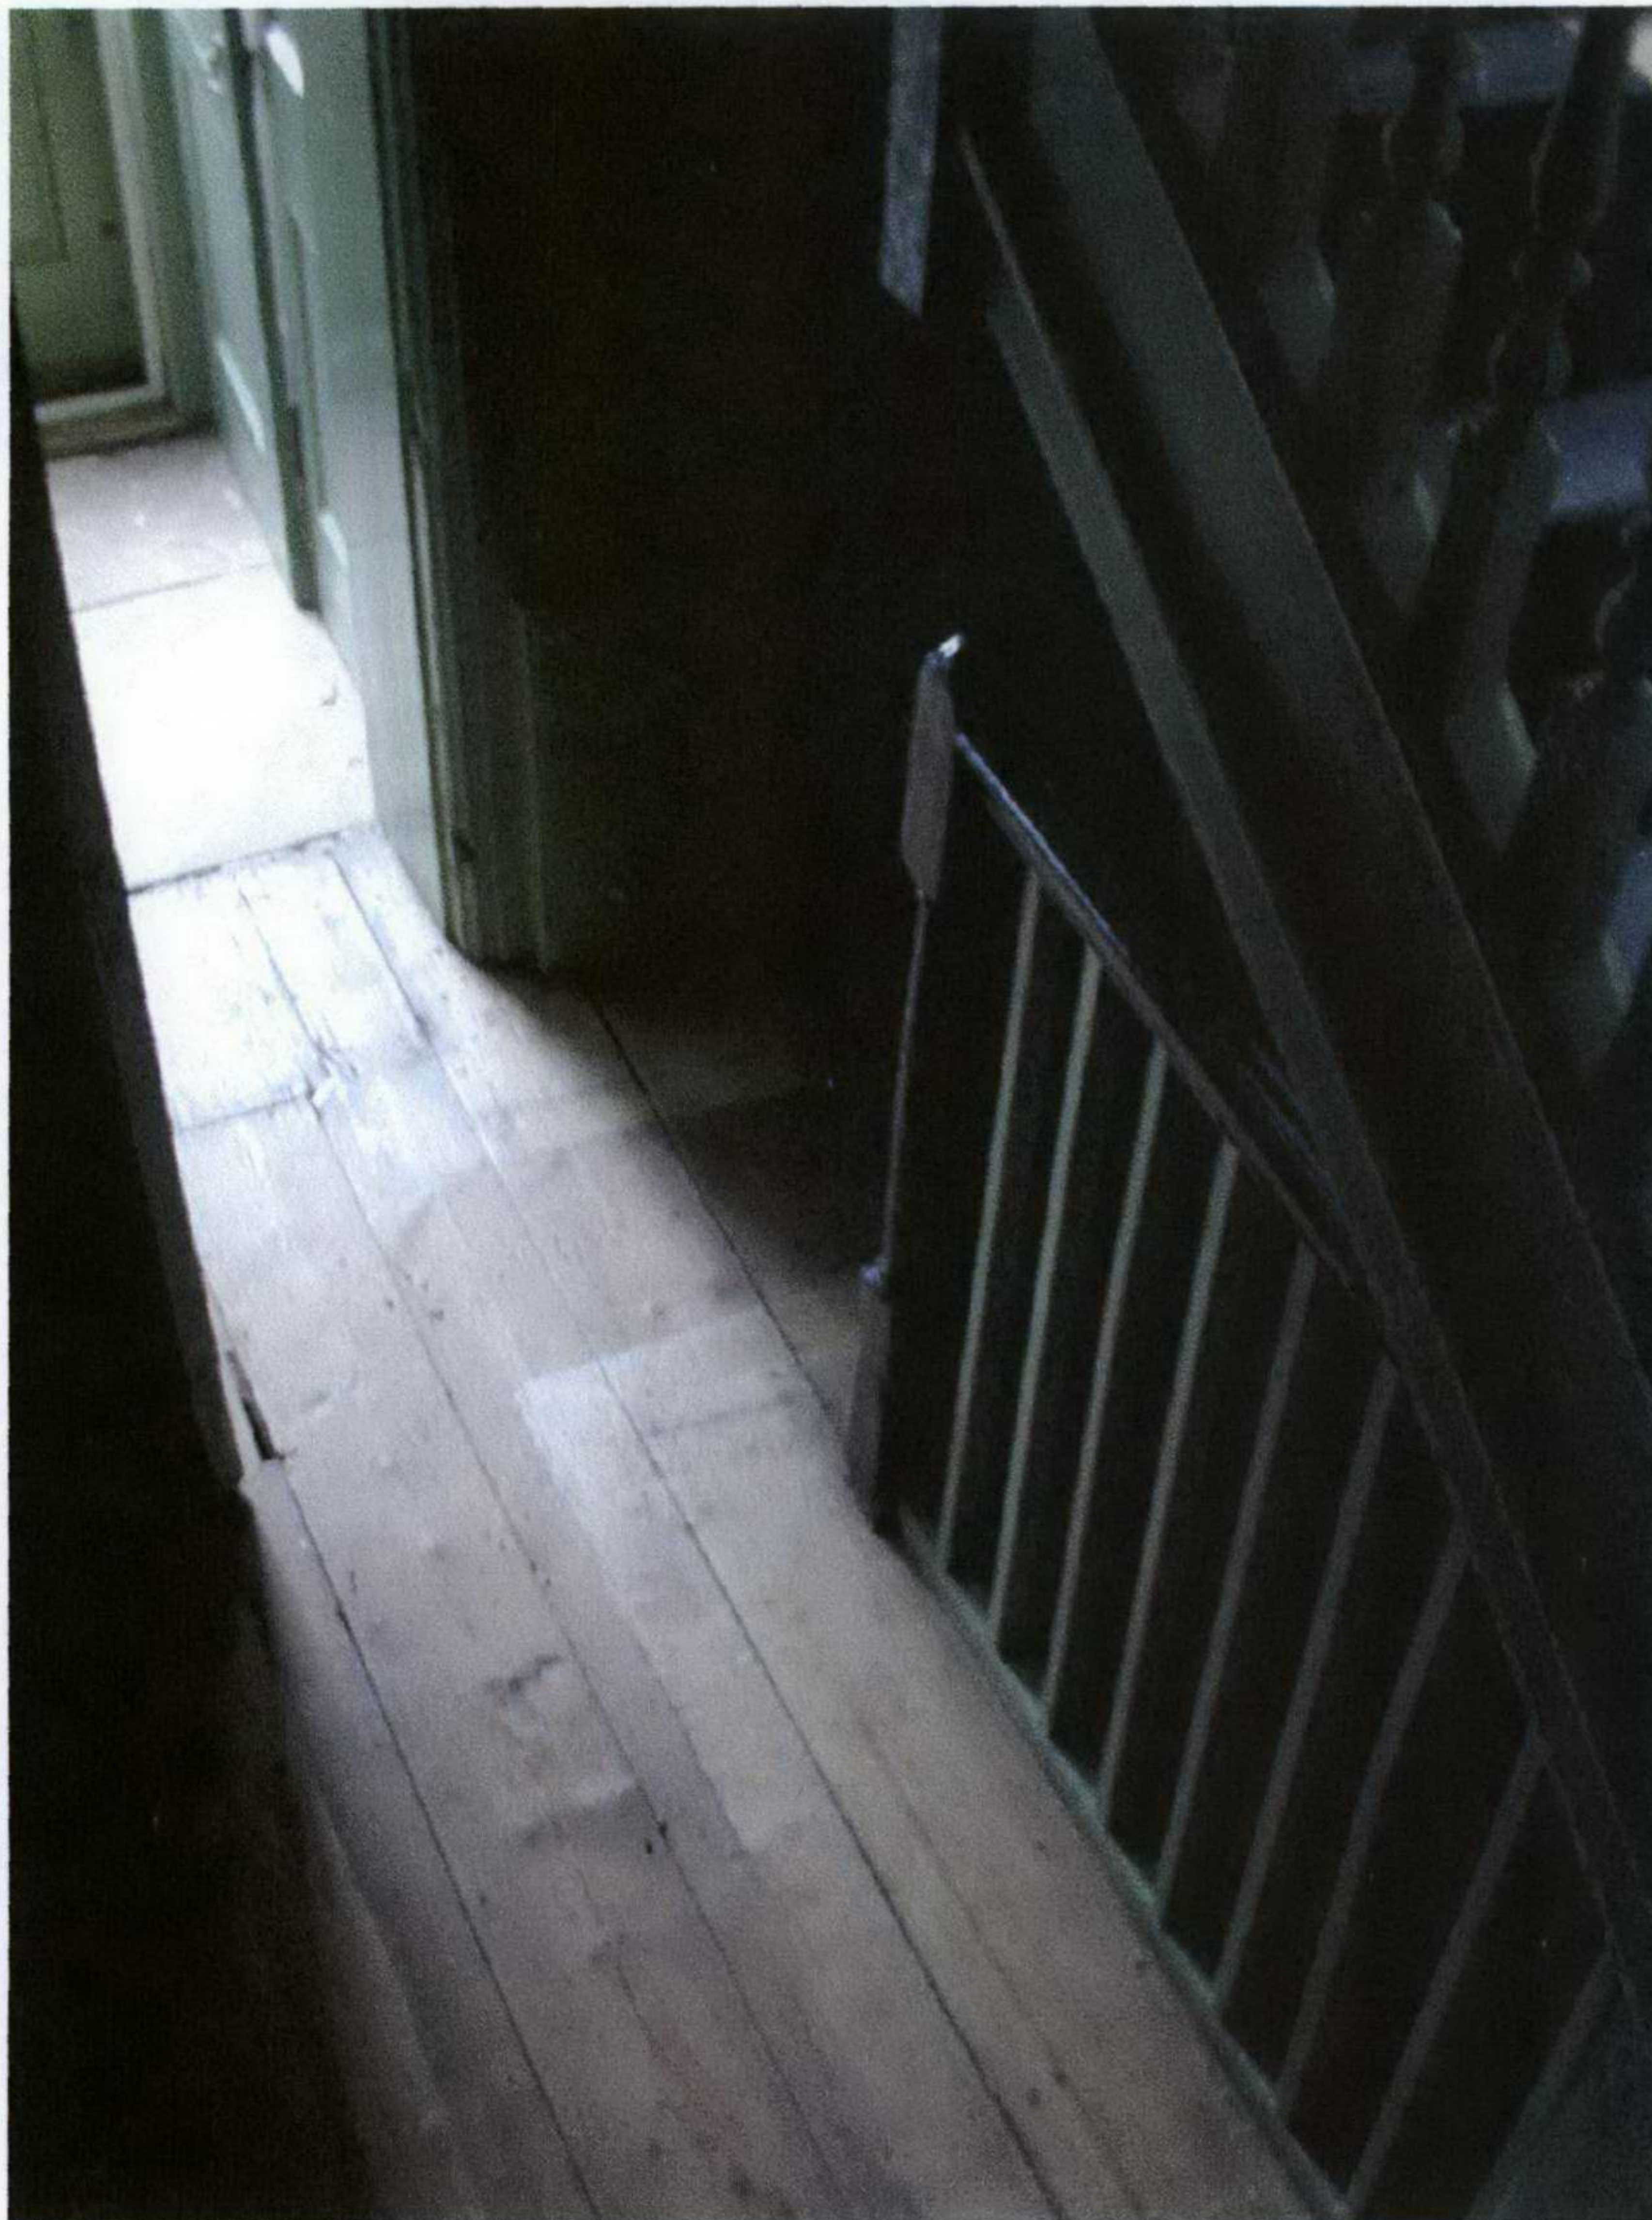
A

Photograph showing the top of the stair from the ground floor hall. The Dark line from the post to the back wall would be the first step down in the proposed new arrangement.

This application seeks consent to reconstruct the stair at this level with a minor change to the run of risers and treads. Starting from the ground floor and moving down, in its original form the first riser occurs on a 30 degree turning off the stair hall timber flooring (a 4-part 90 degree winder minus the top step). In our proposal, the stair would be reconstructed with the top step down in line with the timber of the hall, effectively shifting the entire stair down by one step.

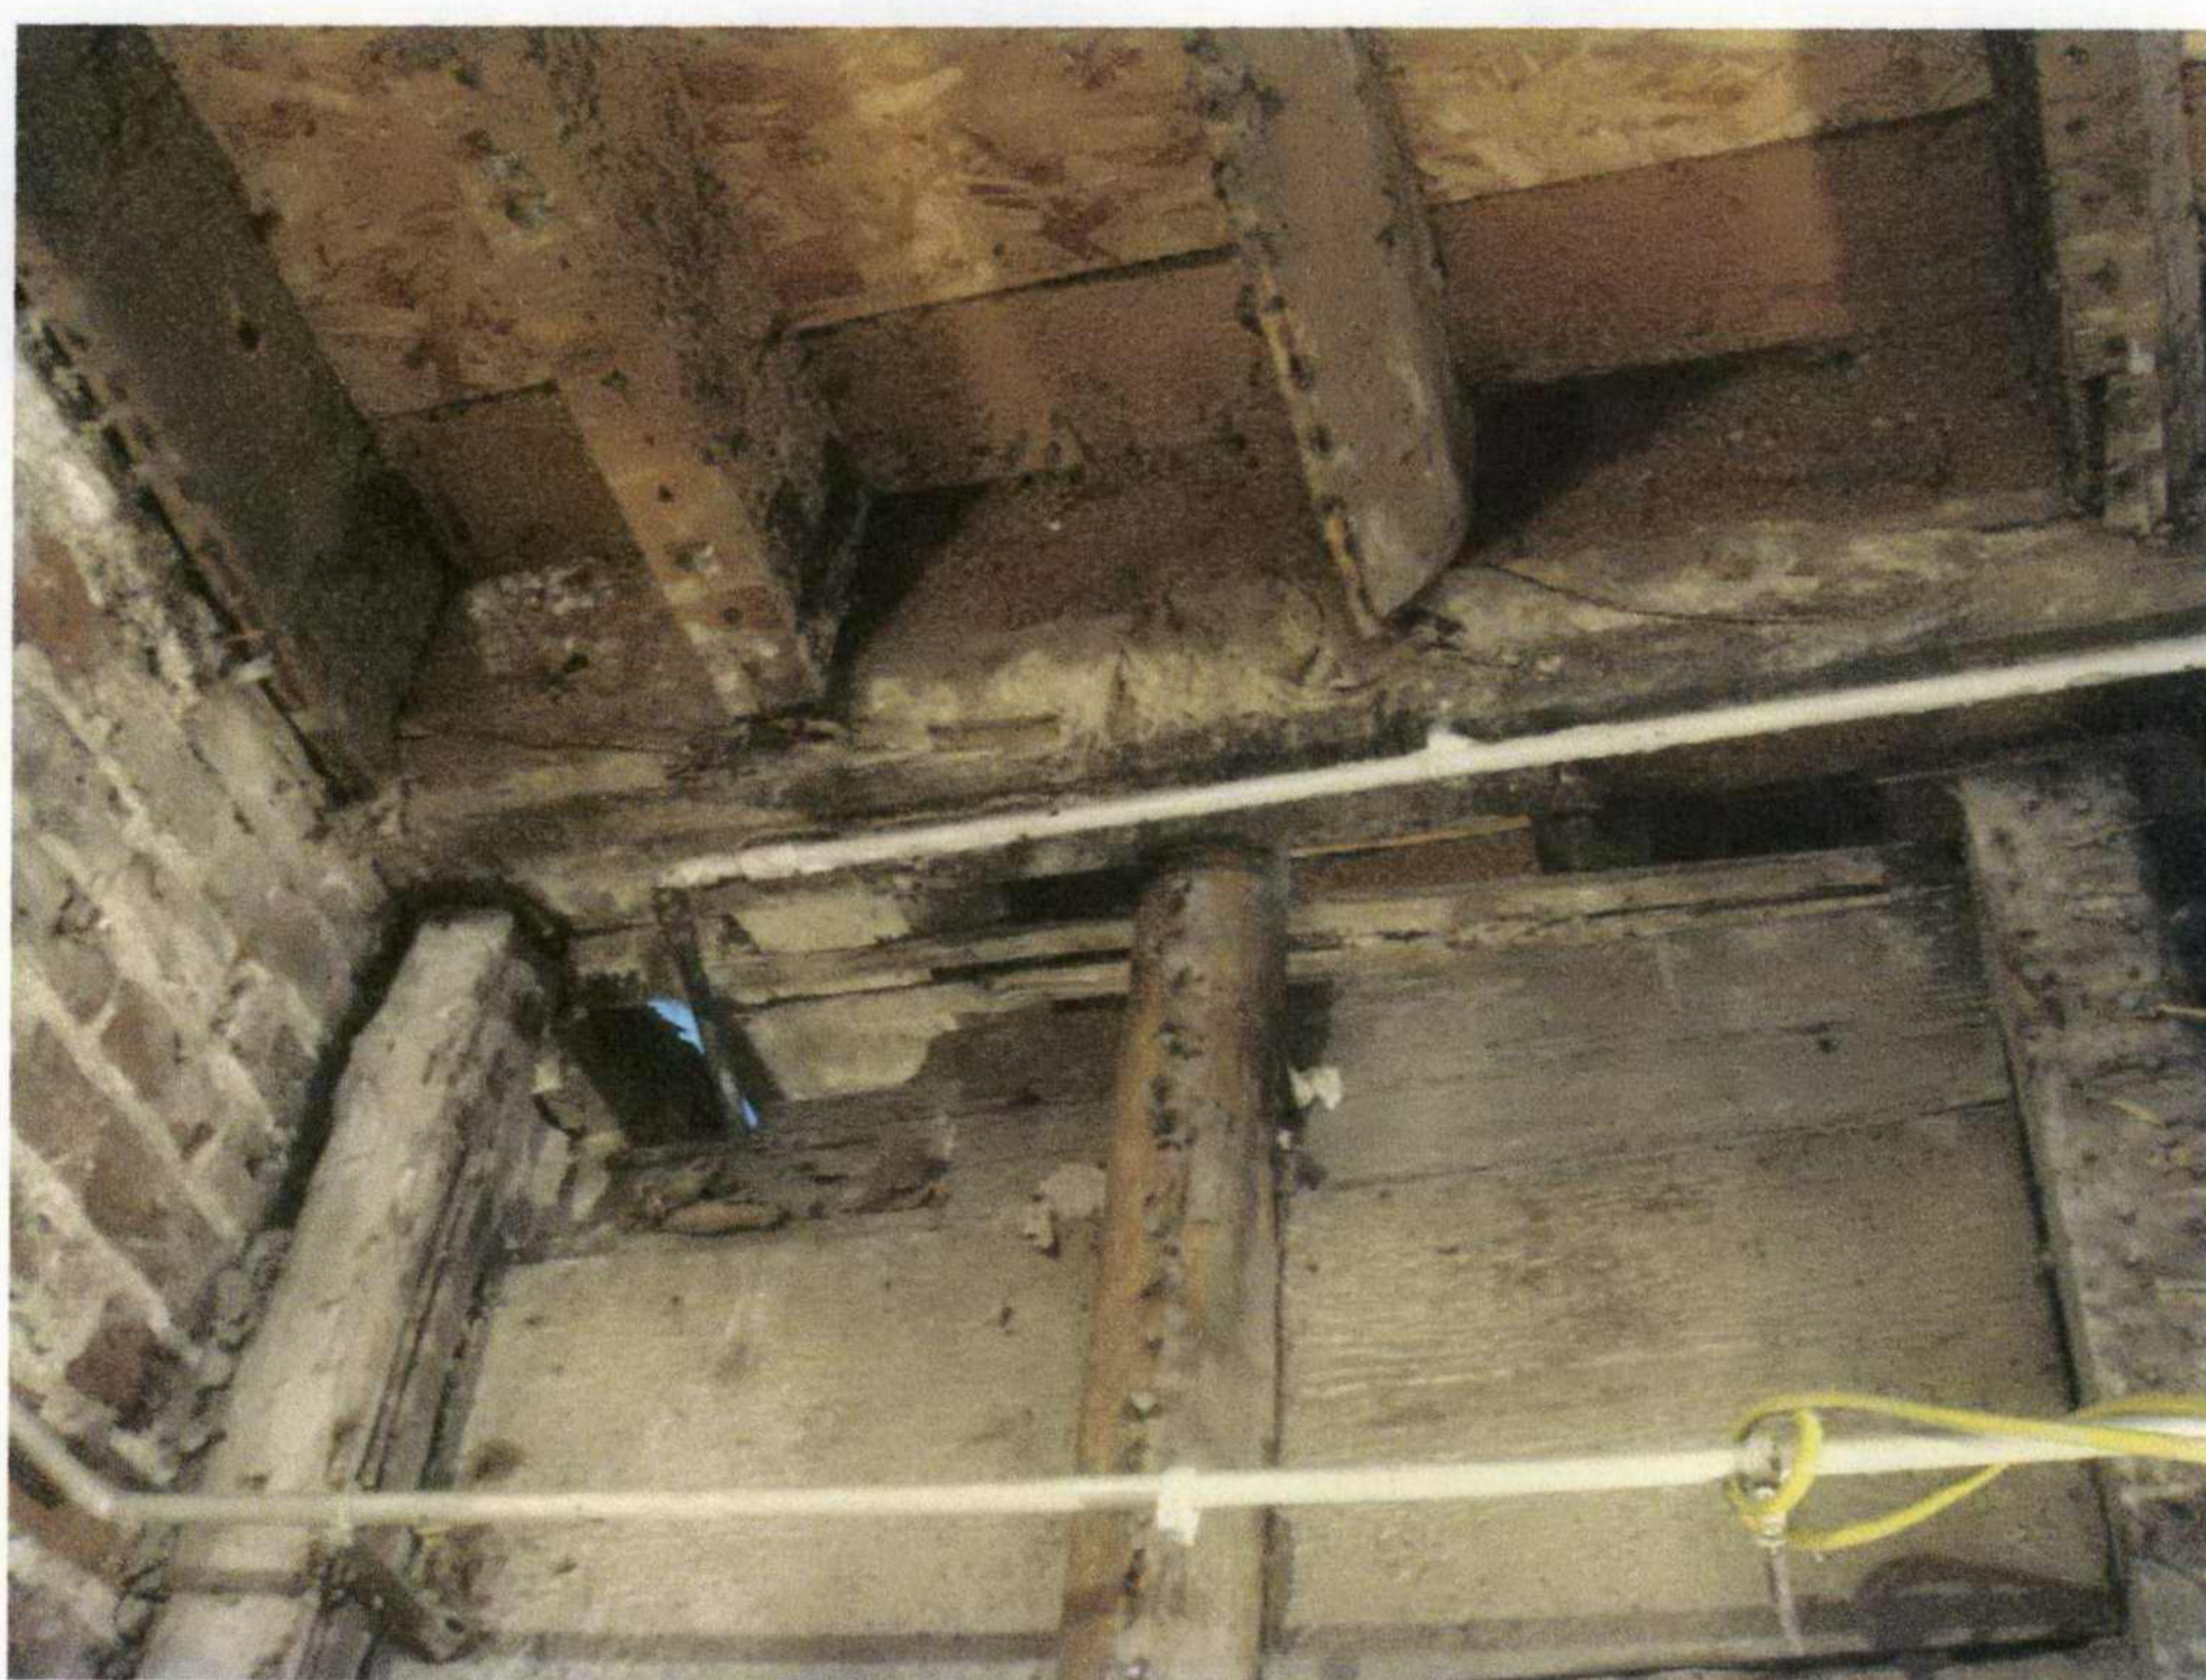
B

Investigation by our project engineers has revealed the main cause of this deformation to be a failing (original) beam at the level of the ceiling of the lower ground floor (see accompanying engineer's report). A secondary cause is a long term water leak at the back drains which has seriously eroded the wall beneath this beam as well as parts of the adjacent lowest run of stair, disolving its ability to offer backup support to the beam. The condition of this portion of wall (the partition wall between the back room and stair hall at the lower ground floor) is so bad as to require dismantling and rebuilding. The dismantling of the lowest run of stair is an inevitable part of this conservation work.

Above is a photograph of the beam as it meets the inside wall.

A detailed plan for introducing a new steel beam beneath the existing original beam follows as part of the engineers' report. The lower ground portion only of the wall between the stair and the back room will be rebuilt in a like manner using like materials and thicknesses. Likewise the lowest run of stair will be reconstructed, reusing as much original material as possible.

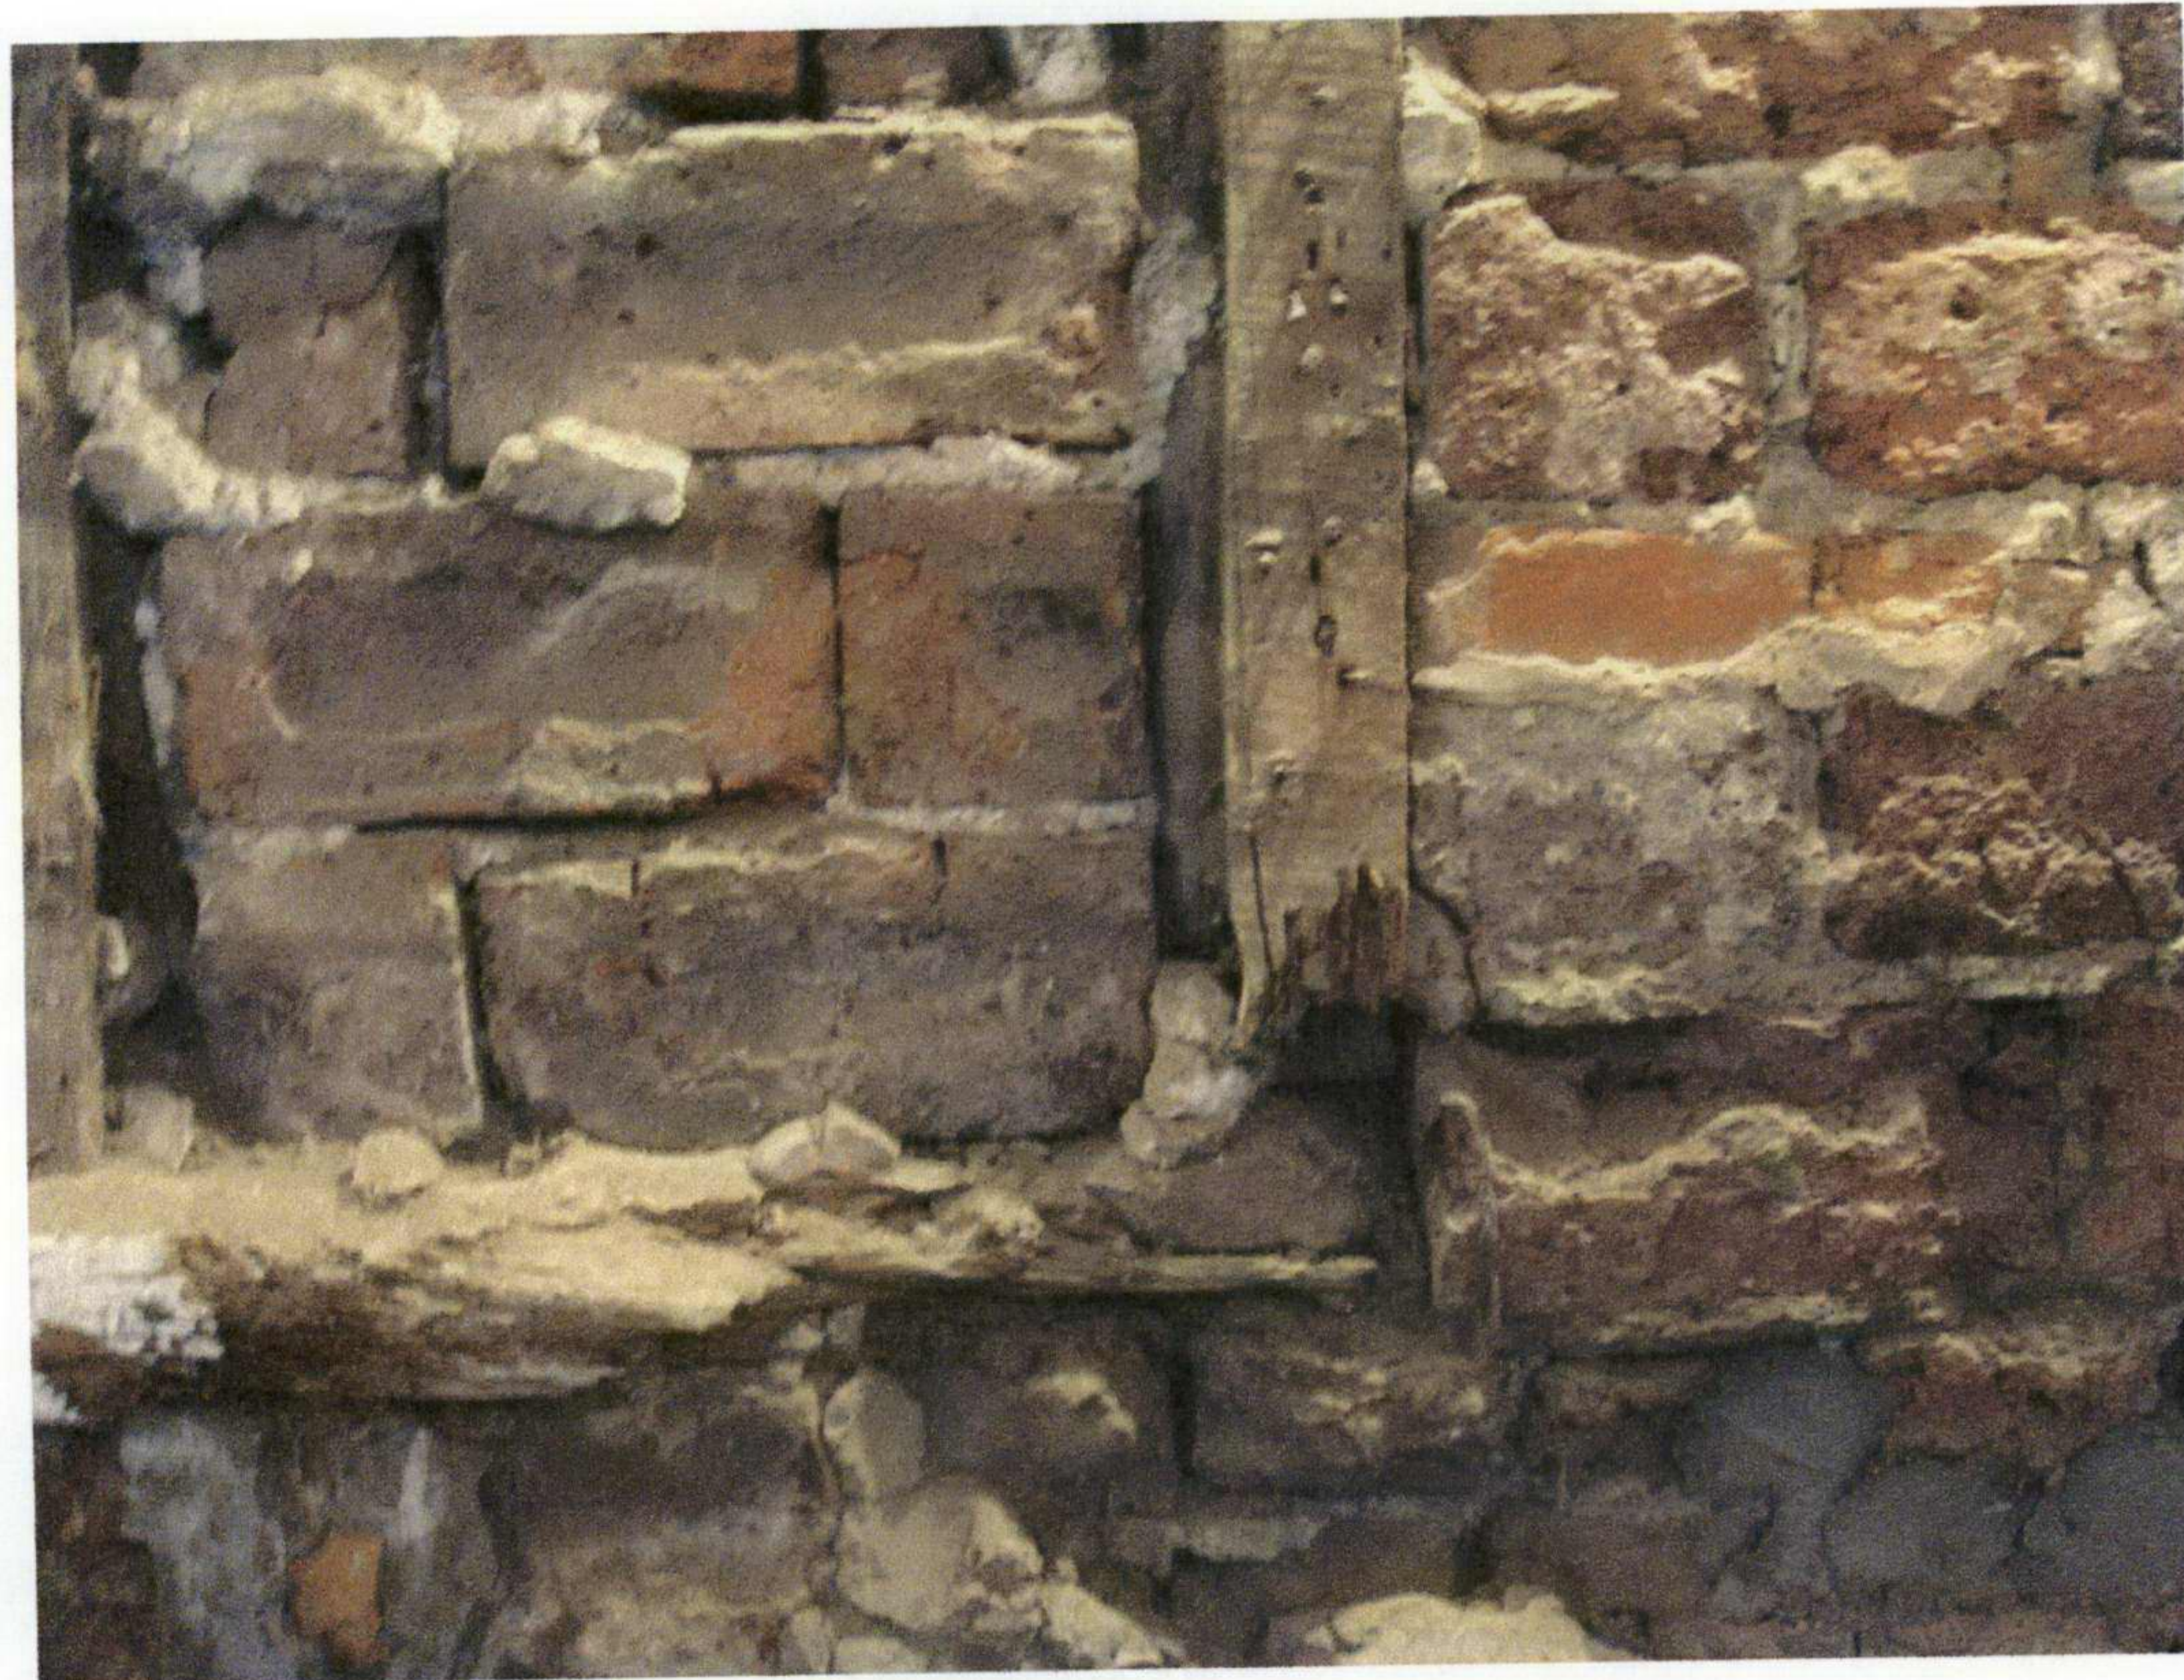
C

Timber within the wall is rotting, while masonry is only fill, not capable of offering support to the beam.

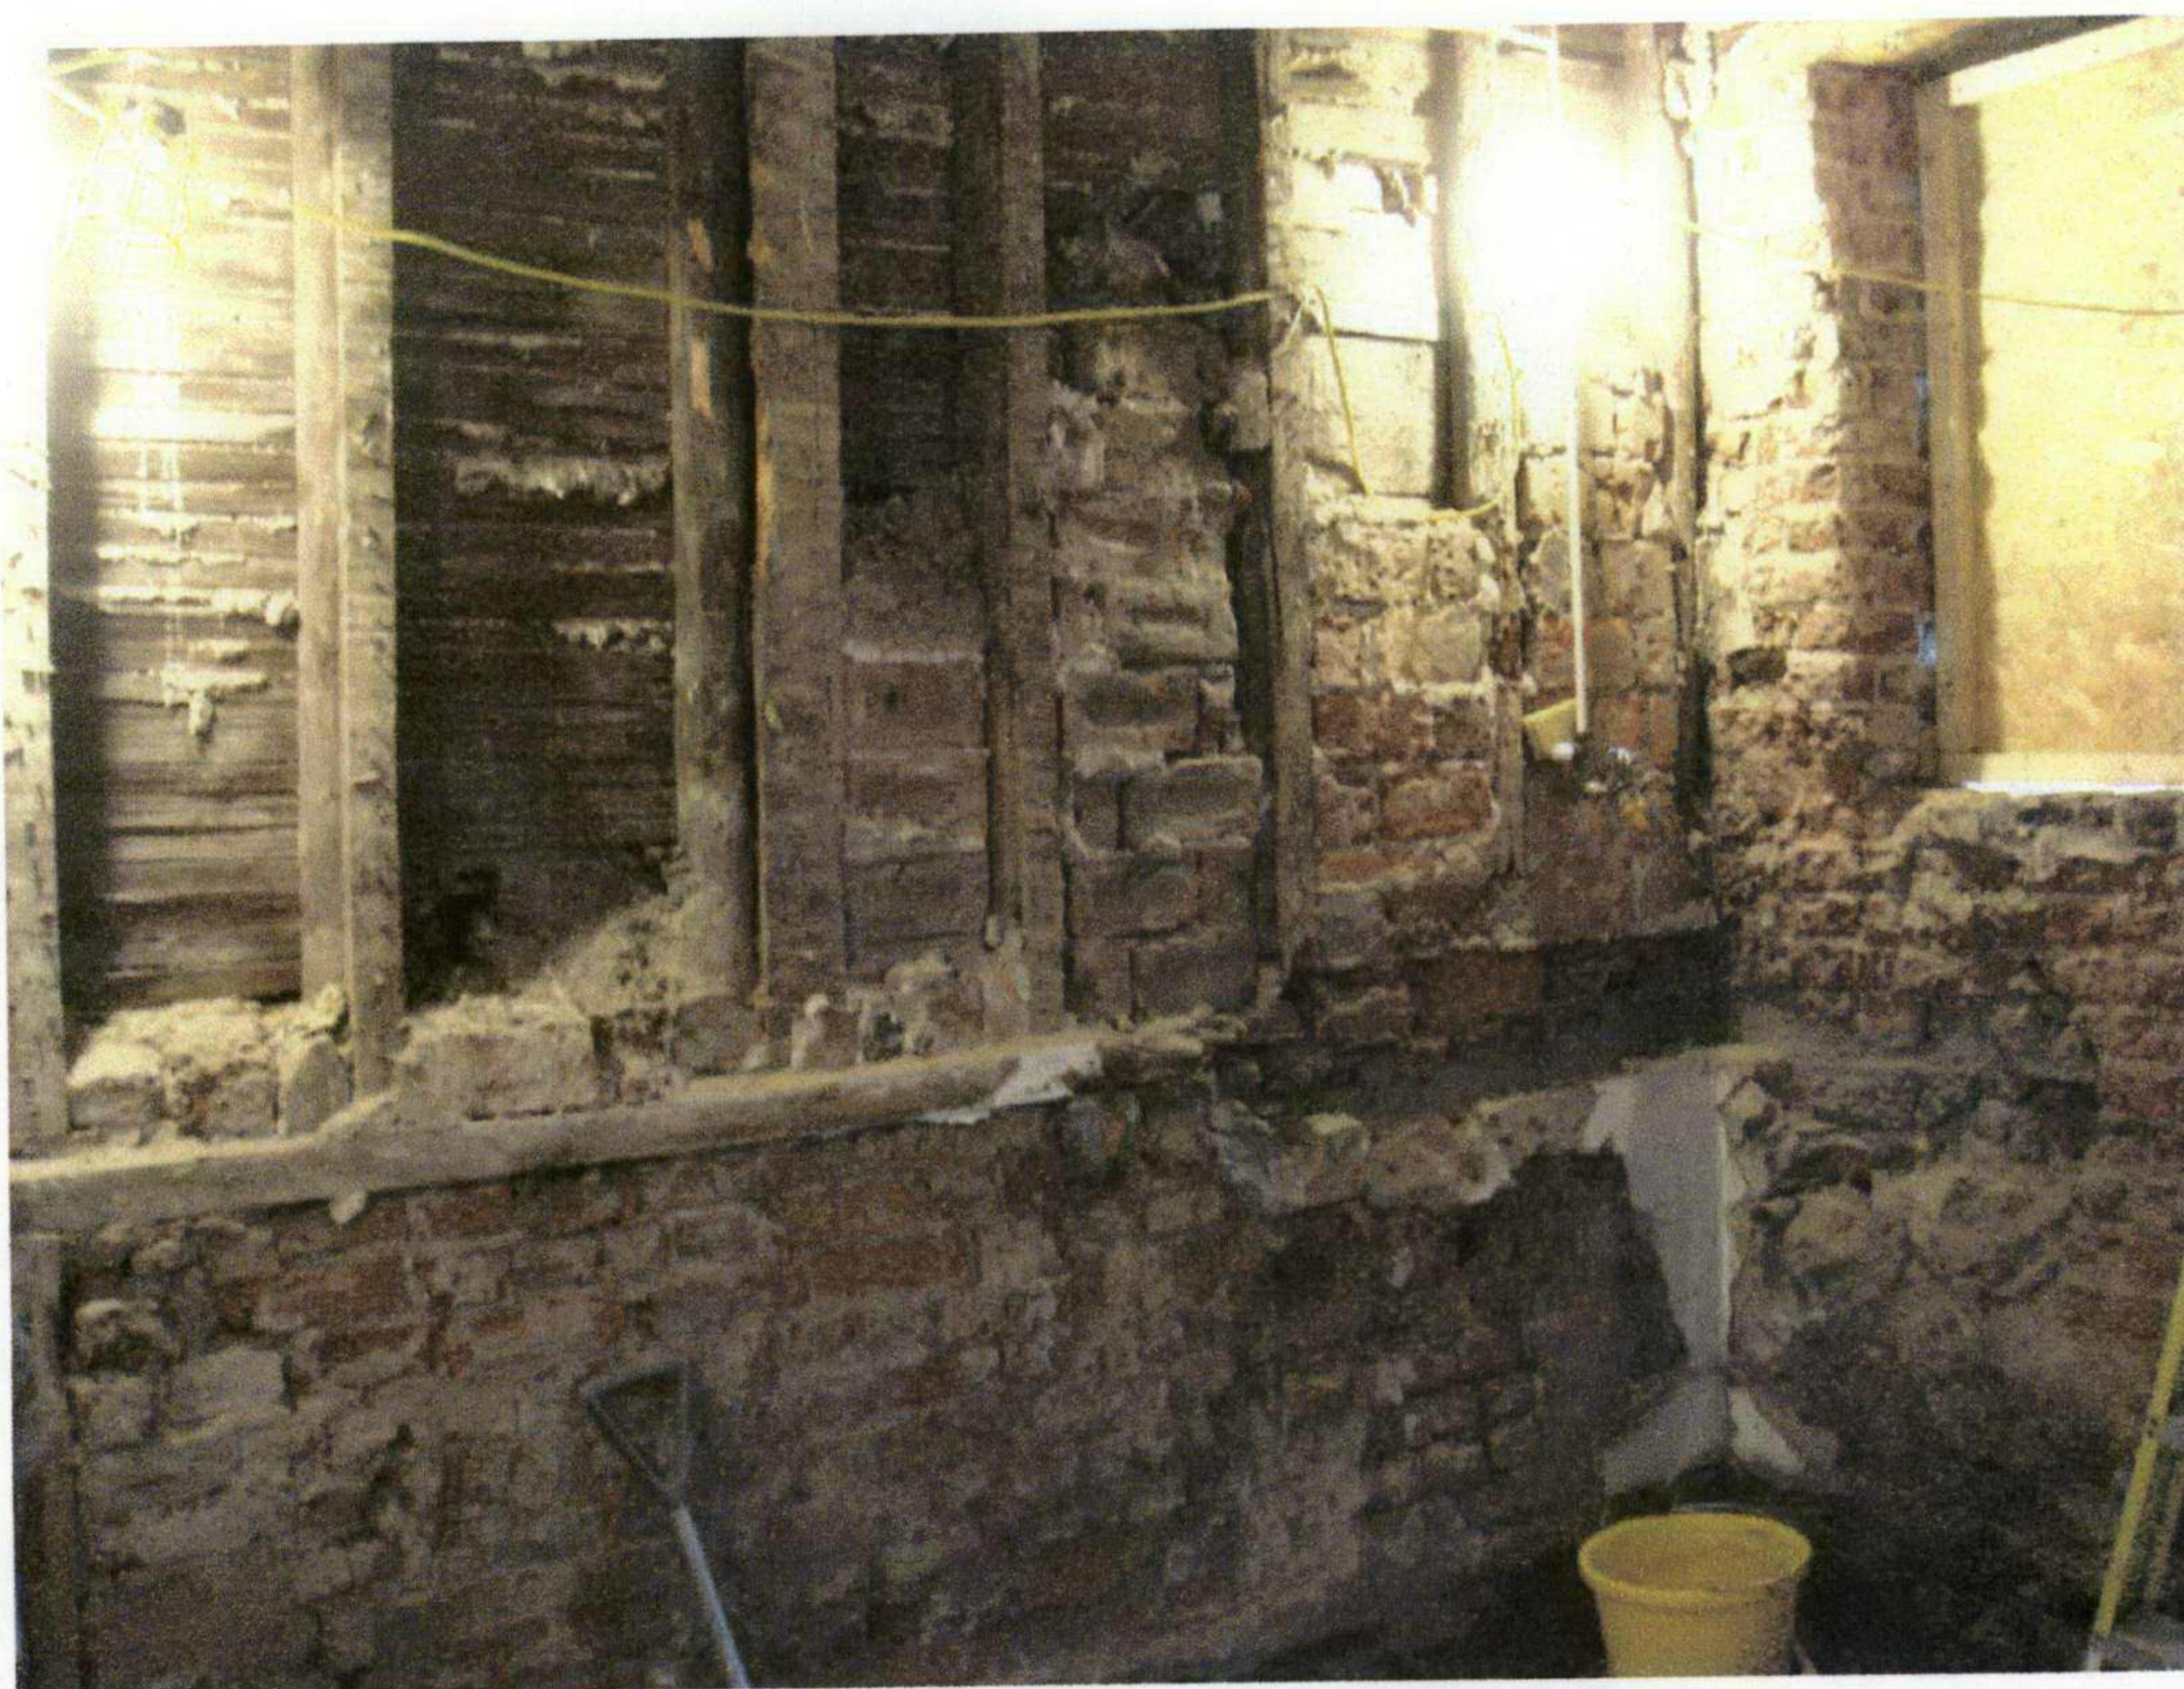
D

A broader view of the corner of the stair wall from the room side. Outside the far corner is the drain which caused the damage to the fabric.
