Pell Frischmann

**18 CHURCH ROW
BASEMENT BEAM REPORT
K84415-VAA-R1-0002-A**

REVISION RECORD Report Ref:					
Rev	Description	Date	Originator	Checked	Approved
A	Report on Basement Beam at 18 Church Row.	18.06.07	R. Harvey	L. Chapman	D. Sivyier

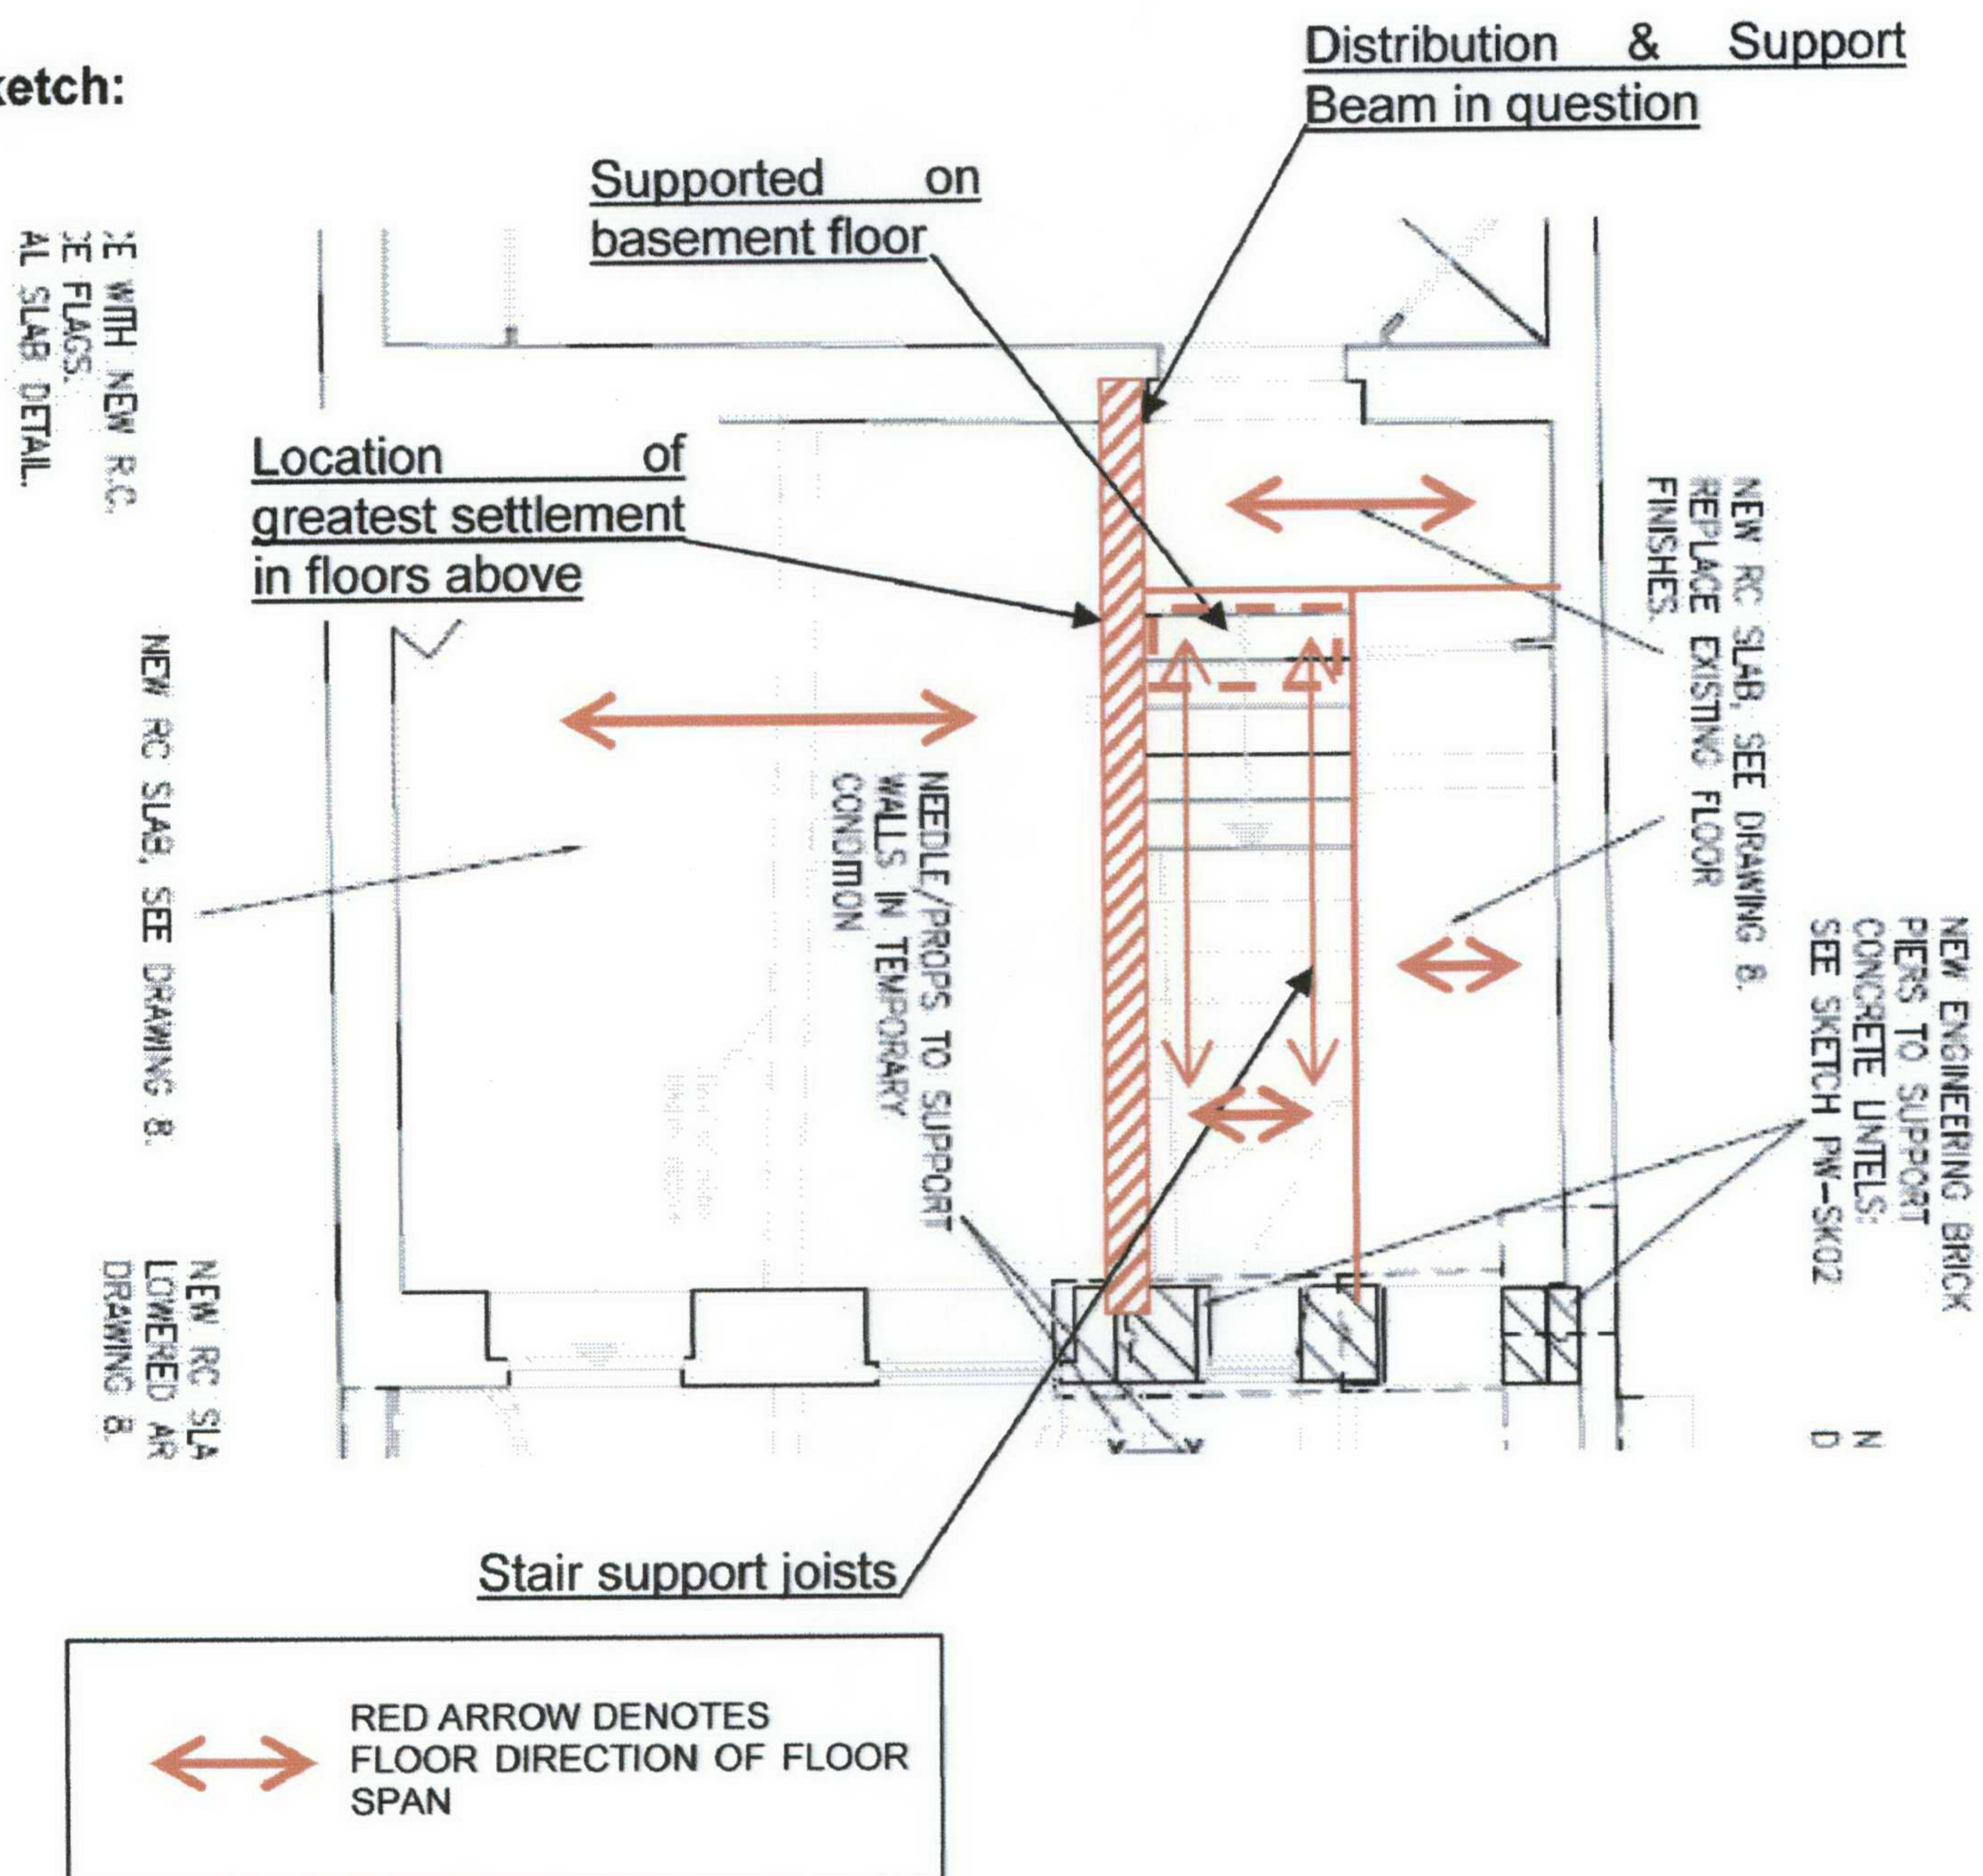
Sketch 1: Structural loading diagram

The beam denoted with red hatching below spans between the two masonry walls and provides partial support for the ground floor joists; it also provides some and distributes the remaining support for the walls and floors above, see sketch 1.

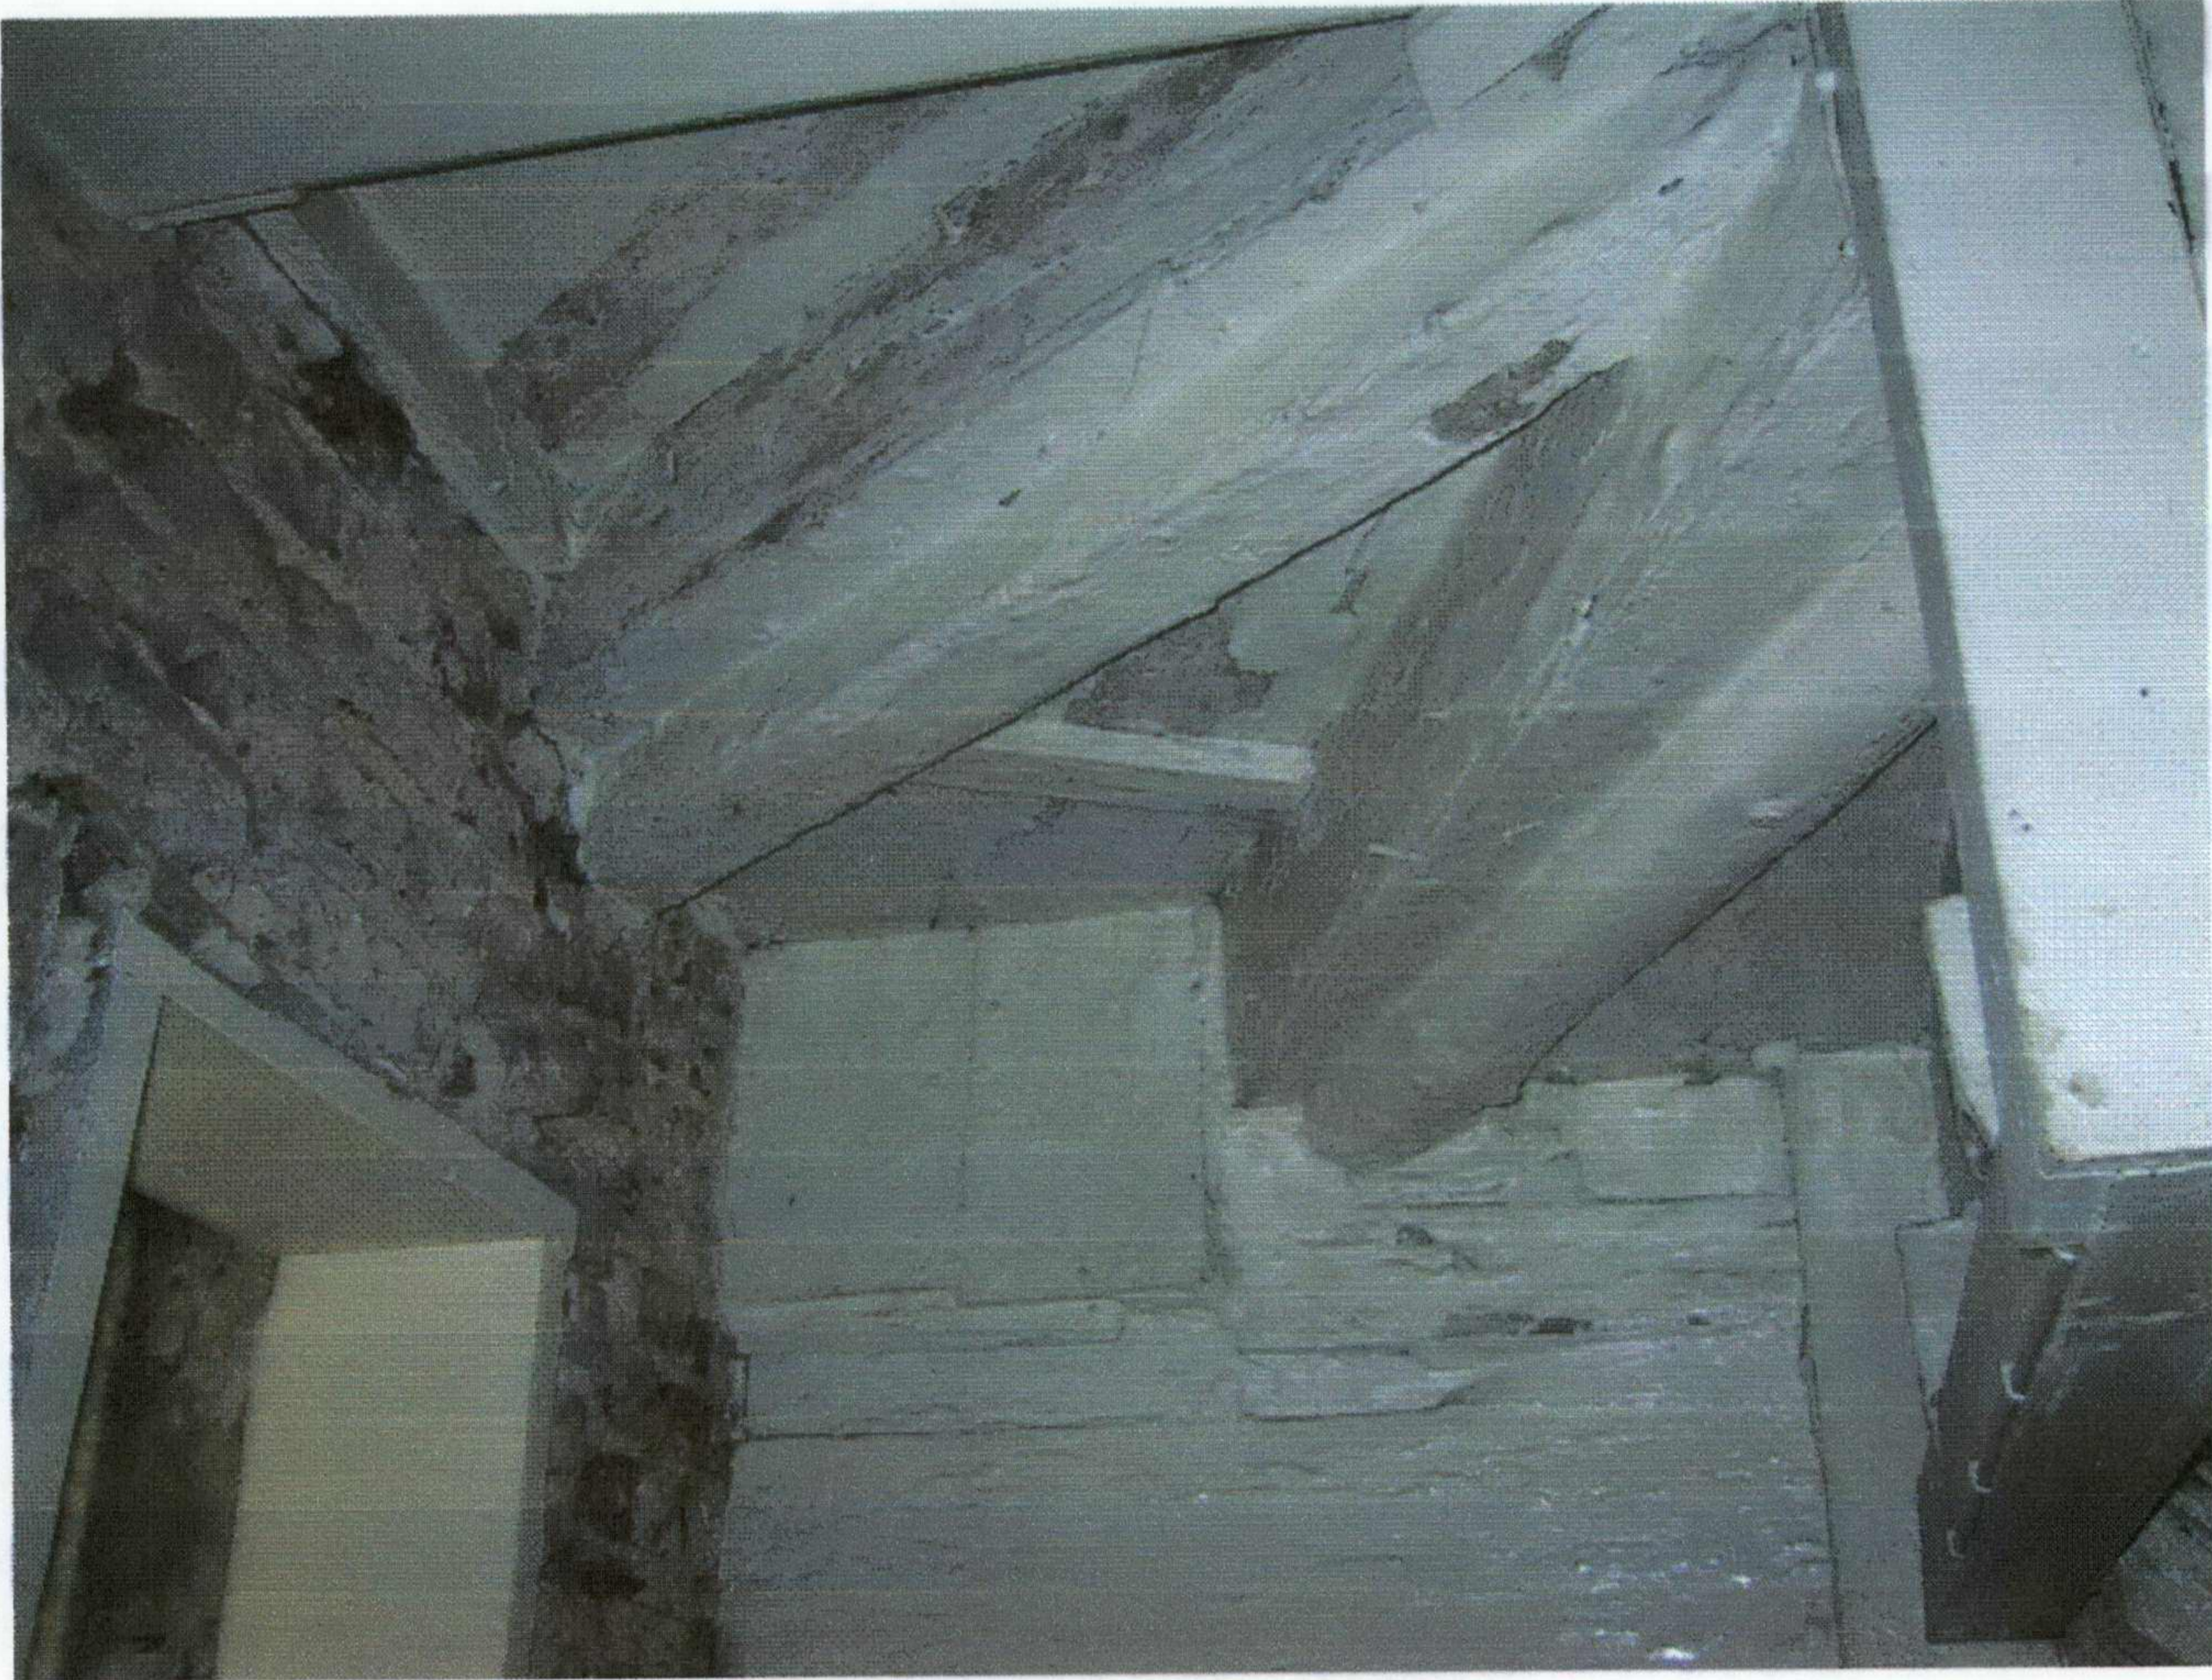
Photo 1: Stair support from wall

The below wall in the basement is carries the loads not supported by the beam. The staircase is supported off of this wall at high level, see photo 1.

To install the new beam beneath the existing wooden beam the load bearing stair wall will need to be removed for the duration of the works. This in turn requires the removal of the stair case which is in part supported off the wall. Before the steel beam can be installed the existing beam and the floor joists need to be jacked/propped to remove the applied load to the existing timber beam.

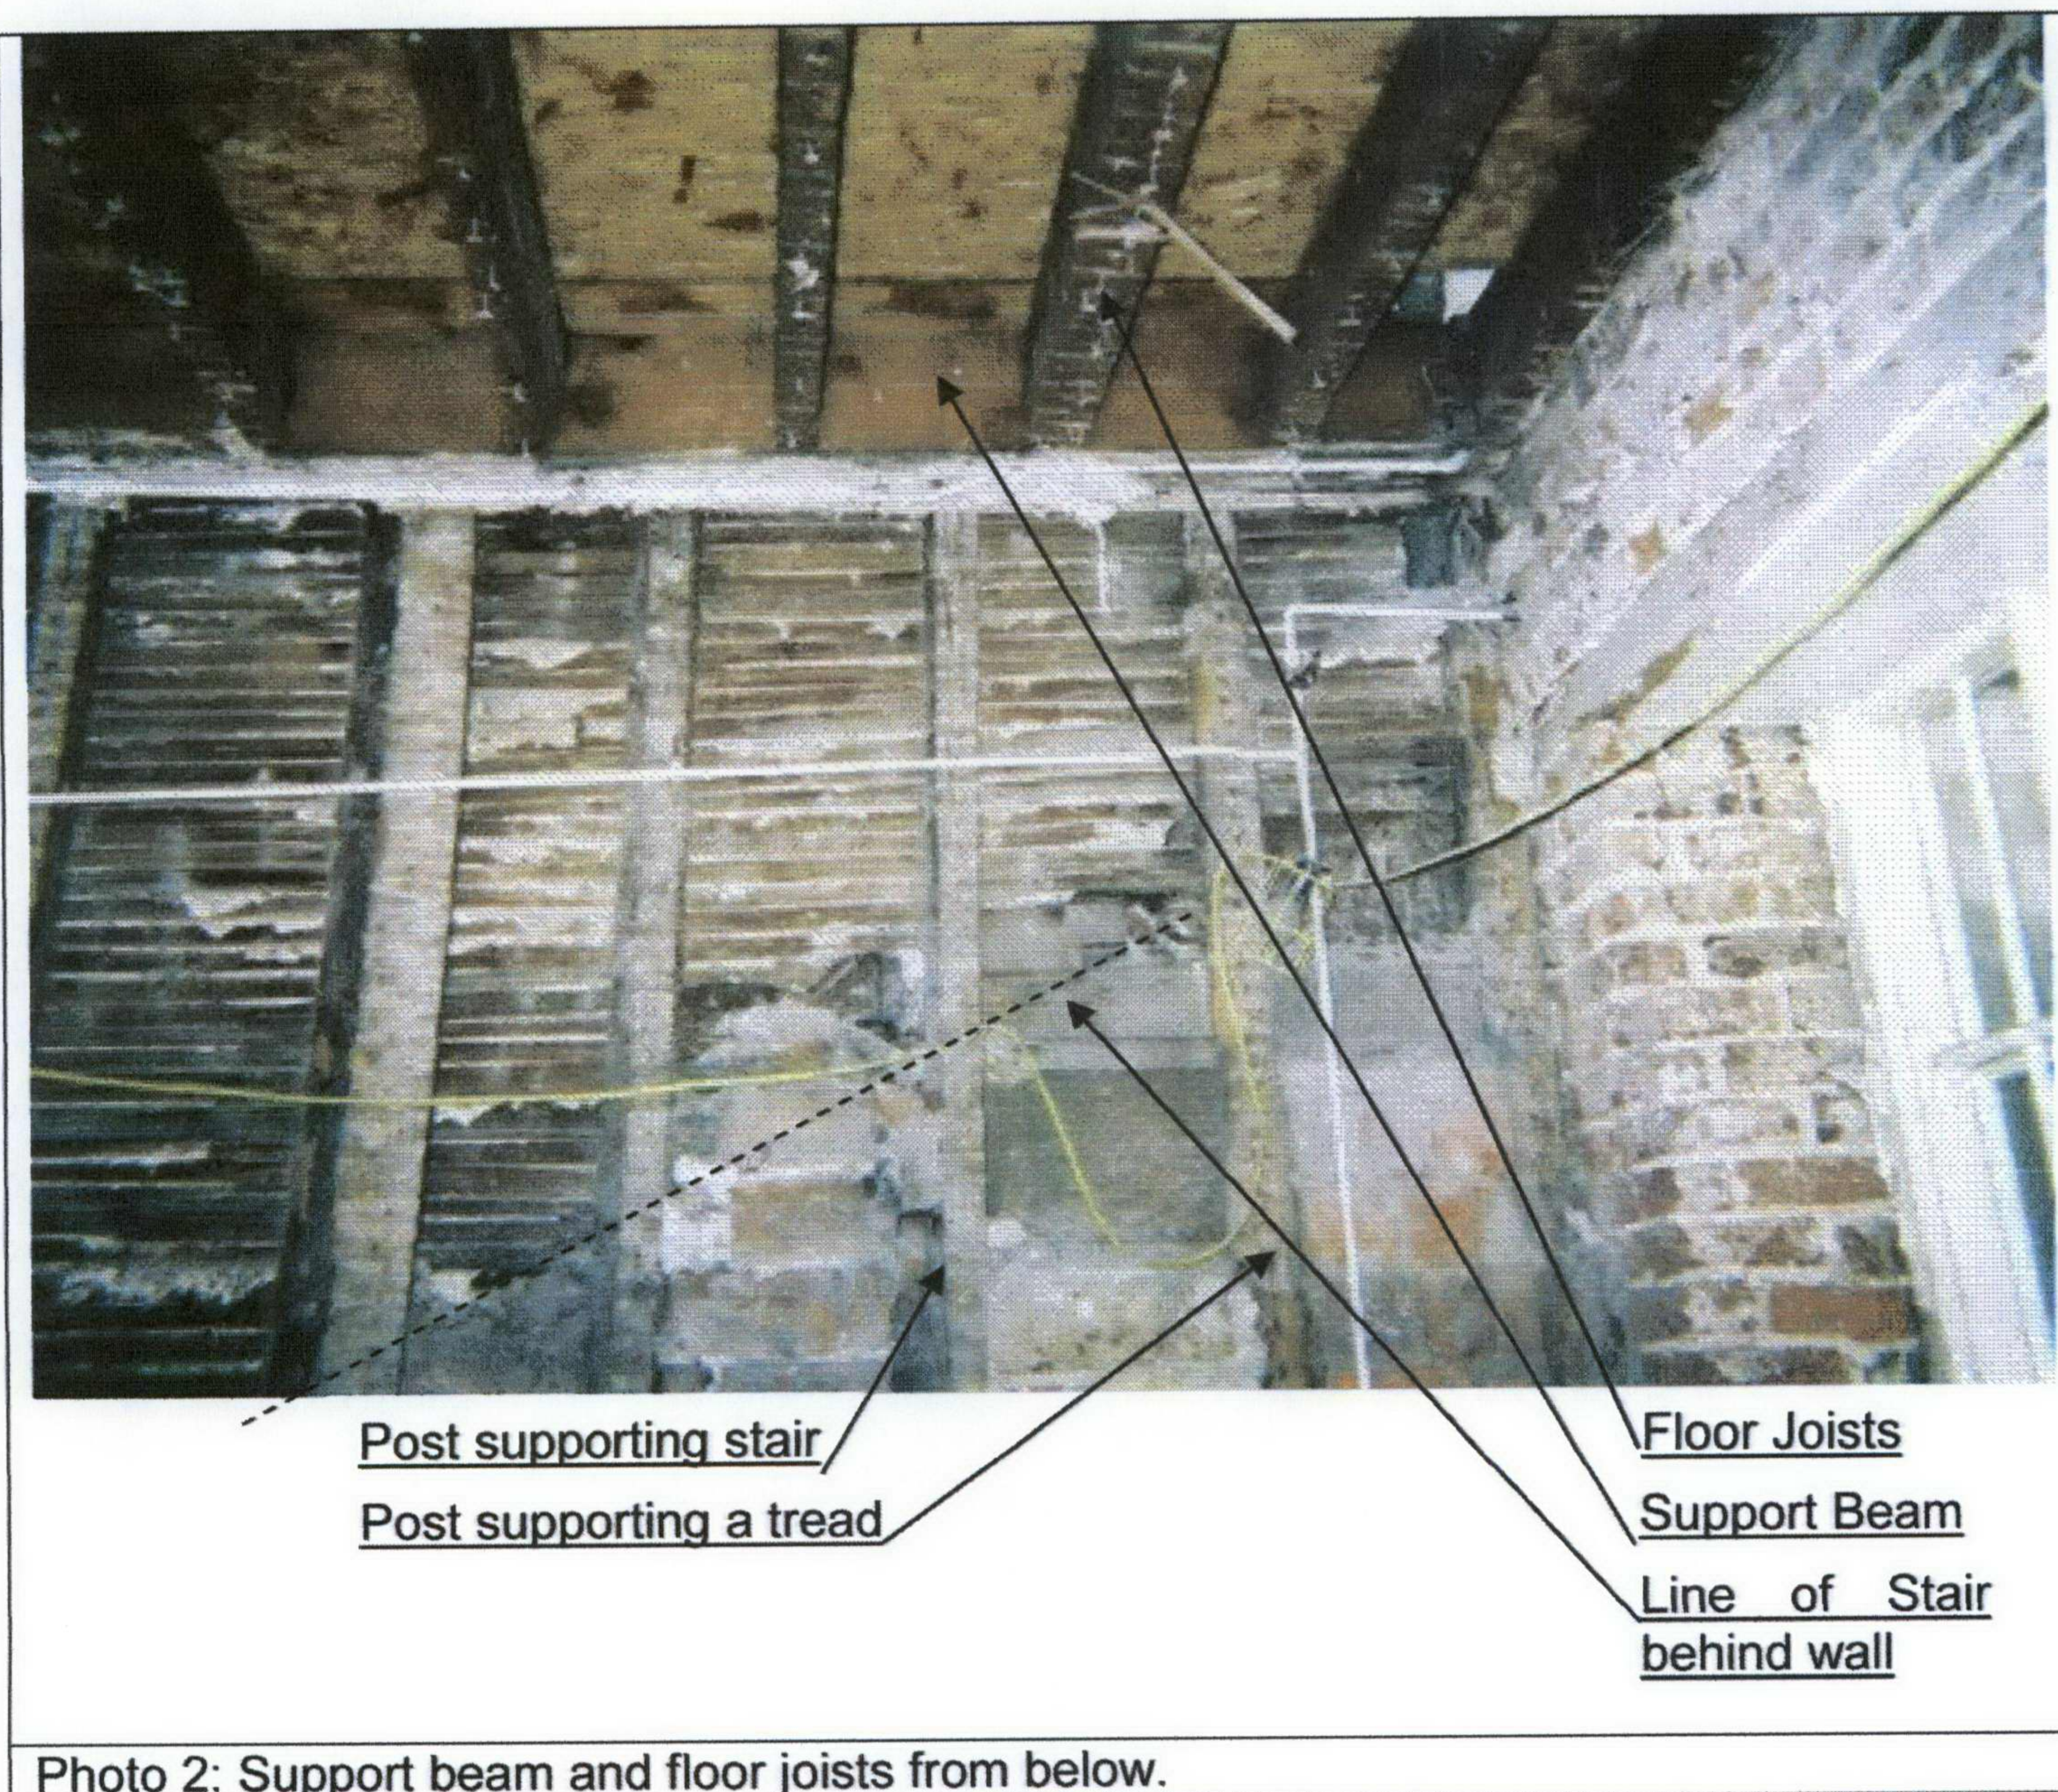
Following the removal of the wall and ceiling surfacing during renovation works the primary support beam was exposed, see photos 2 - 4. The newer timber intermediary post shown in photo 3, is positioned to provide extra support to this primary beam. It is believed that this post was not part of the original design and is a later addition to the structure to provide a temporary support due to the deterioration of the Support Beam.

The beam has excessive deflection caused by it attracting too much load as the wall below is deteriorating. This is exacerbated through the structure on the higher floors which are suffering increased levels of settlement to location of this post.

The beam does not pass the load assessment and it is recommended by this report that the beam is supported by a new structural steel section ensuring the buildings structural stability throughout its expected lifetime. The required steel beam has been initially sized as a 203UC46, this is approximately the same physical size as the existing timber beam so will fit within the wall structure and is strong enough to support the applied loads alone. Concrete padstones will be required to found the new steel beam in the masonry wall.

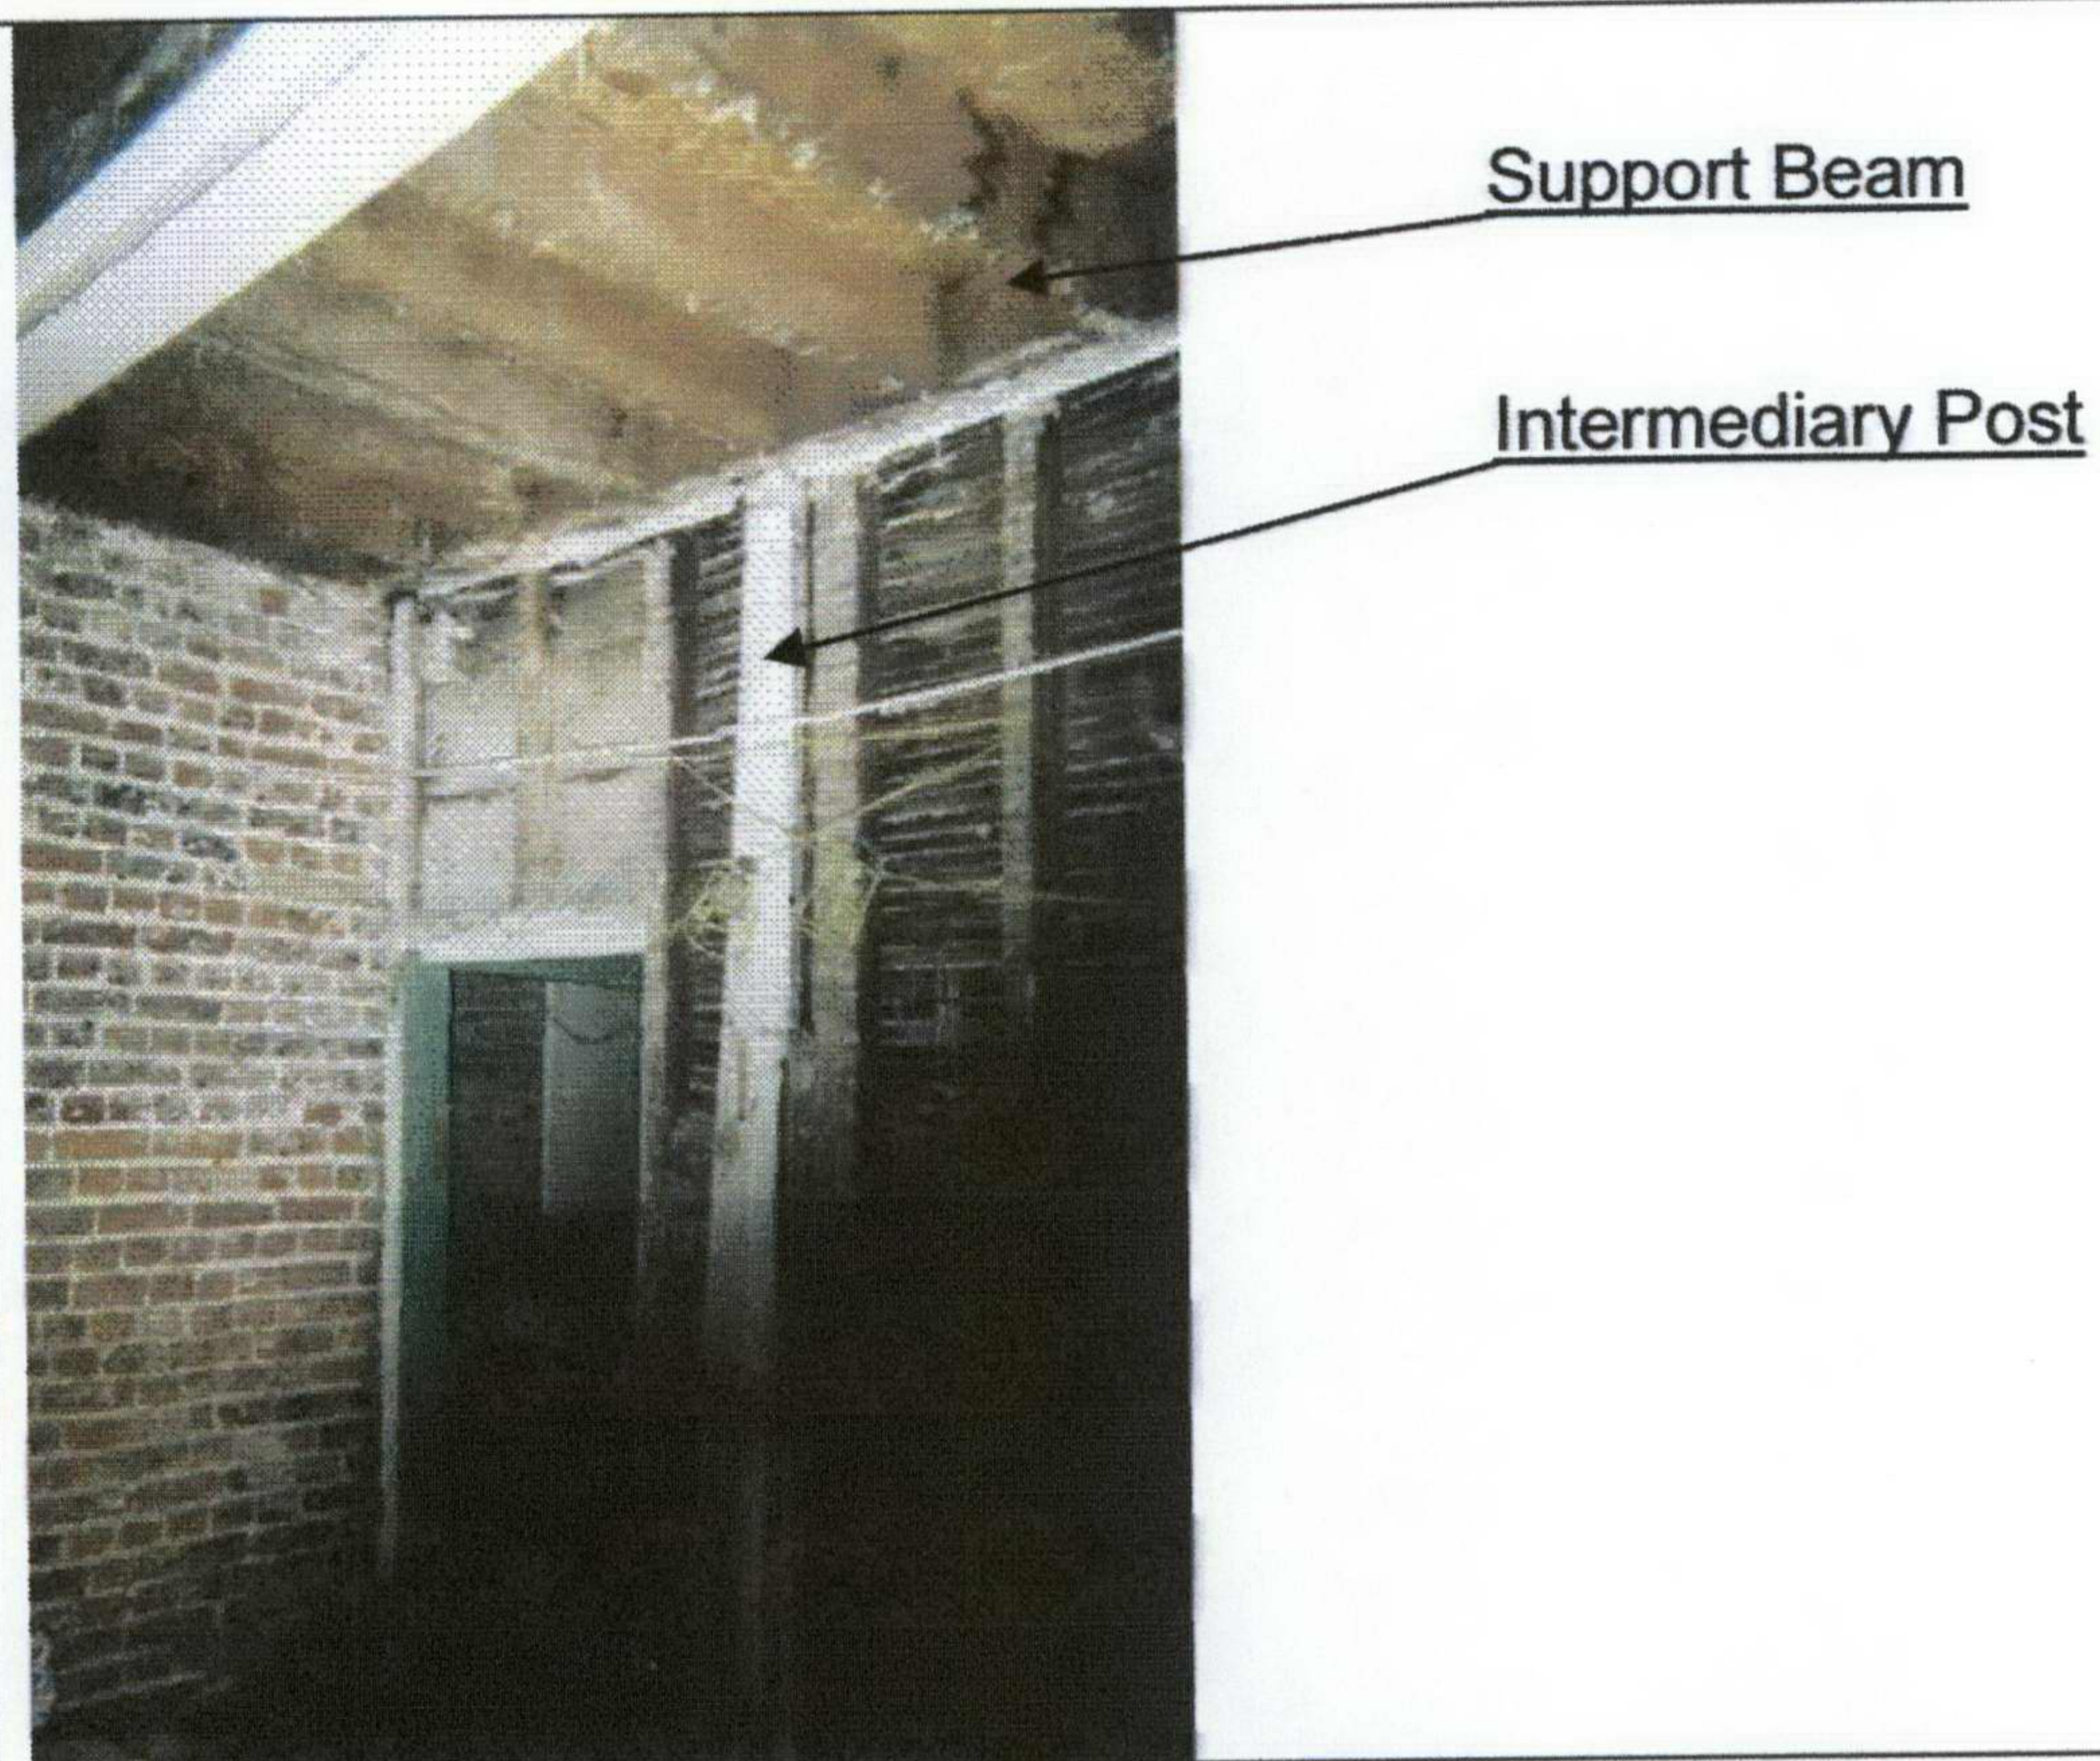
Photo 3: Support beam being supported by intermediate post.

From the first inspection the support beam appears to have suffered deterioration from a water leak above the location of the post. Further assessment confirms that the beam is not capable of carrying the applied loads alone.

1. Dismantle stair
2. Replace Vertical members in above walls
3. Prop timber beam & floor
4. Jack to remove deflection in beam, taking load into props away from wall
5. Remove wall
6. Install padstones and new steel beam directly below the existing beam
7. Slowly remove props letting beam rest on new steel beam
8. Reinstall wall beneath steel beam
9. Reinstall stair case

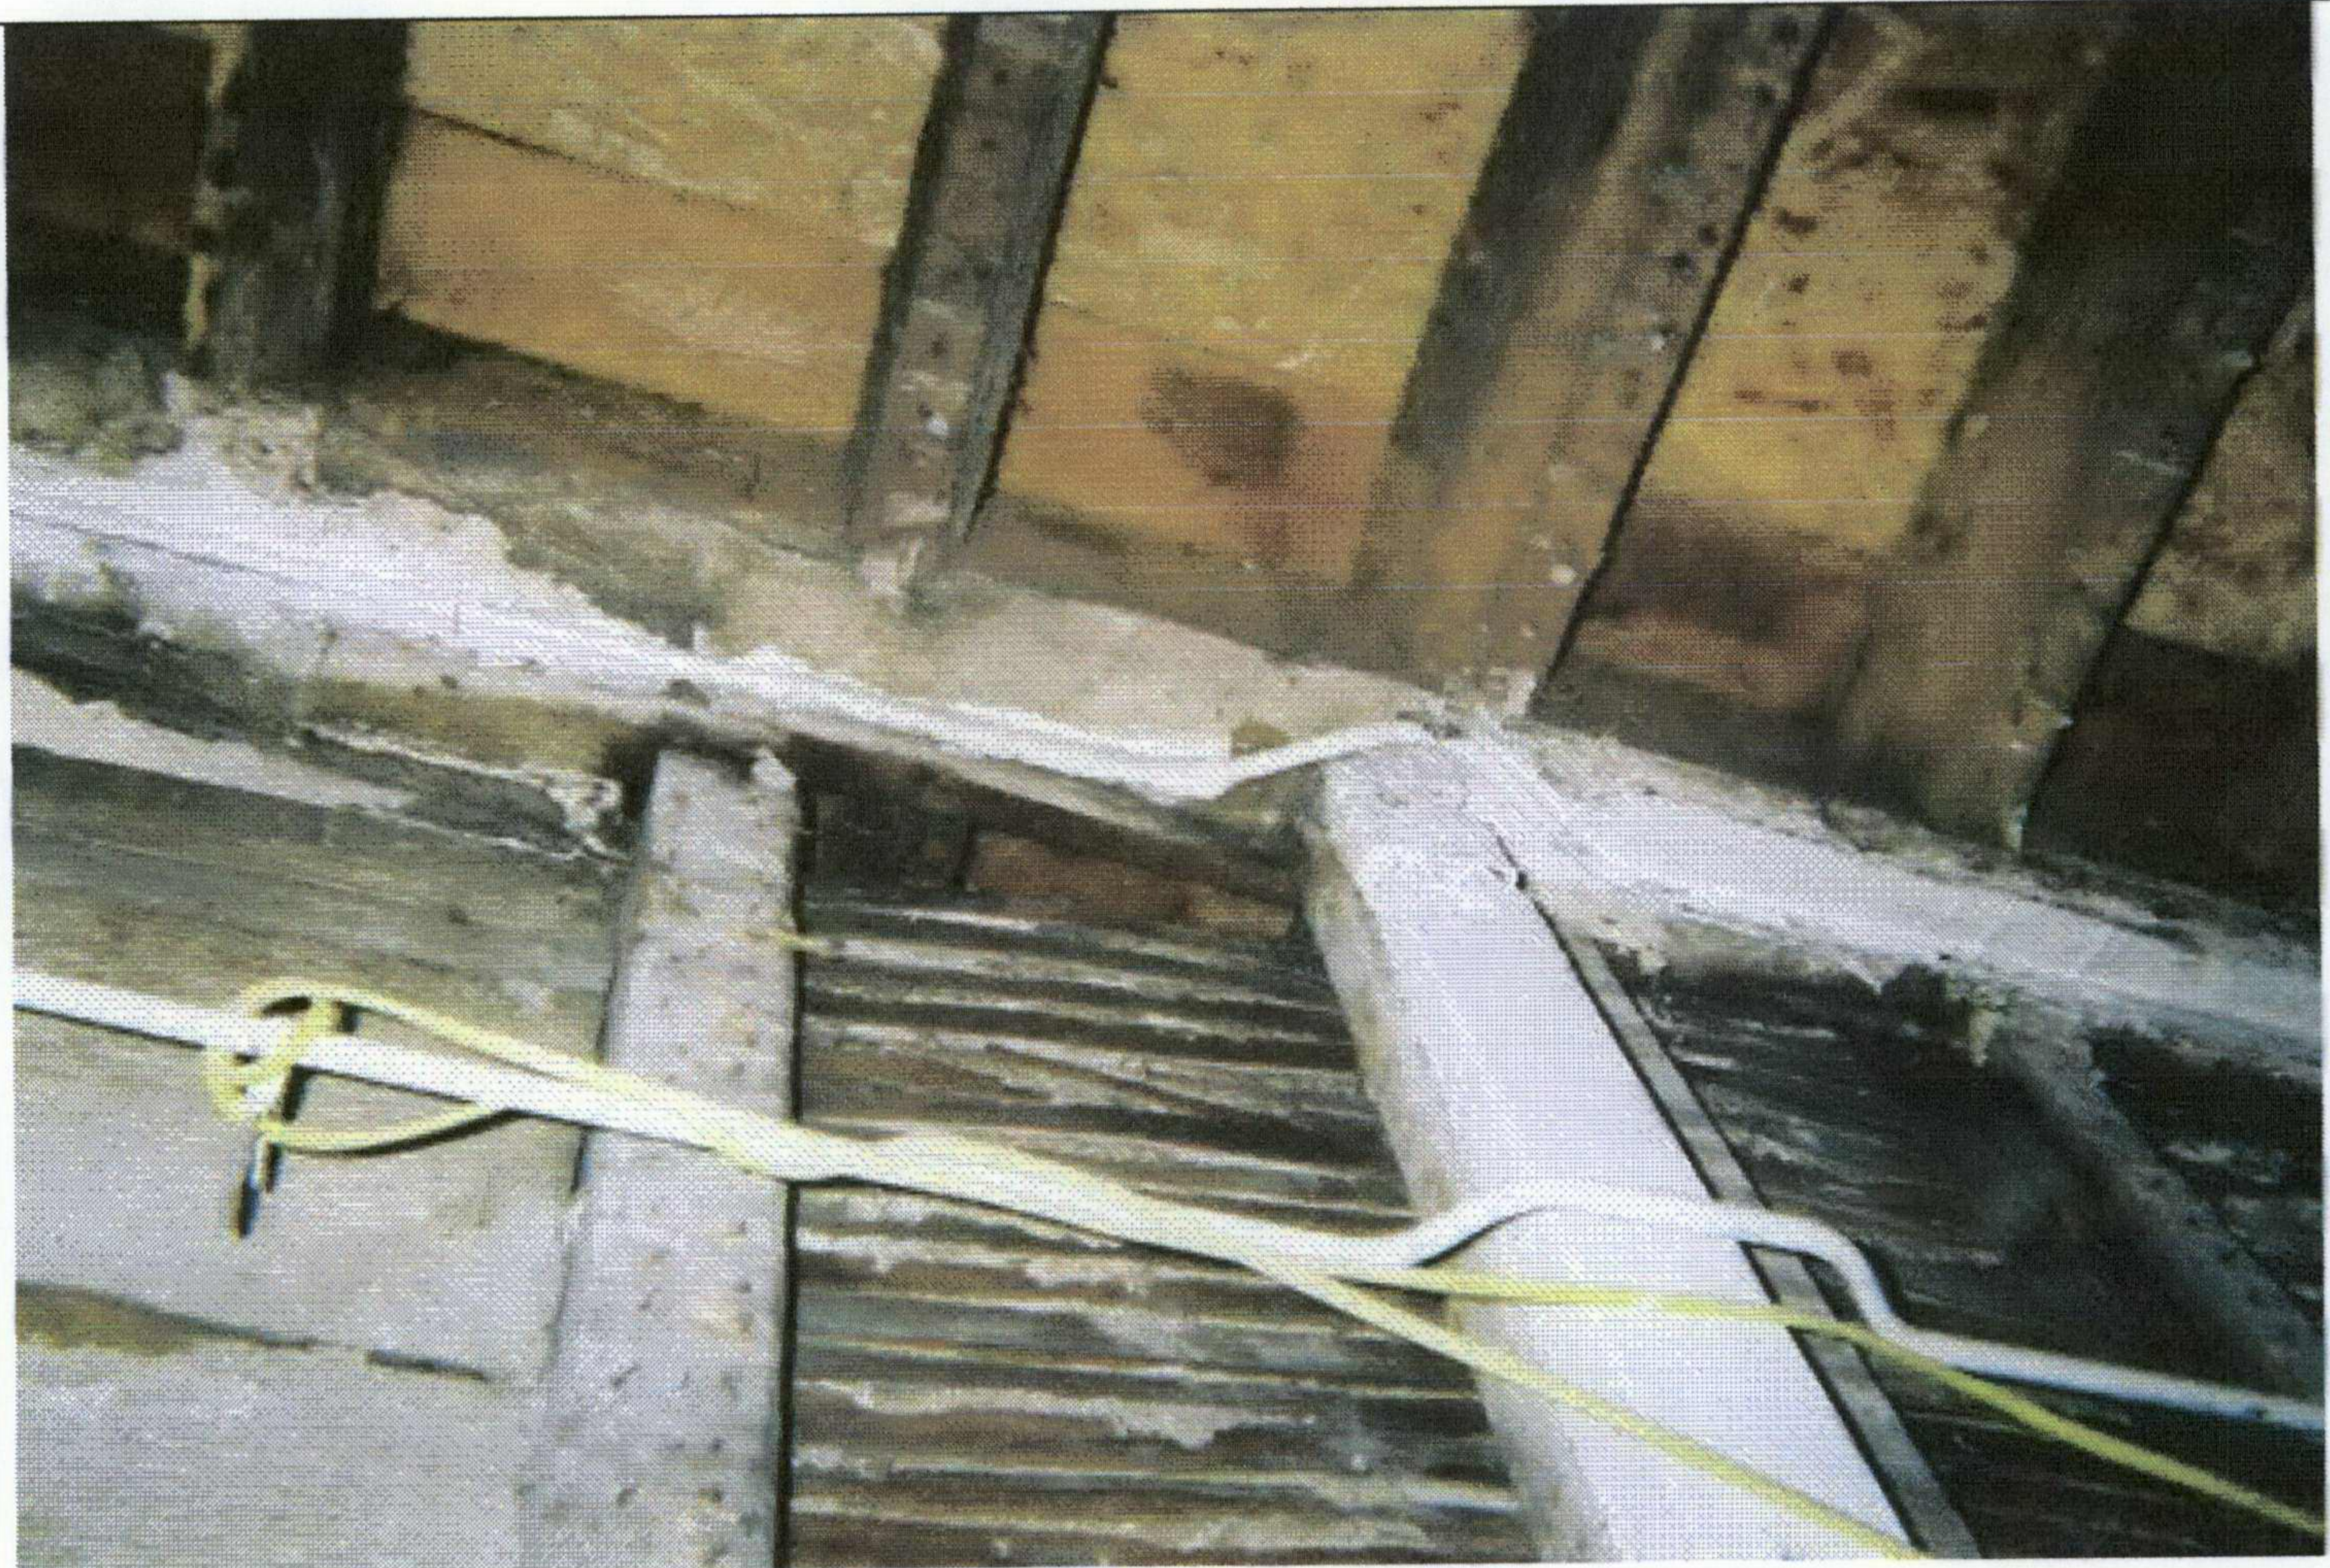
Photo 4: Close up of support beam and post.
