**Simon Pryce, Arboricultural Consultant**

**Site:** Land at rear of Prime House, Finchley Road, London, NW3

**Subject:** Trees and proposed building work

**Reference:** 07/191

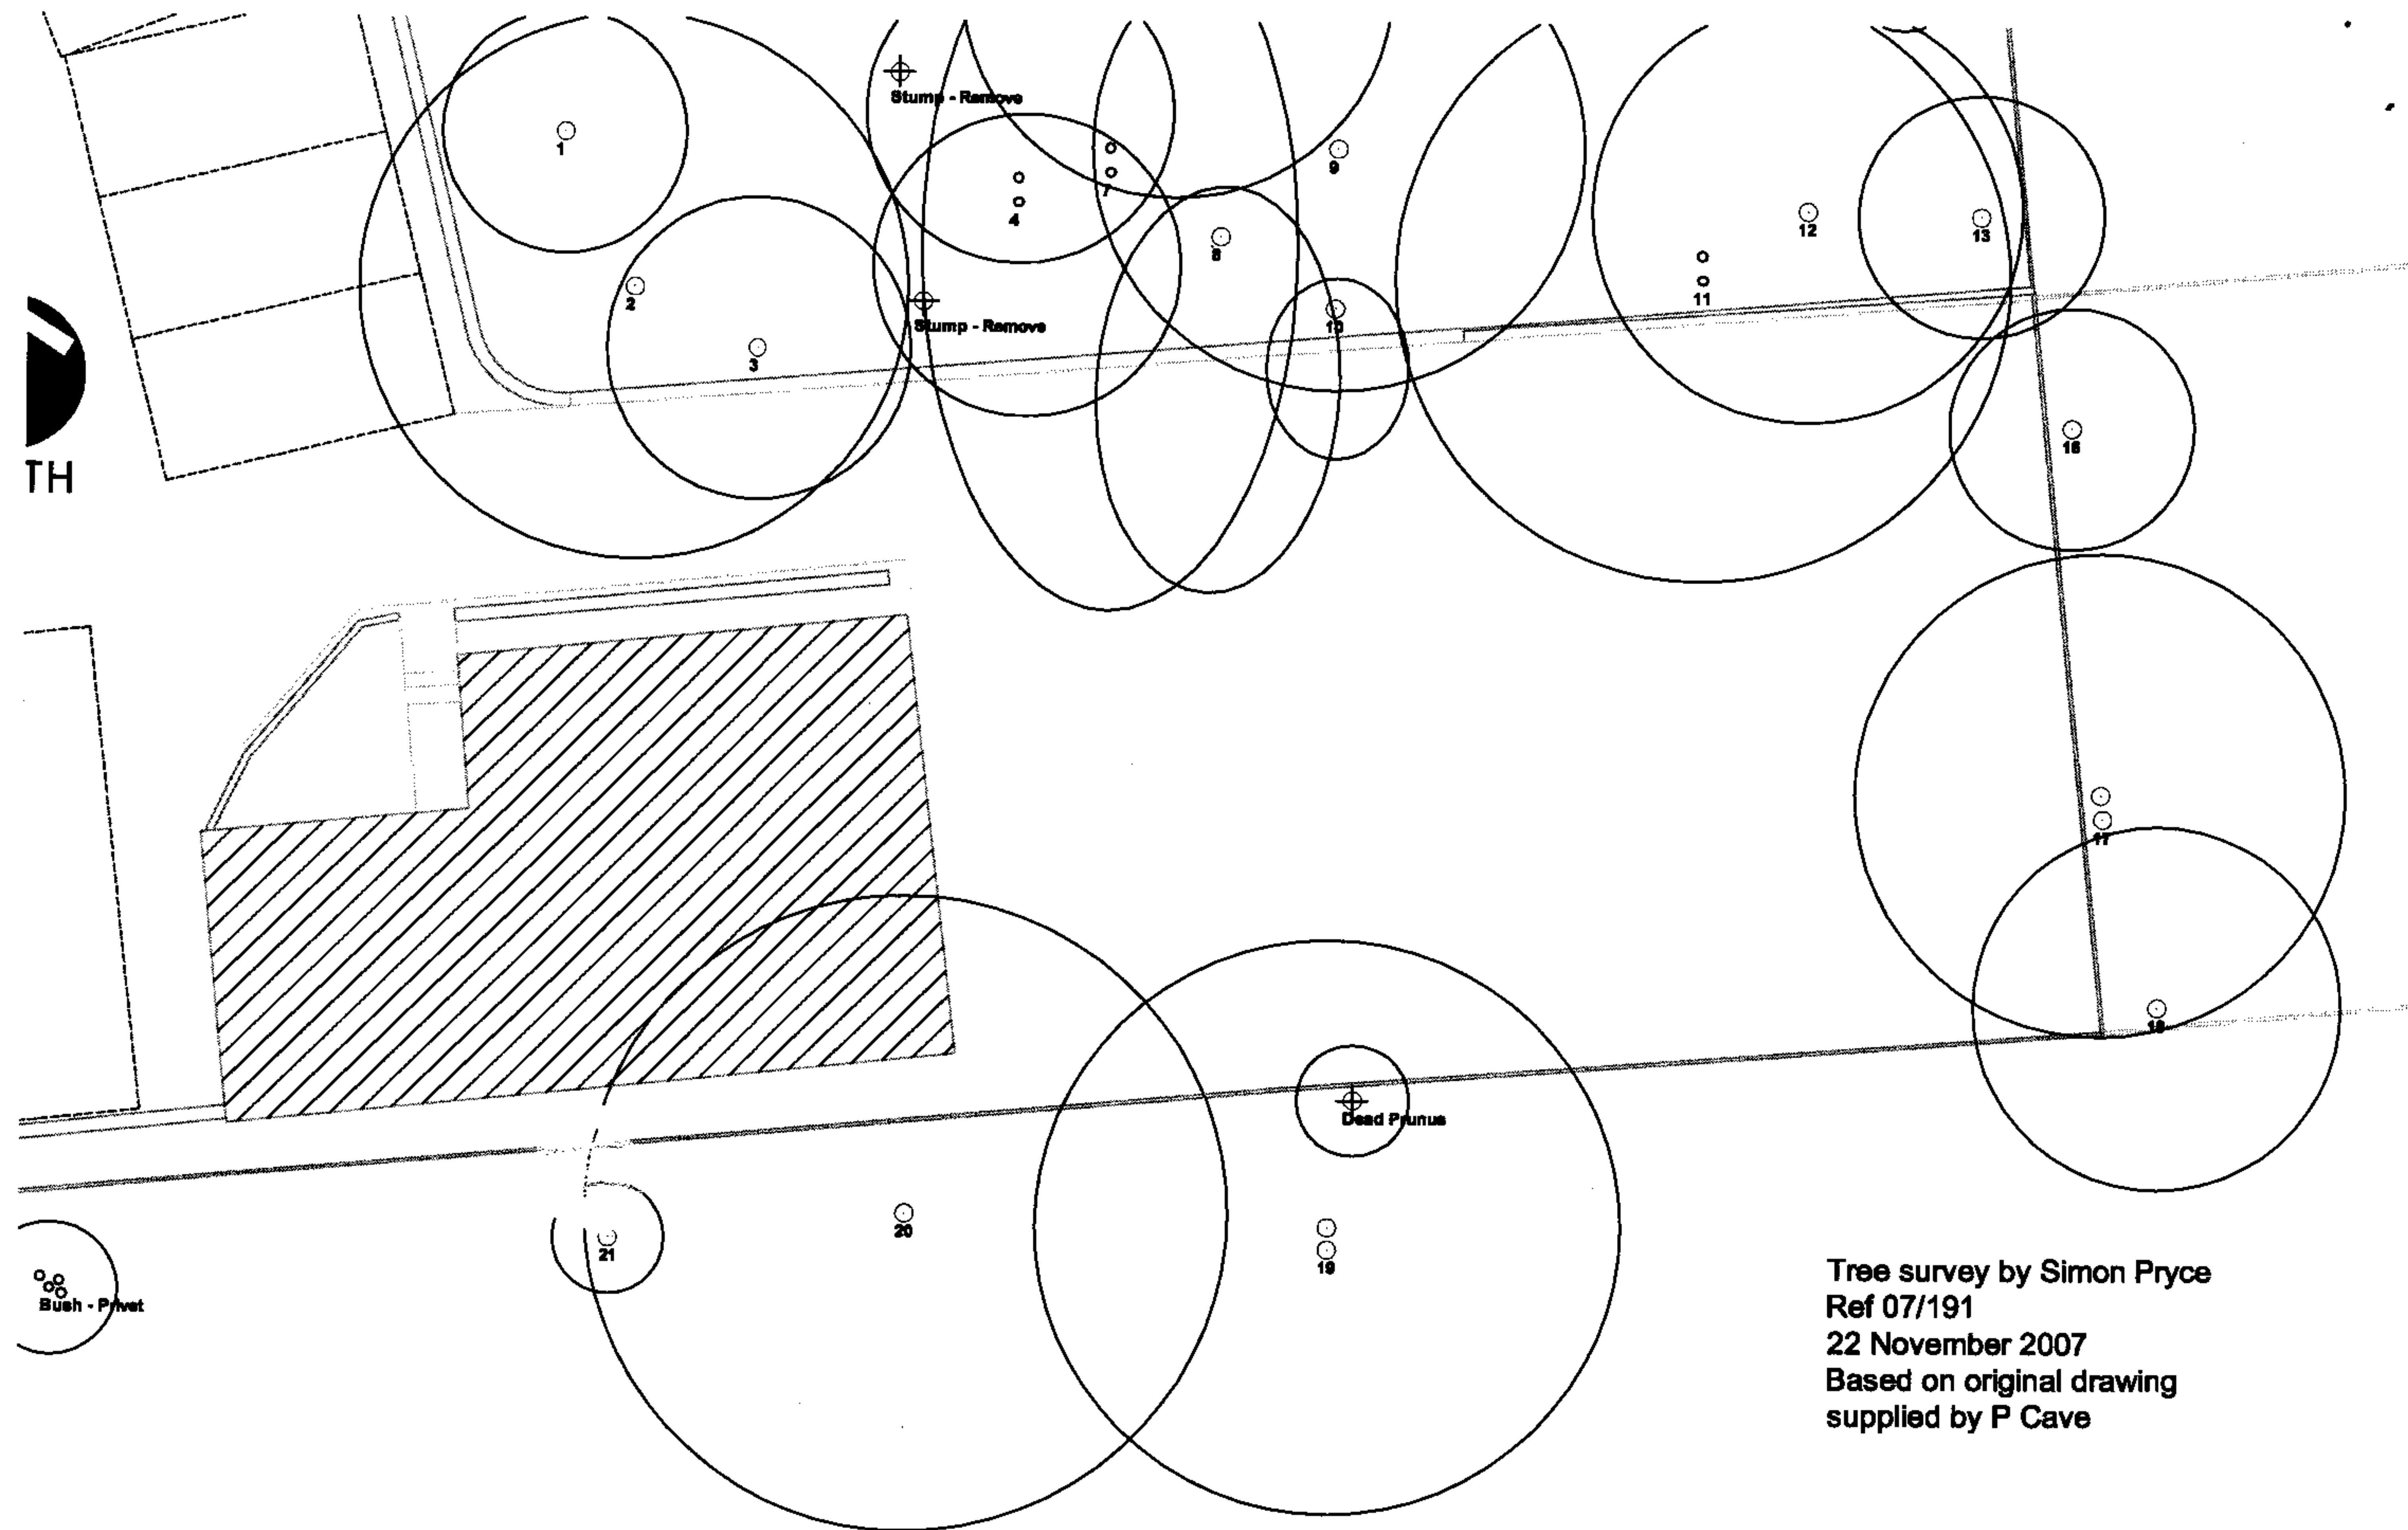
Tree survey by Simon Pryce  
Ref 07/191  
22 November 2007  
Based on original drawing  
supplied by P Cave

- 4.3 In this case the new building falls within the RPAs of trees 17, 20 and 21.
- 4.4 With tree 17 the area affected is a significant part of the RPA, but the tree is in poor condition and has a severely limited safe useful life expectancy. If it is retained a small amount of crown pruning would be required to accommodate the building superstructure, but this would be limited to a few minor low branches.

- 4.5 In the case of tree 20 the proportion of the RPA crossing the boundary into the site is small and the tree has almost unlimited space for root growth in other directions, so it is highly unlikely to be affected adversely by ground work. Crown overhang into the site is also minimal, so only minor pruning would be required.

- 4.6 With tree 21 a larger part of the RPA extends into the site. The comments below apply if it is retained, but its condition is not entirely clear at present and there is evidence that it has defects that might well warrant felling. Even with the ivy cleared it would not be a particularly good specimen. The existing building will restrict root growth to some degree, but the cracks in the walls suggest that at least some roots have grown into the clay under the foundations. However at this range these will be the fine absorbing roots rather than main structural ones and the loss of a moderate amount of these will not affect the tree adversely. At this point the nearest section of the new building is set back, so the foundations are just outside the RPA, with the upper storeys cantilevered towards the boundary. Some work will inevitably take place within the RPA, so the ground will need to be protected while this is in progress and any new surface will need to be permeable and laid with minimal or no excavation.

- 4.7 In addition the tree's crown will need to be pruned to clear the upper storeys of the new building. This would involve complete removal of some of the lower and mid height branches on the north side and some pruning of the south side would be advisable. It would be left somewhat one sided, but the new building would make this less apparent and it is not uncommon in trees near large structures.
