7 Prince Albert Road
structural engineering

main staircase

client: IRIS INVESTMENTS LTD
address: GREENACRES
BUNKER HILL
L'ANCRESE
GUERNSEY, GY3 5JT
project no: 430

7 Prince Albert Road
structural works to main stair

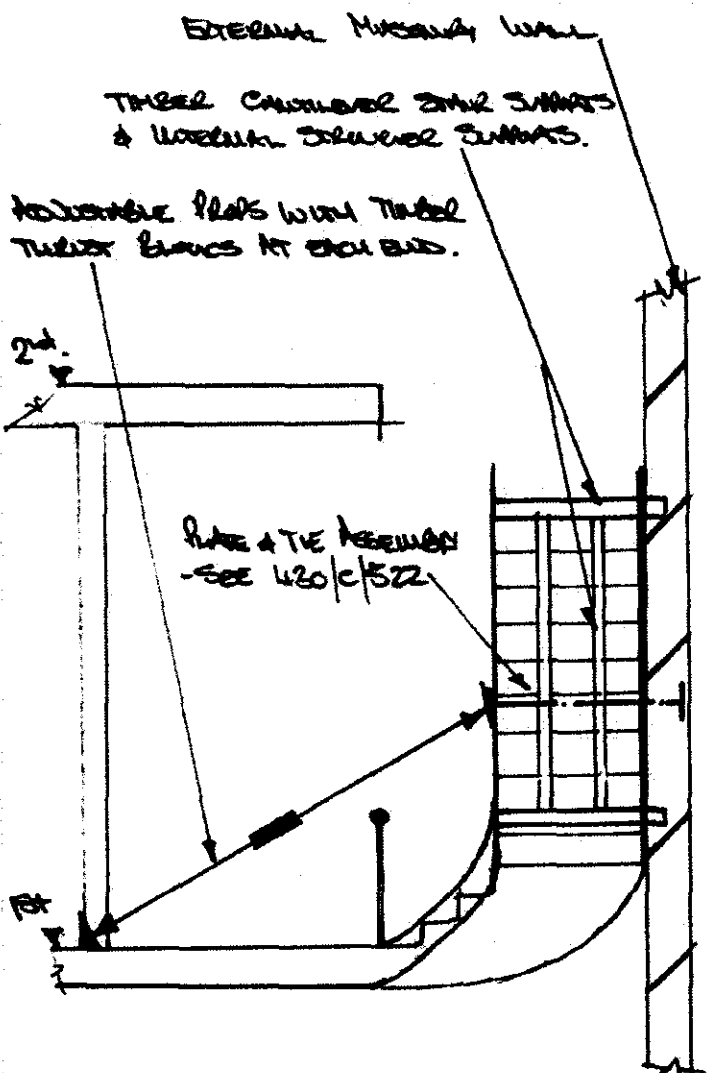
INDICATIVE SECTION.

The existing staircase from first to second floor has over time eased away from the external wall and slopes towards the centre of the stair. The central tread being 55mm out of level.

The proposal seeks to use externally fixed ties to draw the staircase back to the external wall and refix the treads and risers to the original cut stringer fixed to the wall.

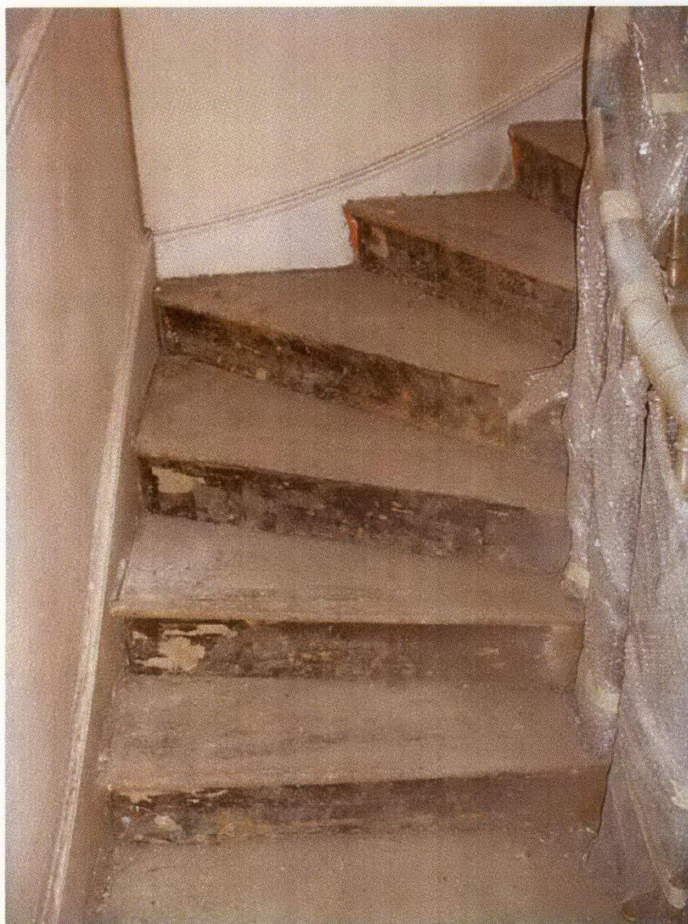
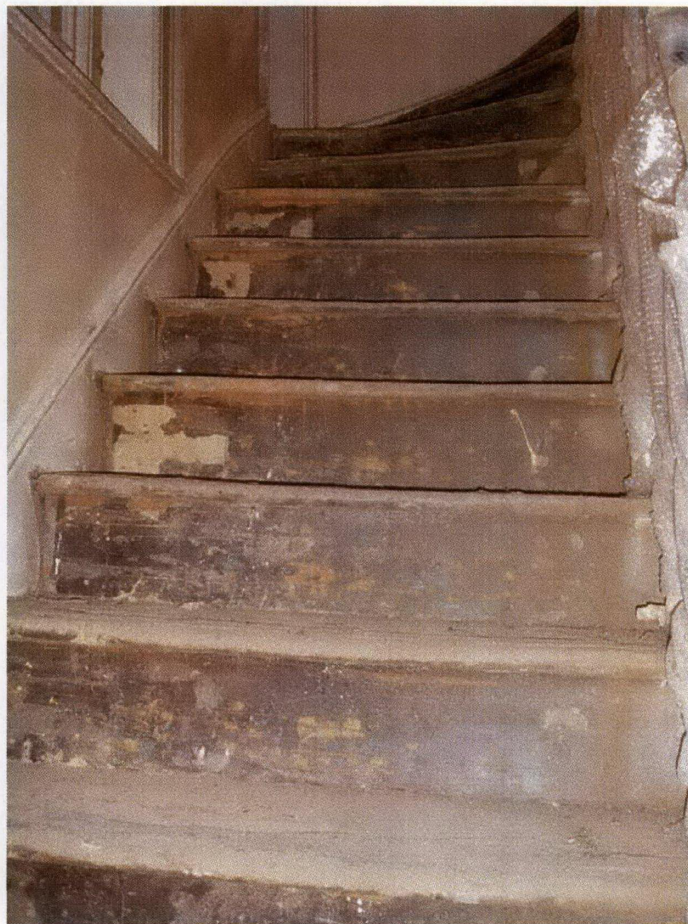
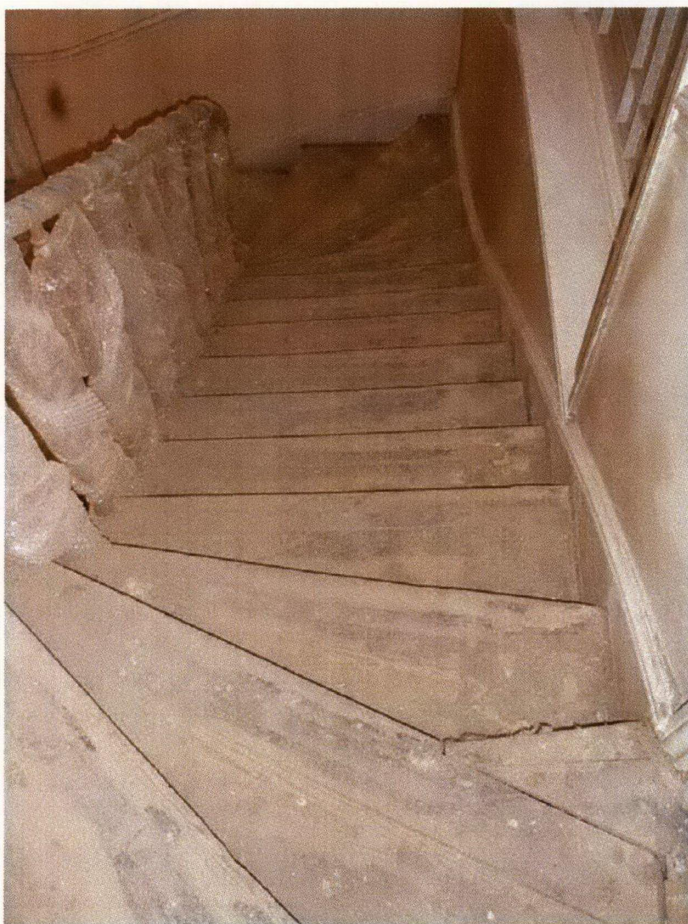
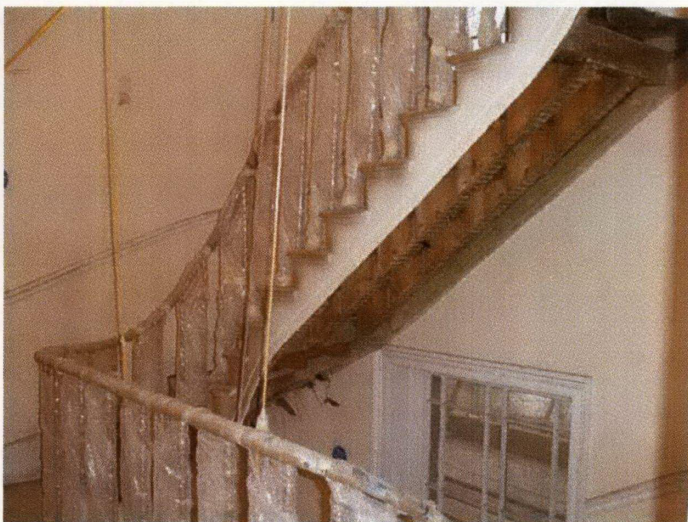
Stair Geometry

The staircase consists of 6 winders at the top and bottom with a straight flight of 8 treads parallel to the external wall.

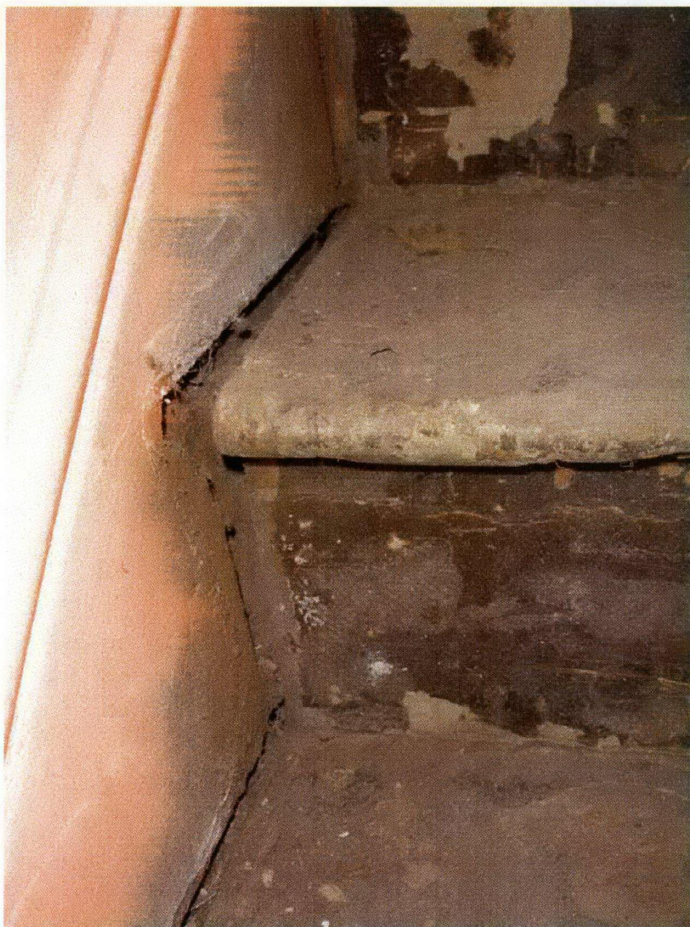
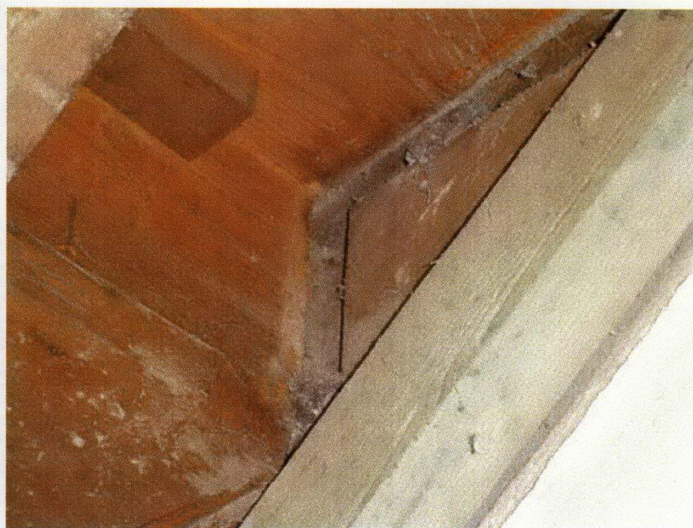
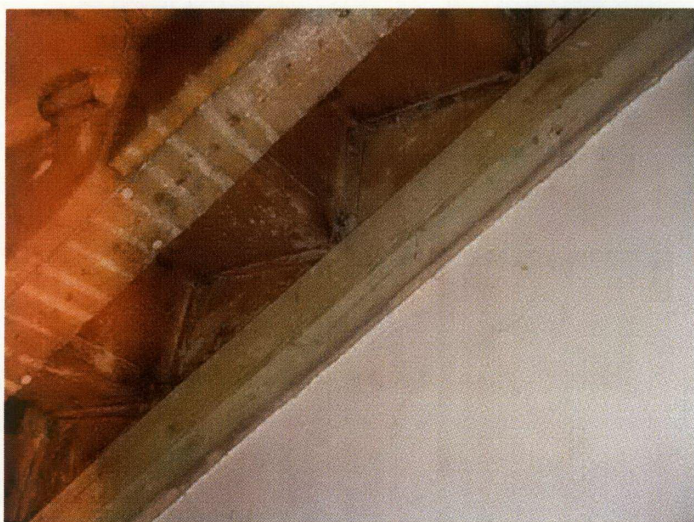
Opening at Cut String & Missing Wedges

11. When stair is fully adjusted lock off external nut on tie rod.
12. Install hard wood wedges into the cut stringer to the underside of the treads and risers.

13. Inspect and refix any loose hardwood wedges.
14. Use 2"x1" softwood blocking to screw fix tread and cut stringer. (This replicates existing detail)
