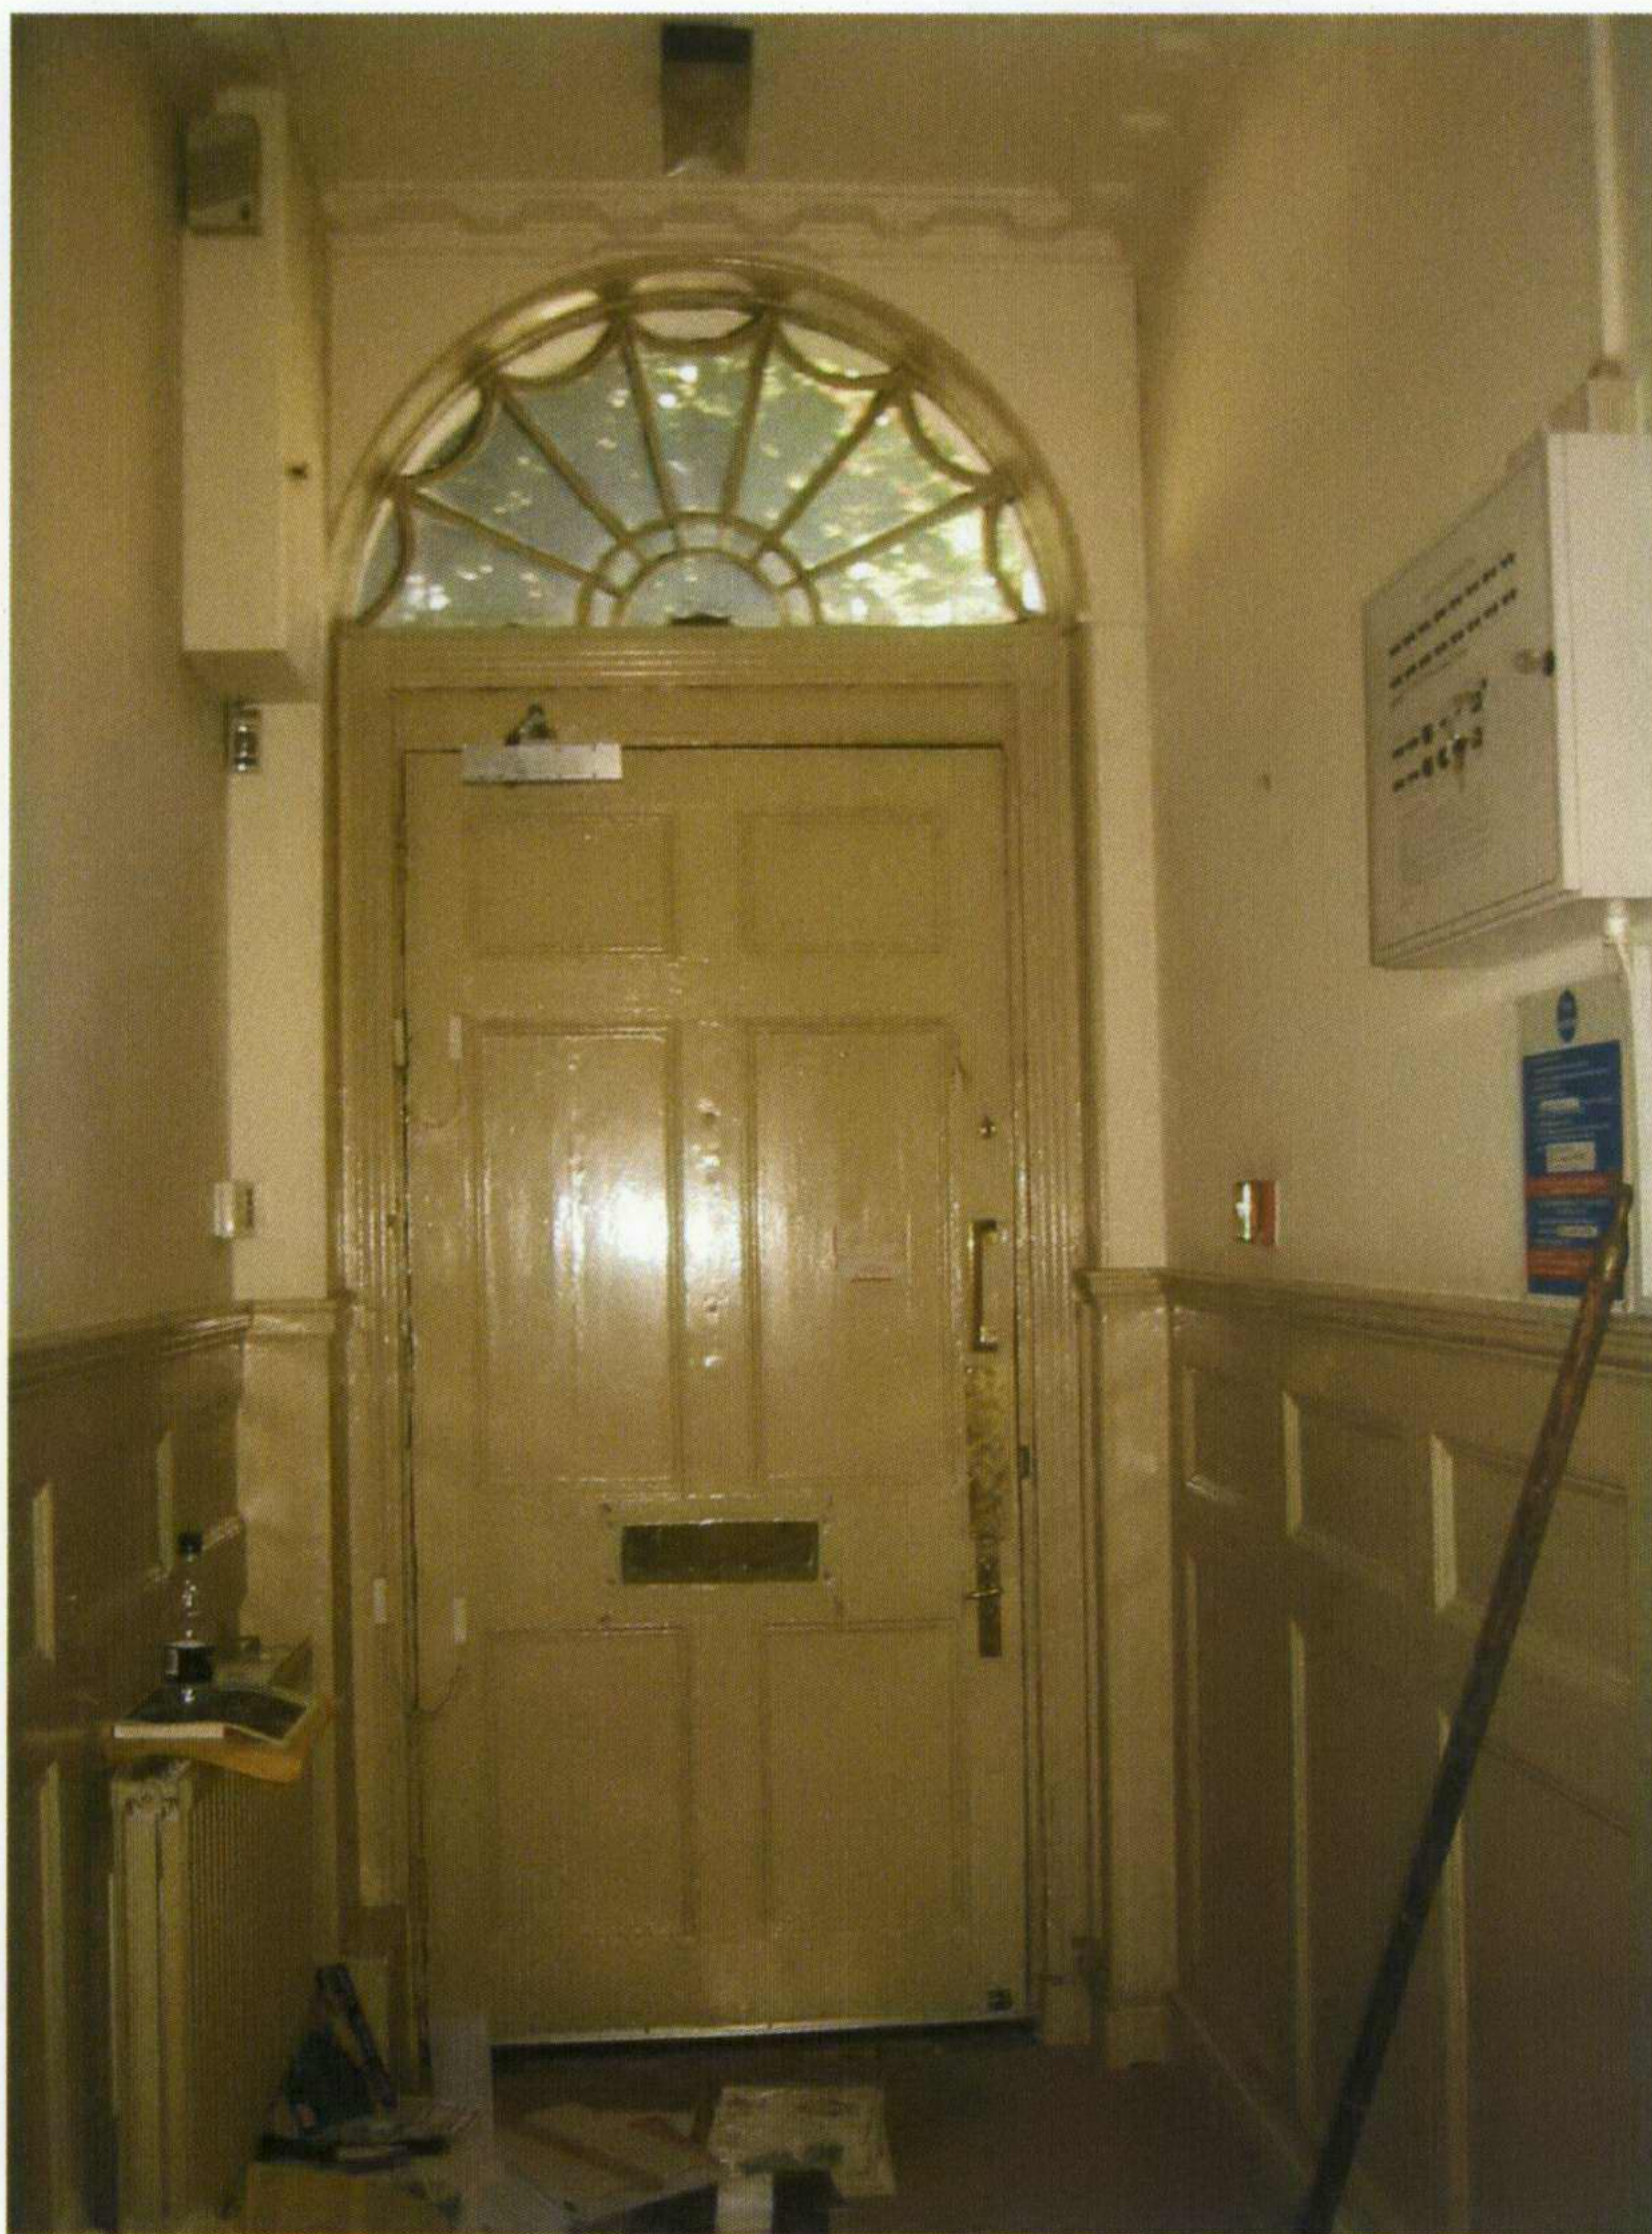
Photograph 16. Back of front door. Much good original detailing but obtrusive services.

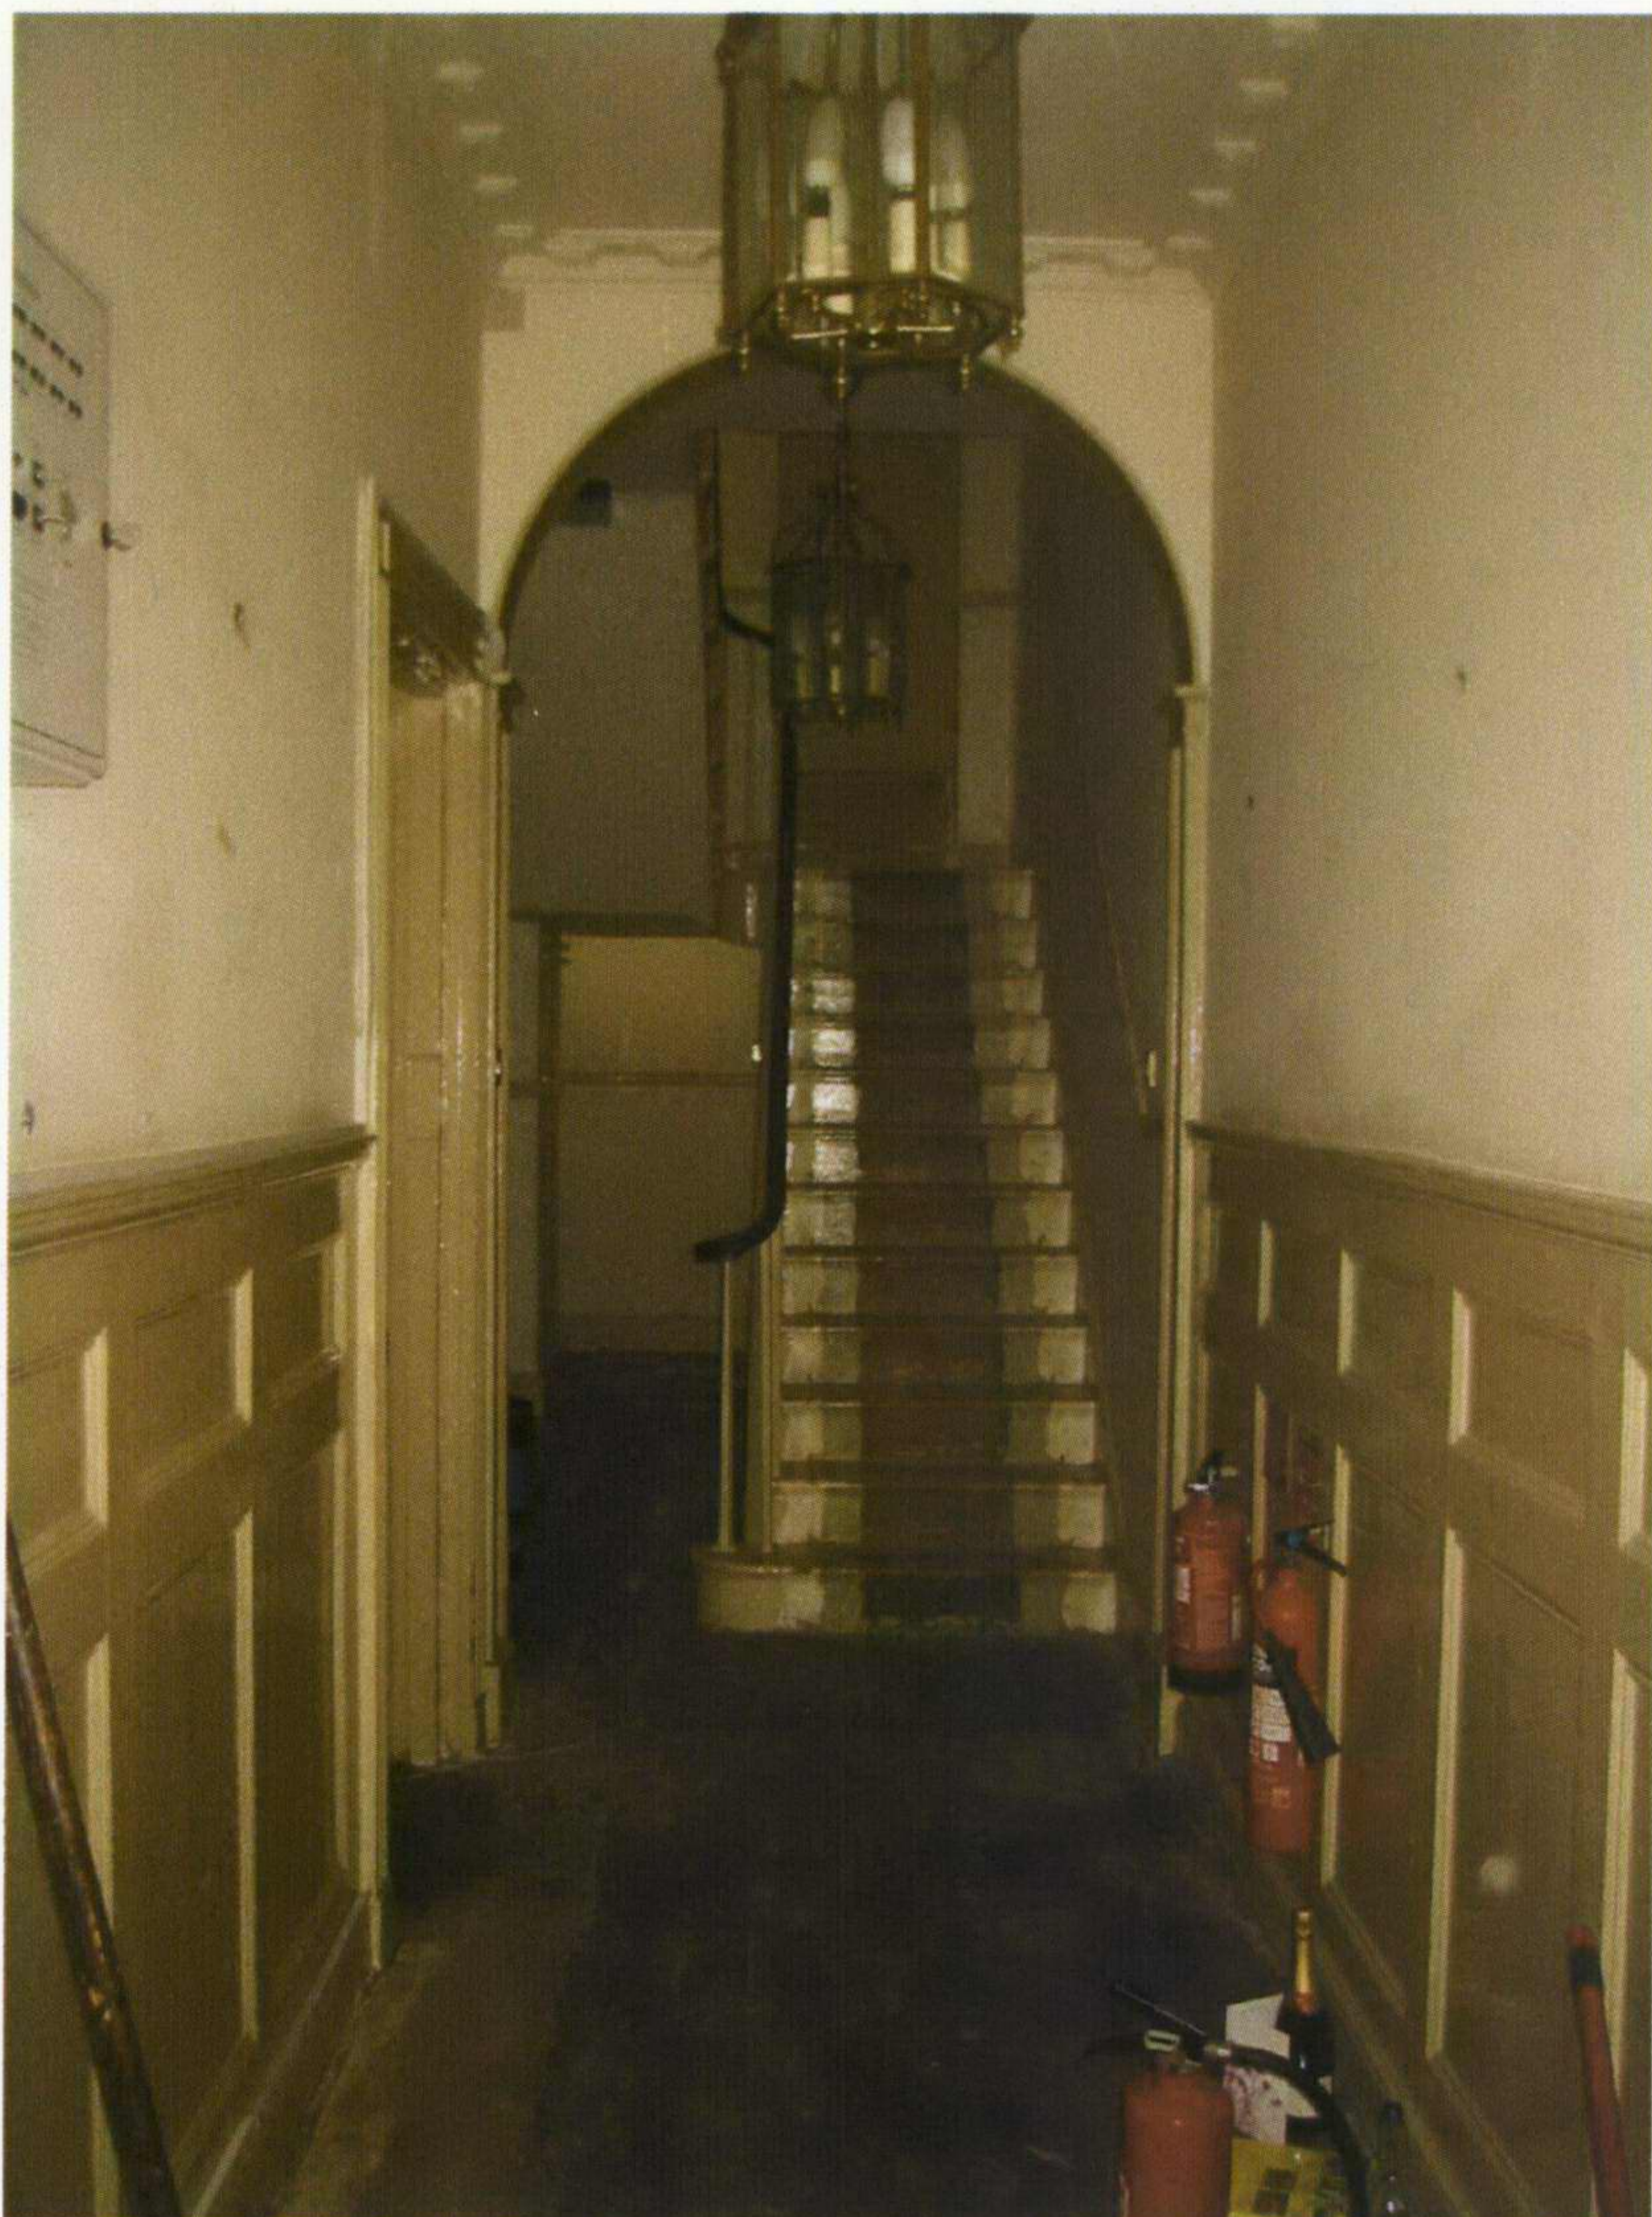
Photograph 17. Looking through the hallway from the front; there is no light at the end of the hall or from the landing due to the modern interventions.

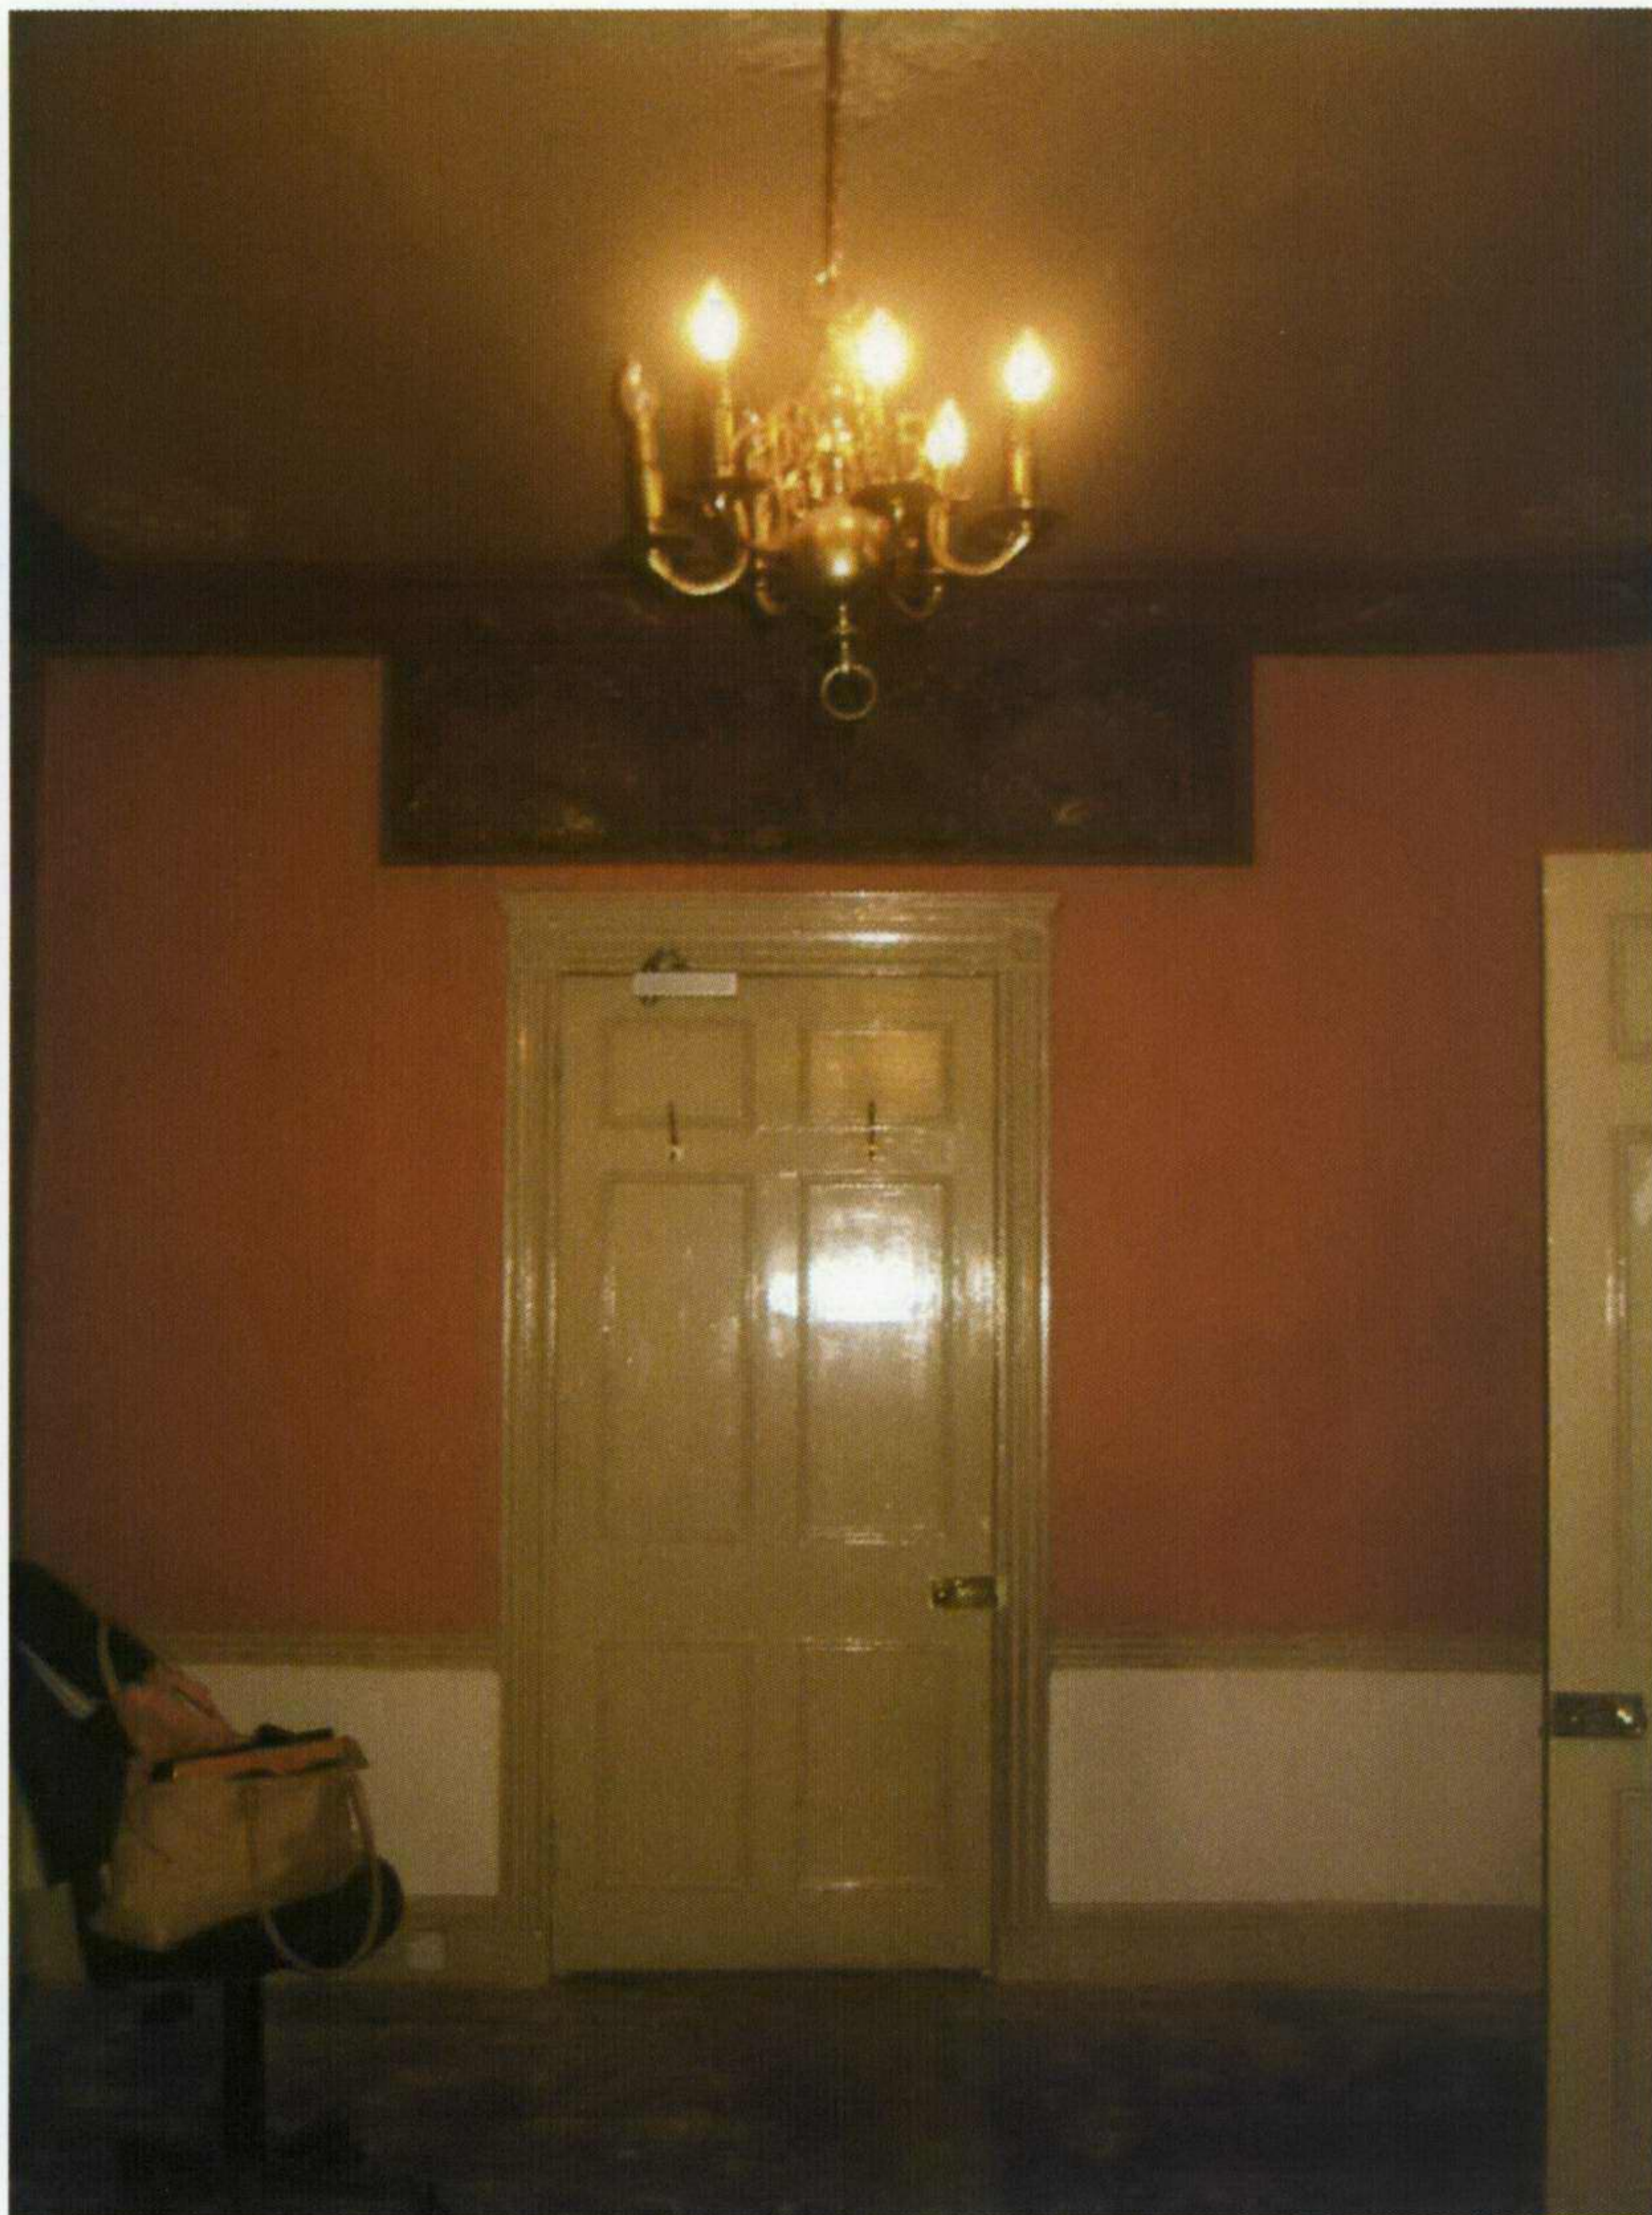
*Photograph 18. Ground Floor. Original door in wrong location (to be resited to hallway). Interconnecting rooms recently blocked up.*

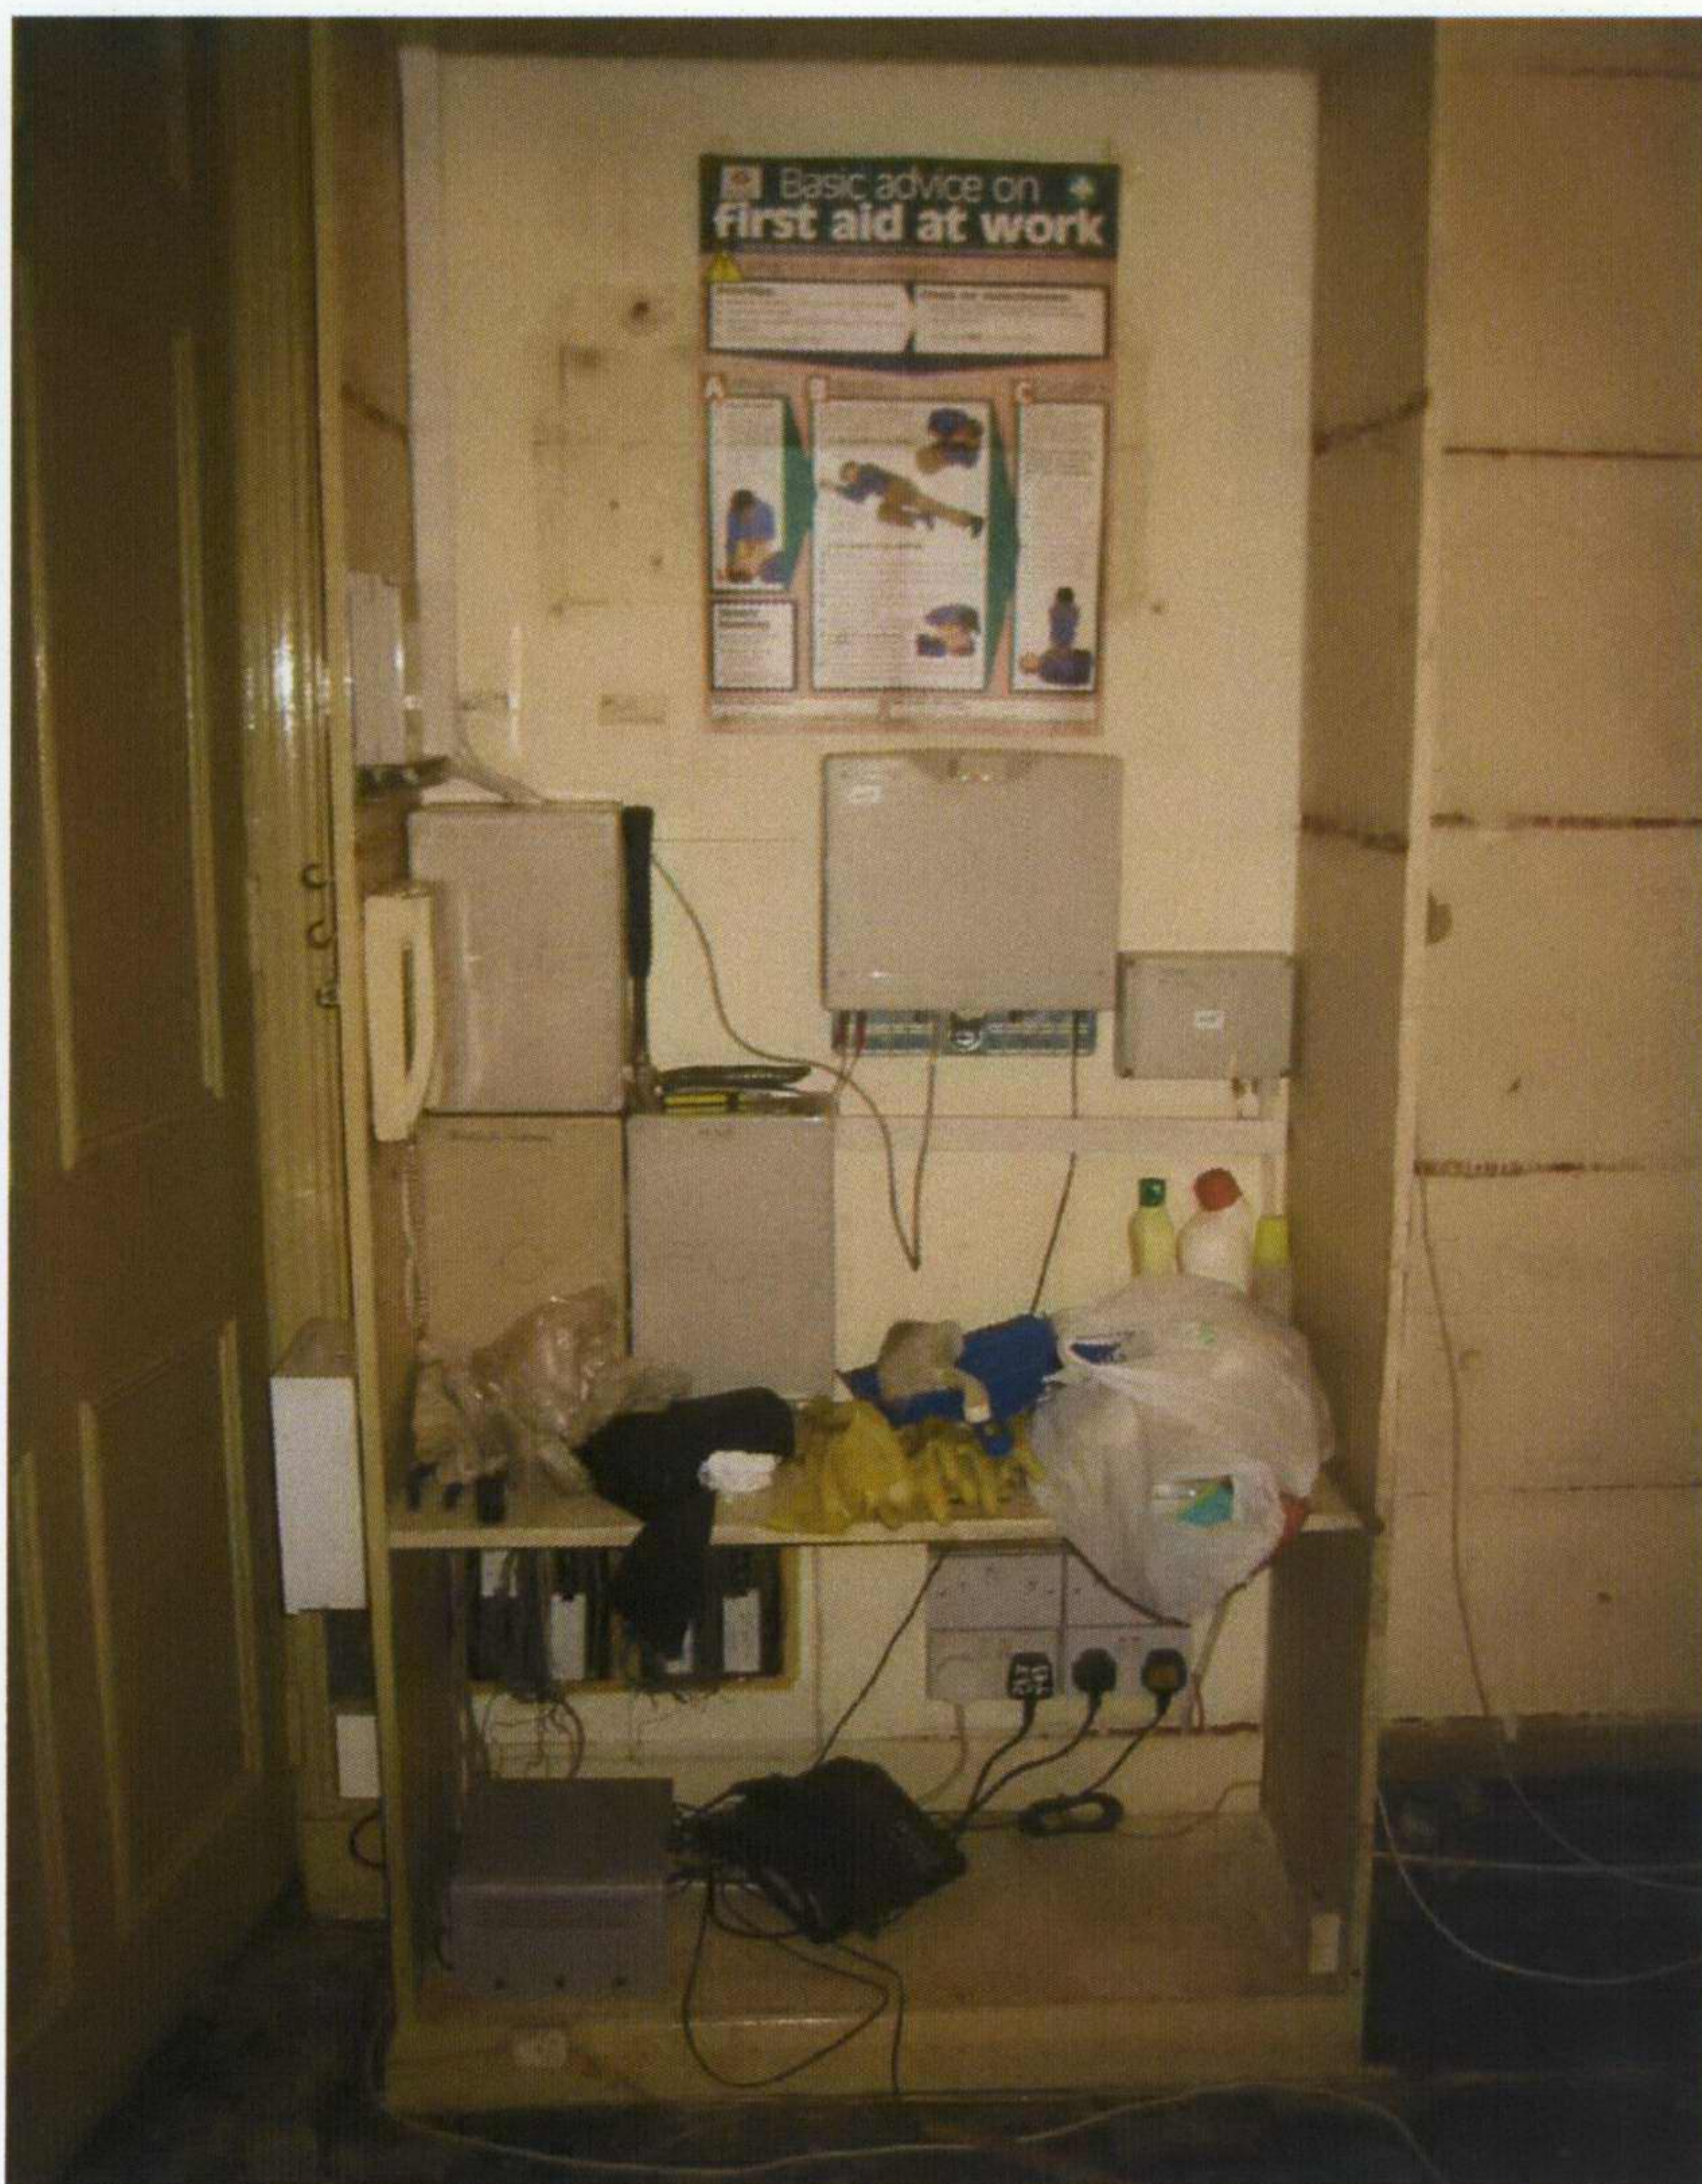
*Photograph 19. Ground Floor. Typical of office installations throughout the house.*

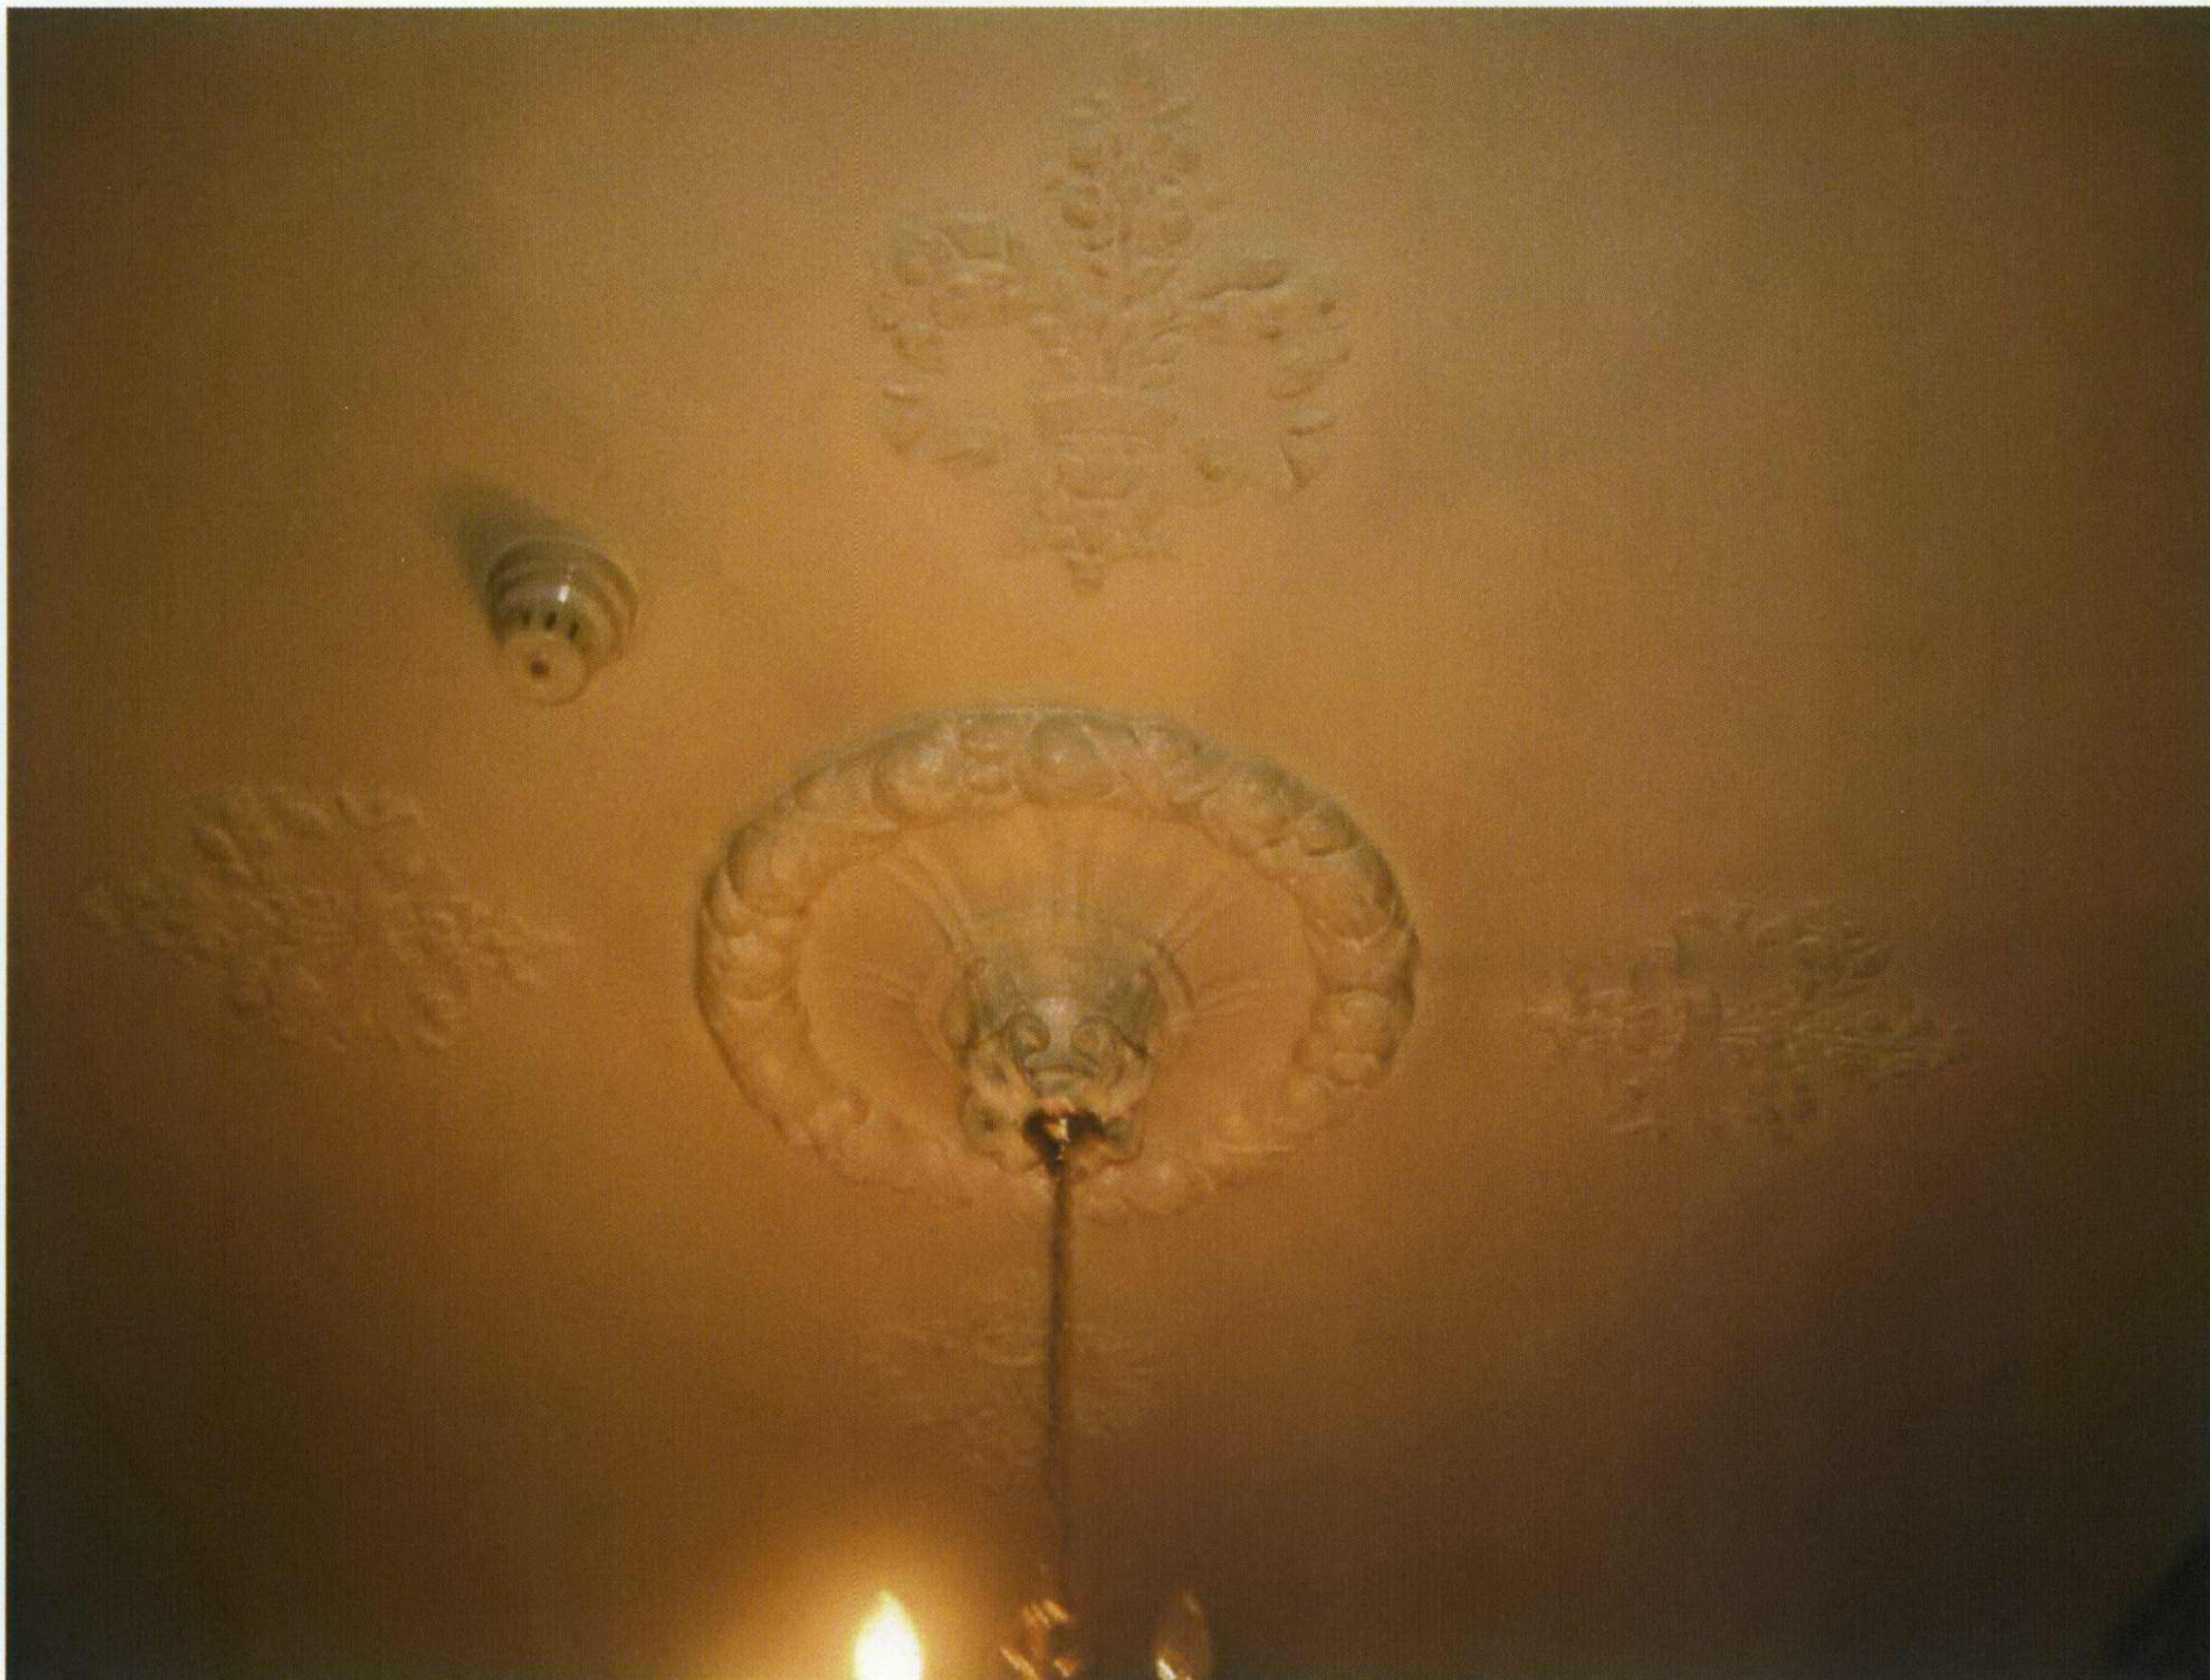
Photograph 20. Ground Floor Front. Crude plaster casts added "recently" to the ceiling, to be removed.

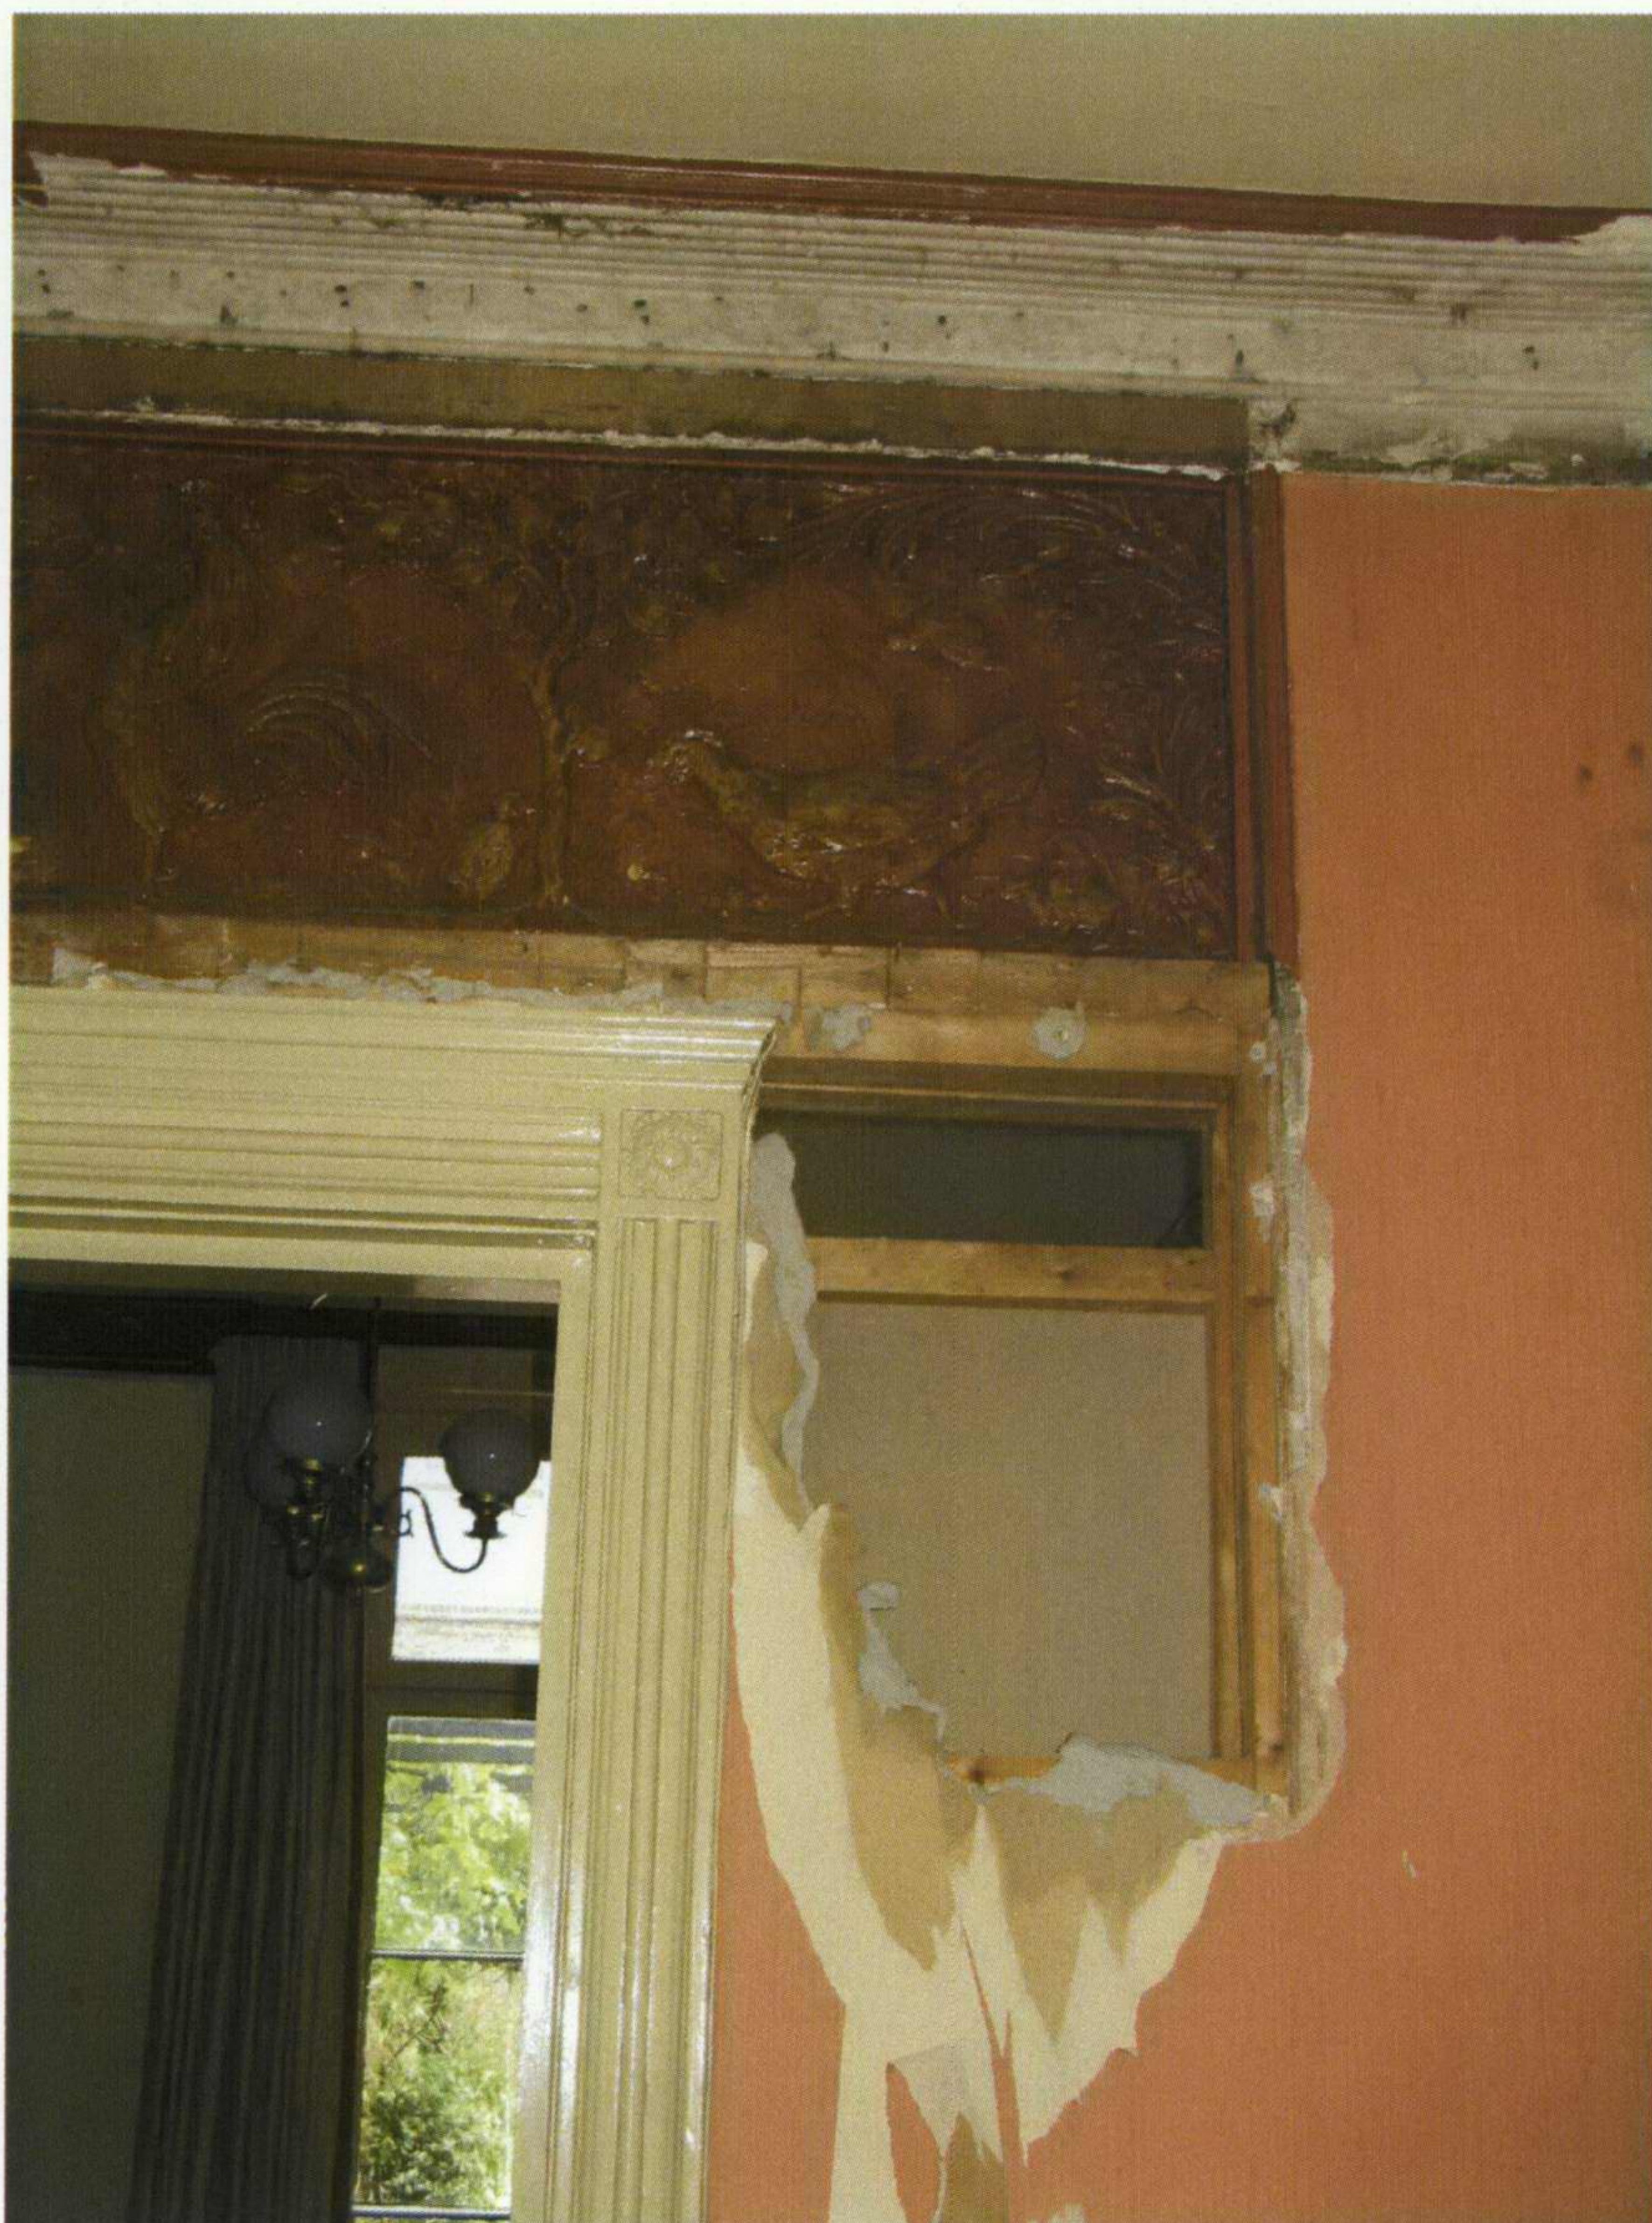
Photograph 21. Original cornice behind crude over-cornice. Also note blocking up of wide doorway and "alien" panel above the door.
