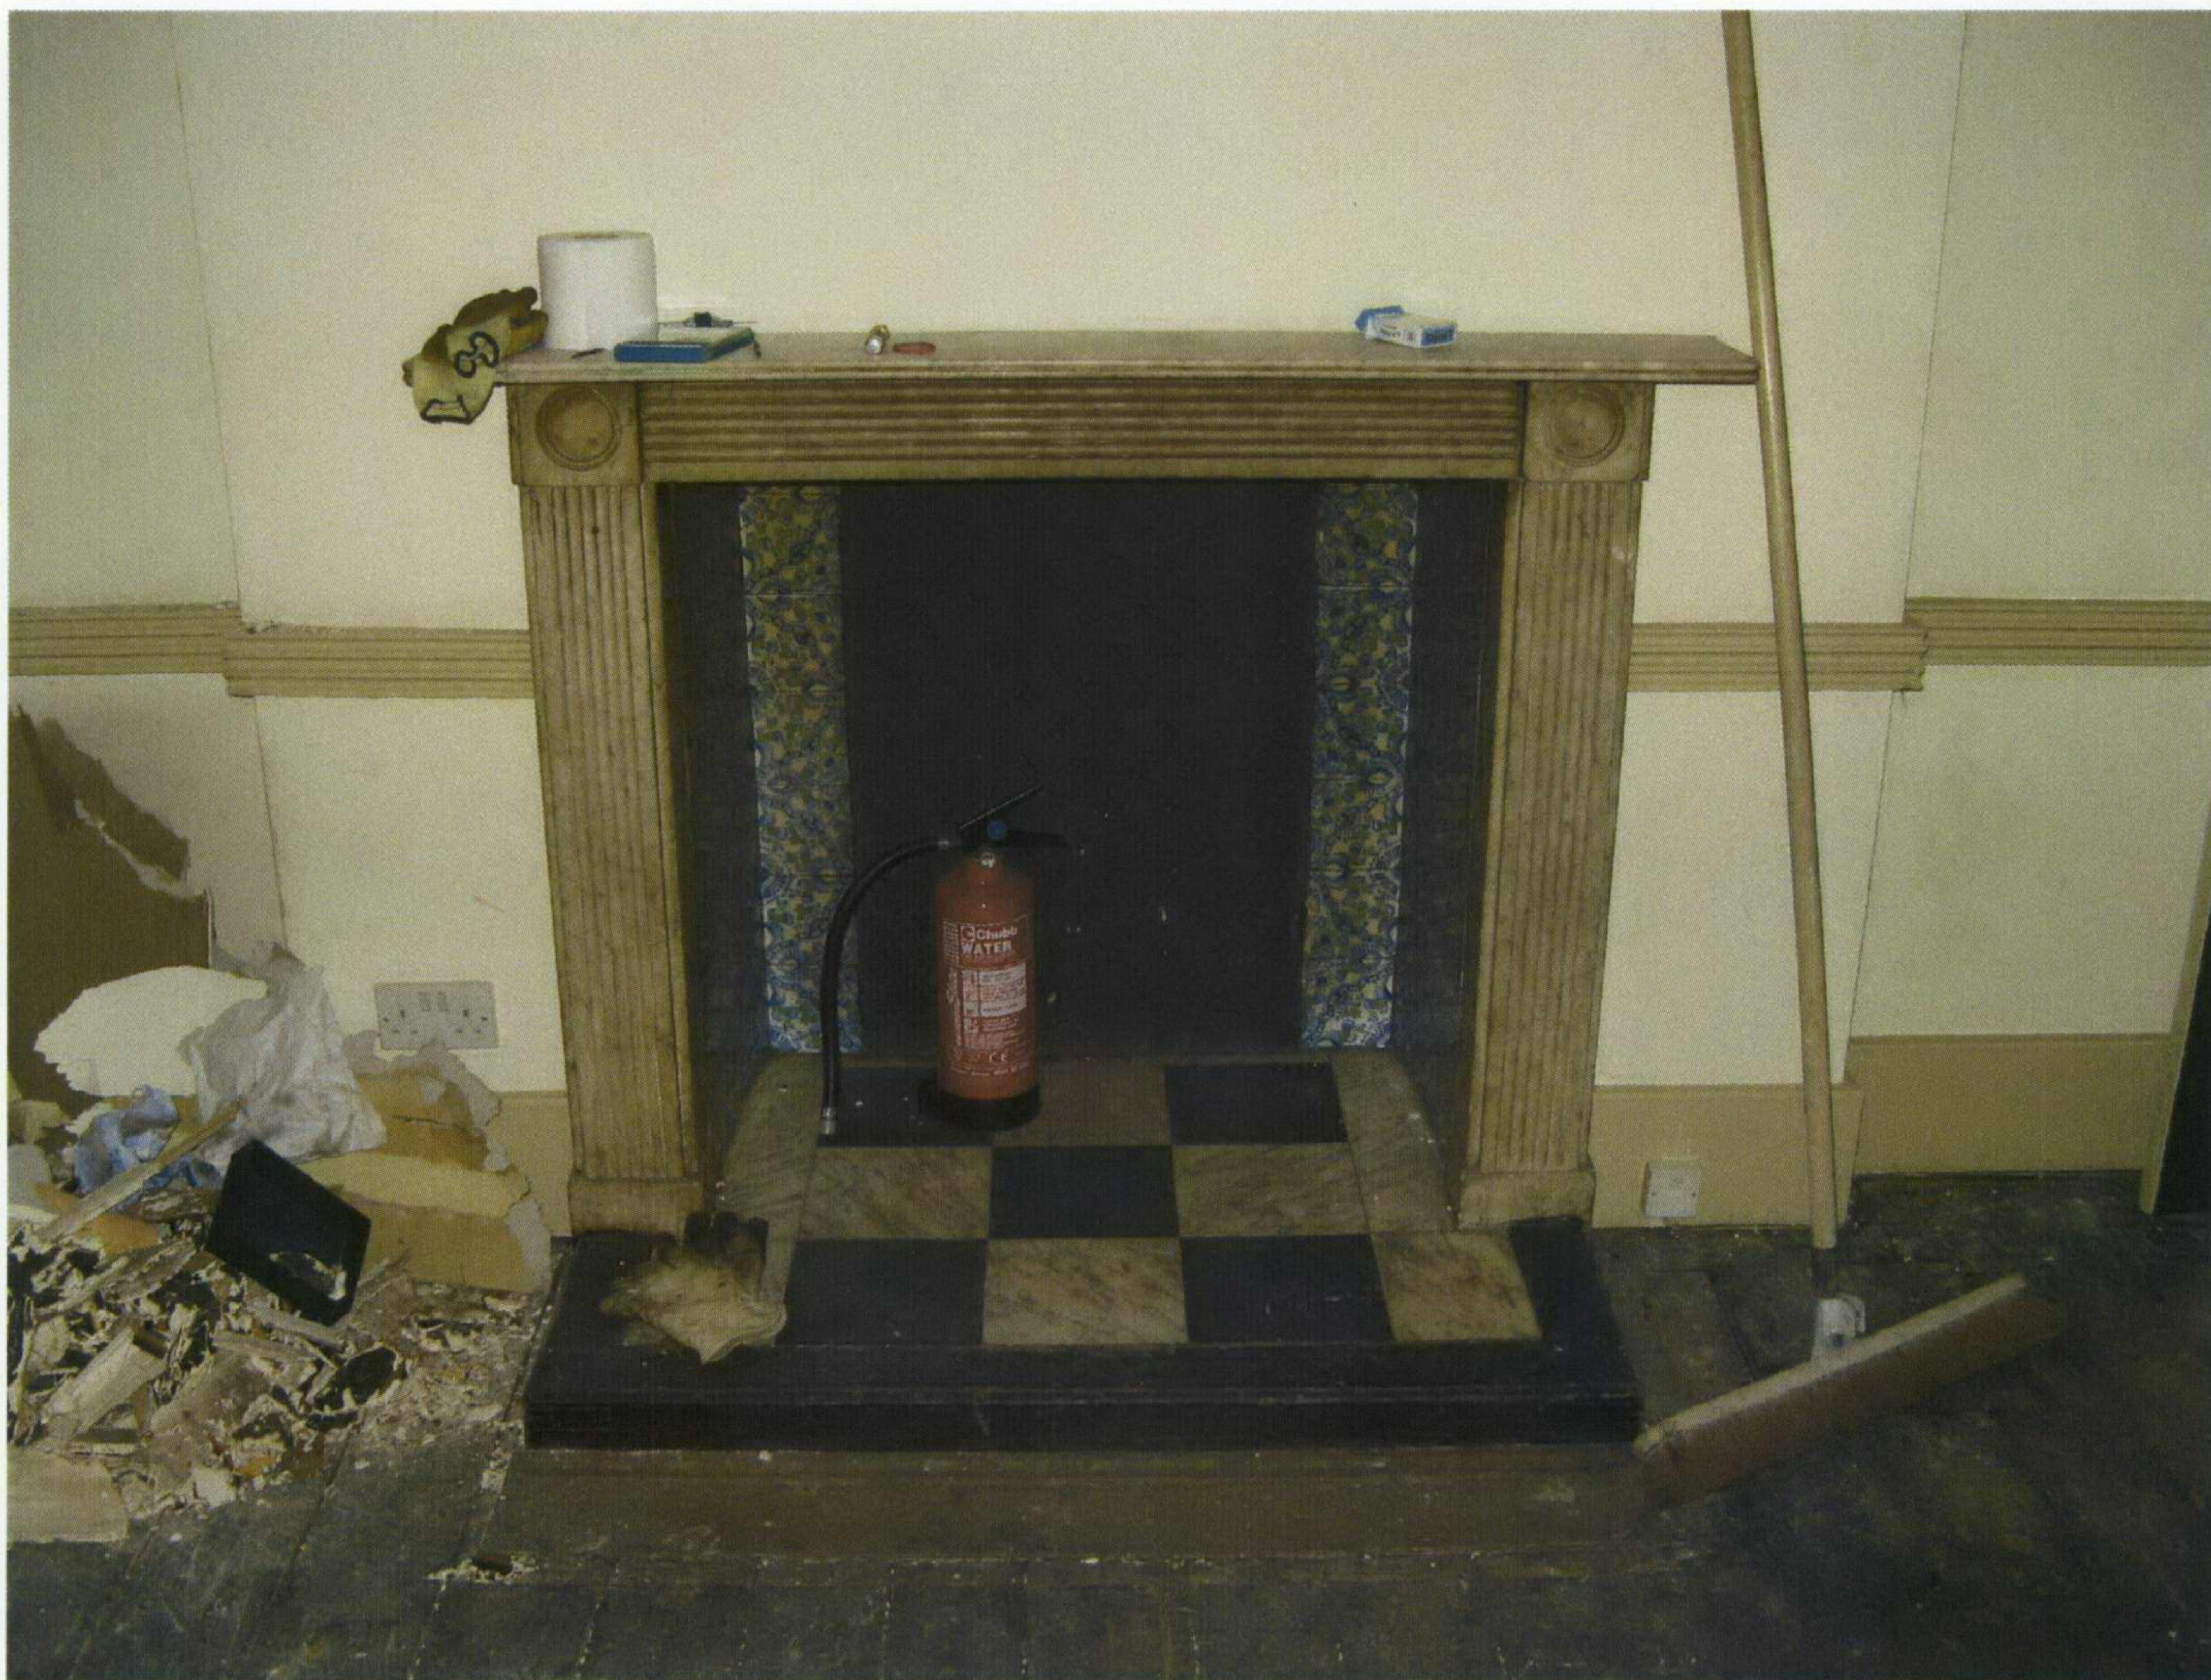
Photograph 22. Ground Floor Rear. Original fireplace with altered hearth (original is underneath). (The original fireplaces survives in damaged state to front room). Also note original dado rail and skirting.

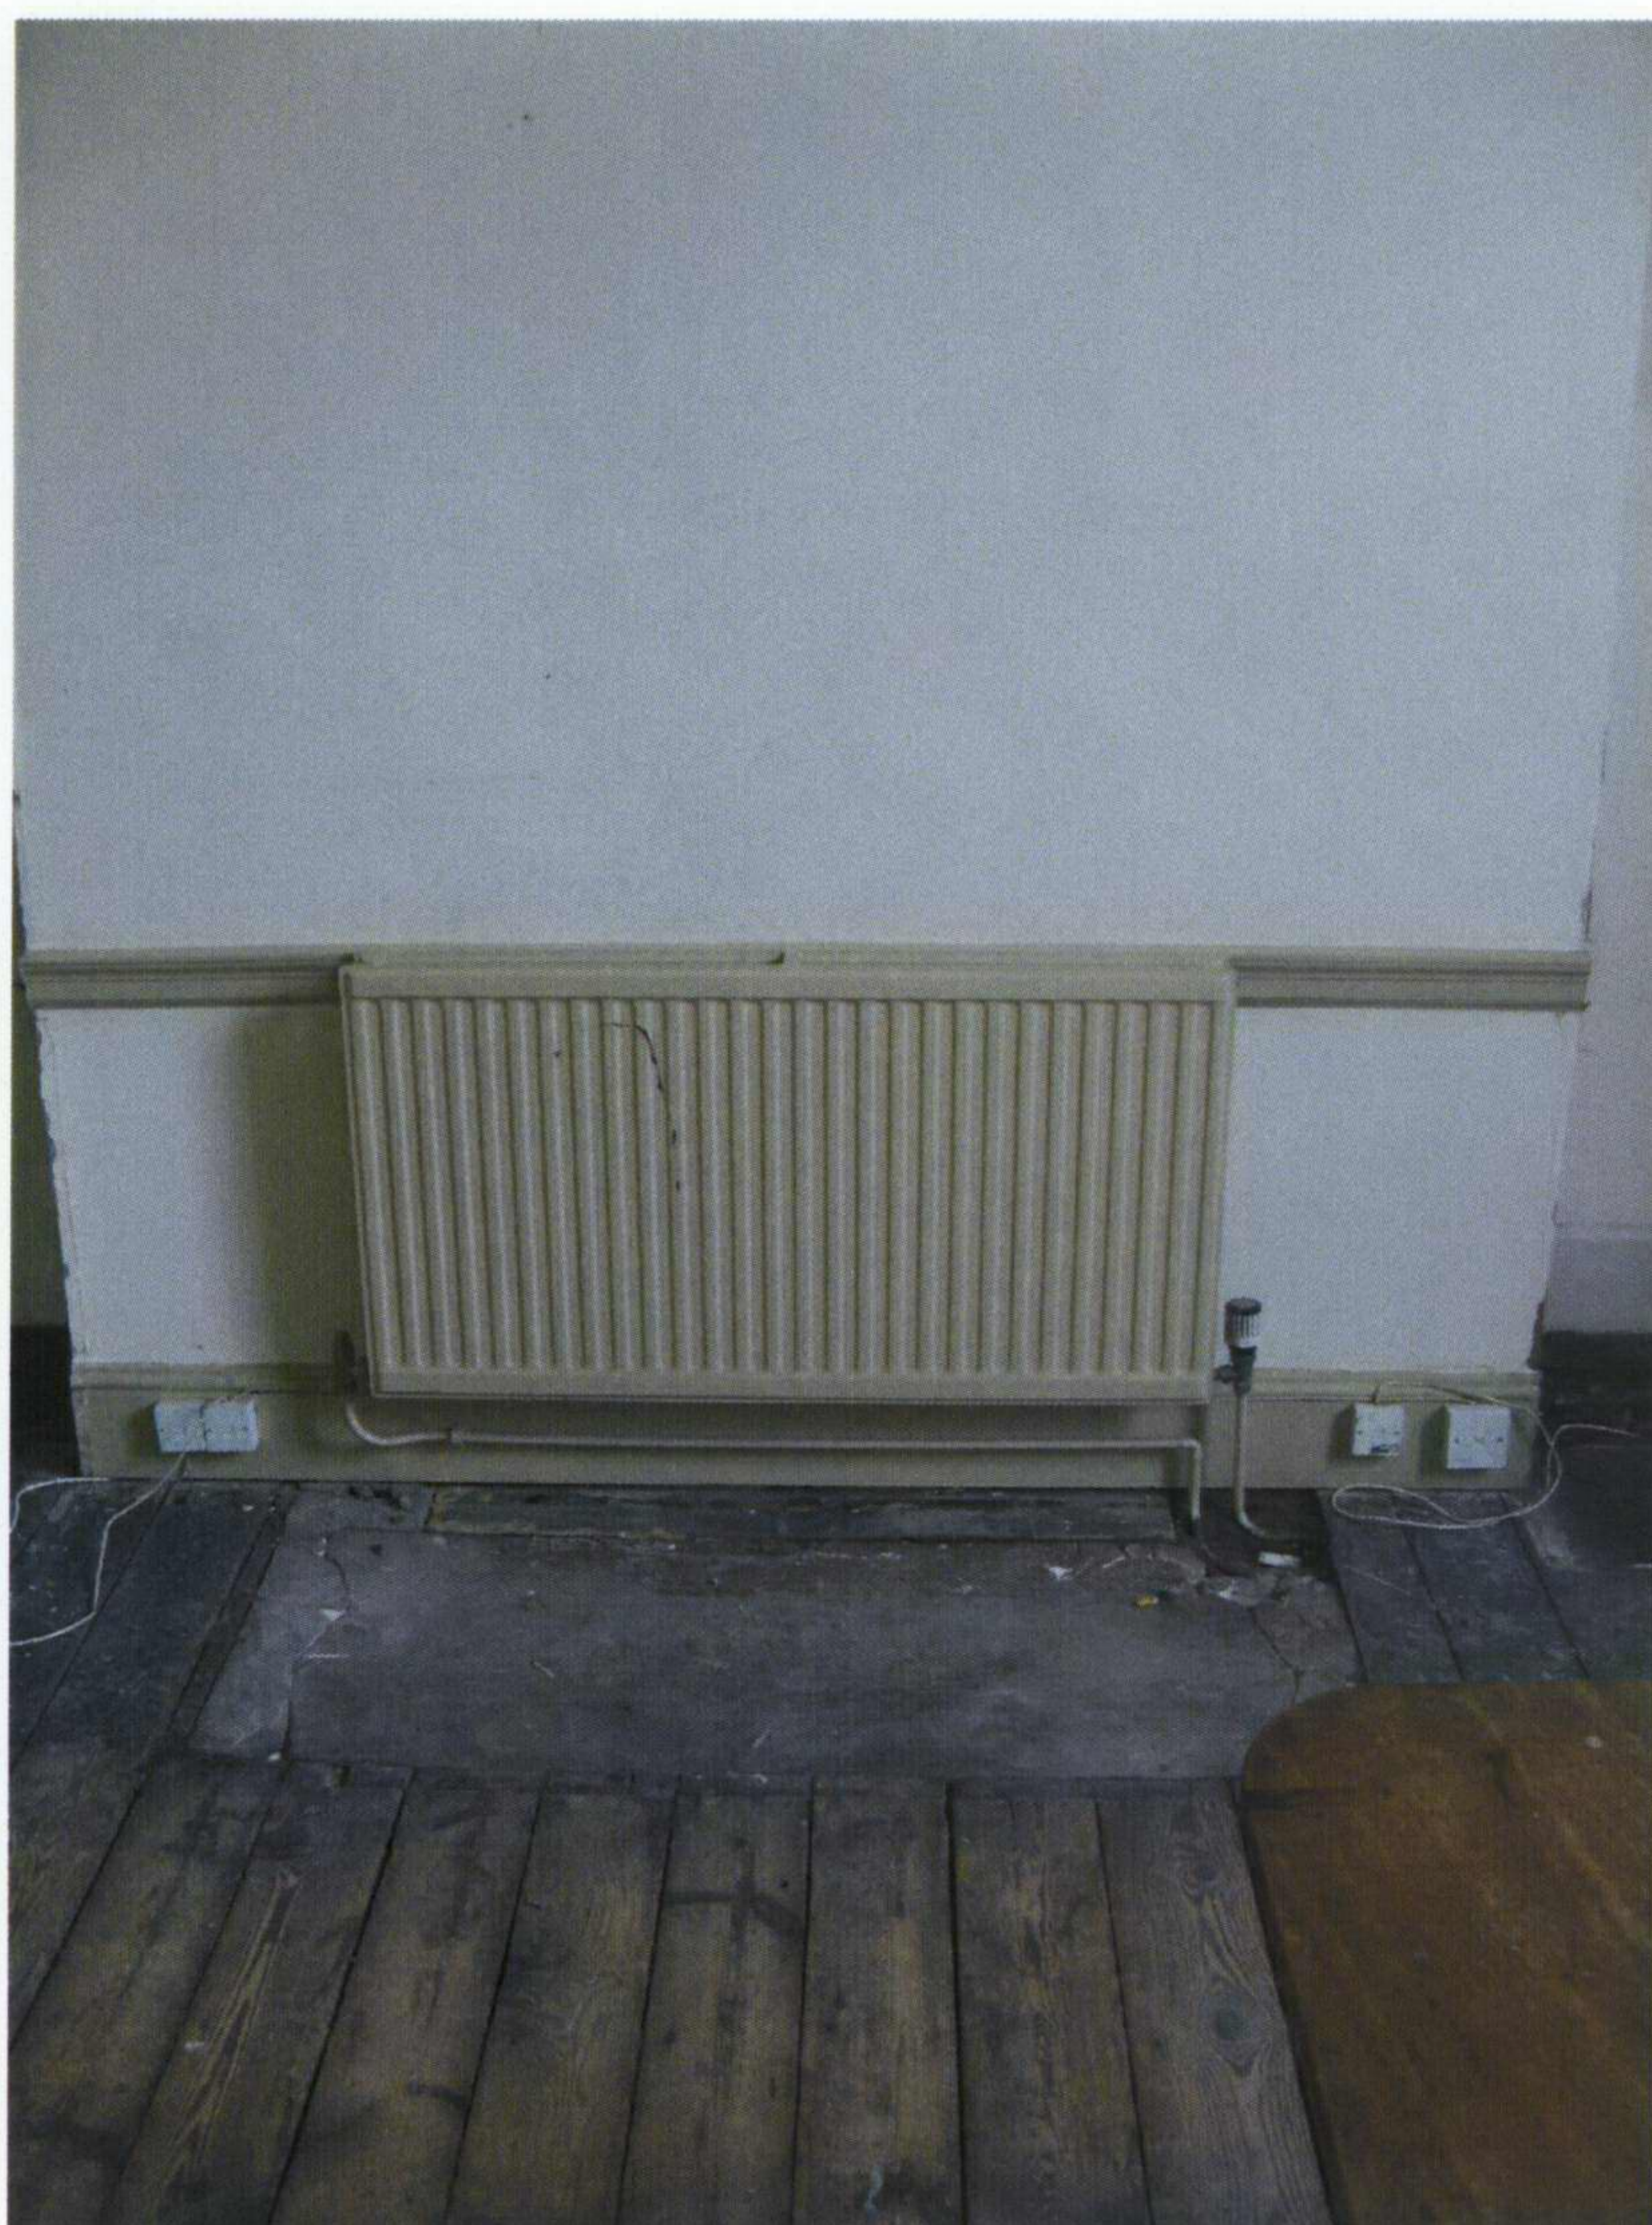
Photograph 23. First Floor Room (Rear). Fireplace removed and blocked – to be reinstated (original was marble to match (damaged) fireplace in front room; proposed to be instated to original design.
