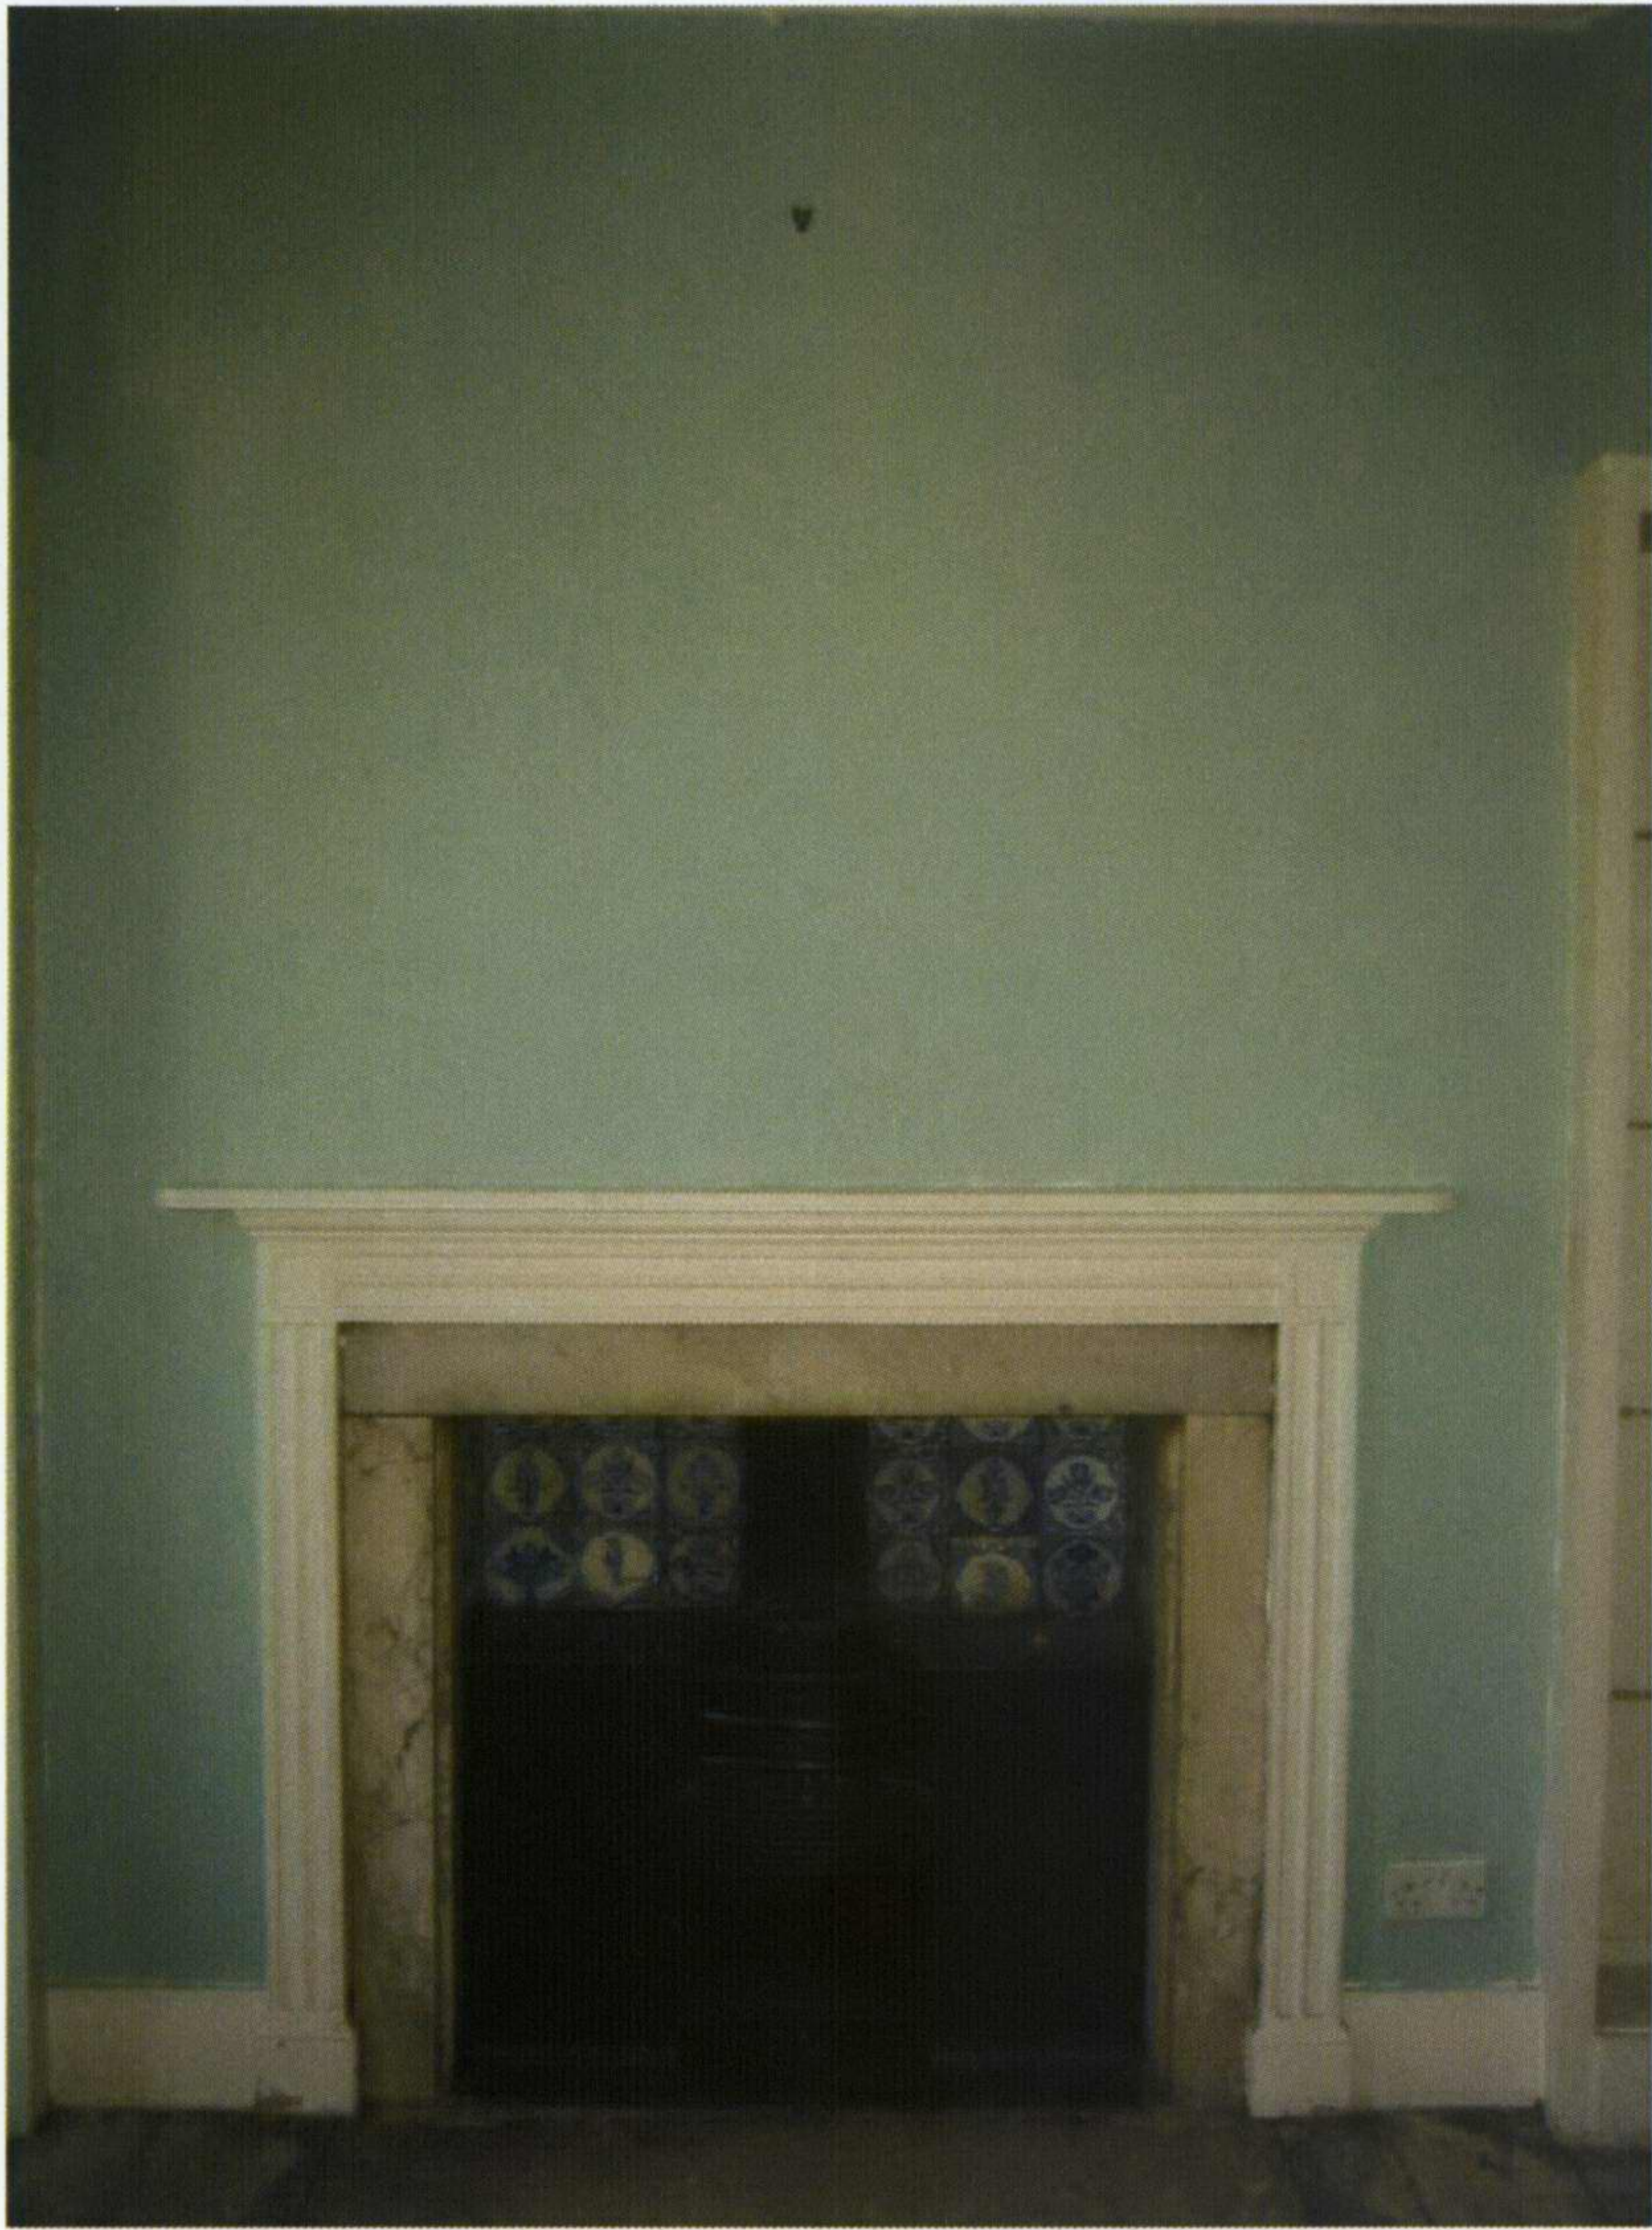
Photograph 24. Second Floor Front – original fireplace.

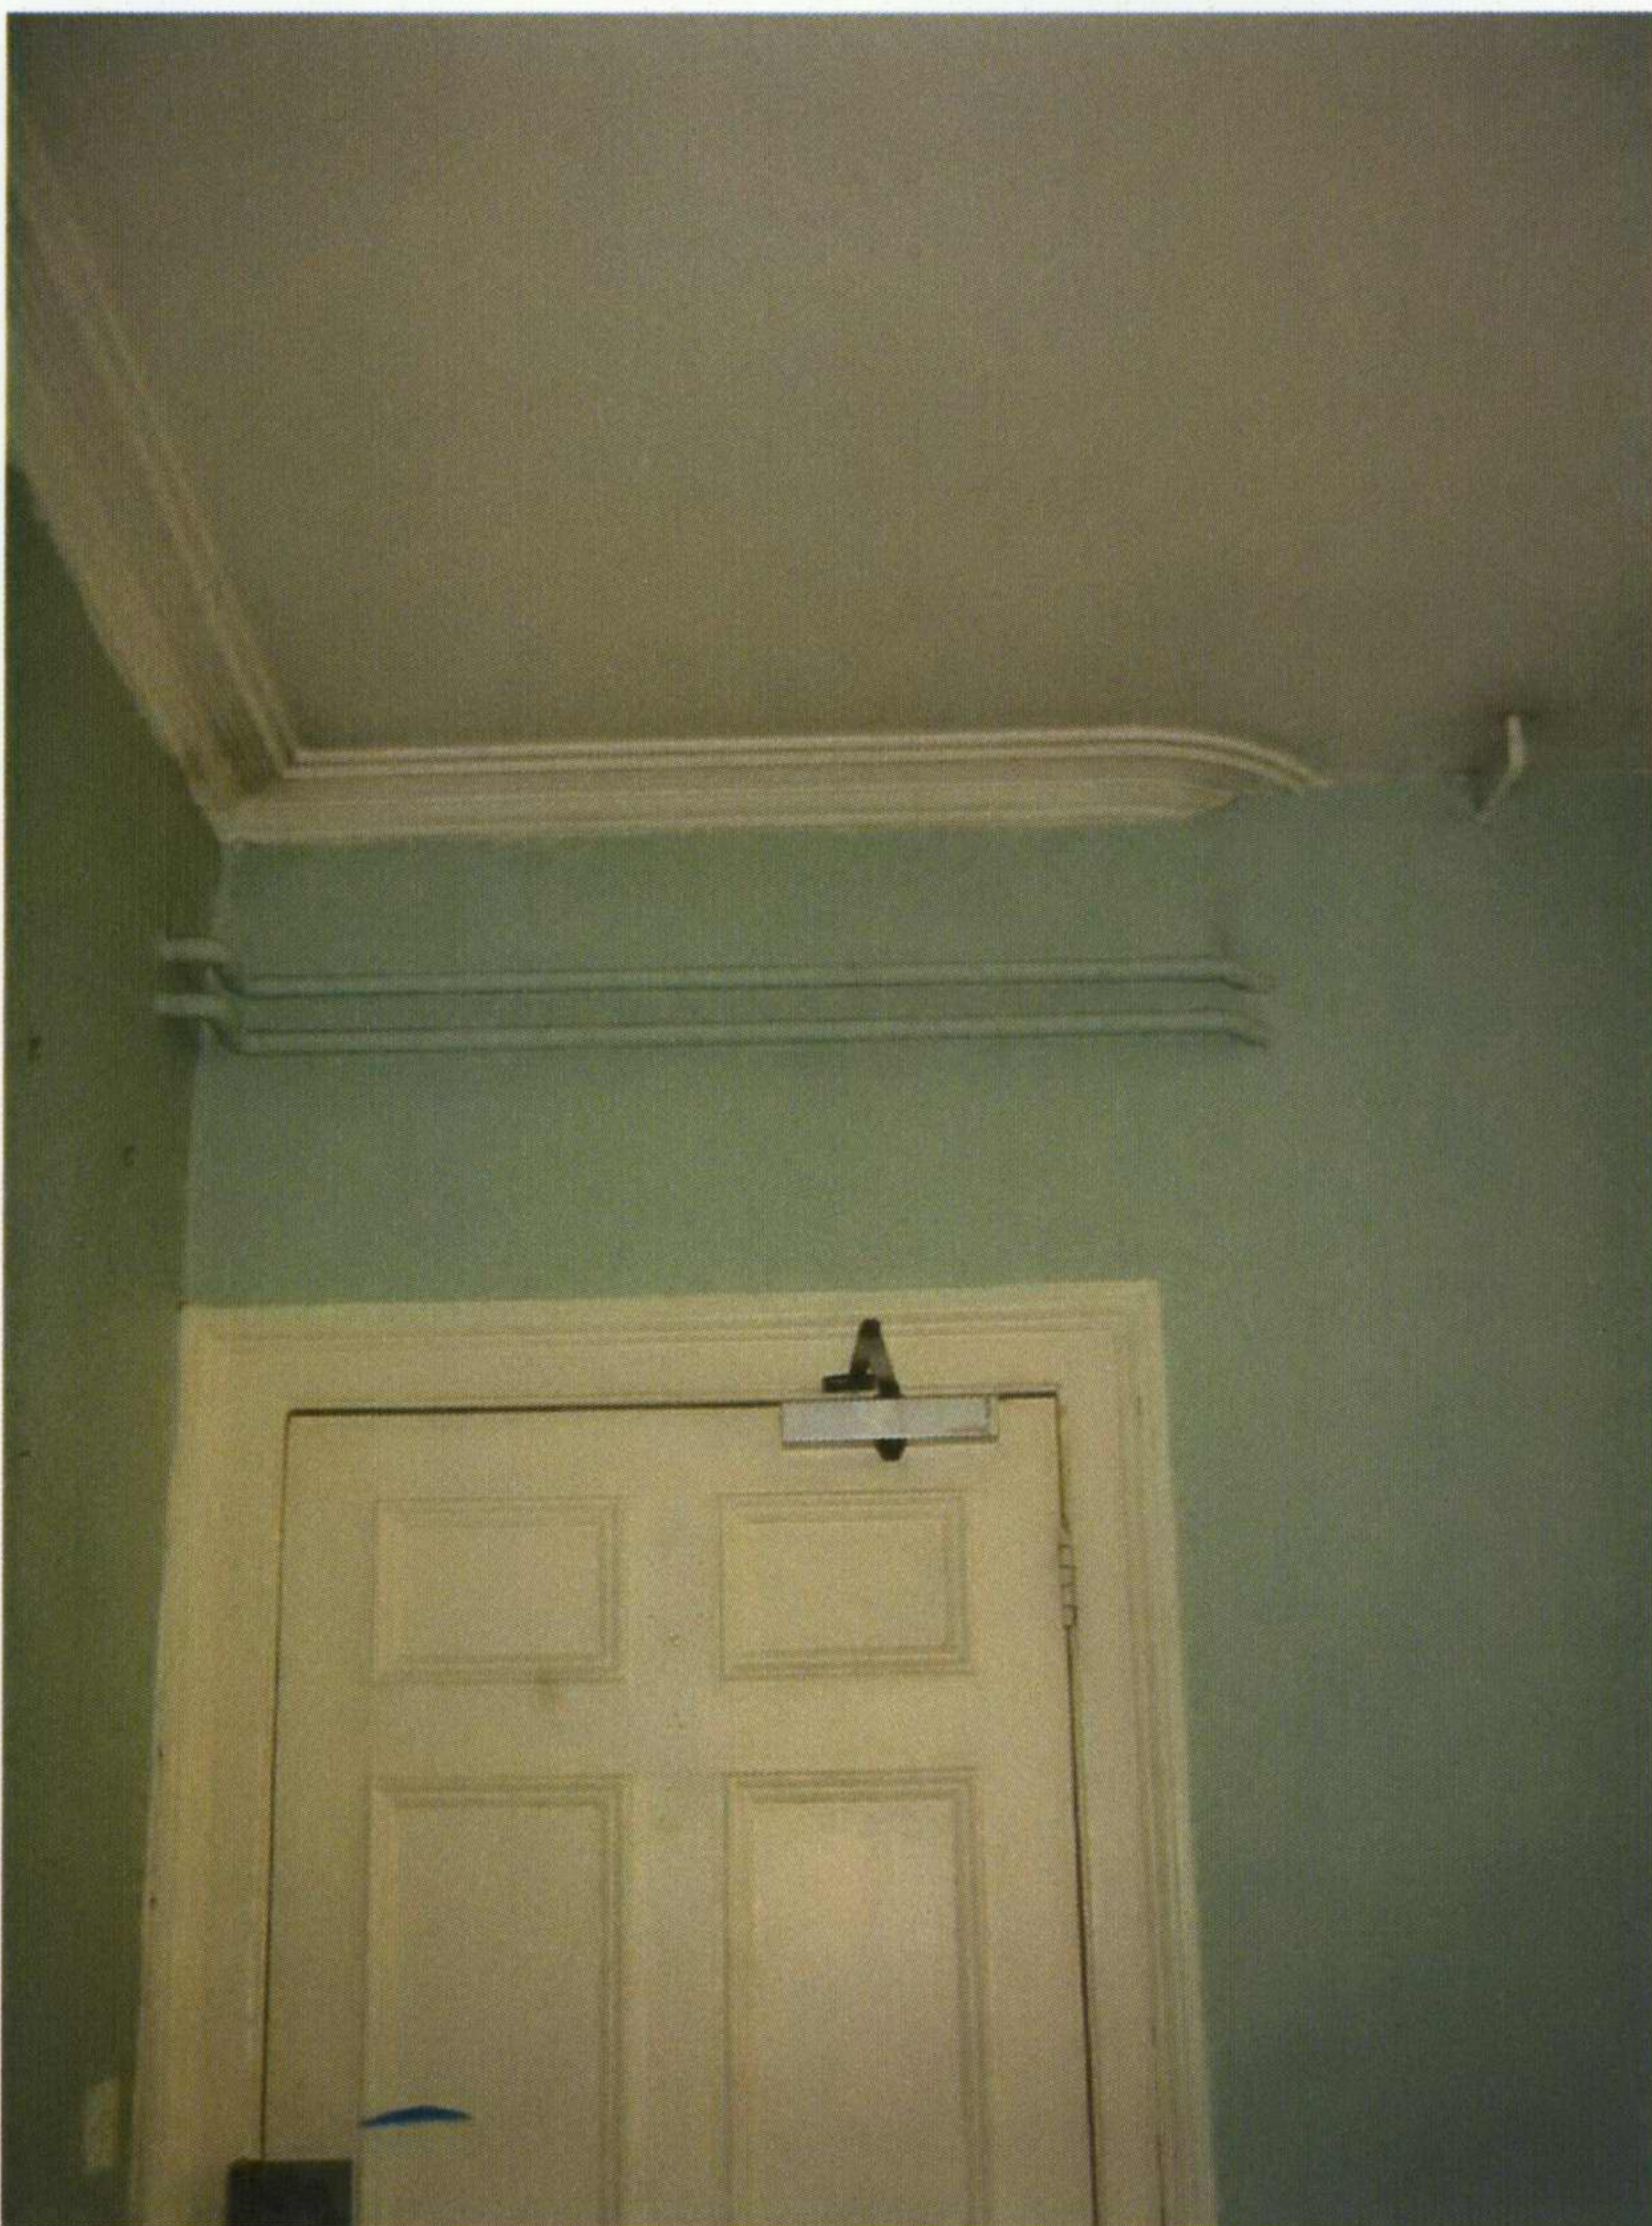
Photograph 25. Second Floor Front. Original cornice obscured by recent partition.

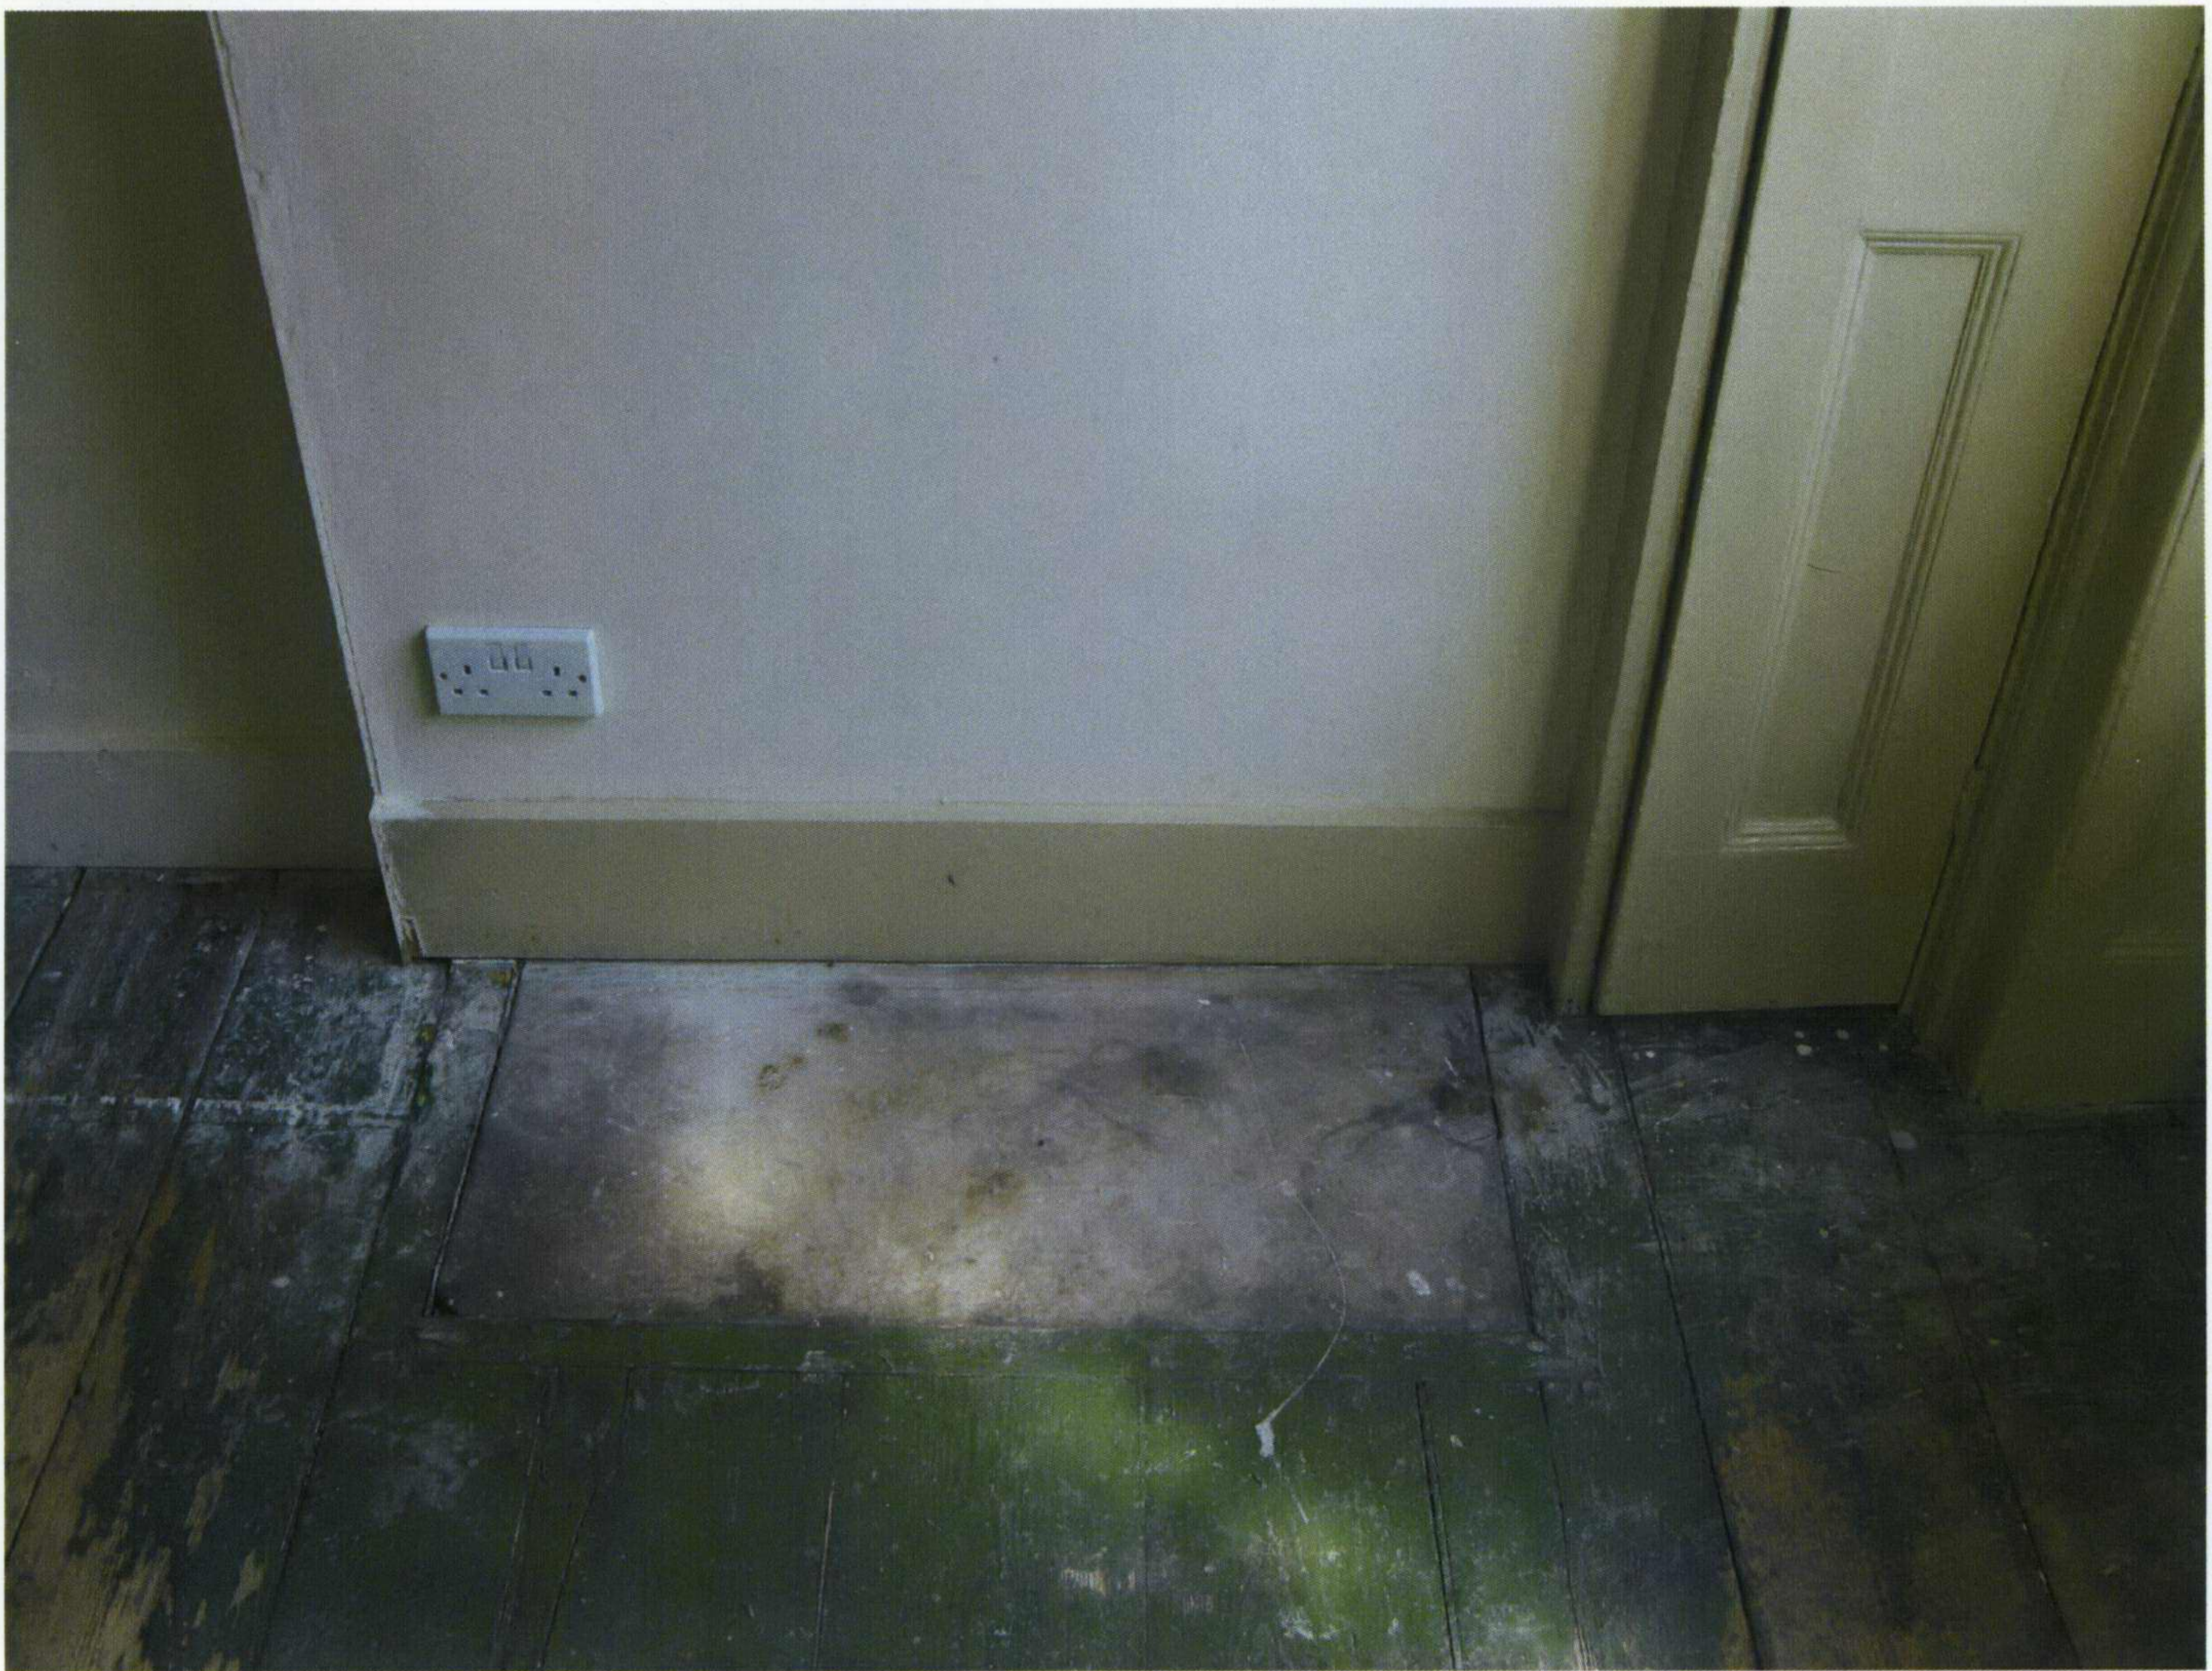
Photograph 26. Second Floor Front. Second fireplace hearth in the room. Very unusual feature.

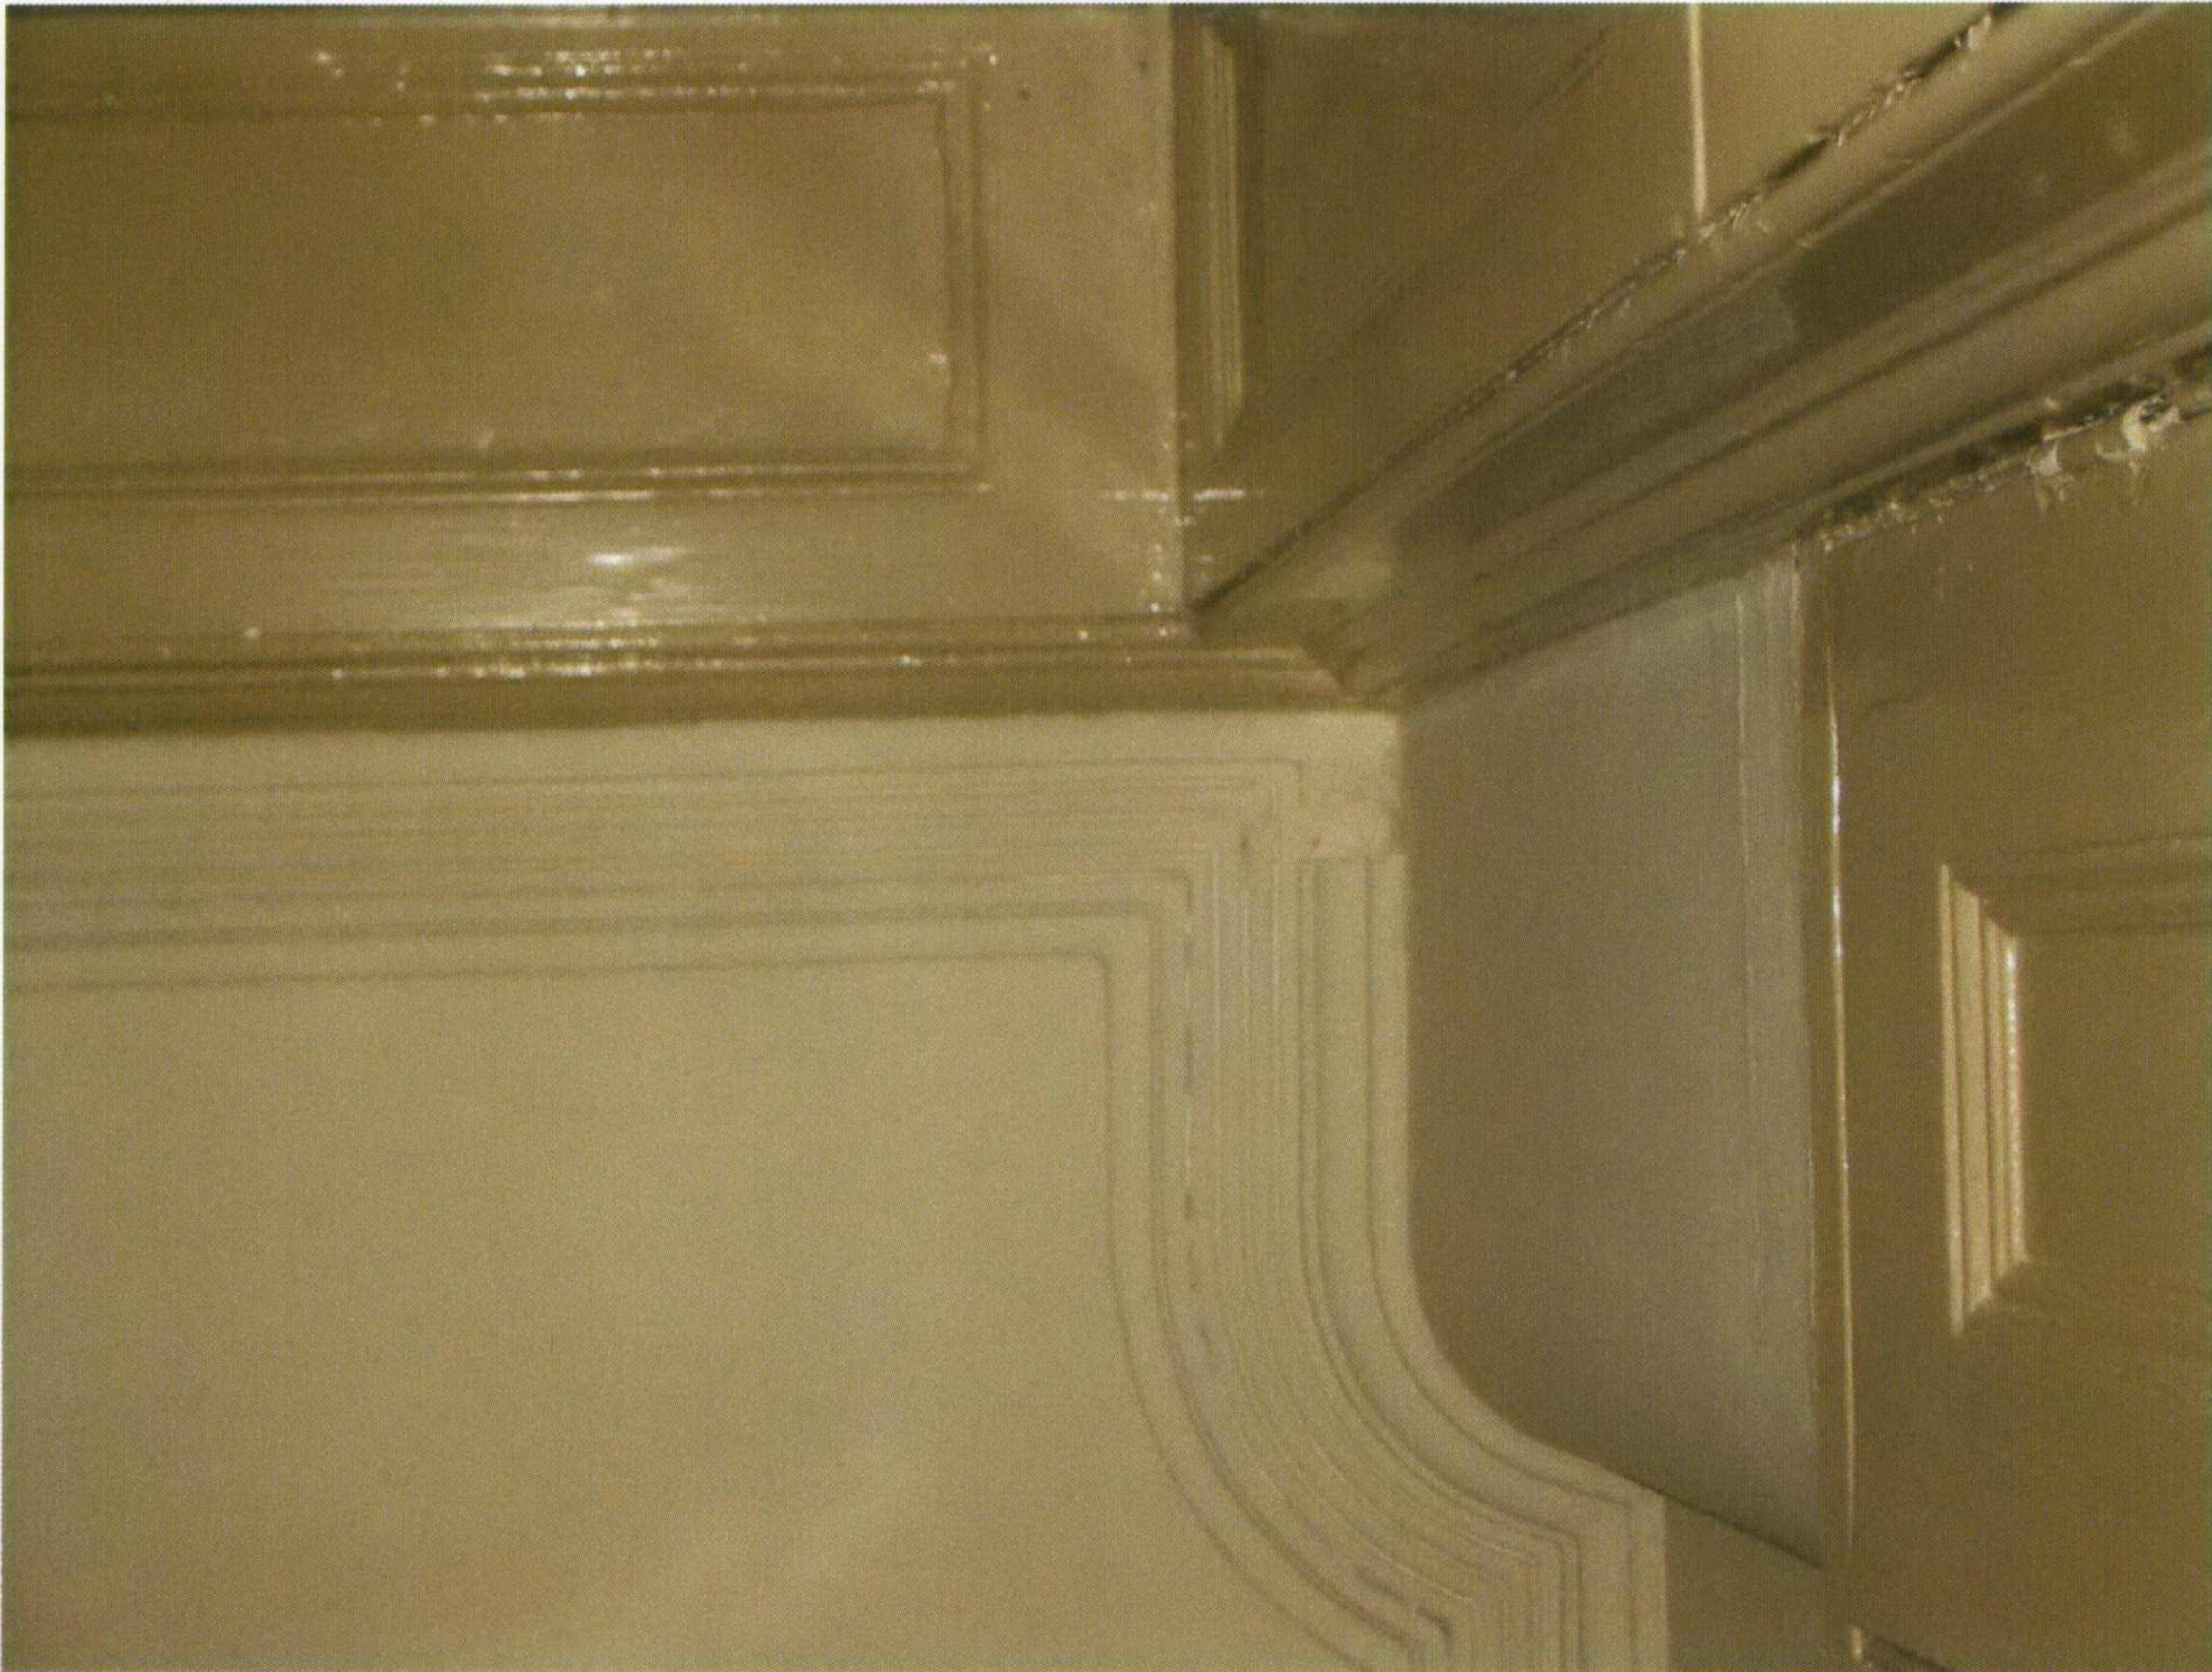
Photograph 27. Original detailing above the hearth referred to above.

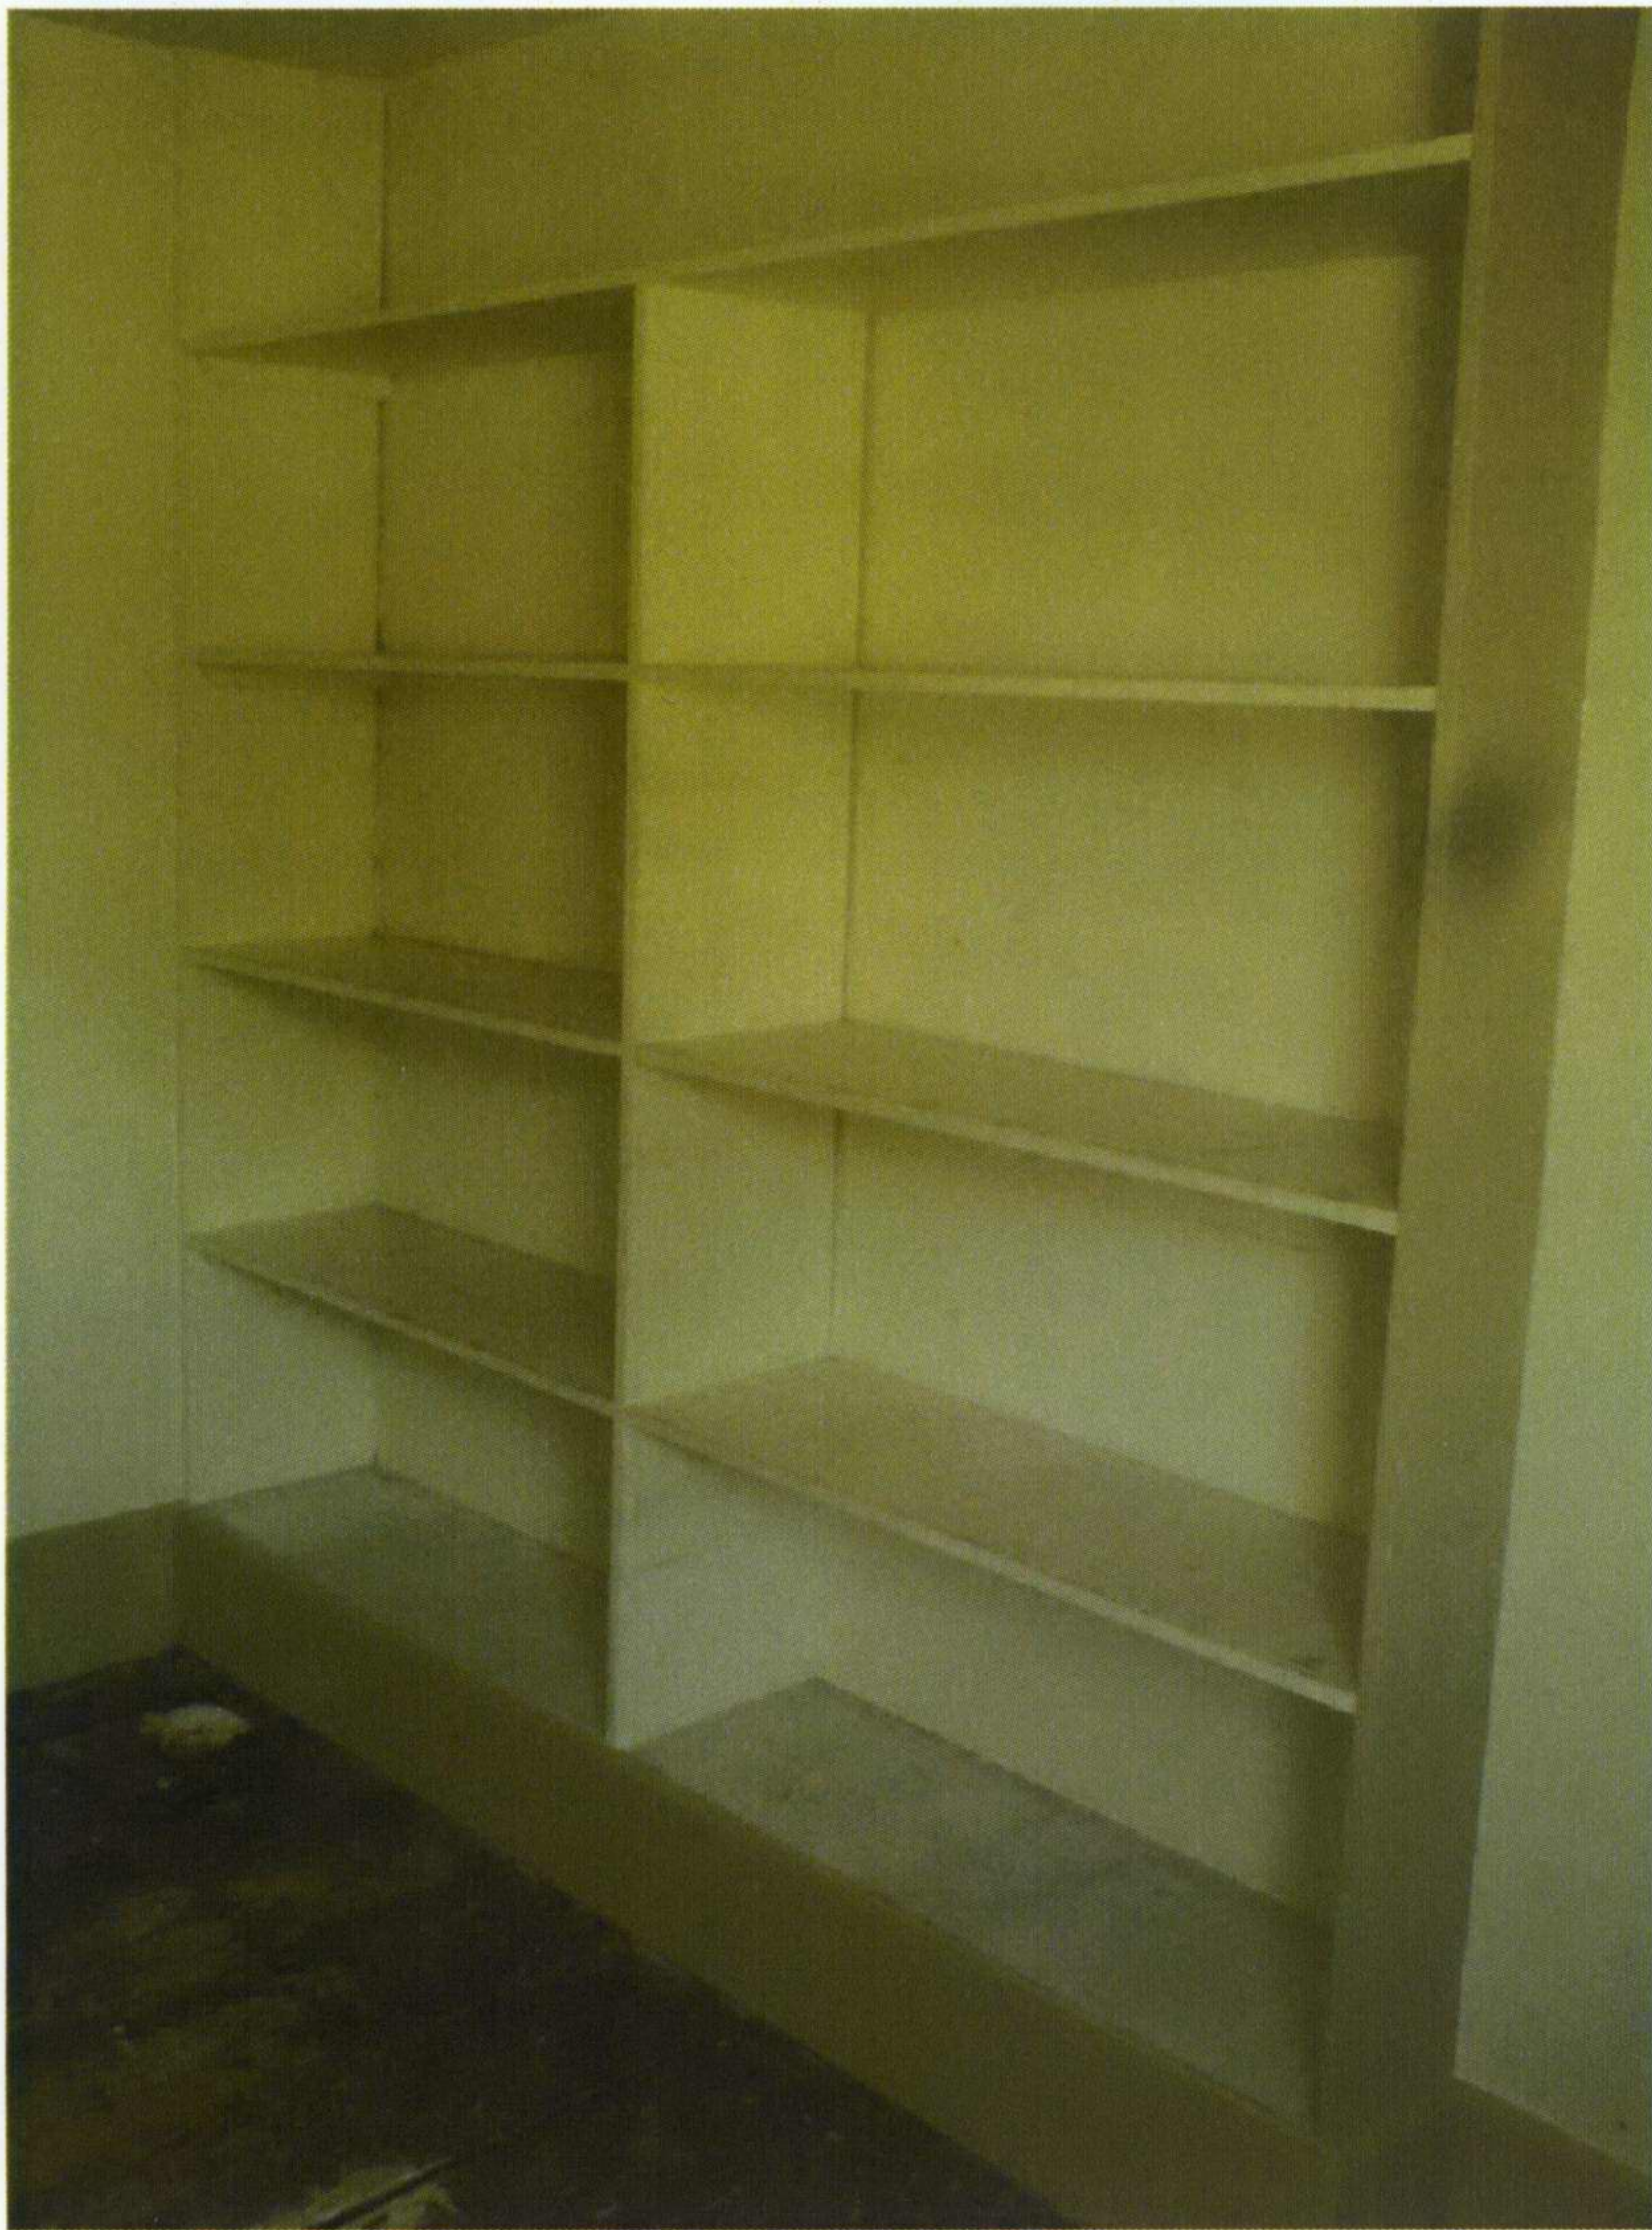
Photograph 28. Third Floor. Office fitting out typical of this floor.

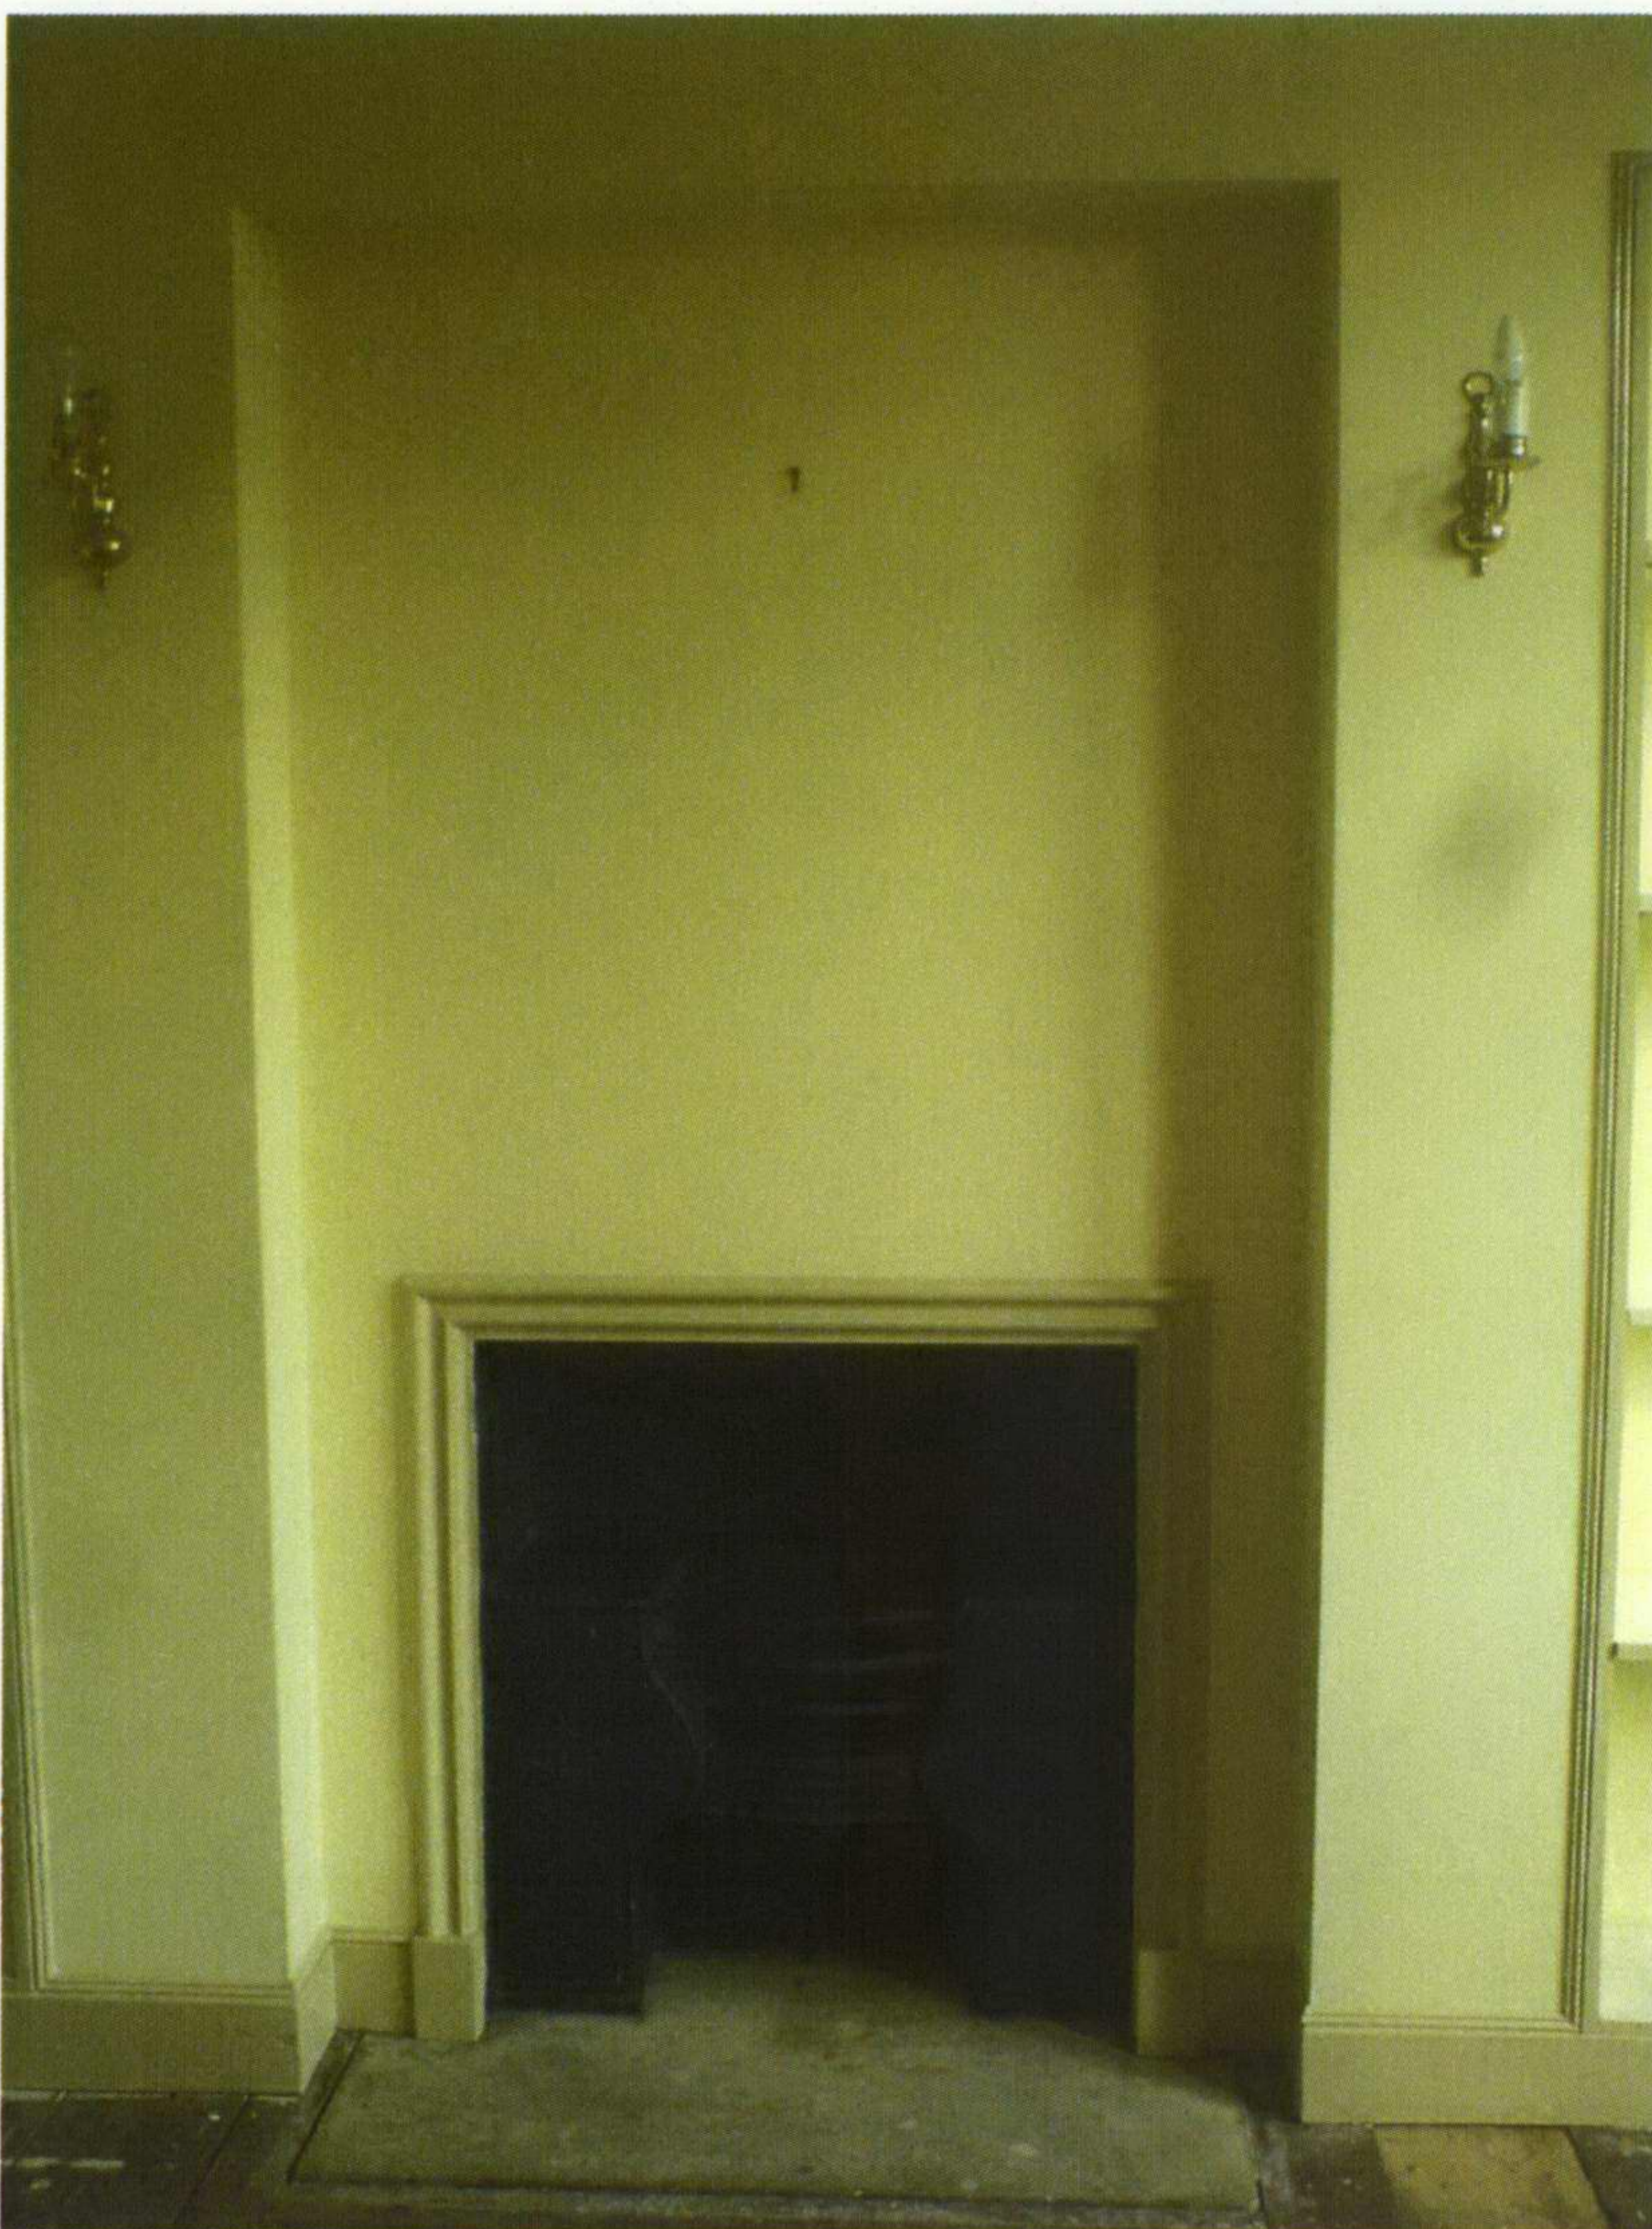
Photograph 29. Third Floor. Office fit-out; but early hearth still in place to be retained.
