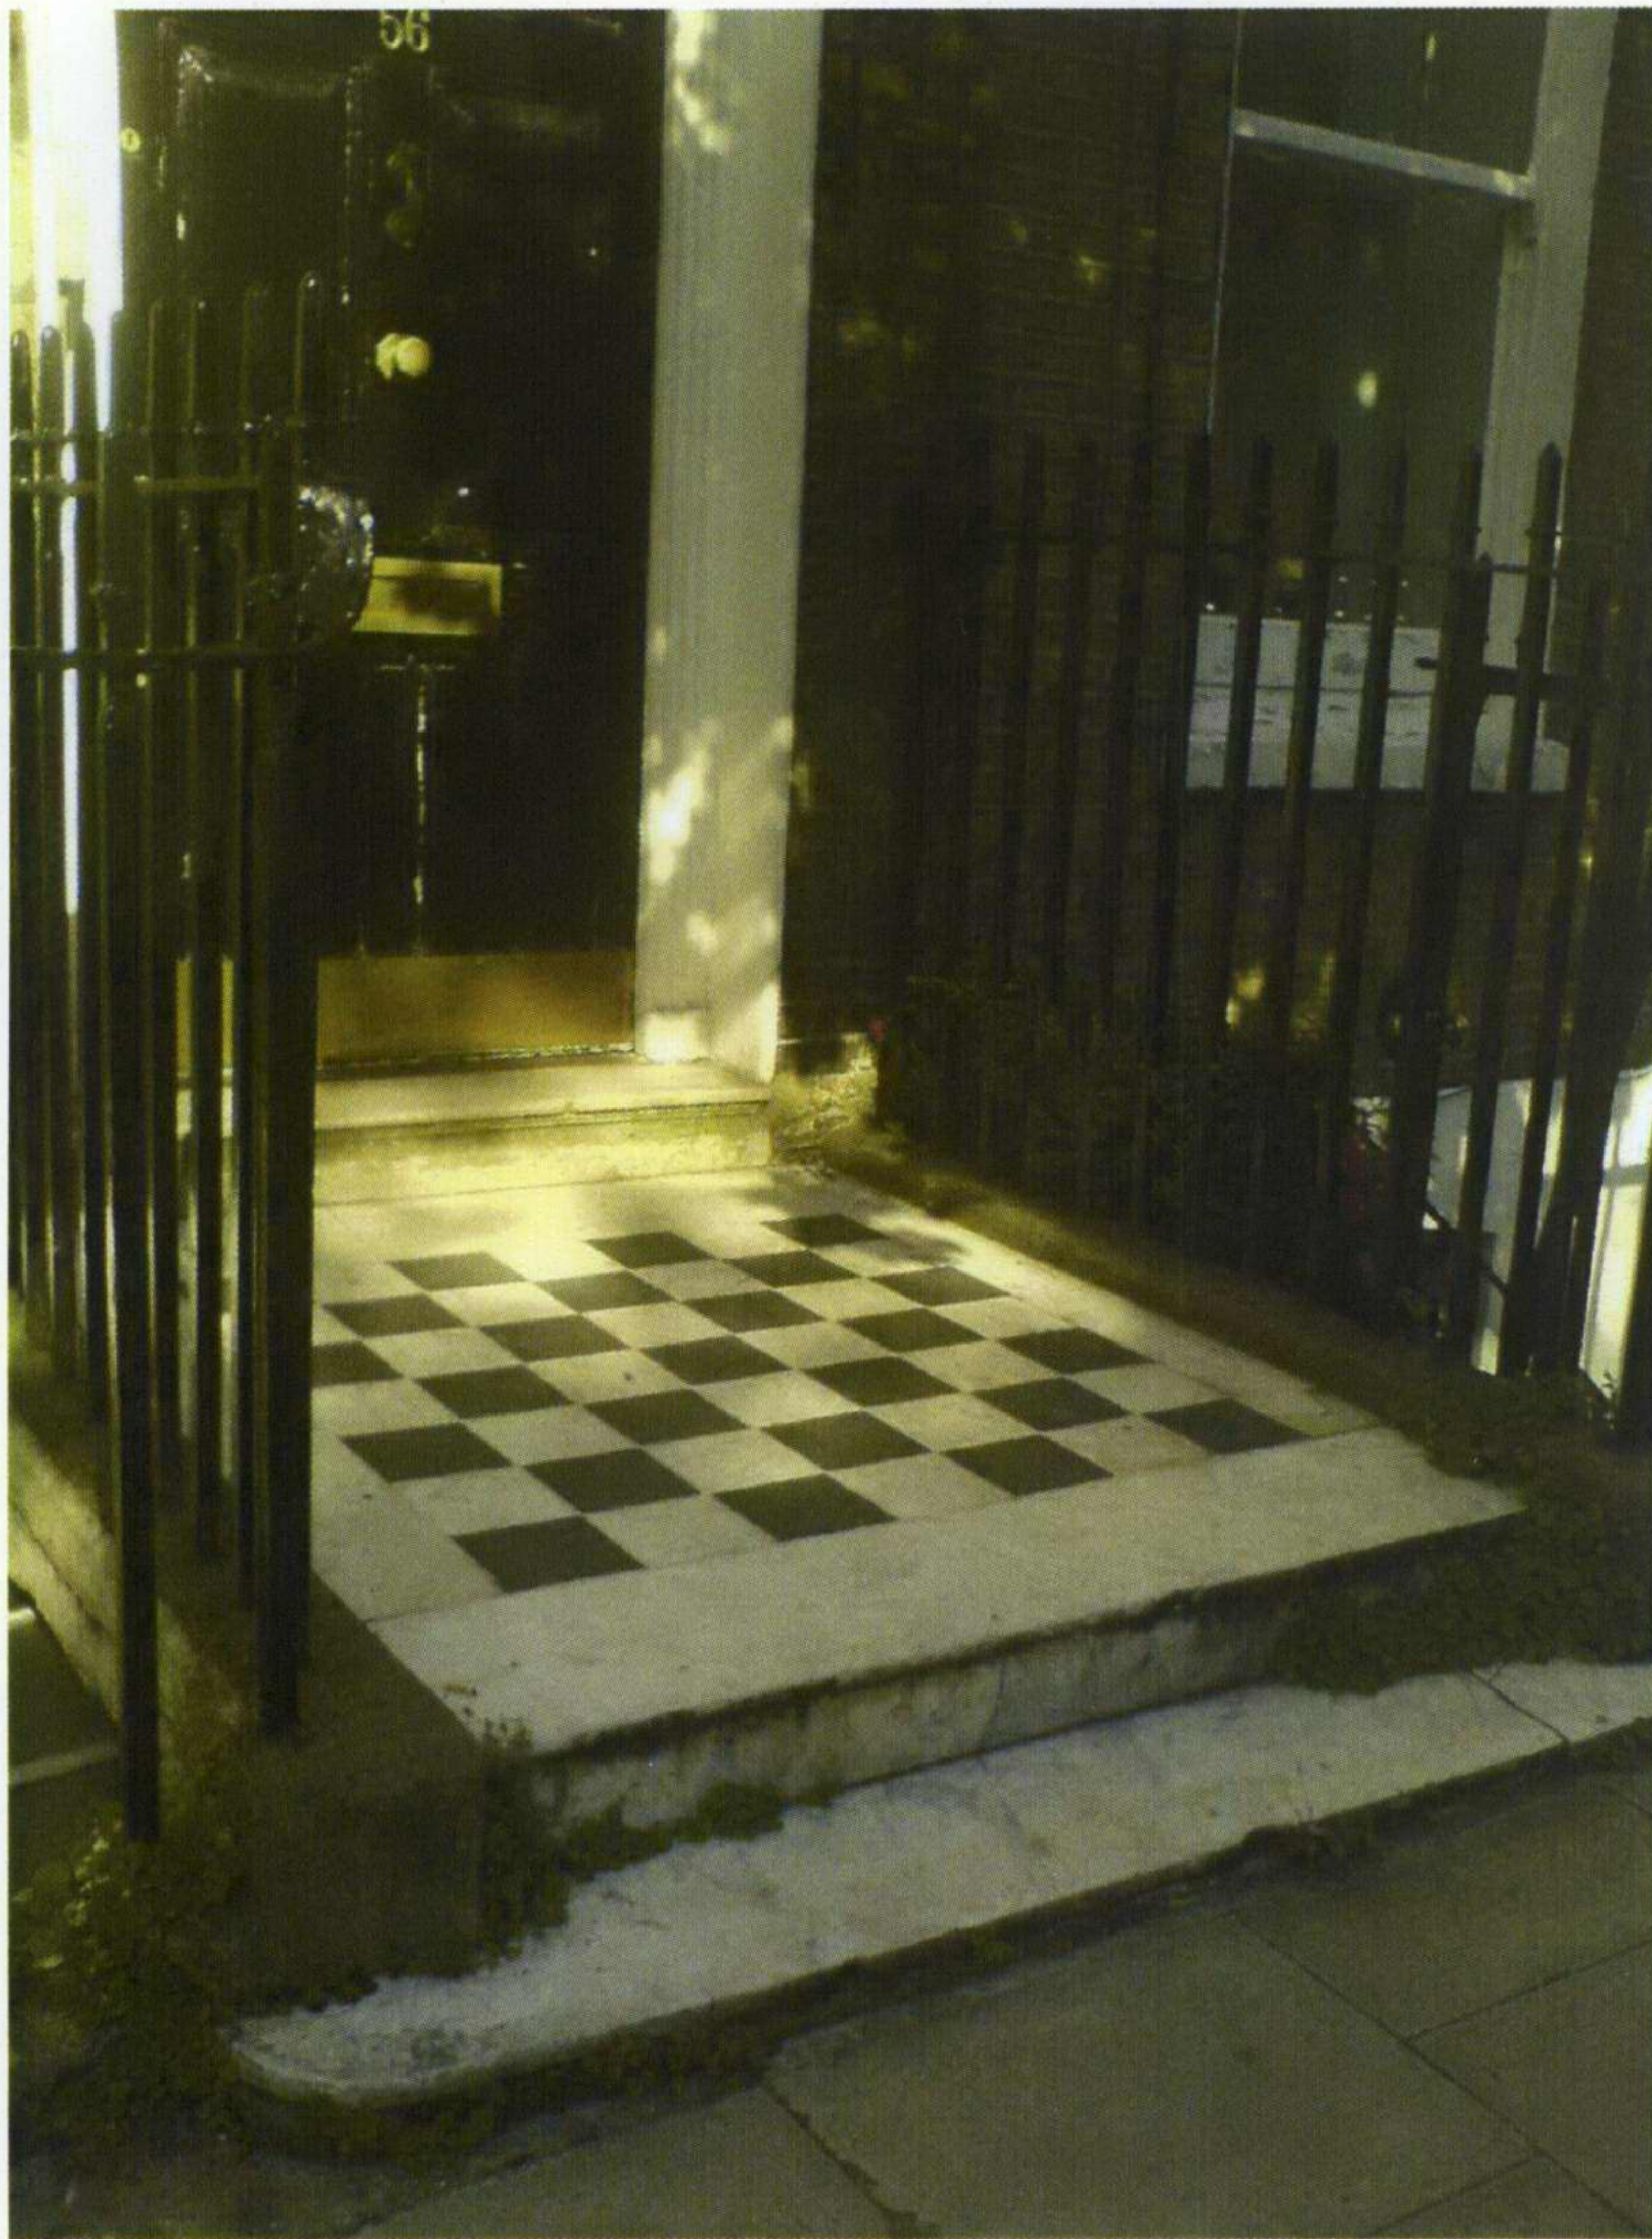
Photograph 30. Front step. (Defective and leaking).

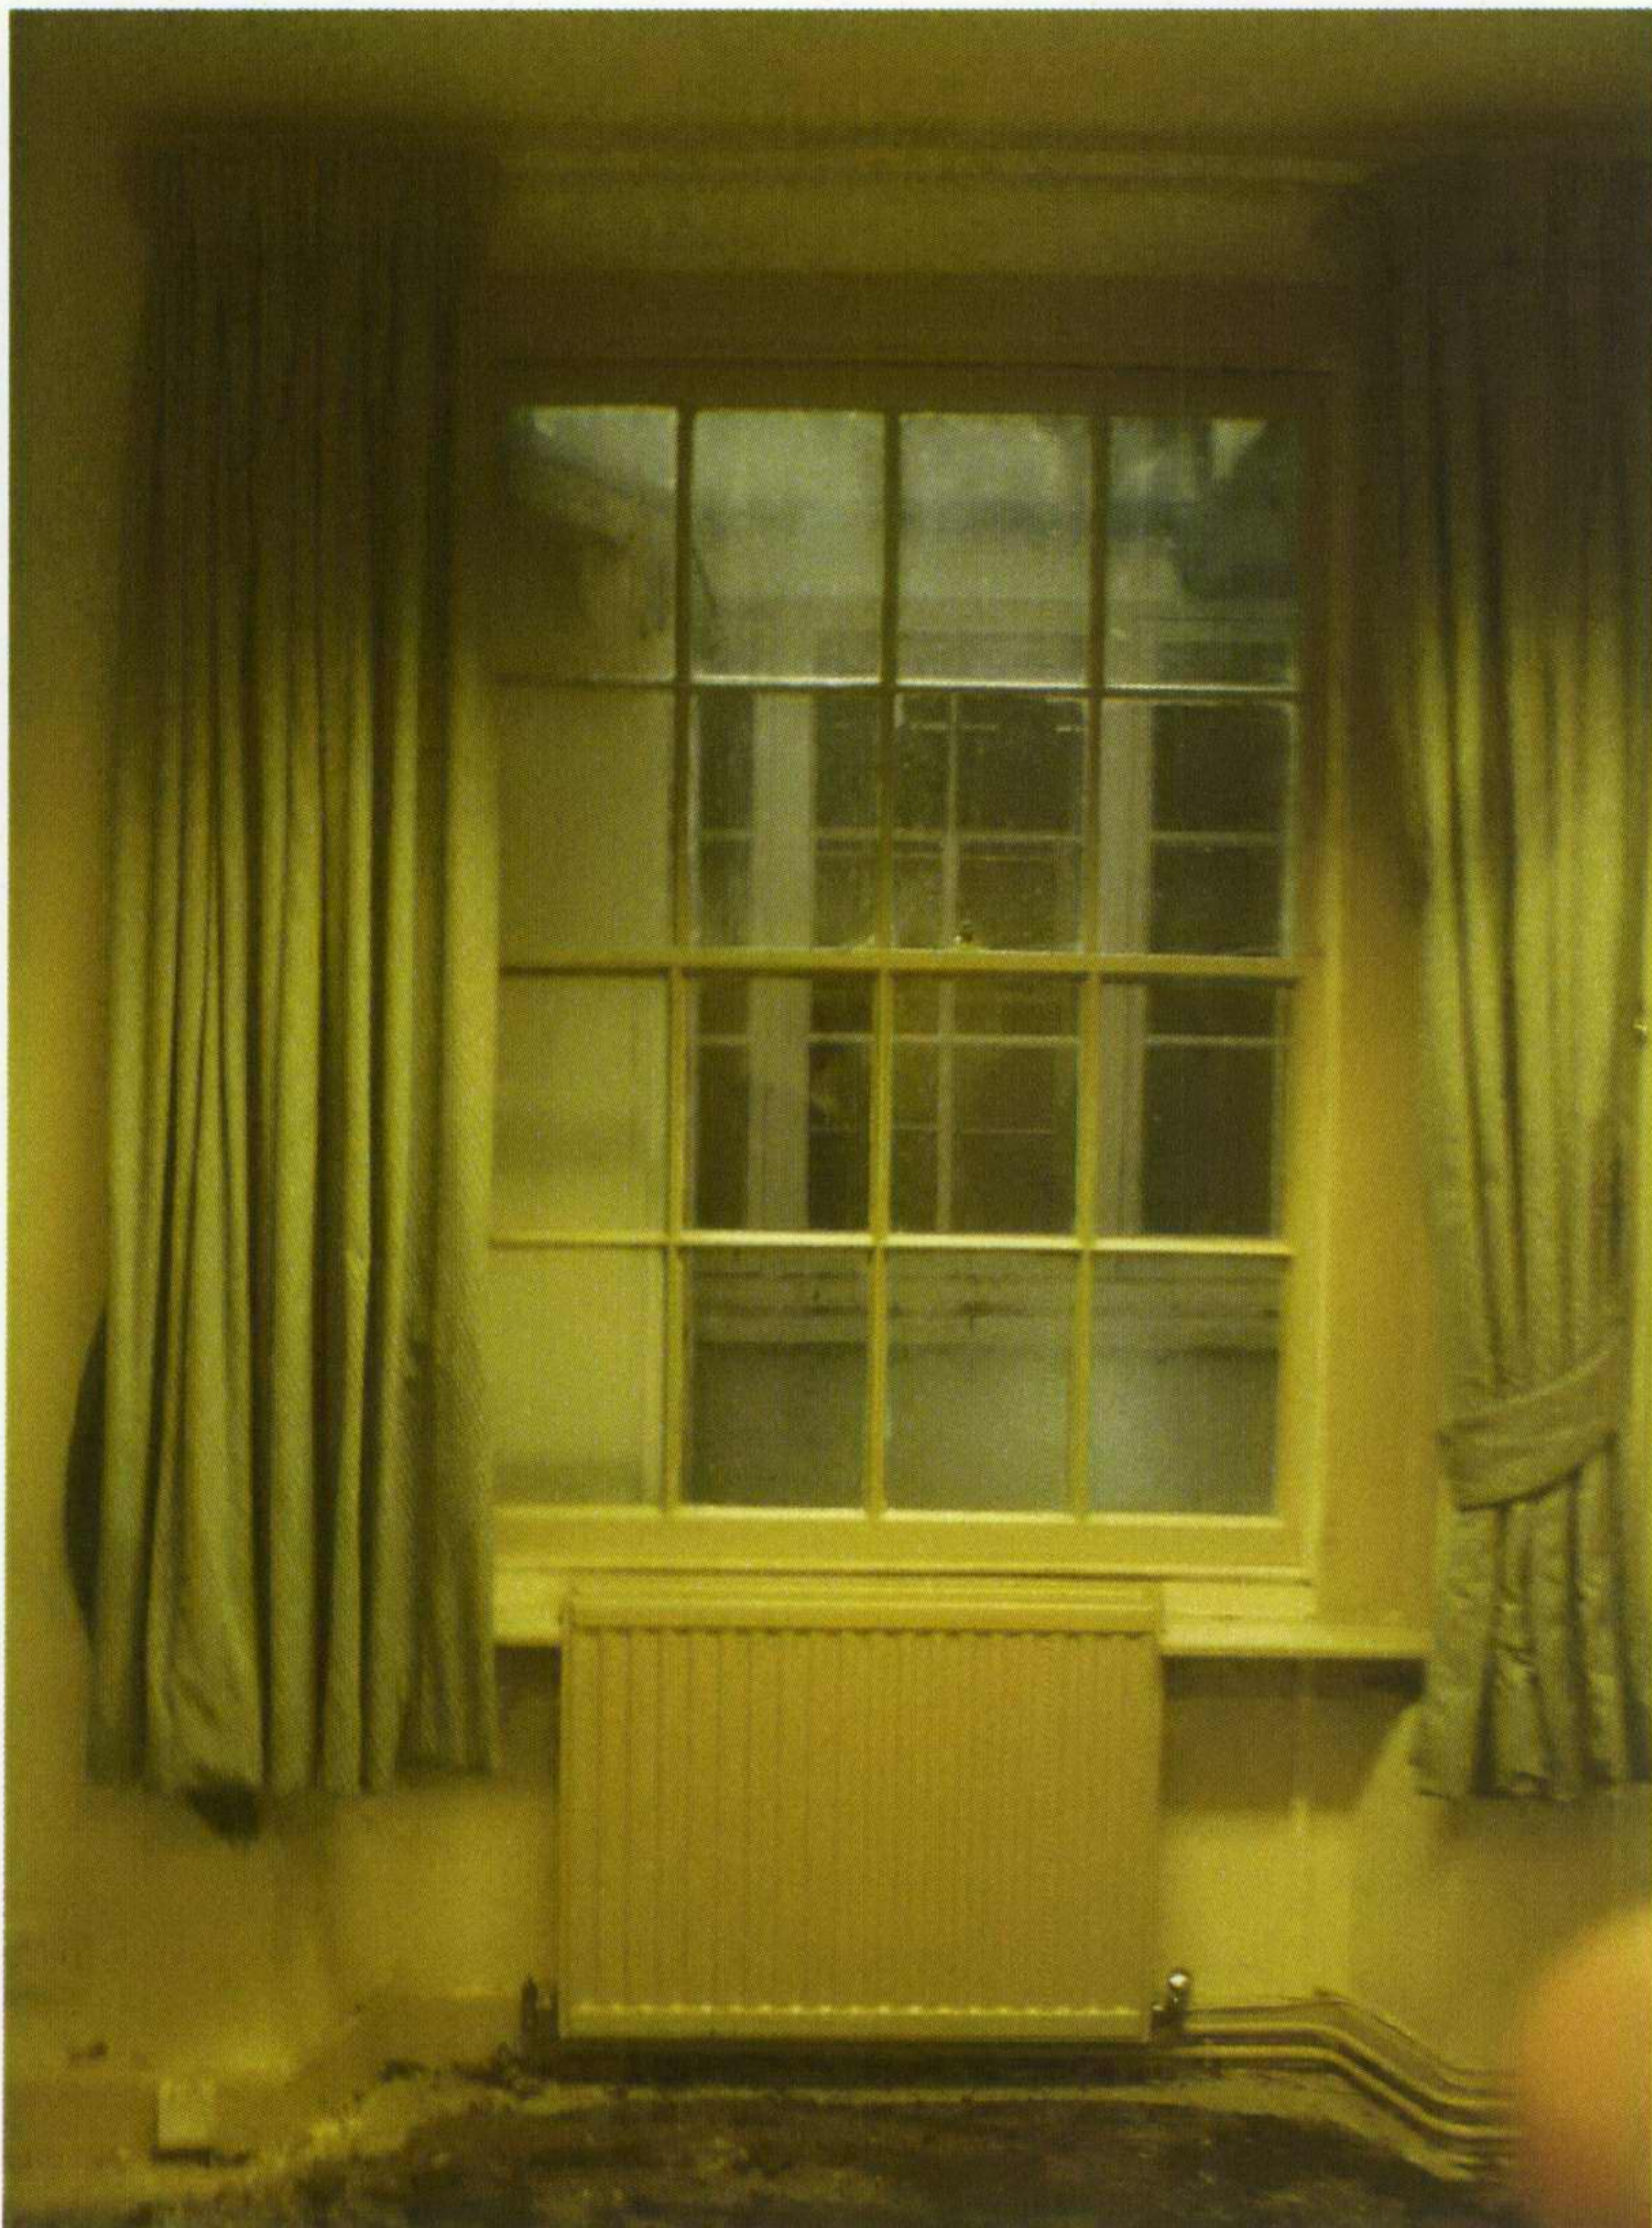
Photograph 31. Basement window into small rear gridded area. Proposed to be glazed double doors using mouldings to match.
NB: This window has been a doorway in the past at some stage.

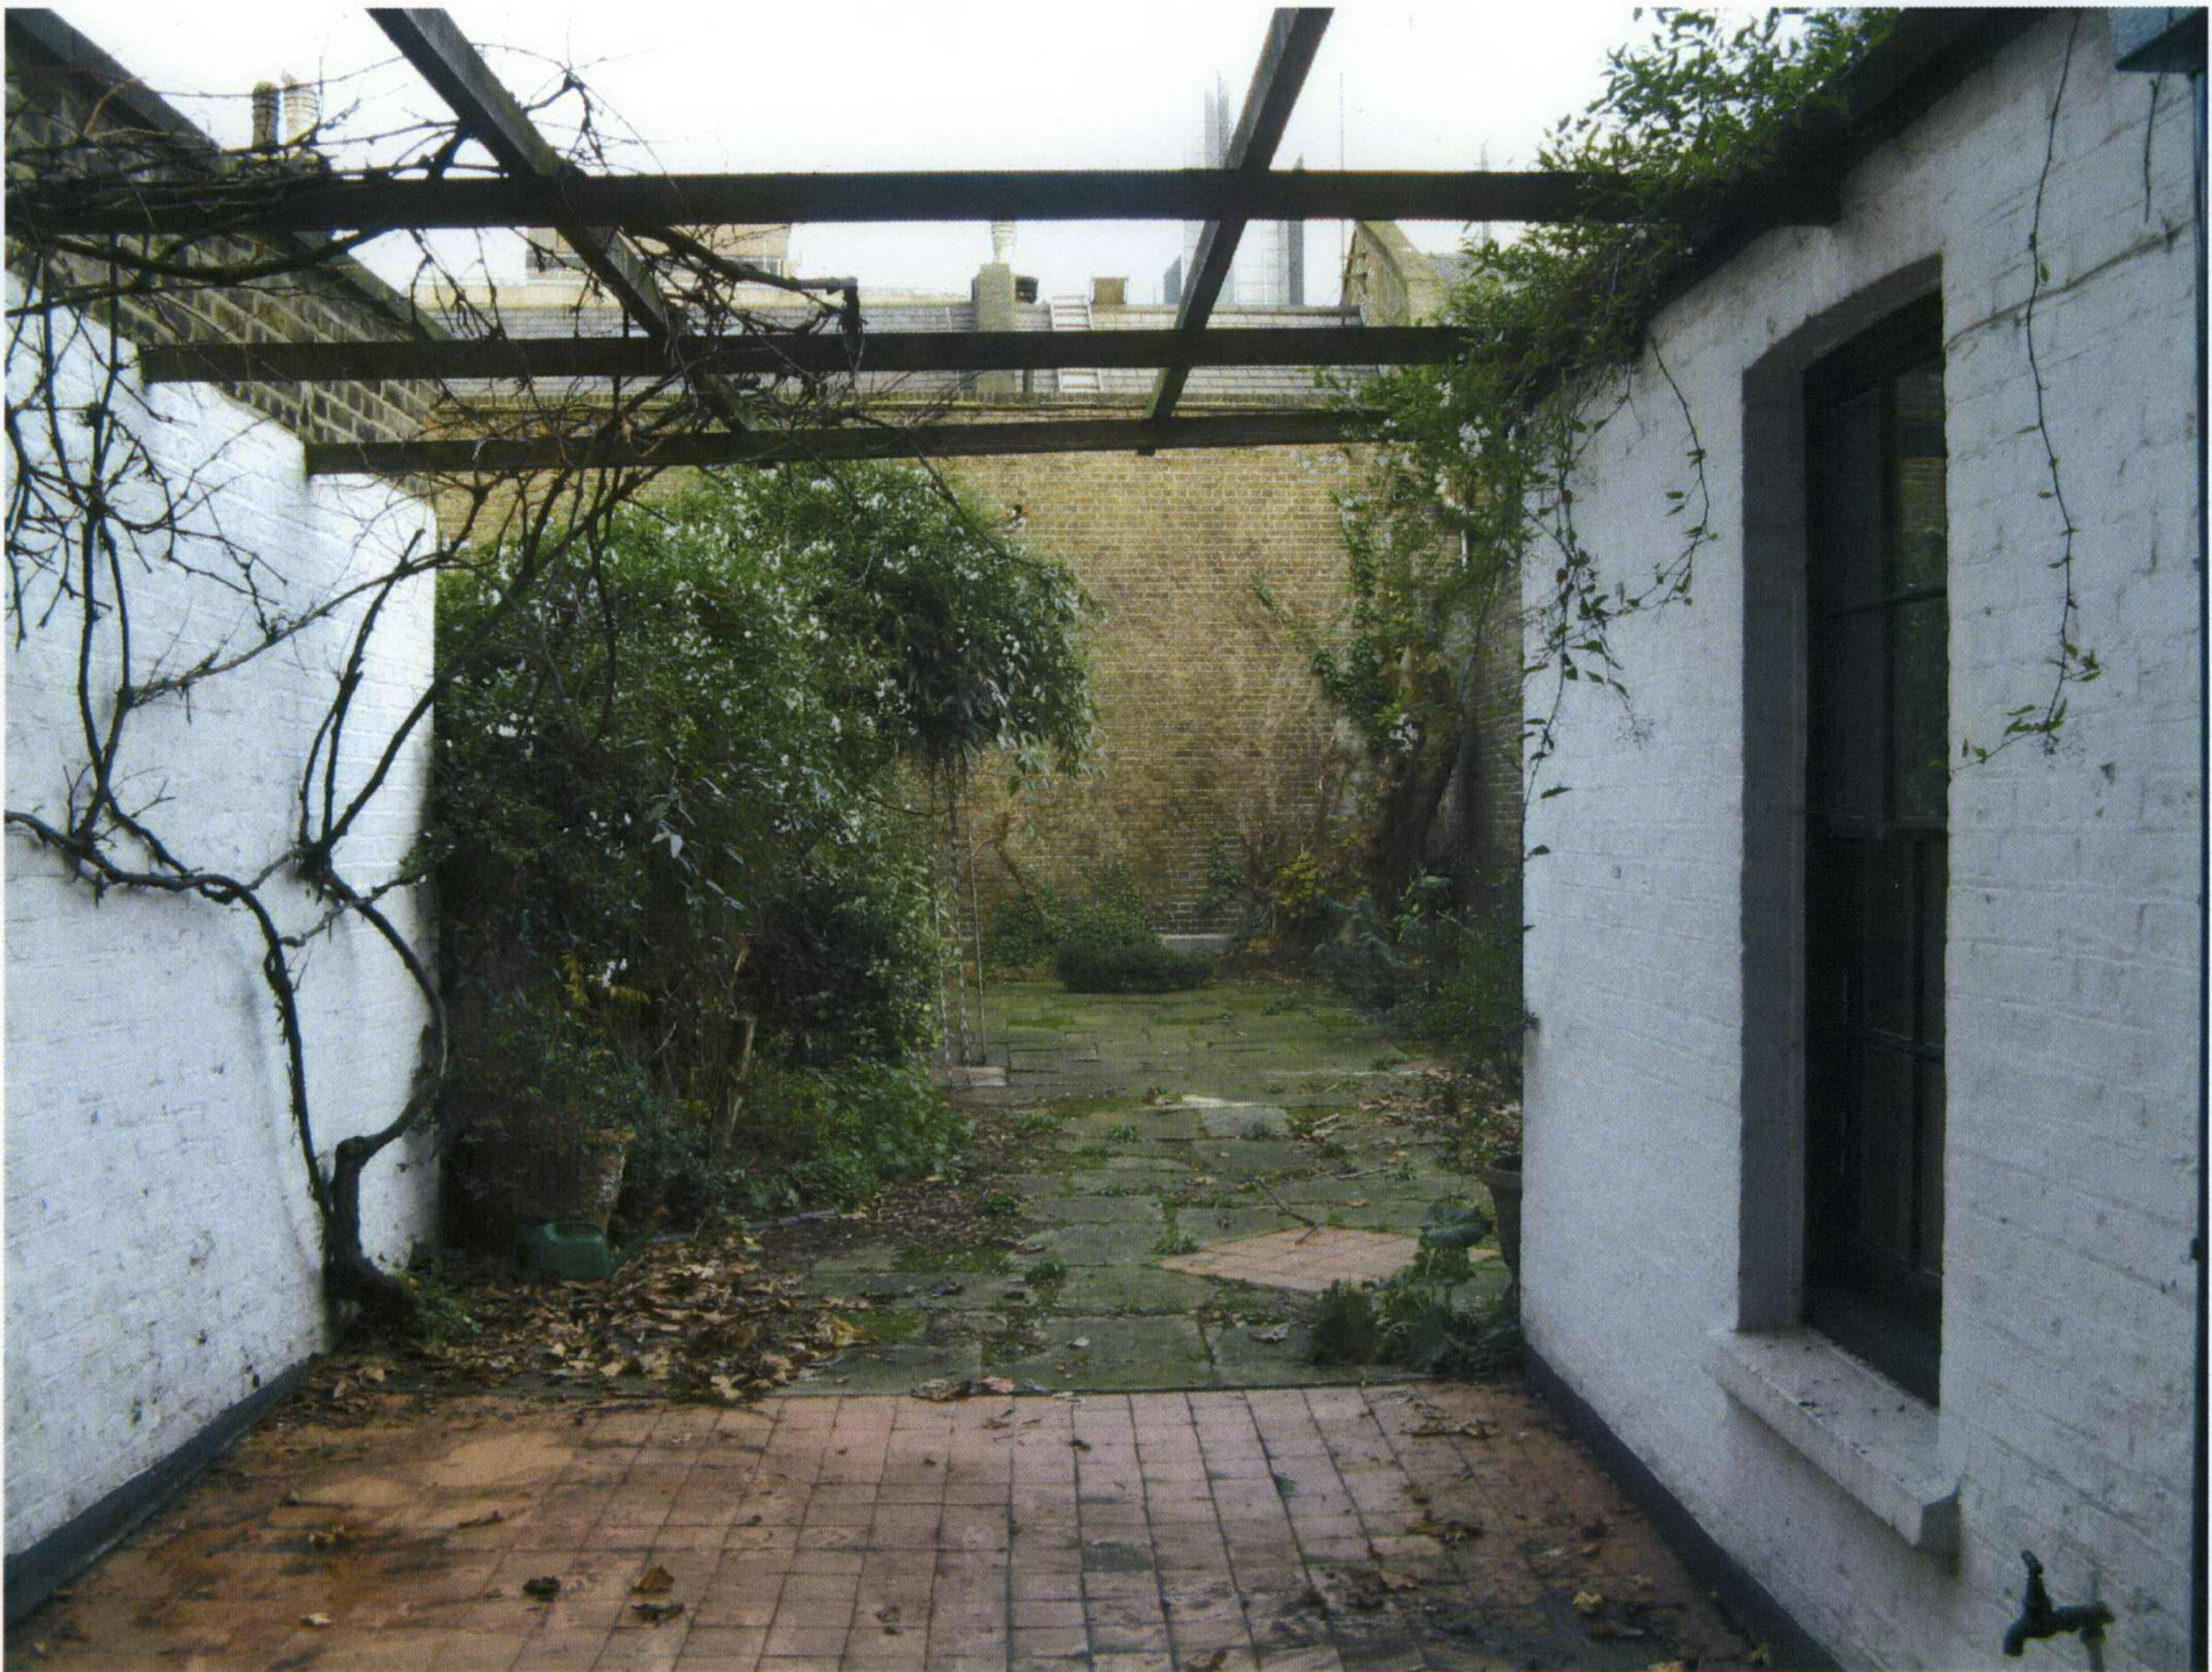
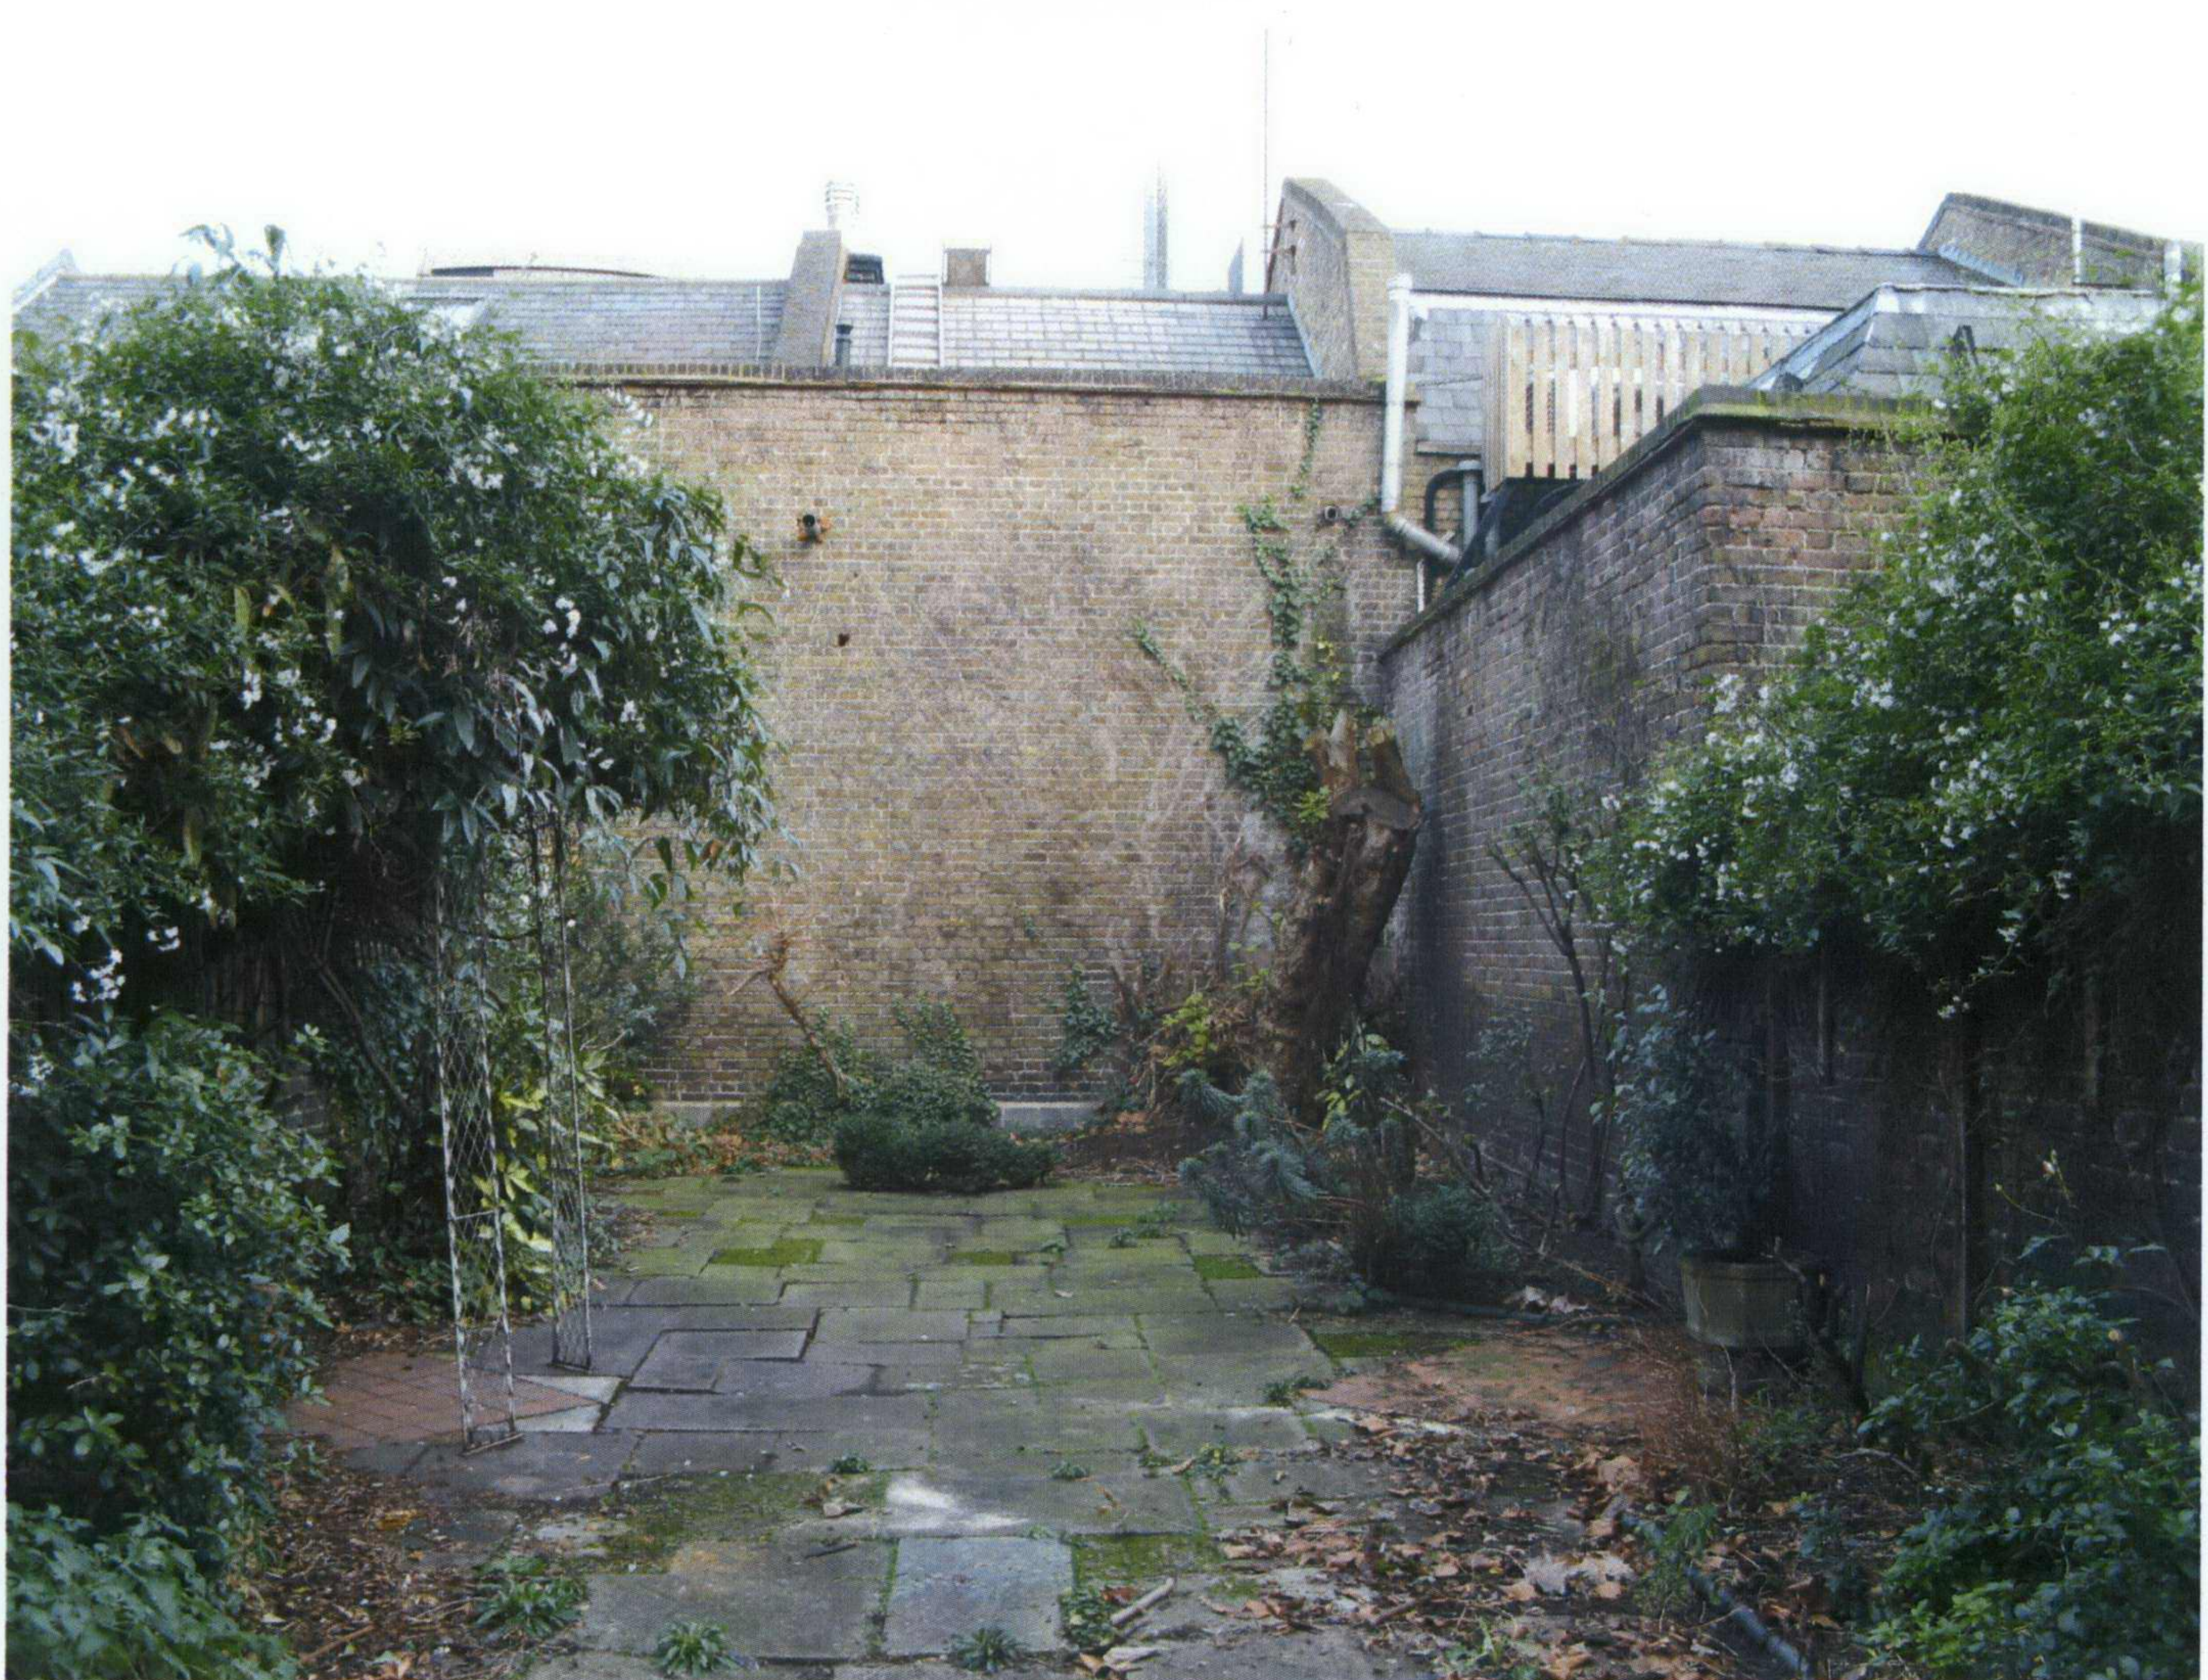
Photograph 33.

Photographs 32 and 33. Views into rear garden No. 56 Doughty Street.
