SUMMARY BUILDING INSPECTION REPORT

**THE MANSE
HIGHGATE ROAD
LONDON
NW5 1BS**

FEBRUARY 2007

**TRIDENT BUILDING CONSULTANCY LIMITED
10 KING WILLIAM STREET
LONDON
EC4N 7TW**

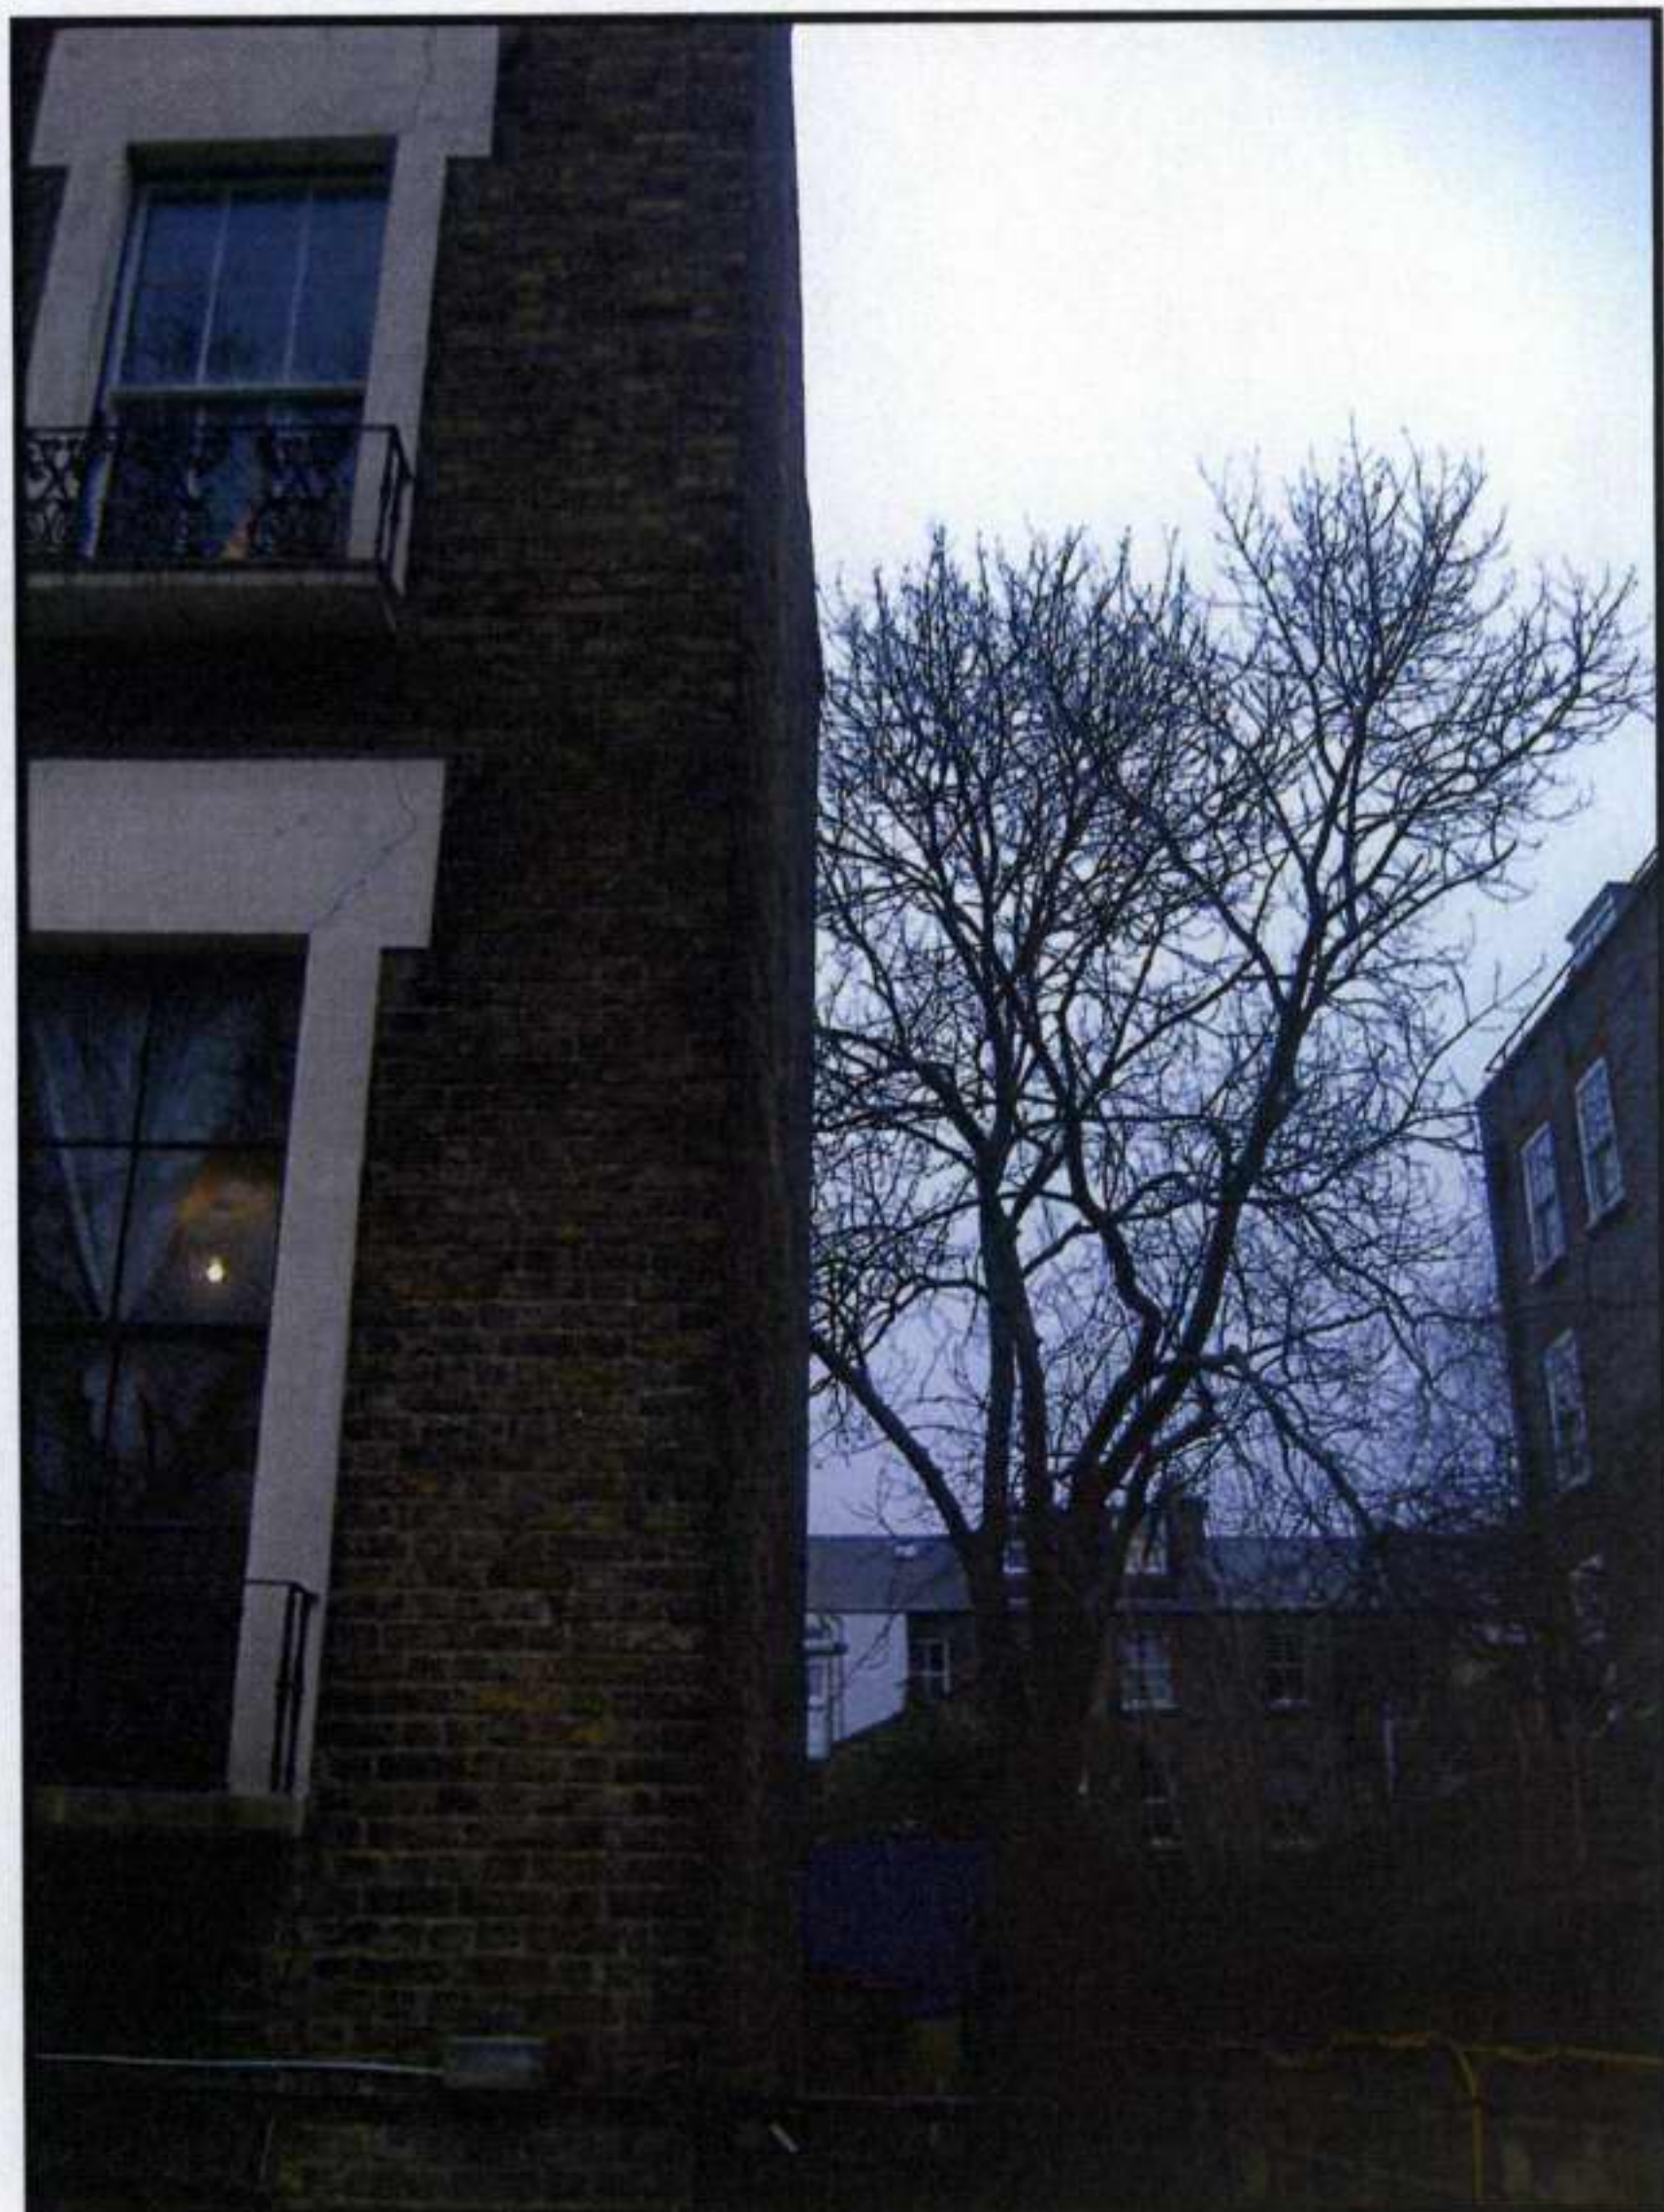
- 3.01.3 The Manse was not originally constructed as a detached dwelling, in our view. The construction adjacent to the Manse immediately to the south (rhs when viewed from front) was demolished some time ago without adequate restraint being provided to the Manse. As a result the south elevation of the Manse has separated from the remainder and has 'bellied out' to a significant extent.

- 3.01.4 This is evidenced by the 'belly' in the brickwork externally, by the severe fractures to all of the lintels and brick soldier arches to the front in particular, the vertical fractures to walls and horizontal fractures to ceilings internally. Numerous photographs in the appendix hereafter clearly illustrate this.

1. Severe bowing/belly to south flank elevation.

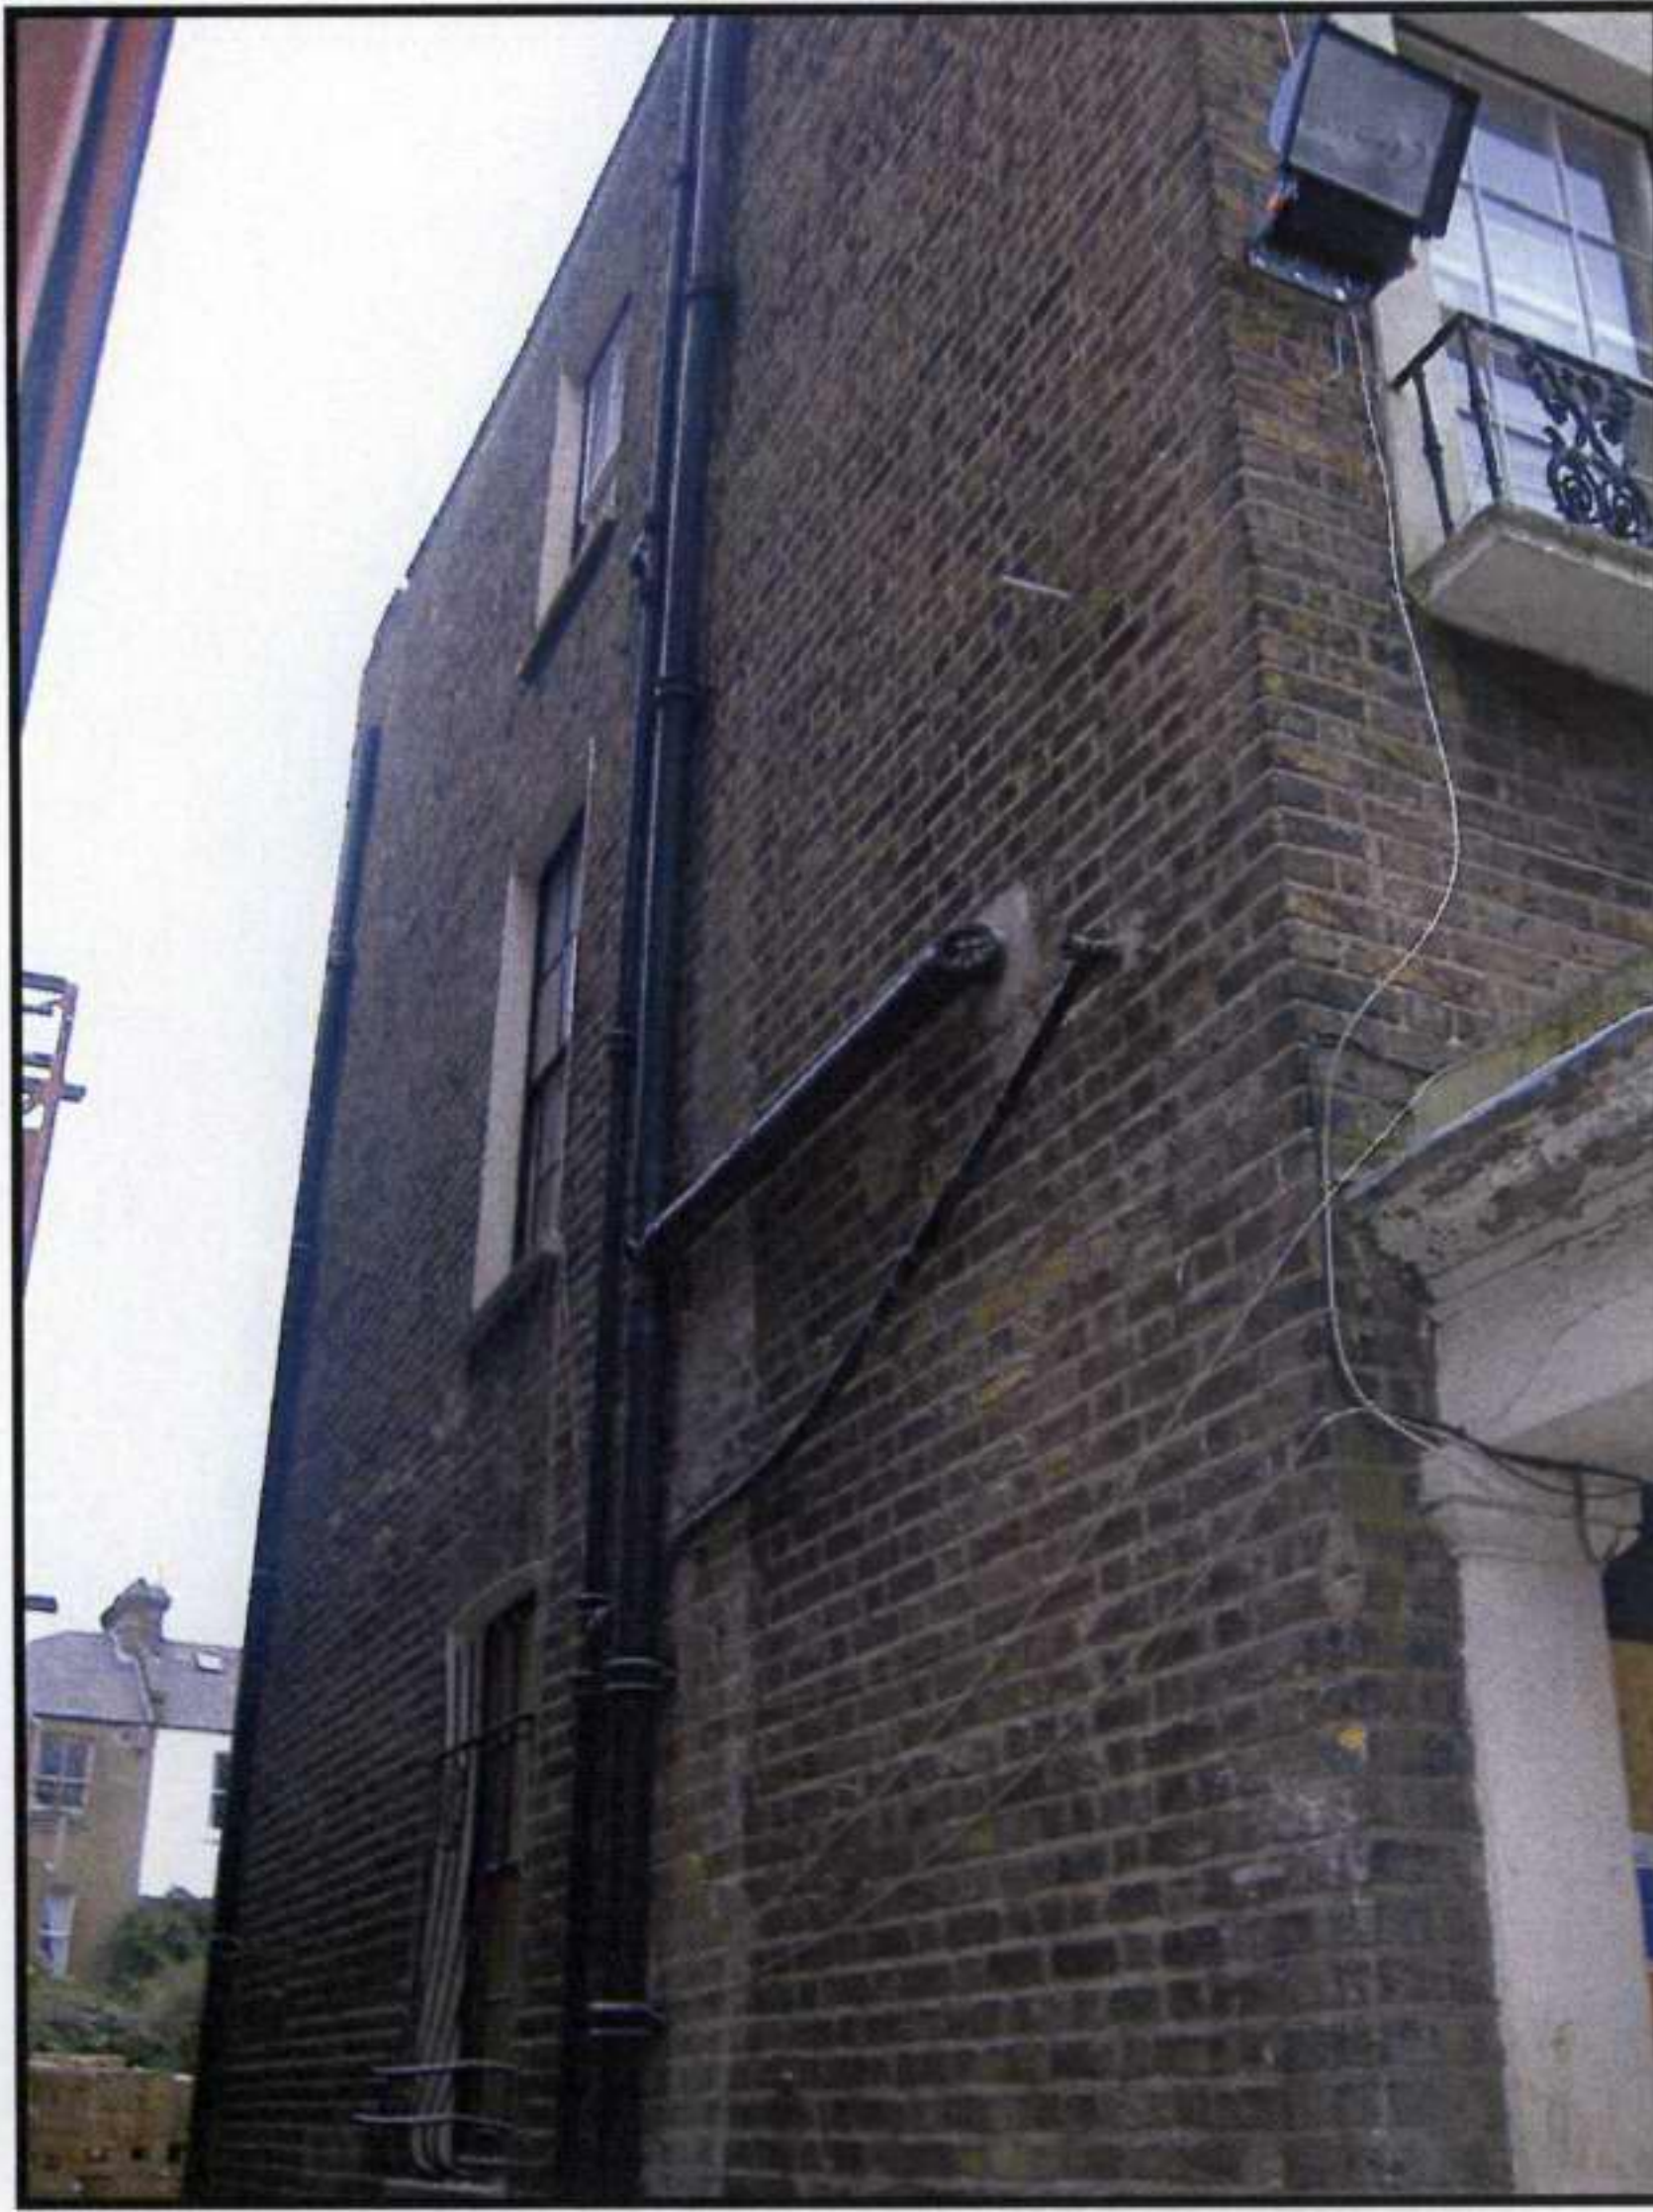
2. General view of north elevation.

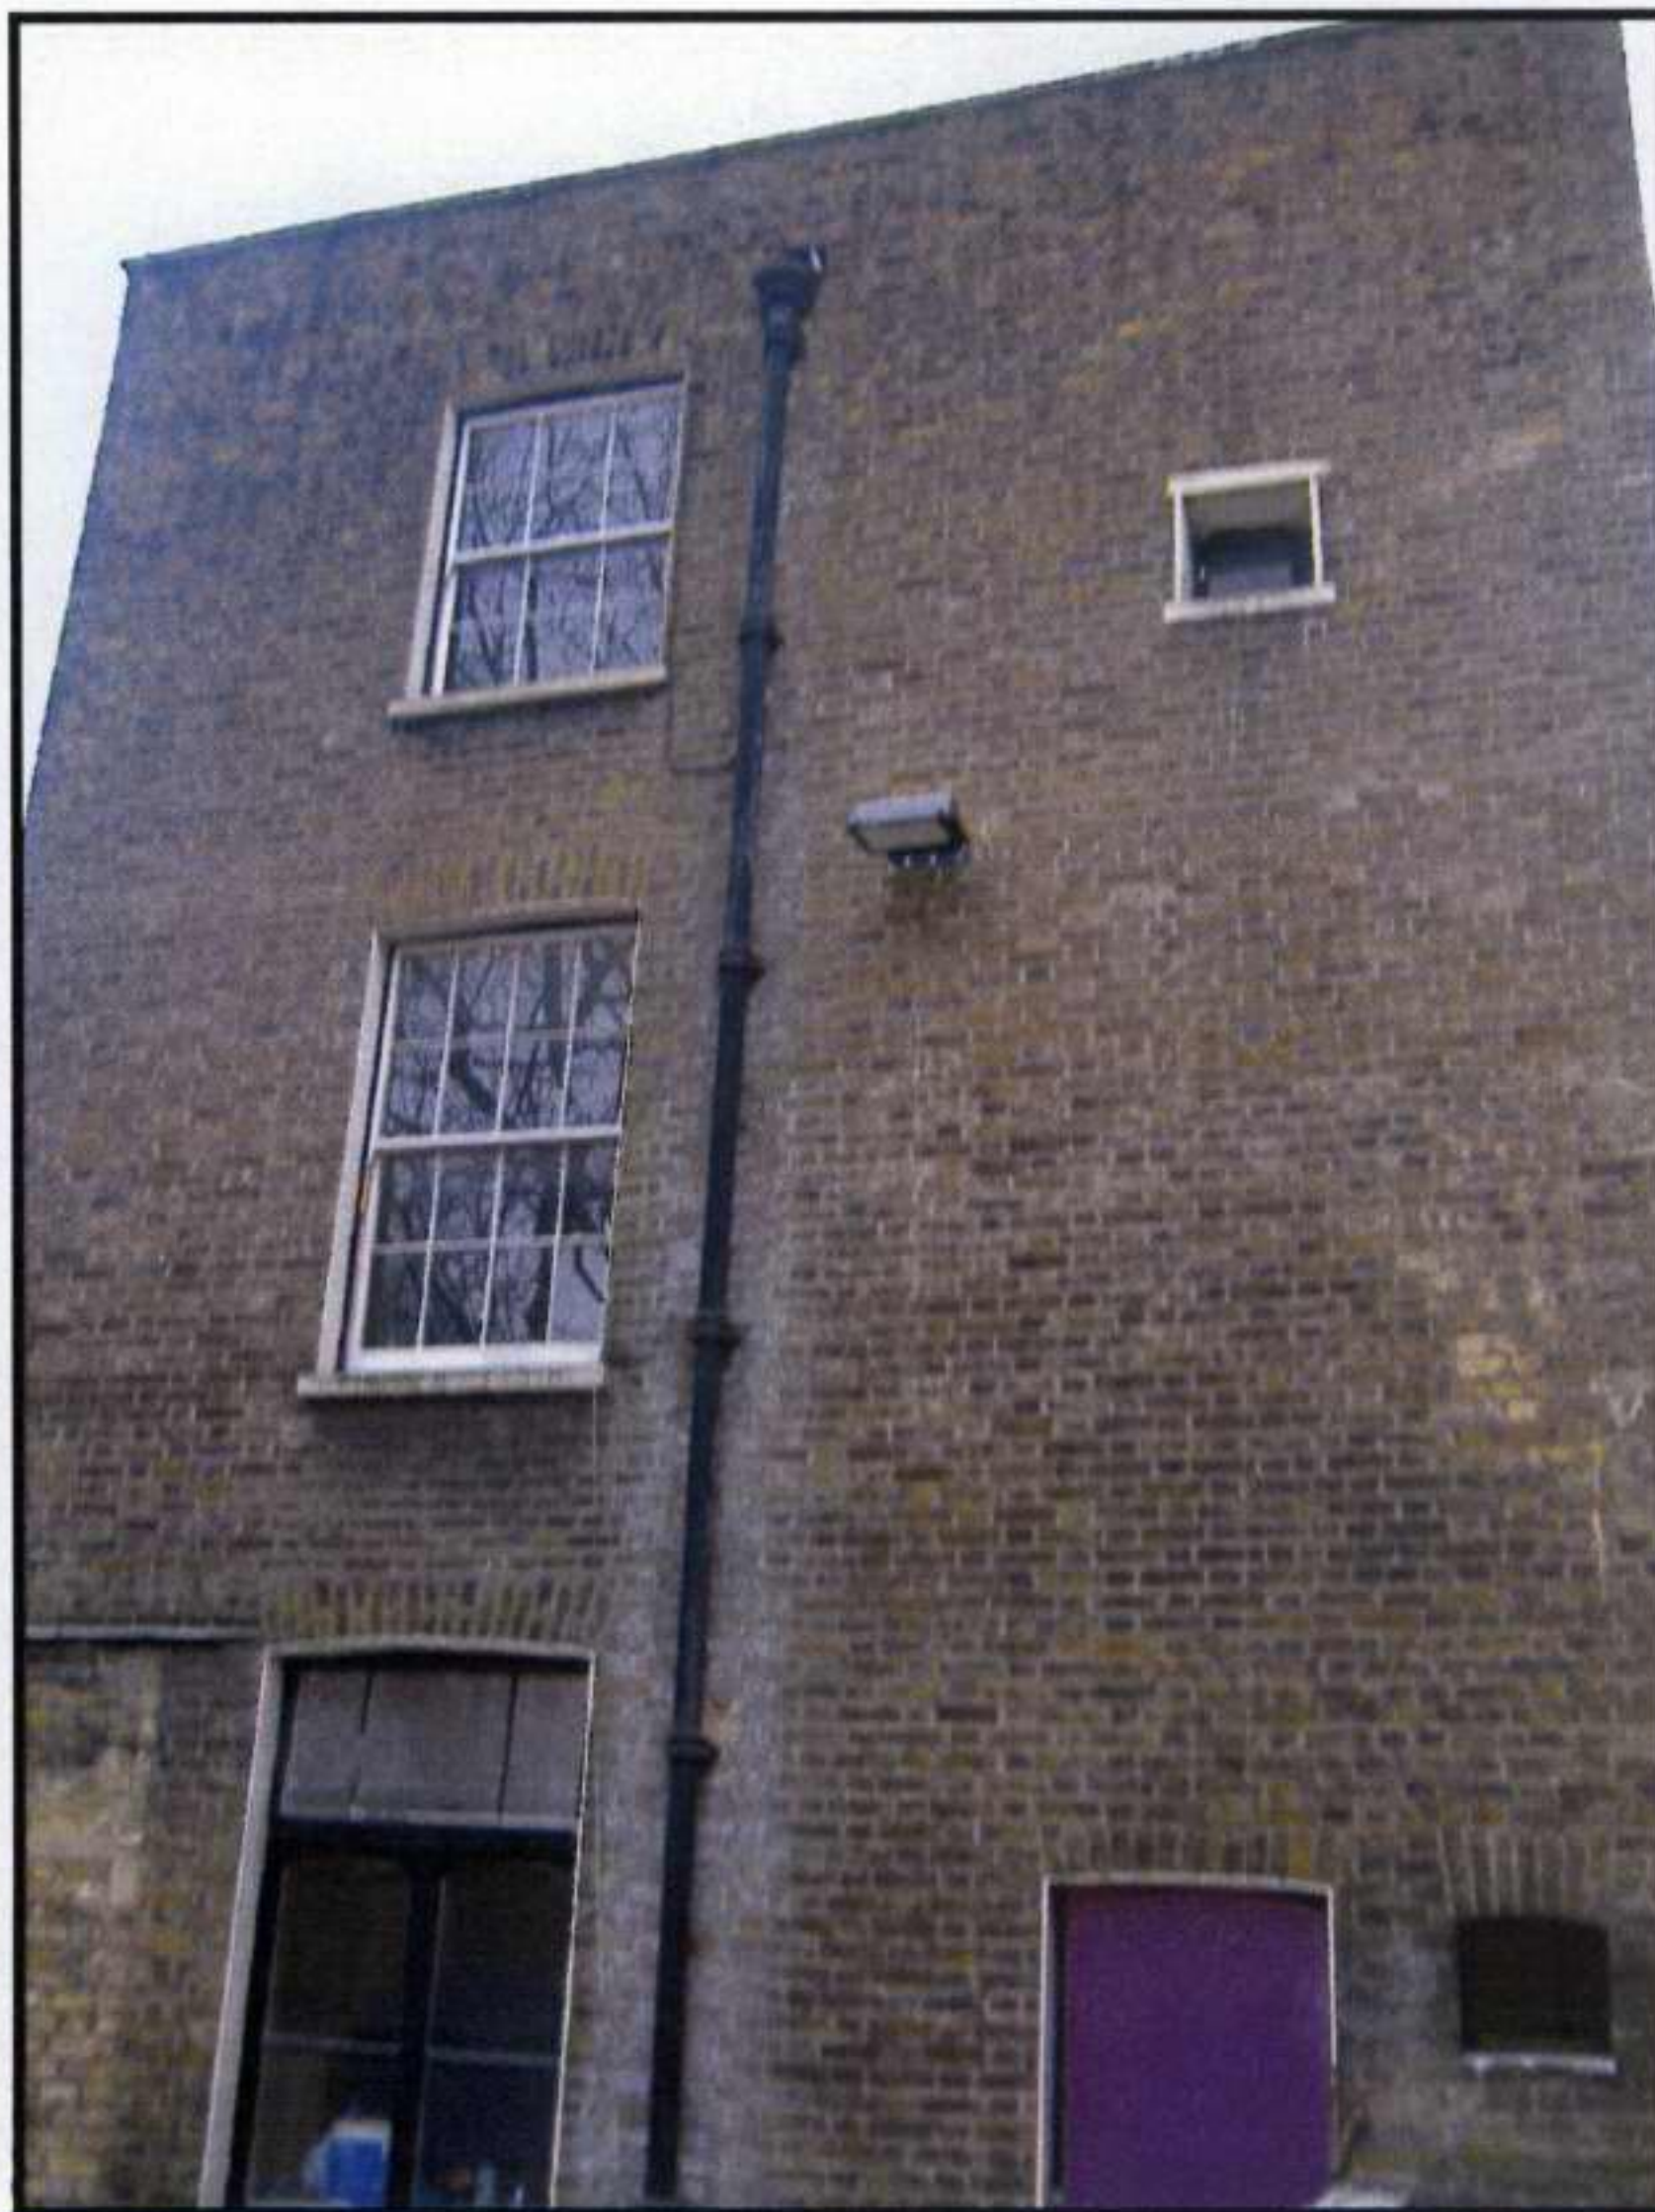
3.01.12 The cast iron rainwater goods have perished and there is severe staining and efflorescence to the external brickwork where rainwater is cascading down the building.

3. Rear (east) elevation showing efflorescence to downpipe.

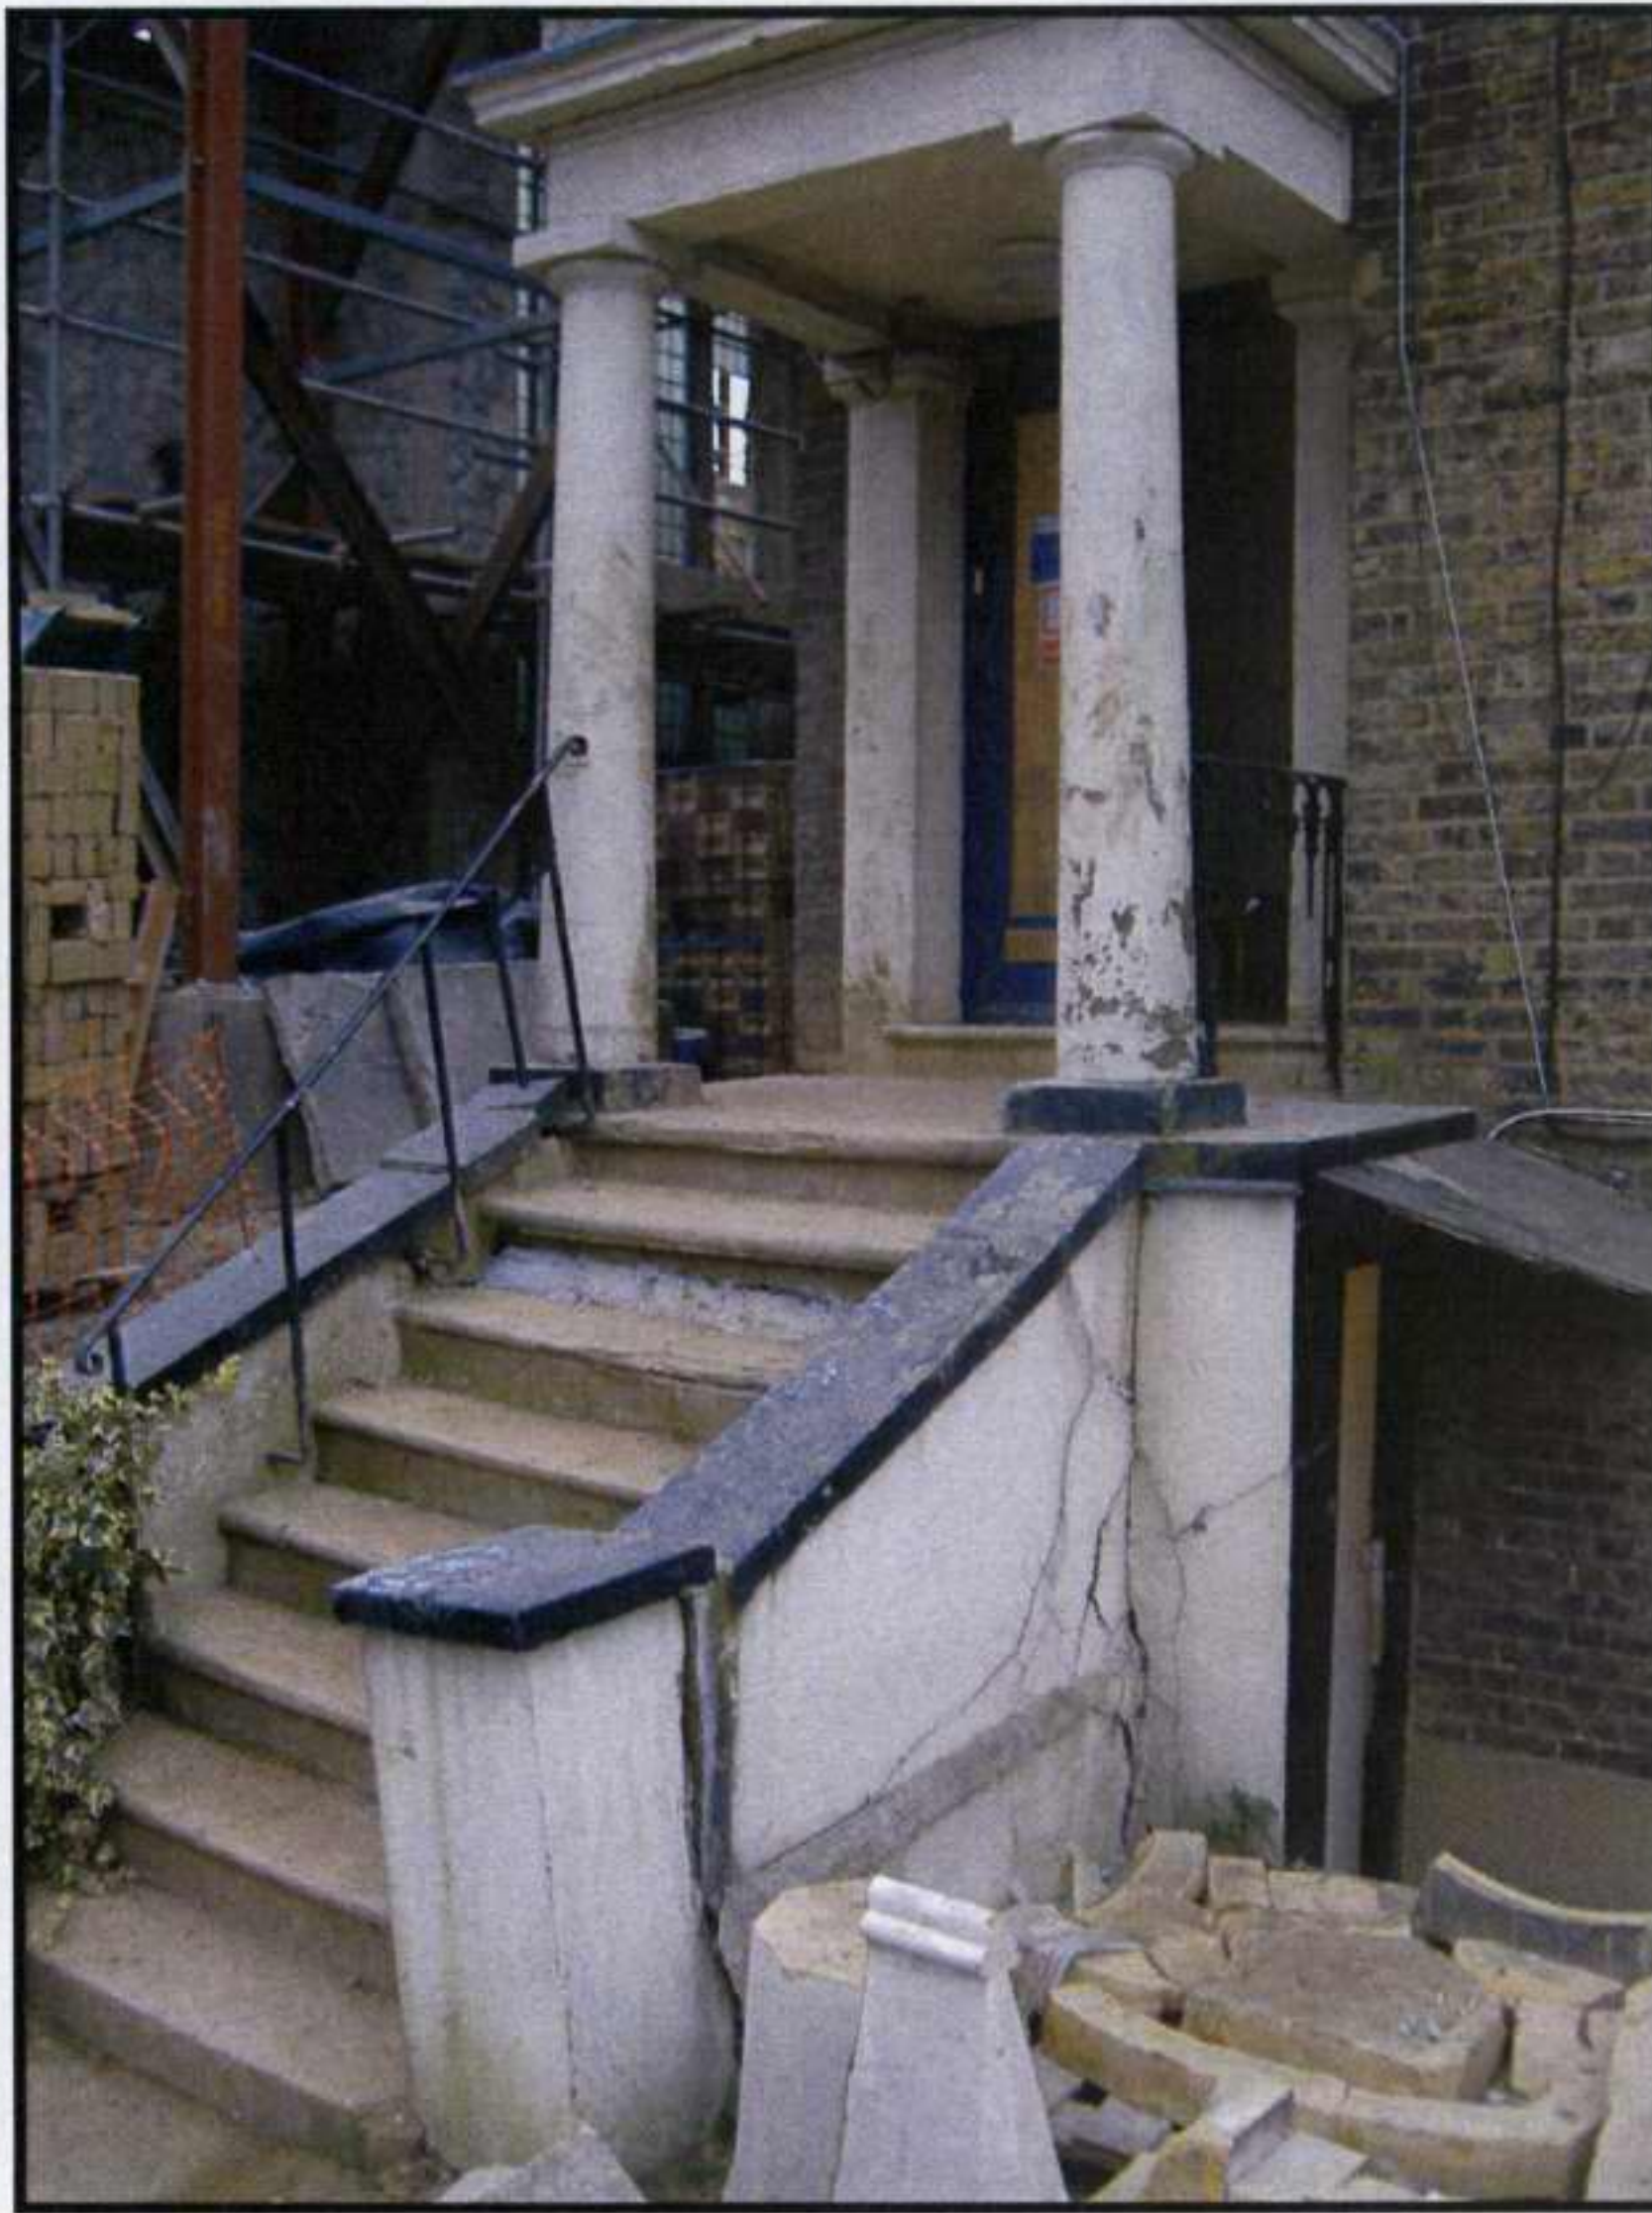
3.01.10 The stone portico steps to the front elevation are collapsing and the brickwork pier to the rhs is unsafe.

4. Collapsing pier and unstable steps and portico to front (west) elevation.

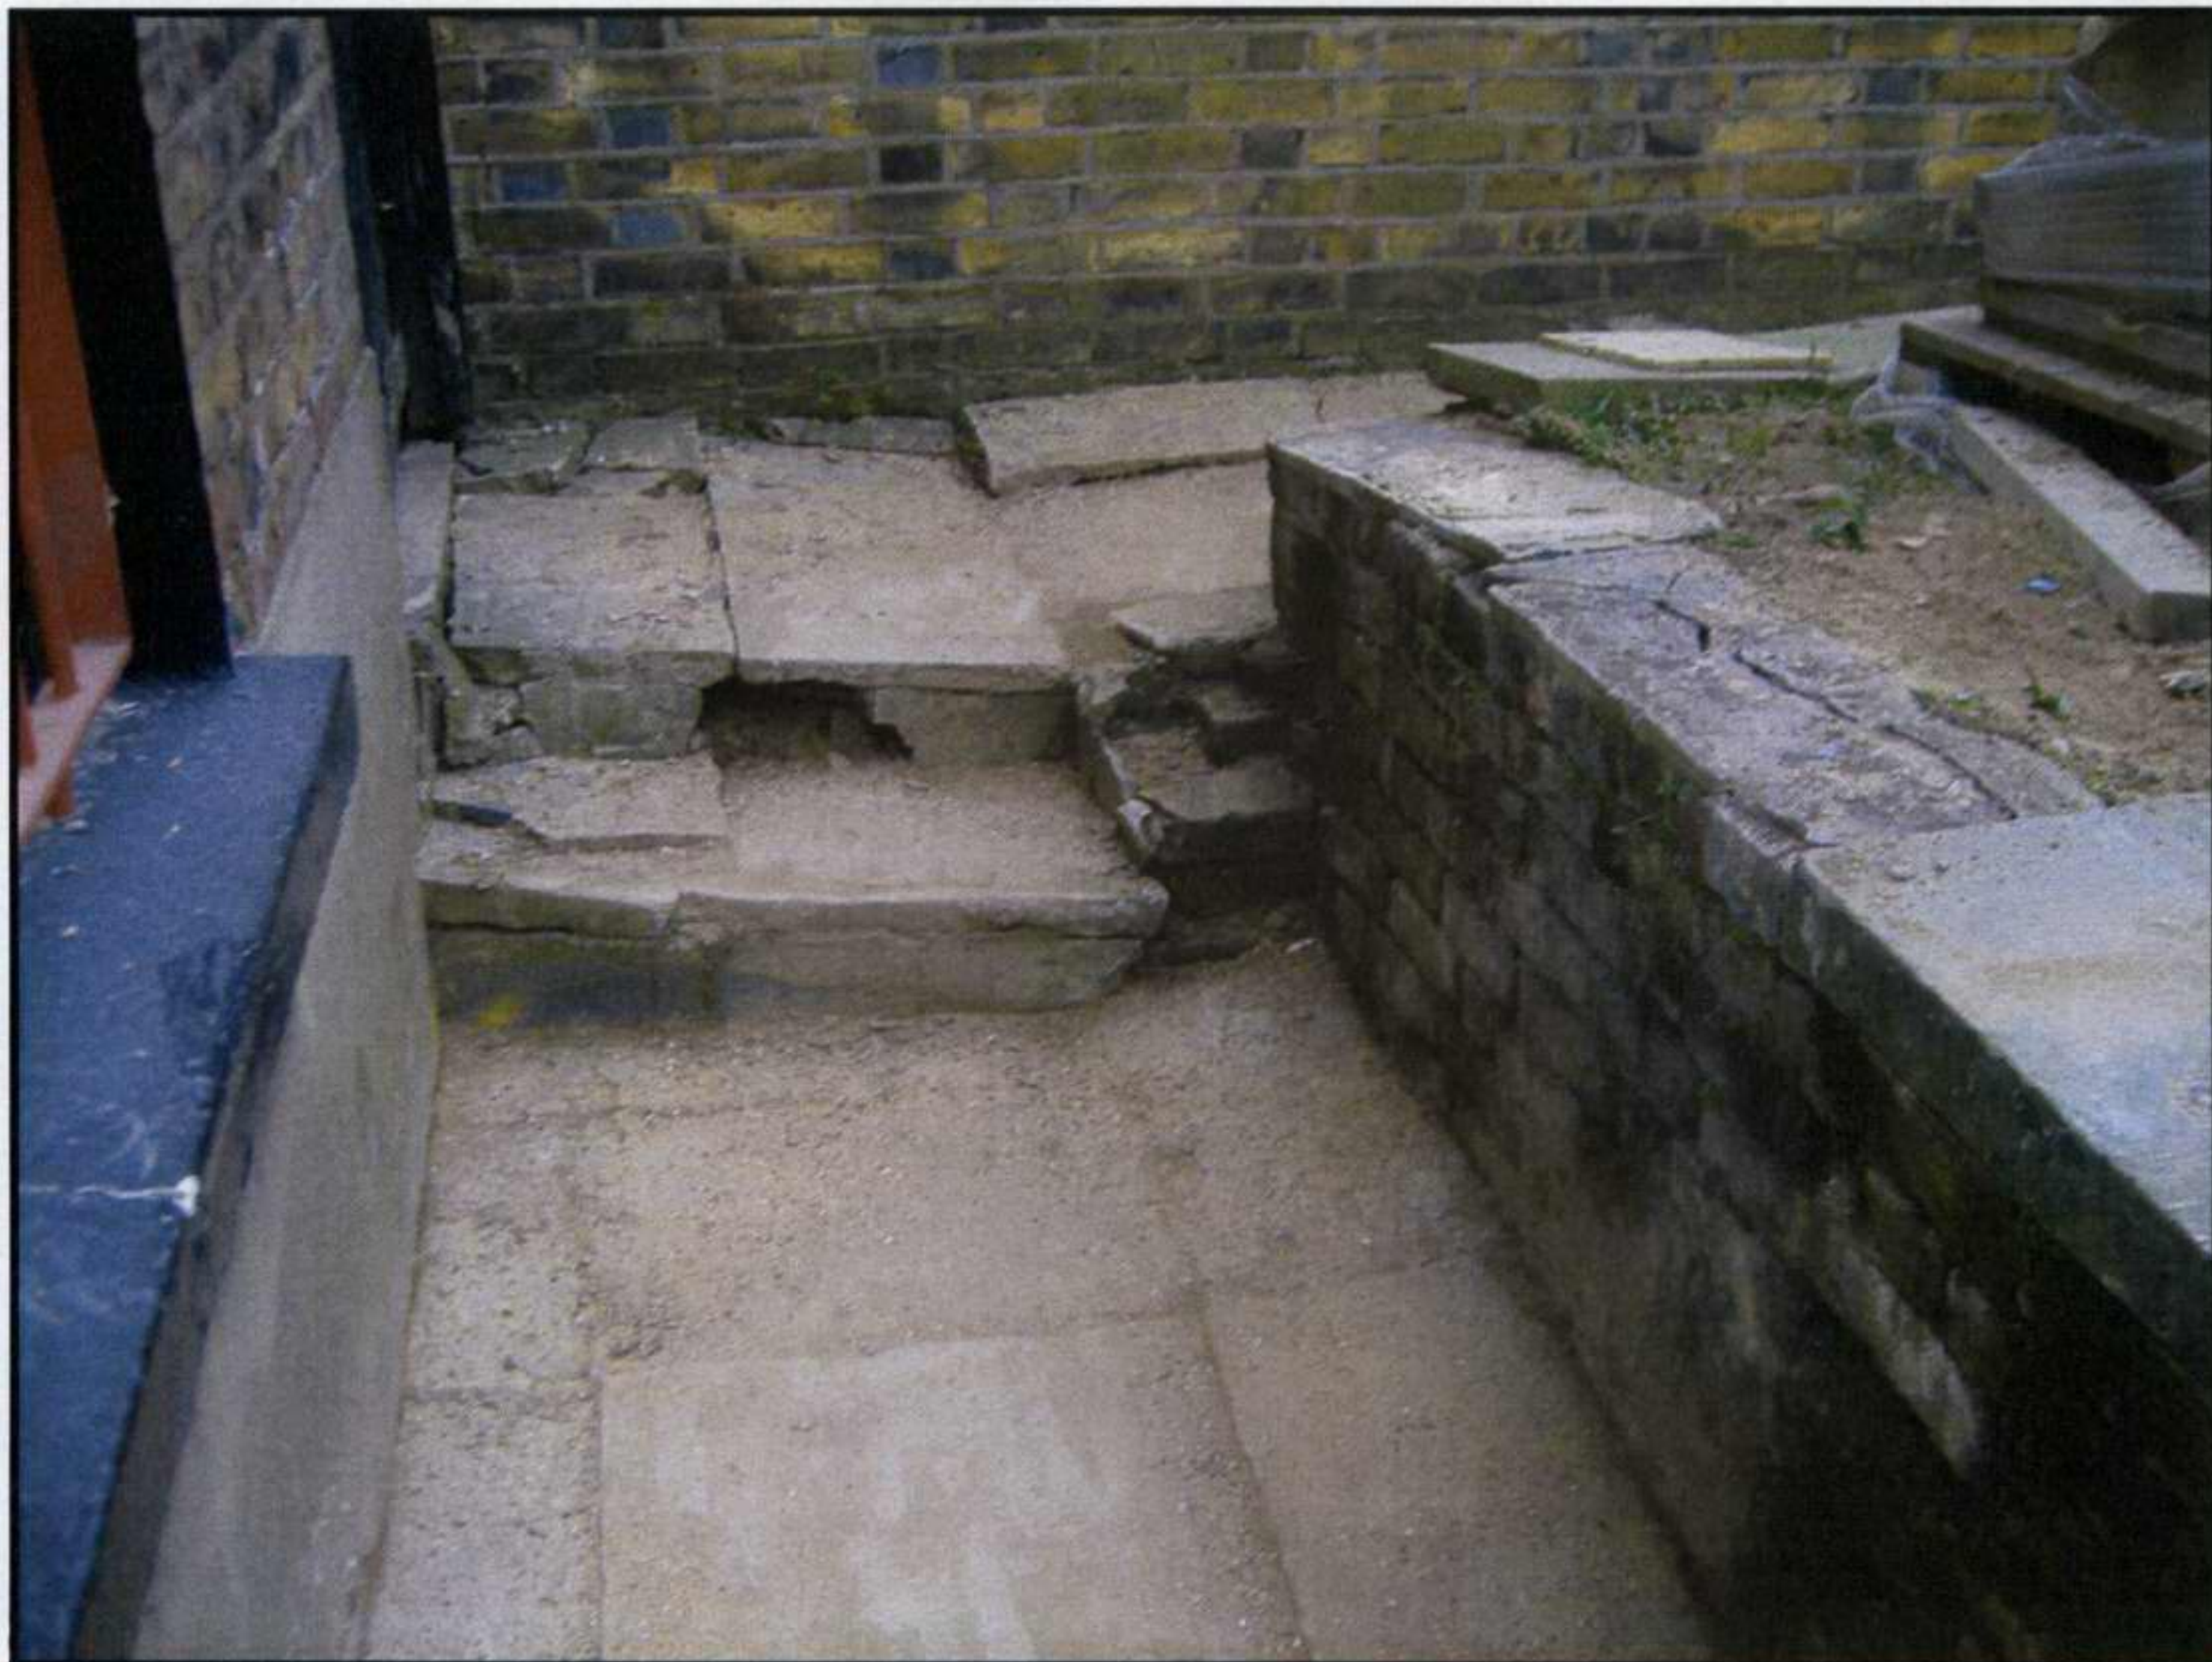
3.01.11 Similarly, the brickwork retaining wall which provides the paved route to the basement flat has failed and is rotating towards the Manse. The stone pavings in this area have settled unevenly.

5. Settlement to steps and unstable retaining wall.

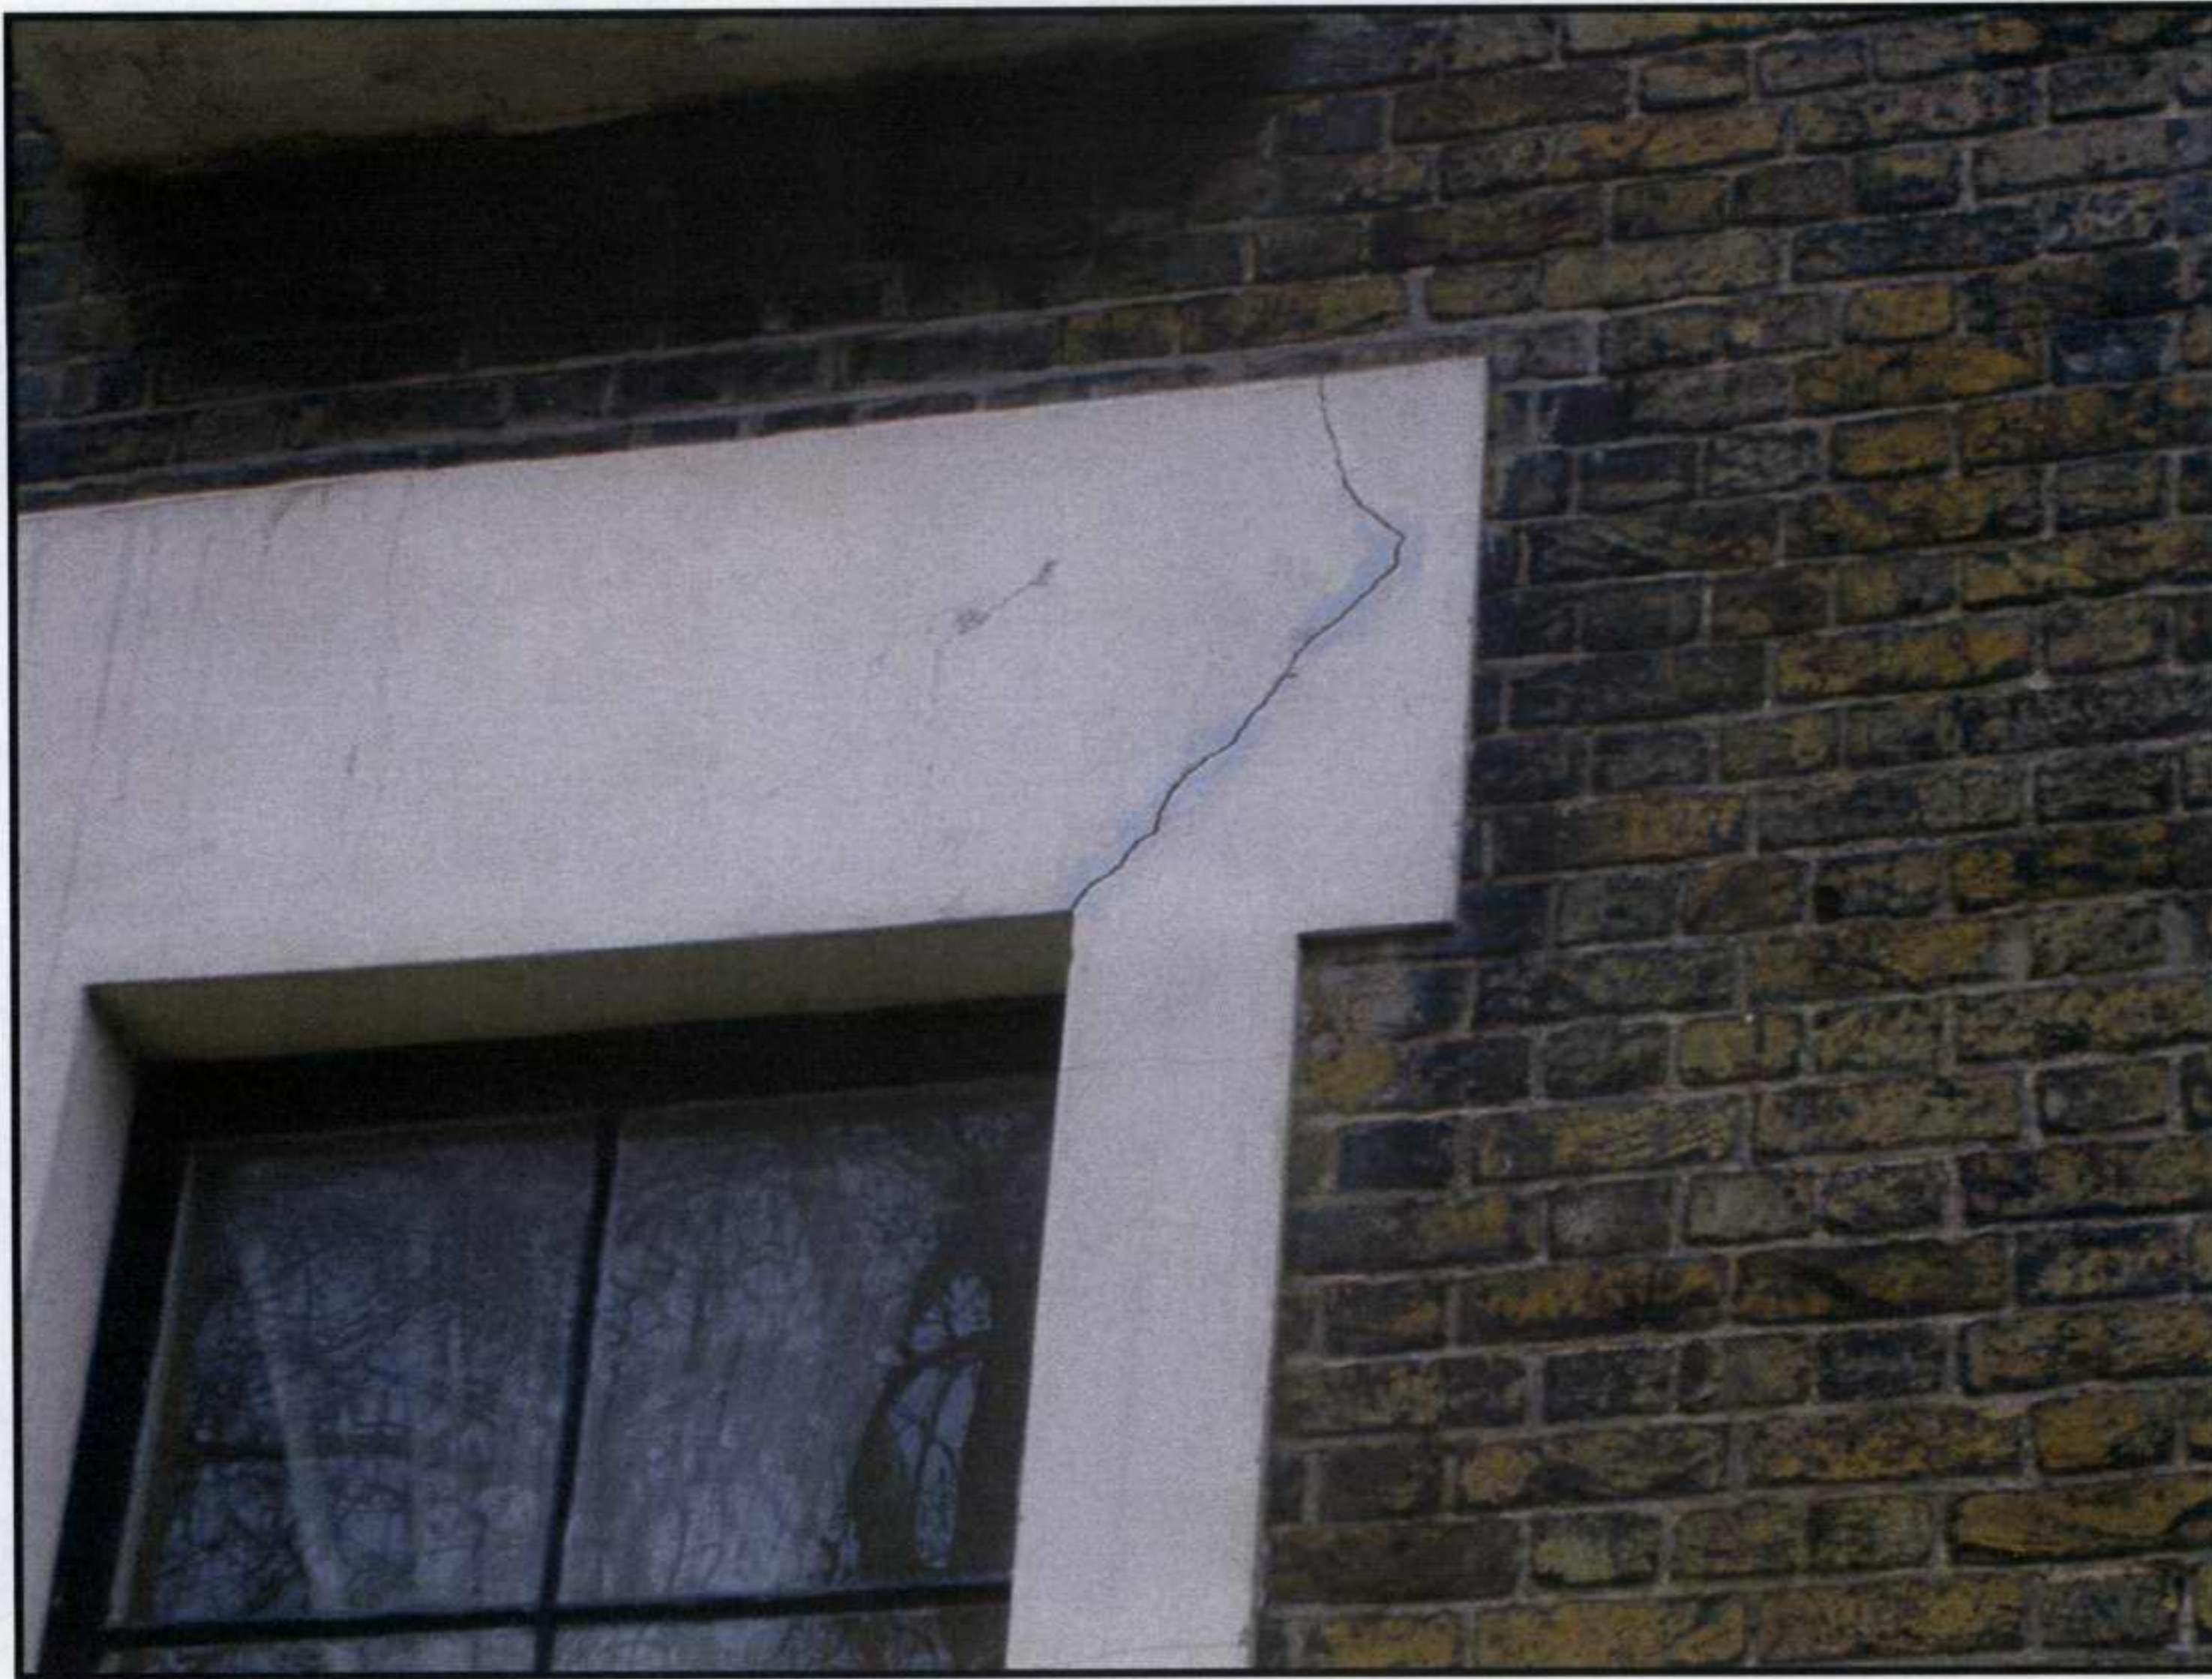
6. Severe diagonal fracture to lintel to Ground floor window.
