SUMMARY BUILDING INSPECTION REPORT

**THE MANSE
HIGHGATE ROAD
LONDON
NW5 1BS**

FEBRUARY 2007

**TRIDENT BUILDING CONSULTANCY LIMITED
10 KING WILLIAM STREET
LONDON
EC4N 7TW**

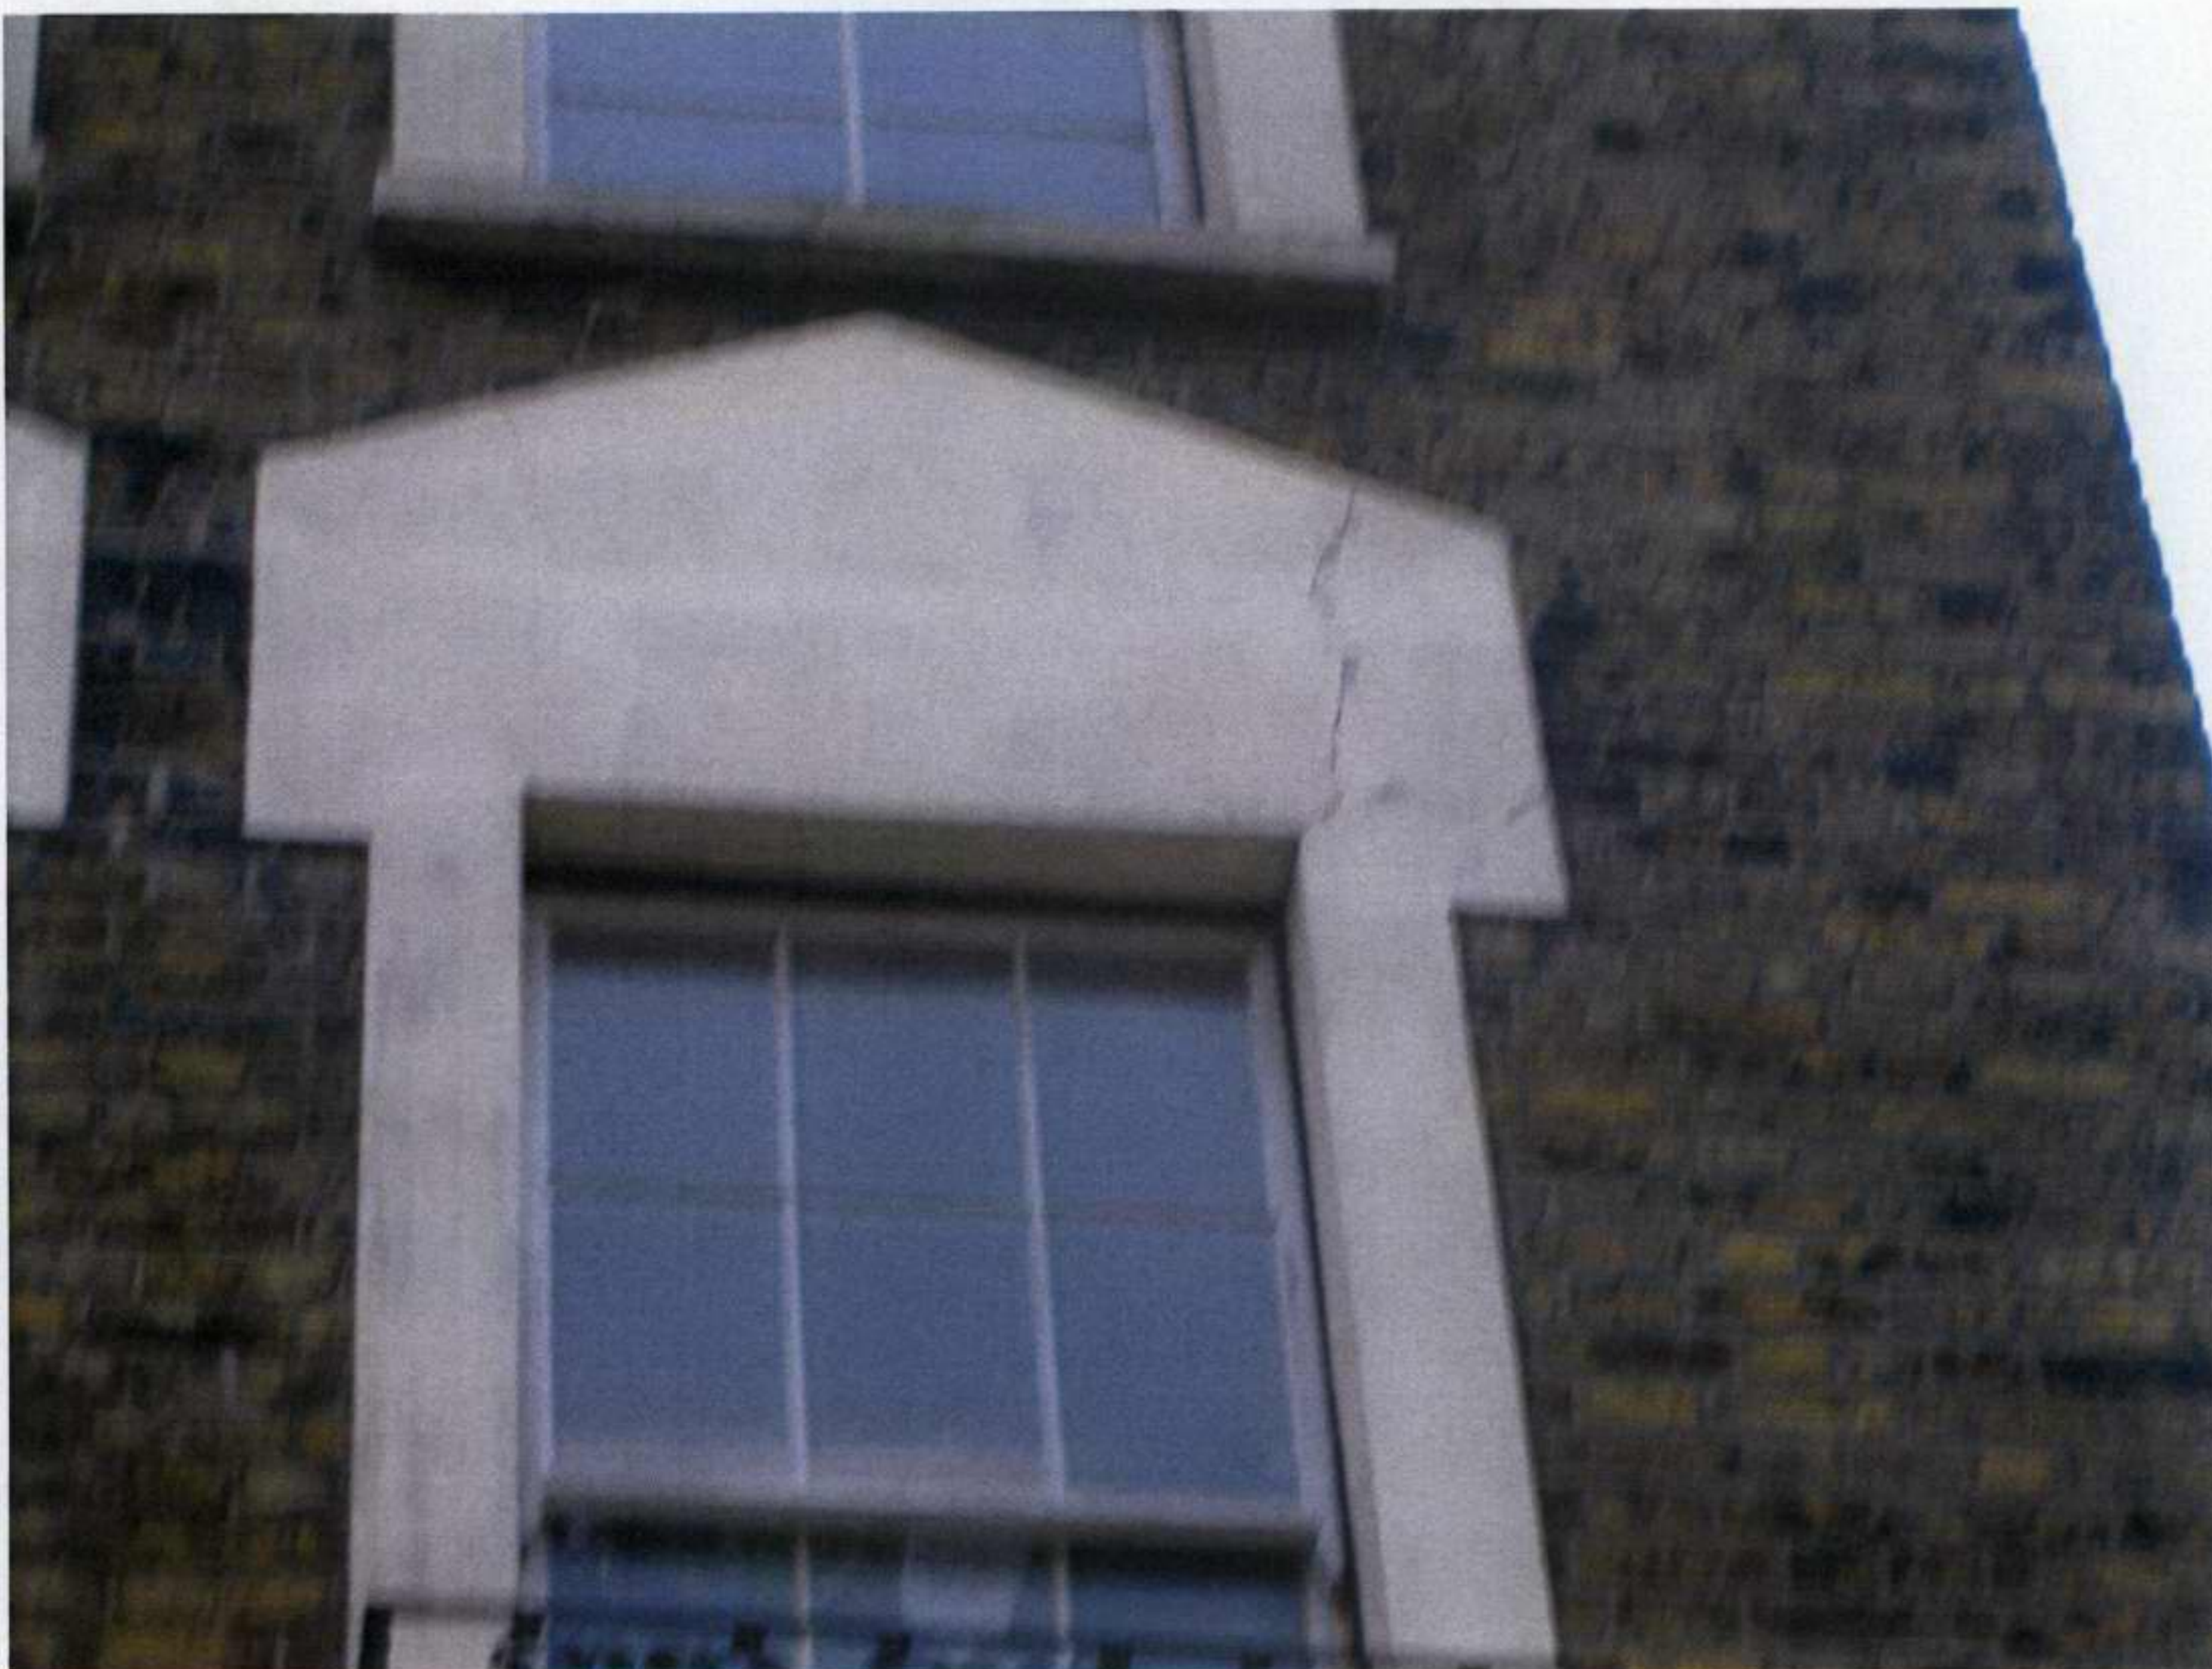
7. Severe vertical fracture to first floor lintel where south wall is separating from building.

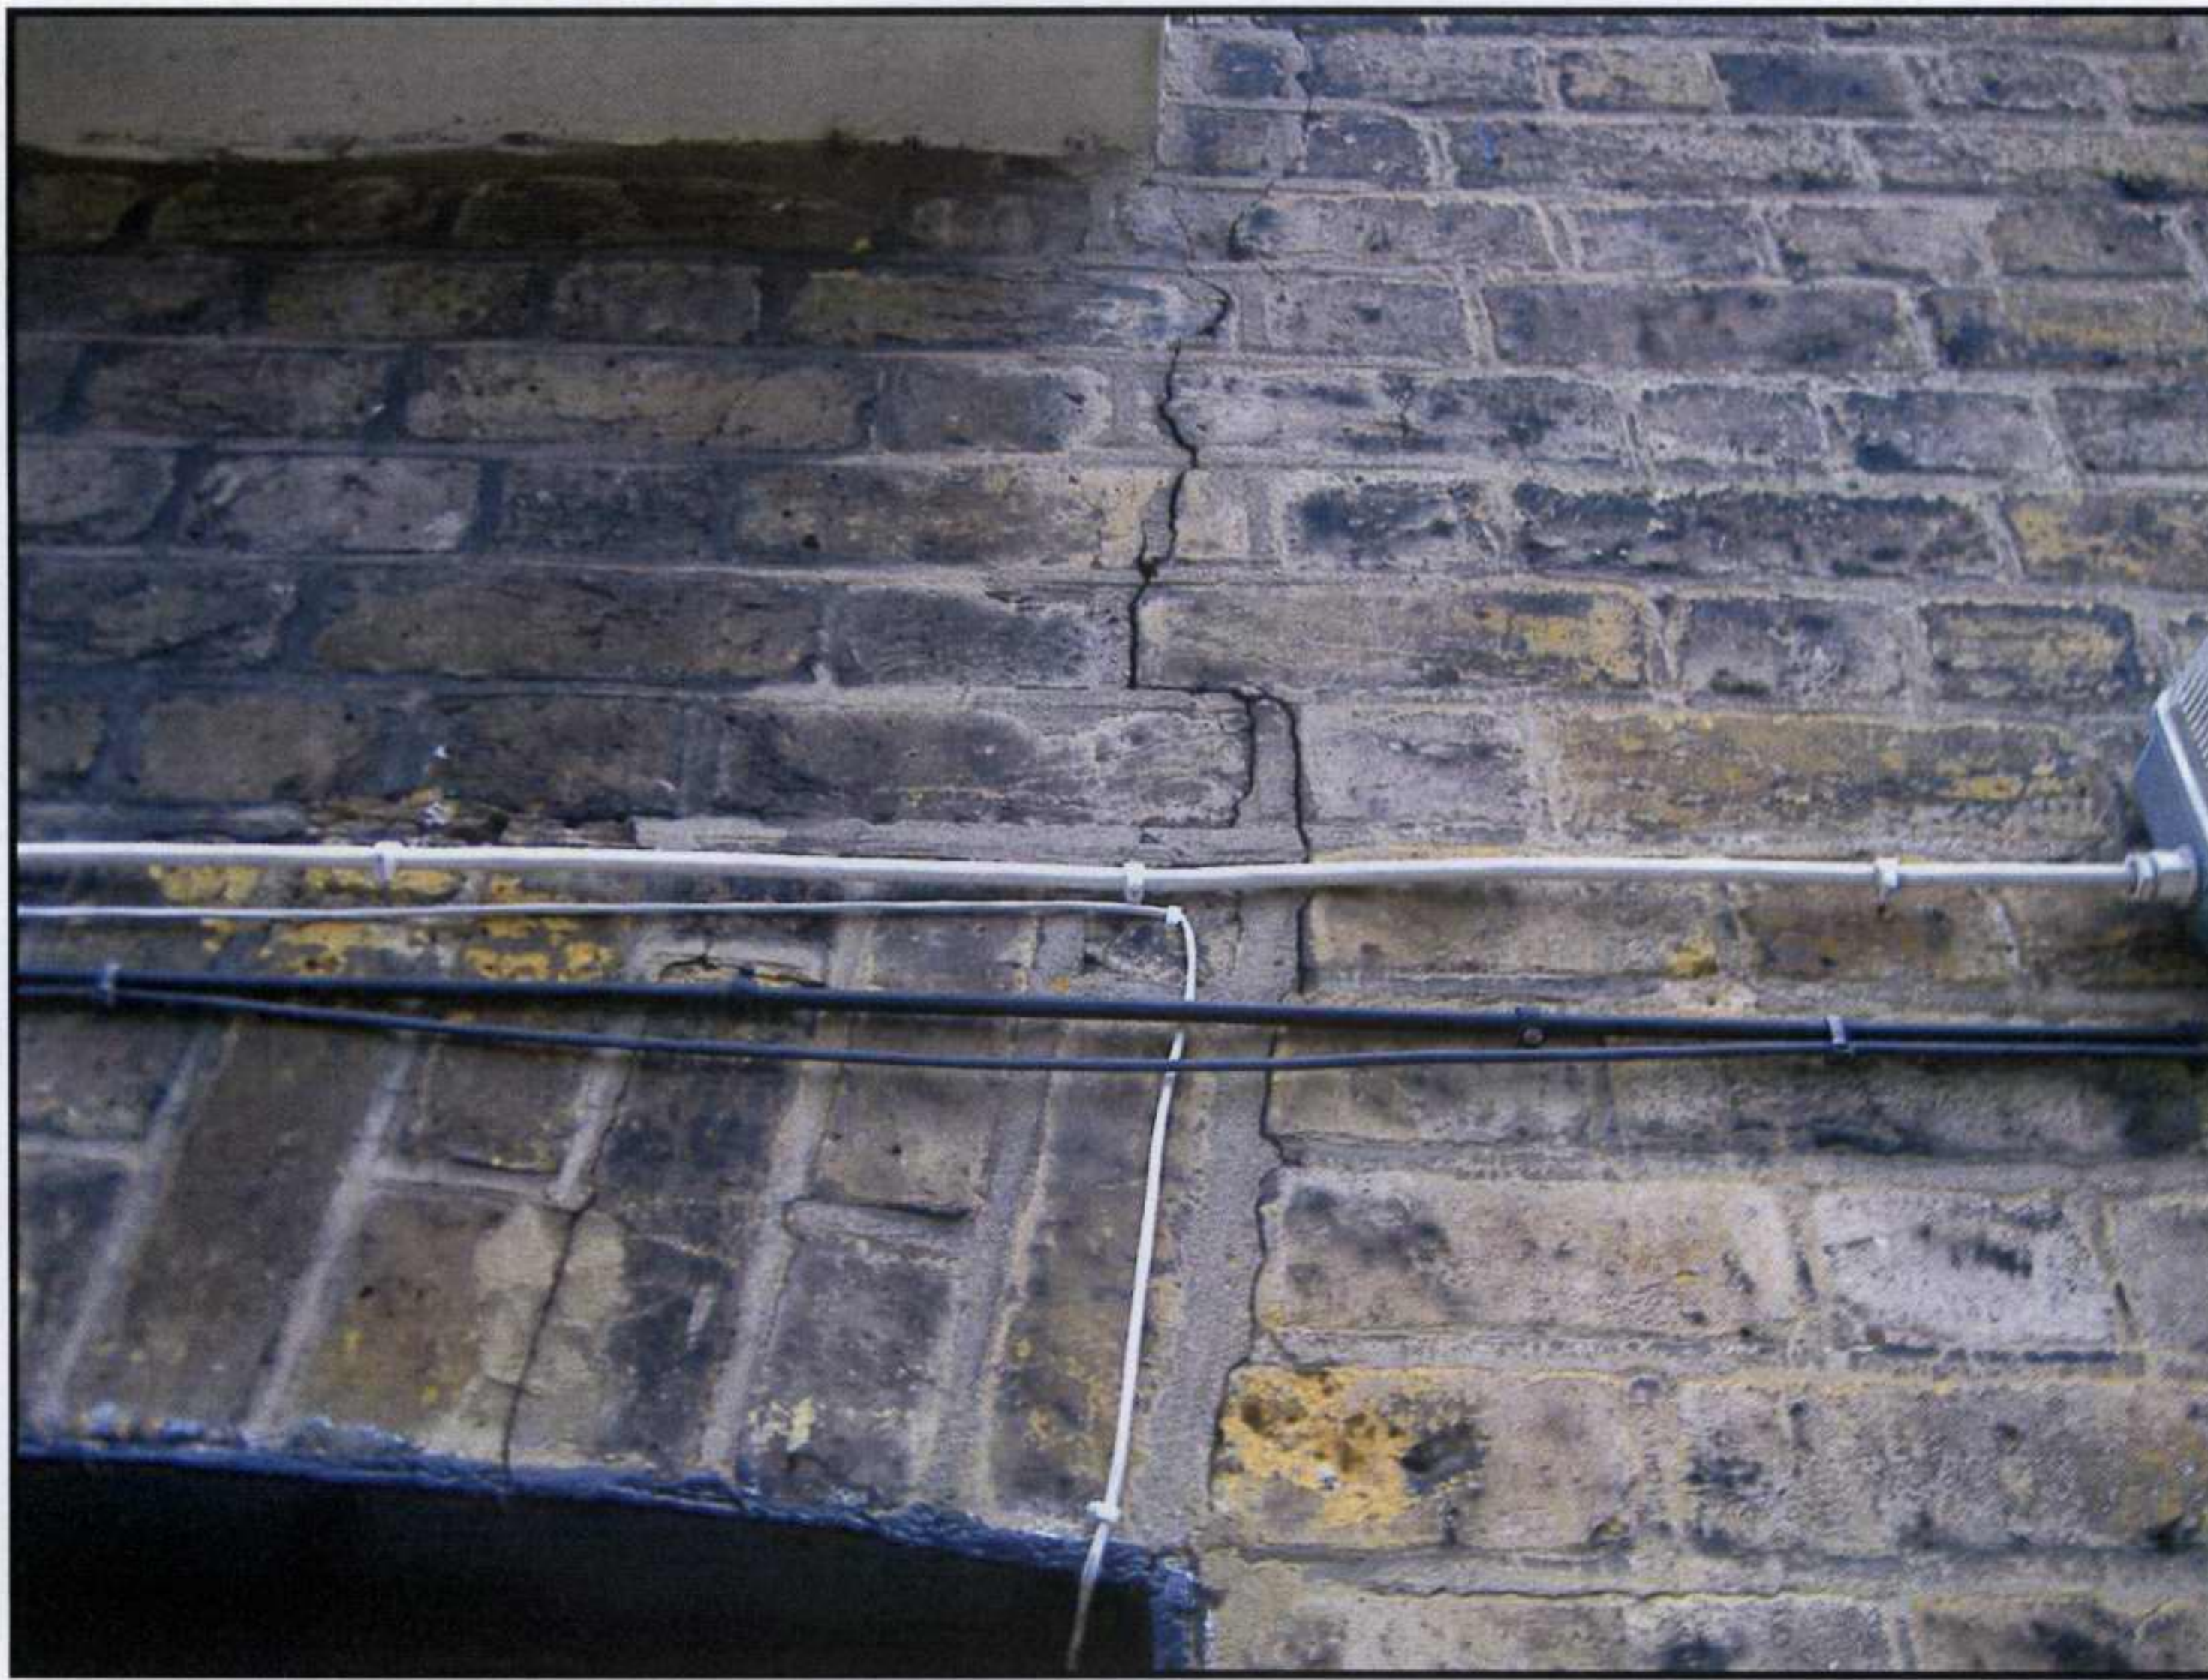
8. 5mm fracture to brickwork at basement level where south wall is separating from the building.

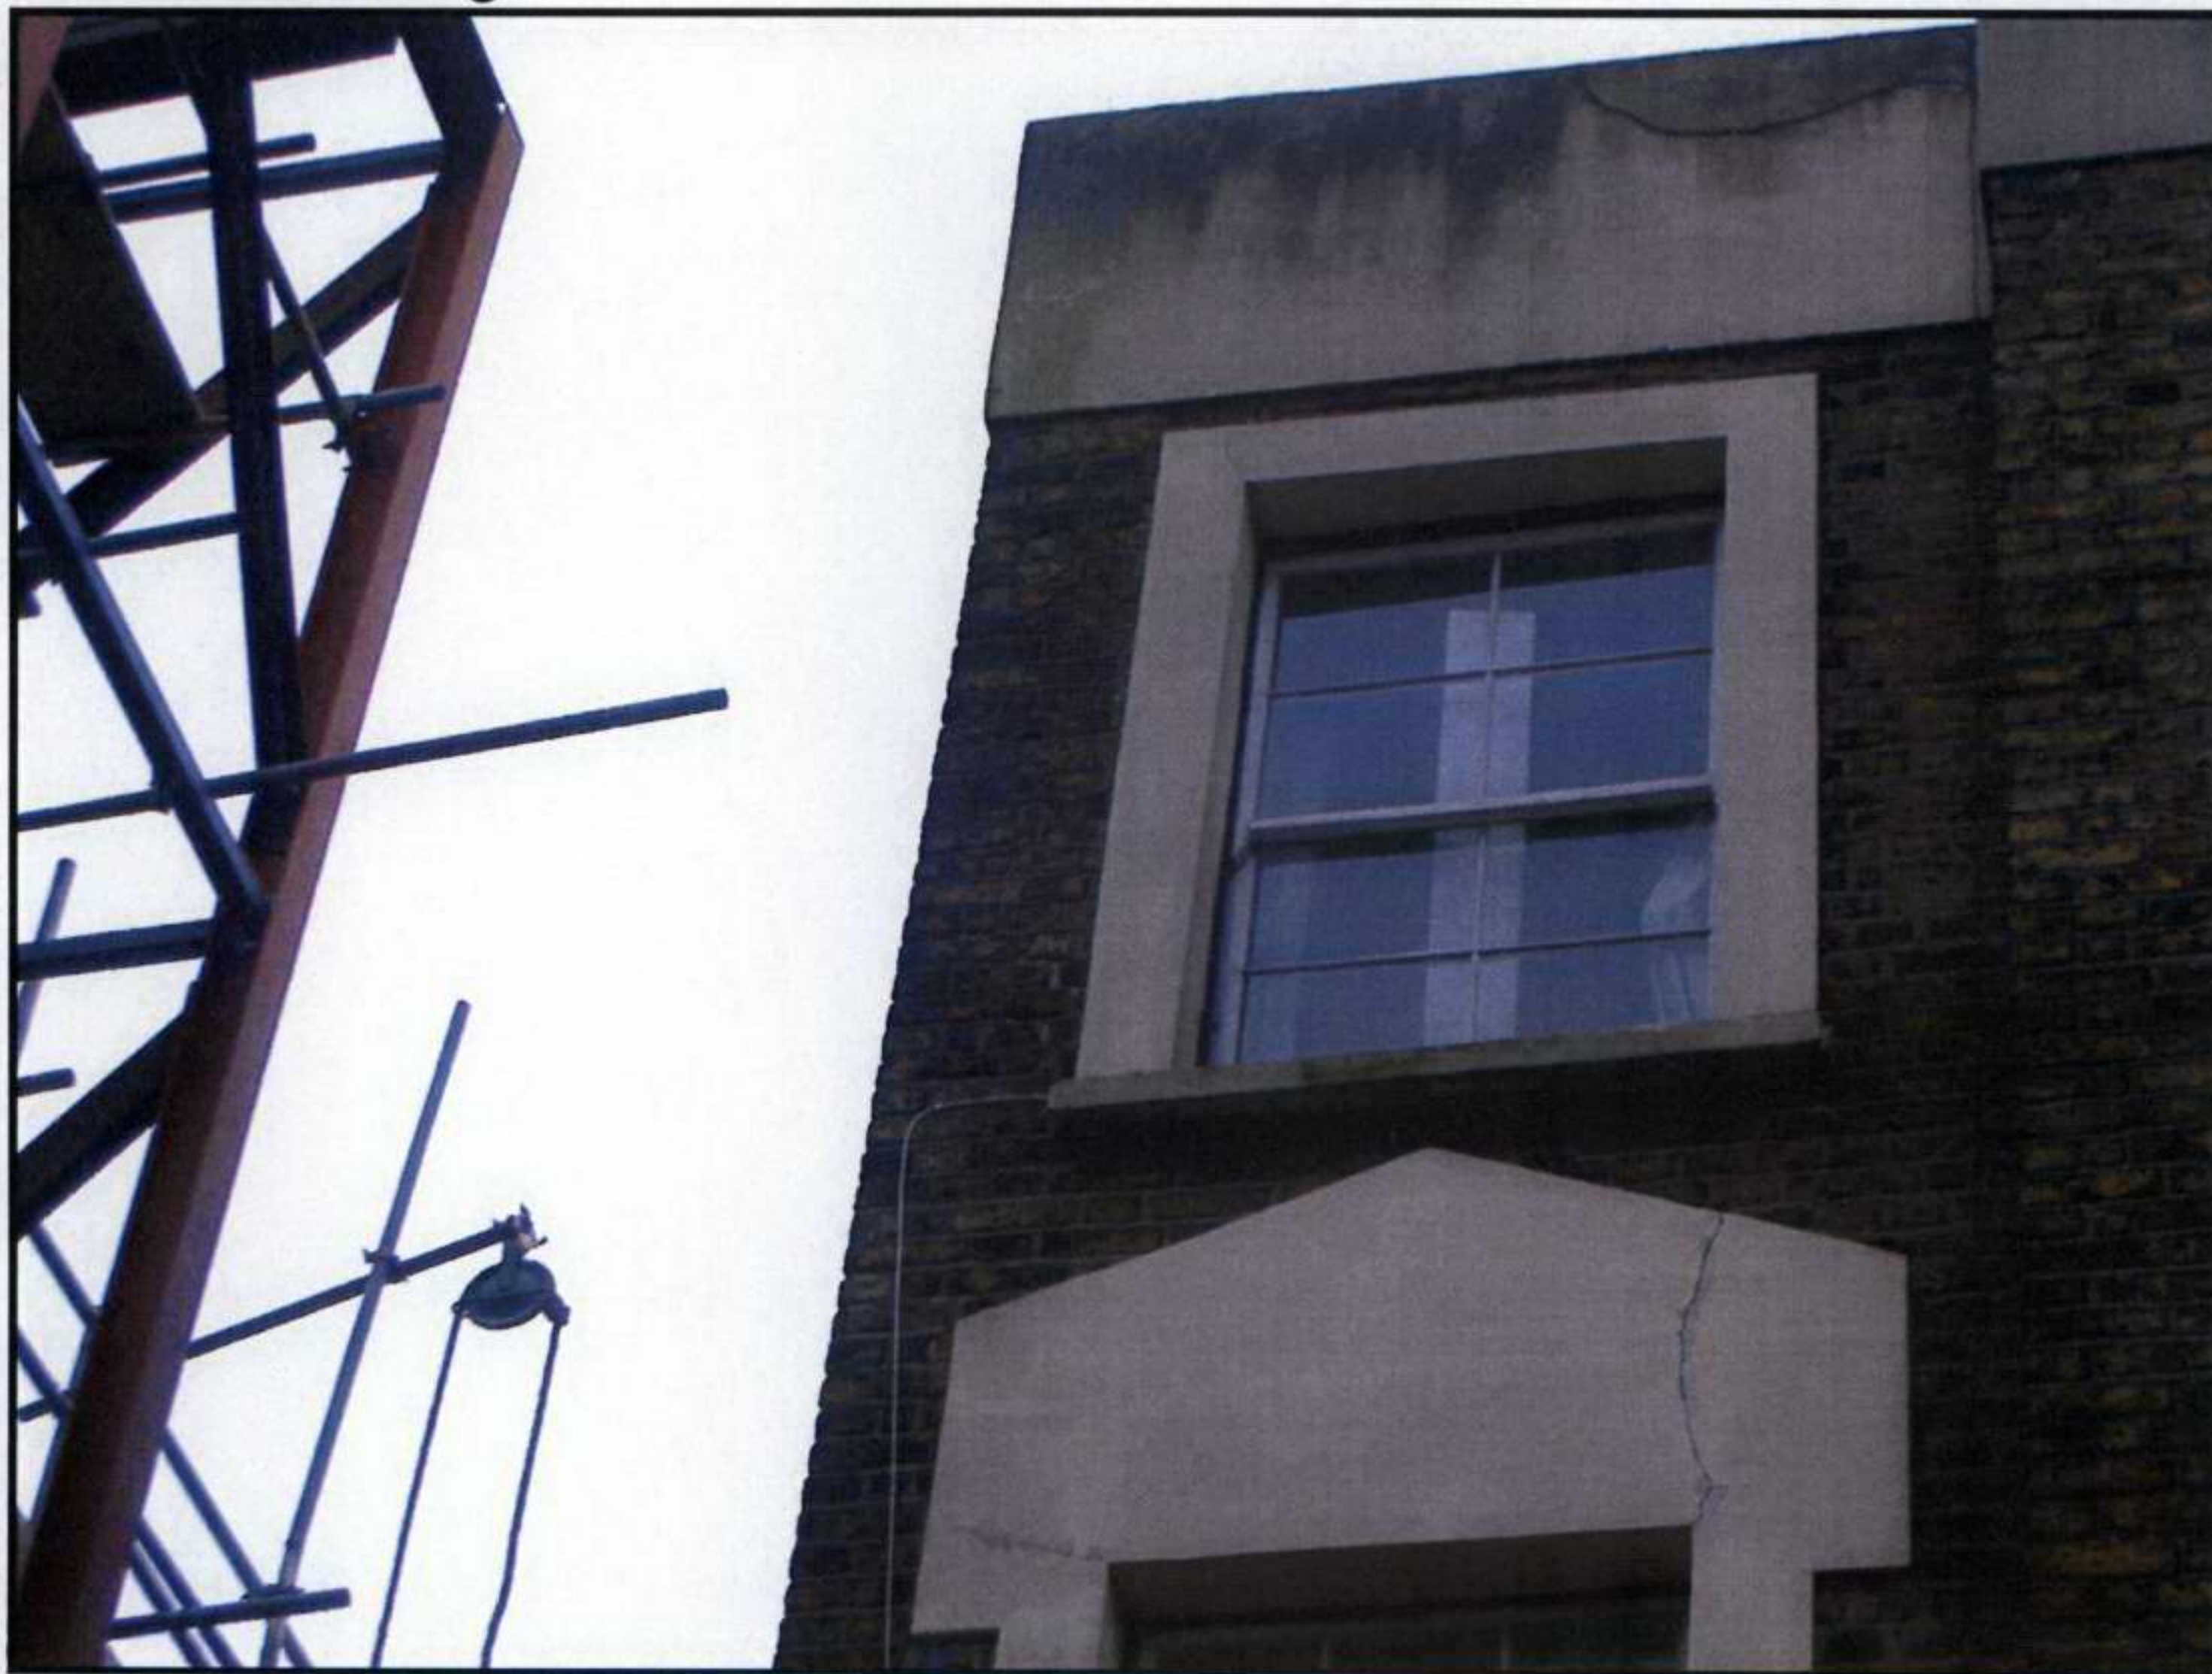
9. Severe vertical lintel fracture at first floor and horizontal fracture to second floor level lintels.

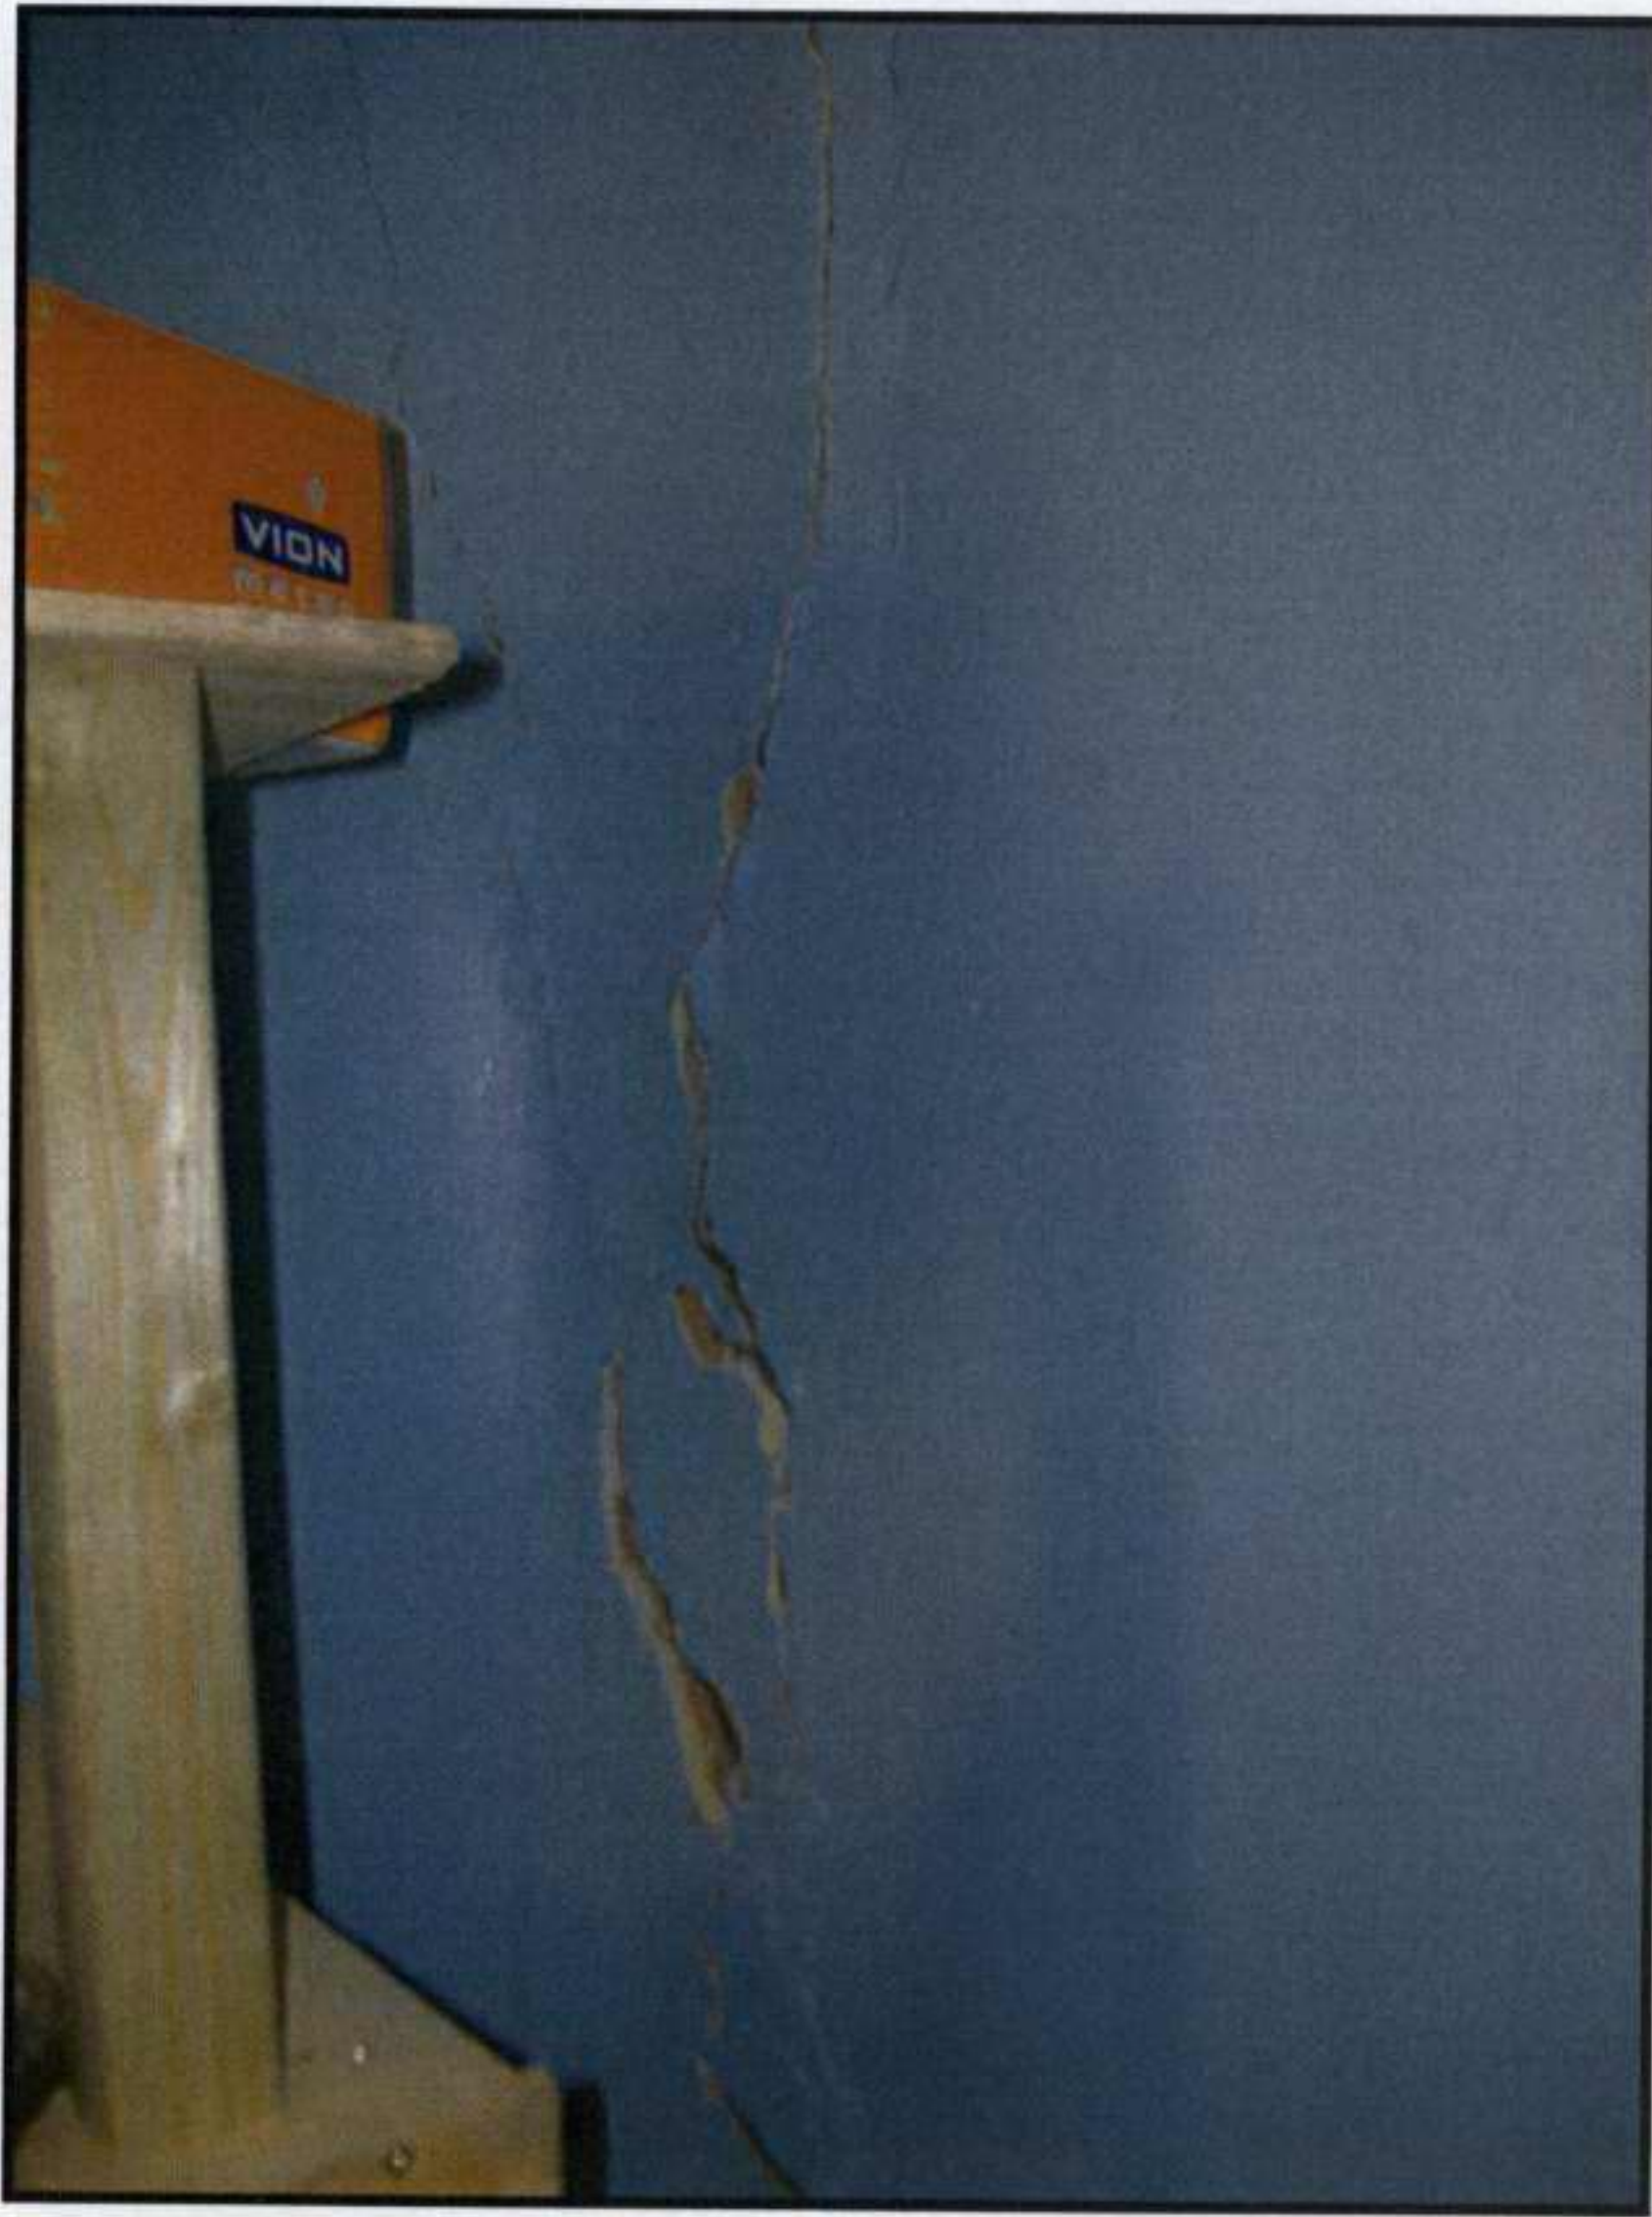
10. 20mm fracture internally at basement level where south wall is separating from the building.

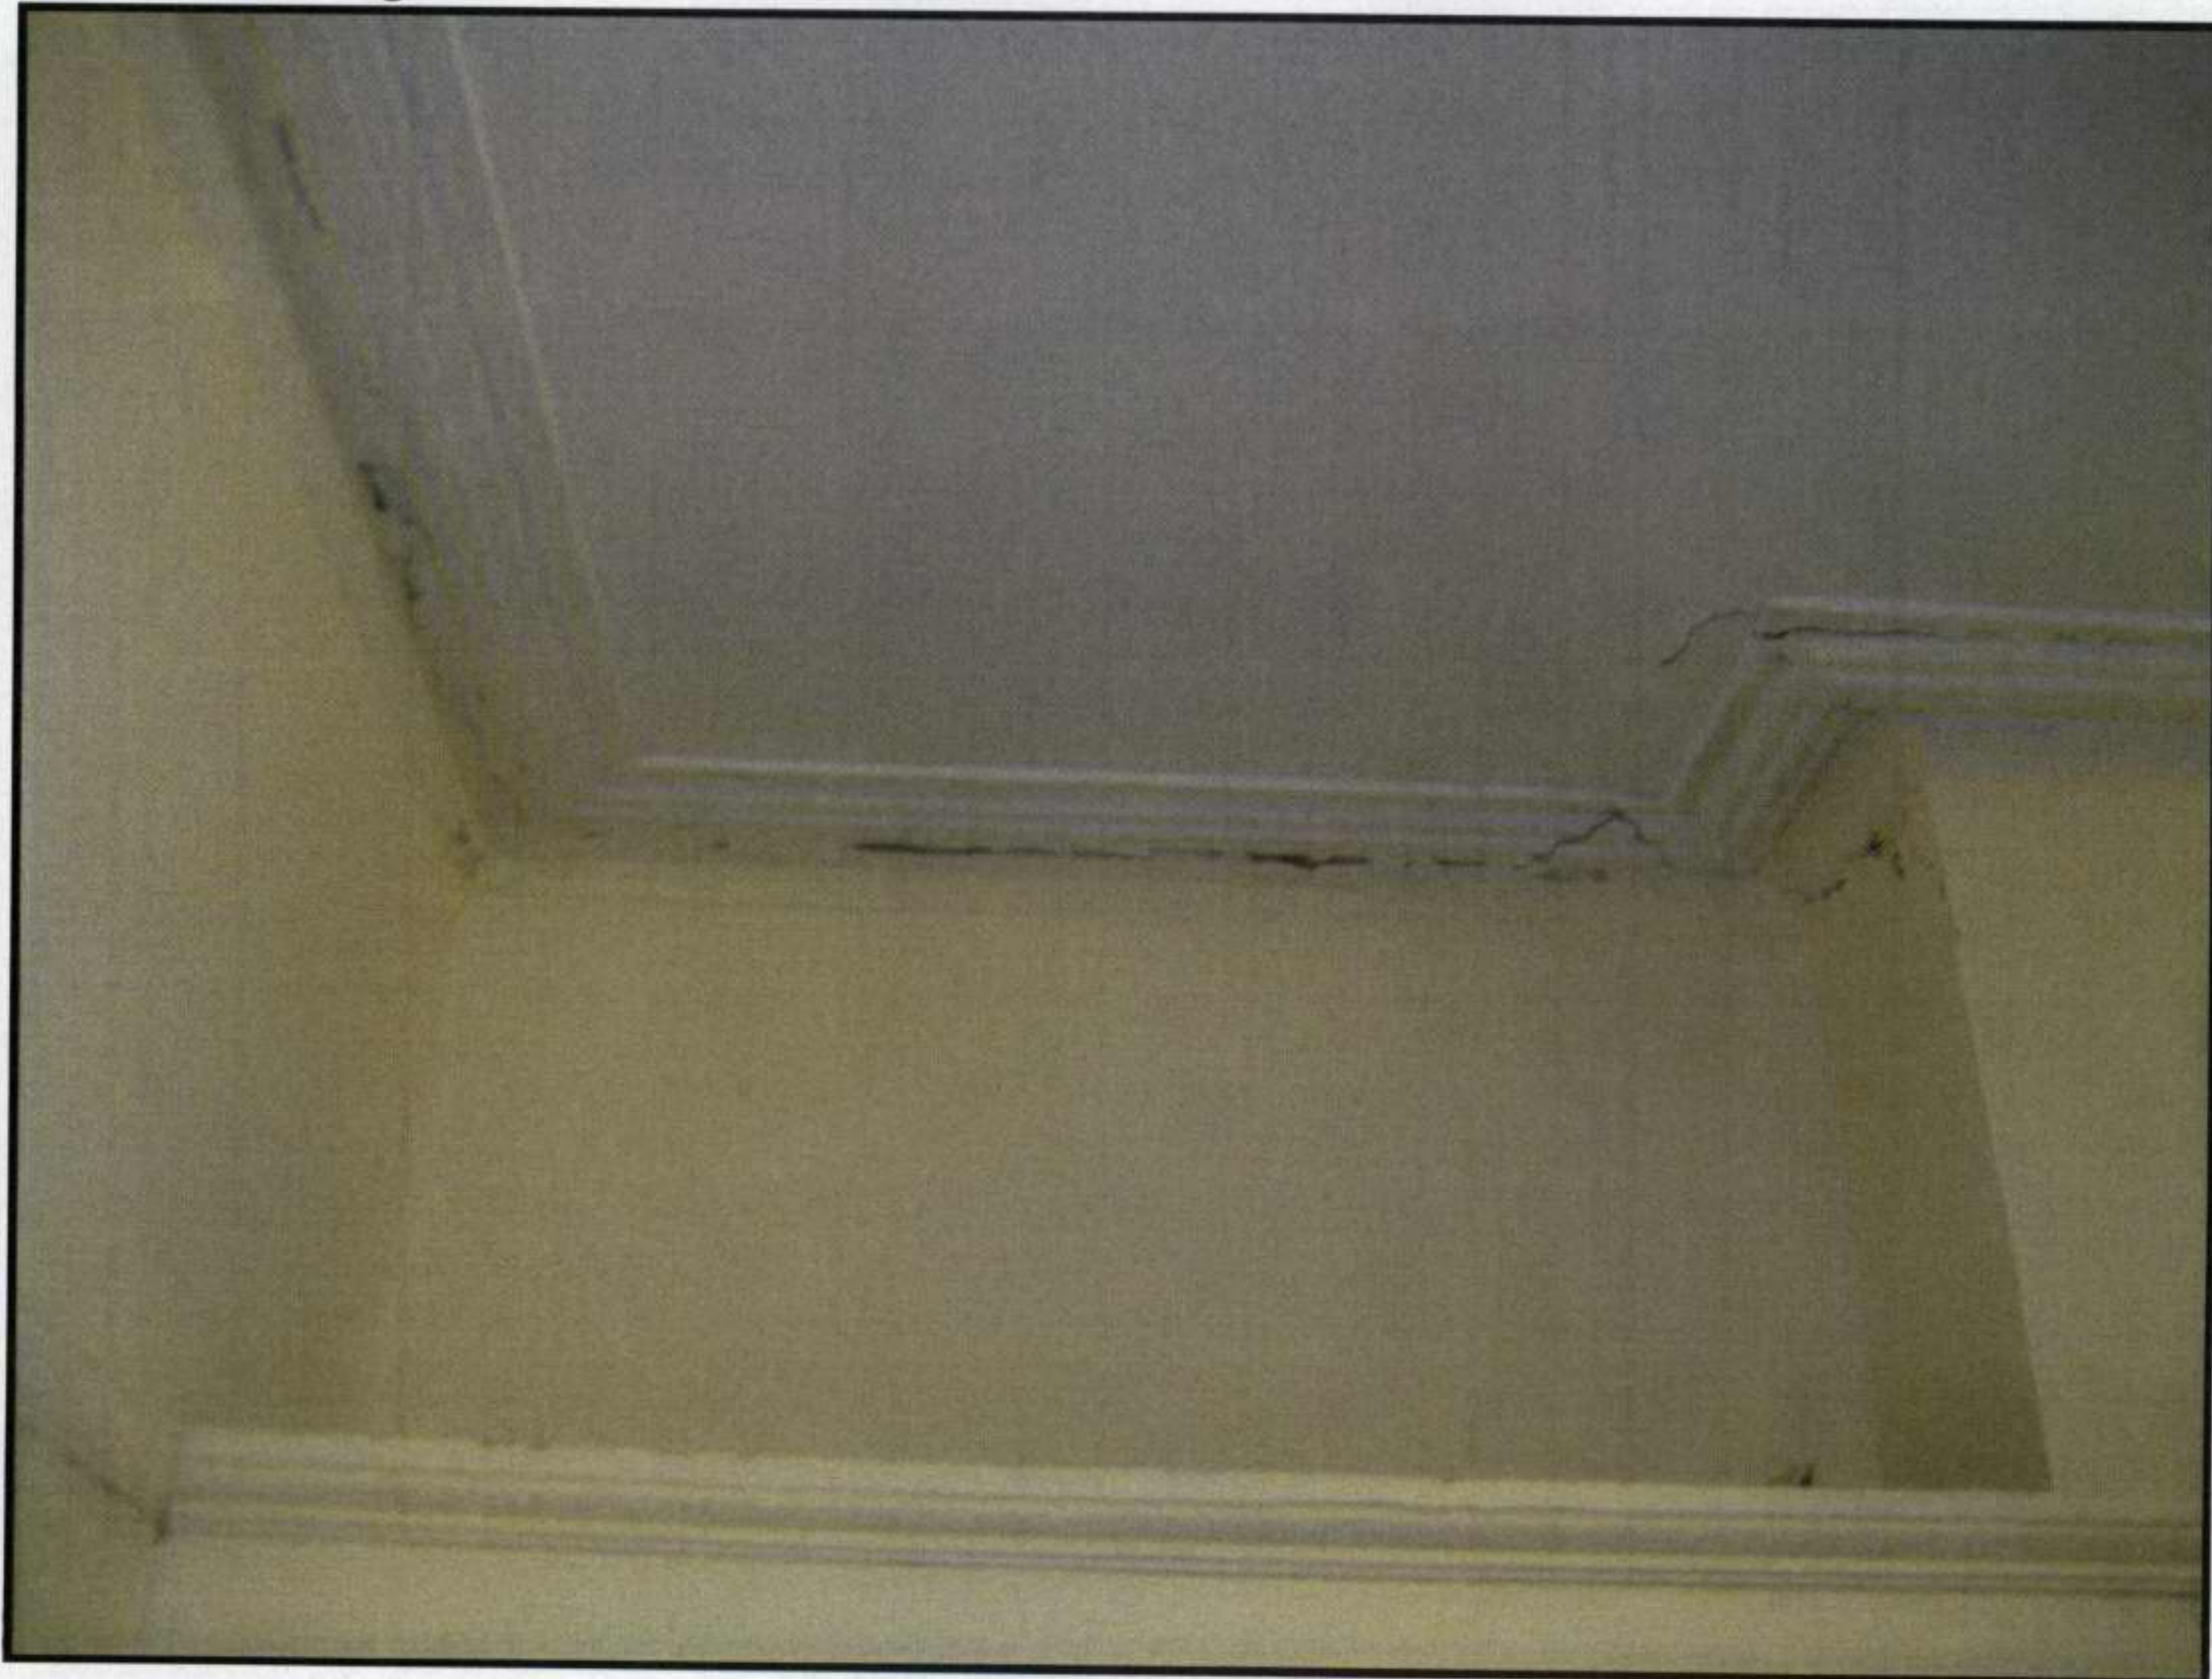
11. Severe fracture to first floor cornice to south elevation.

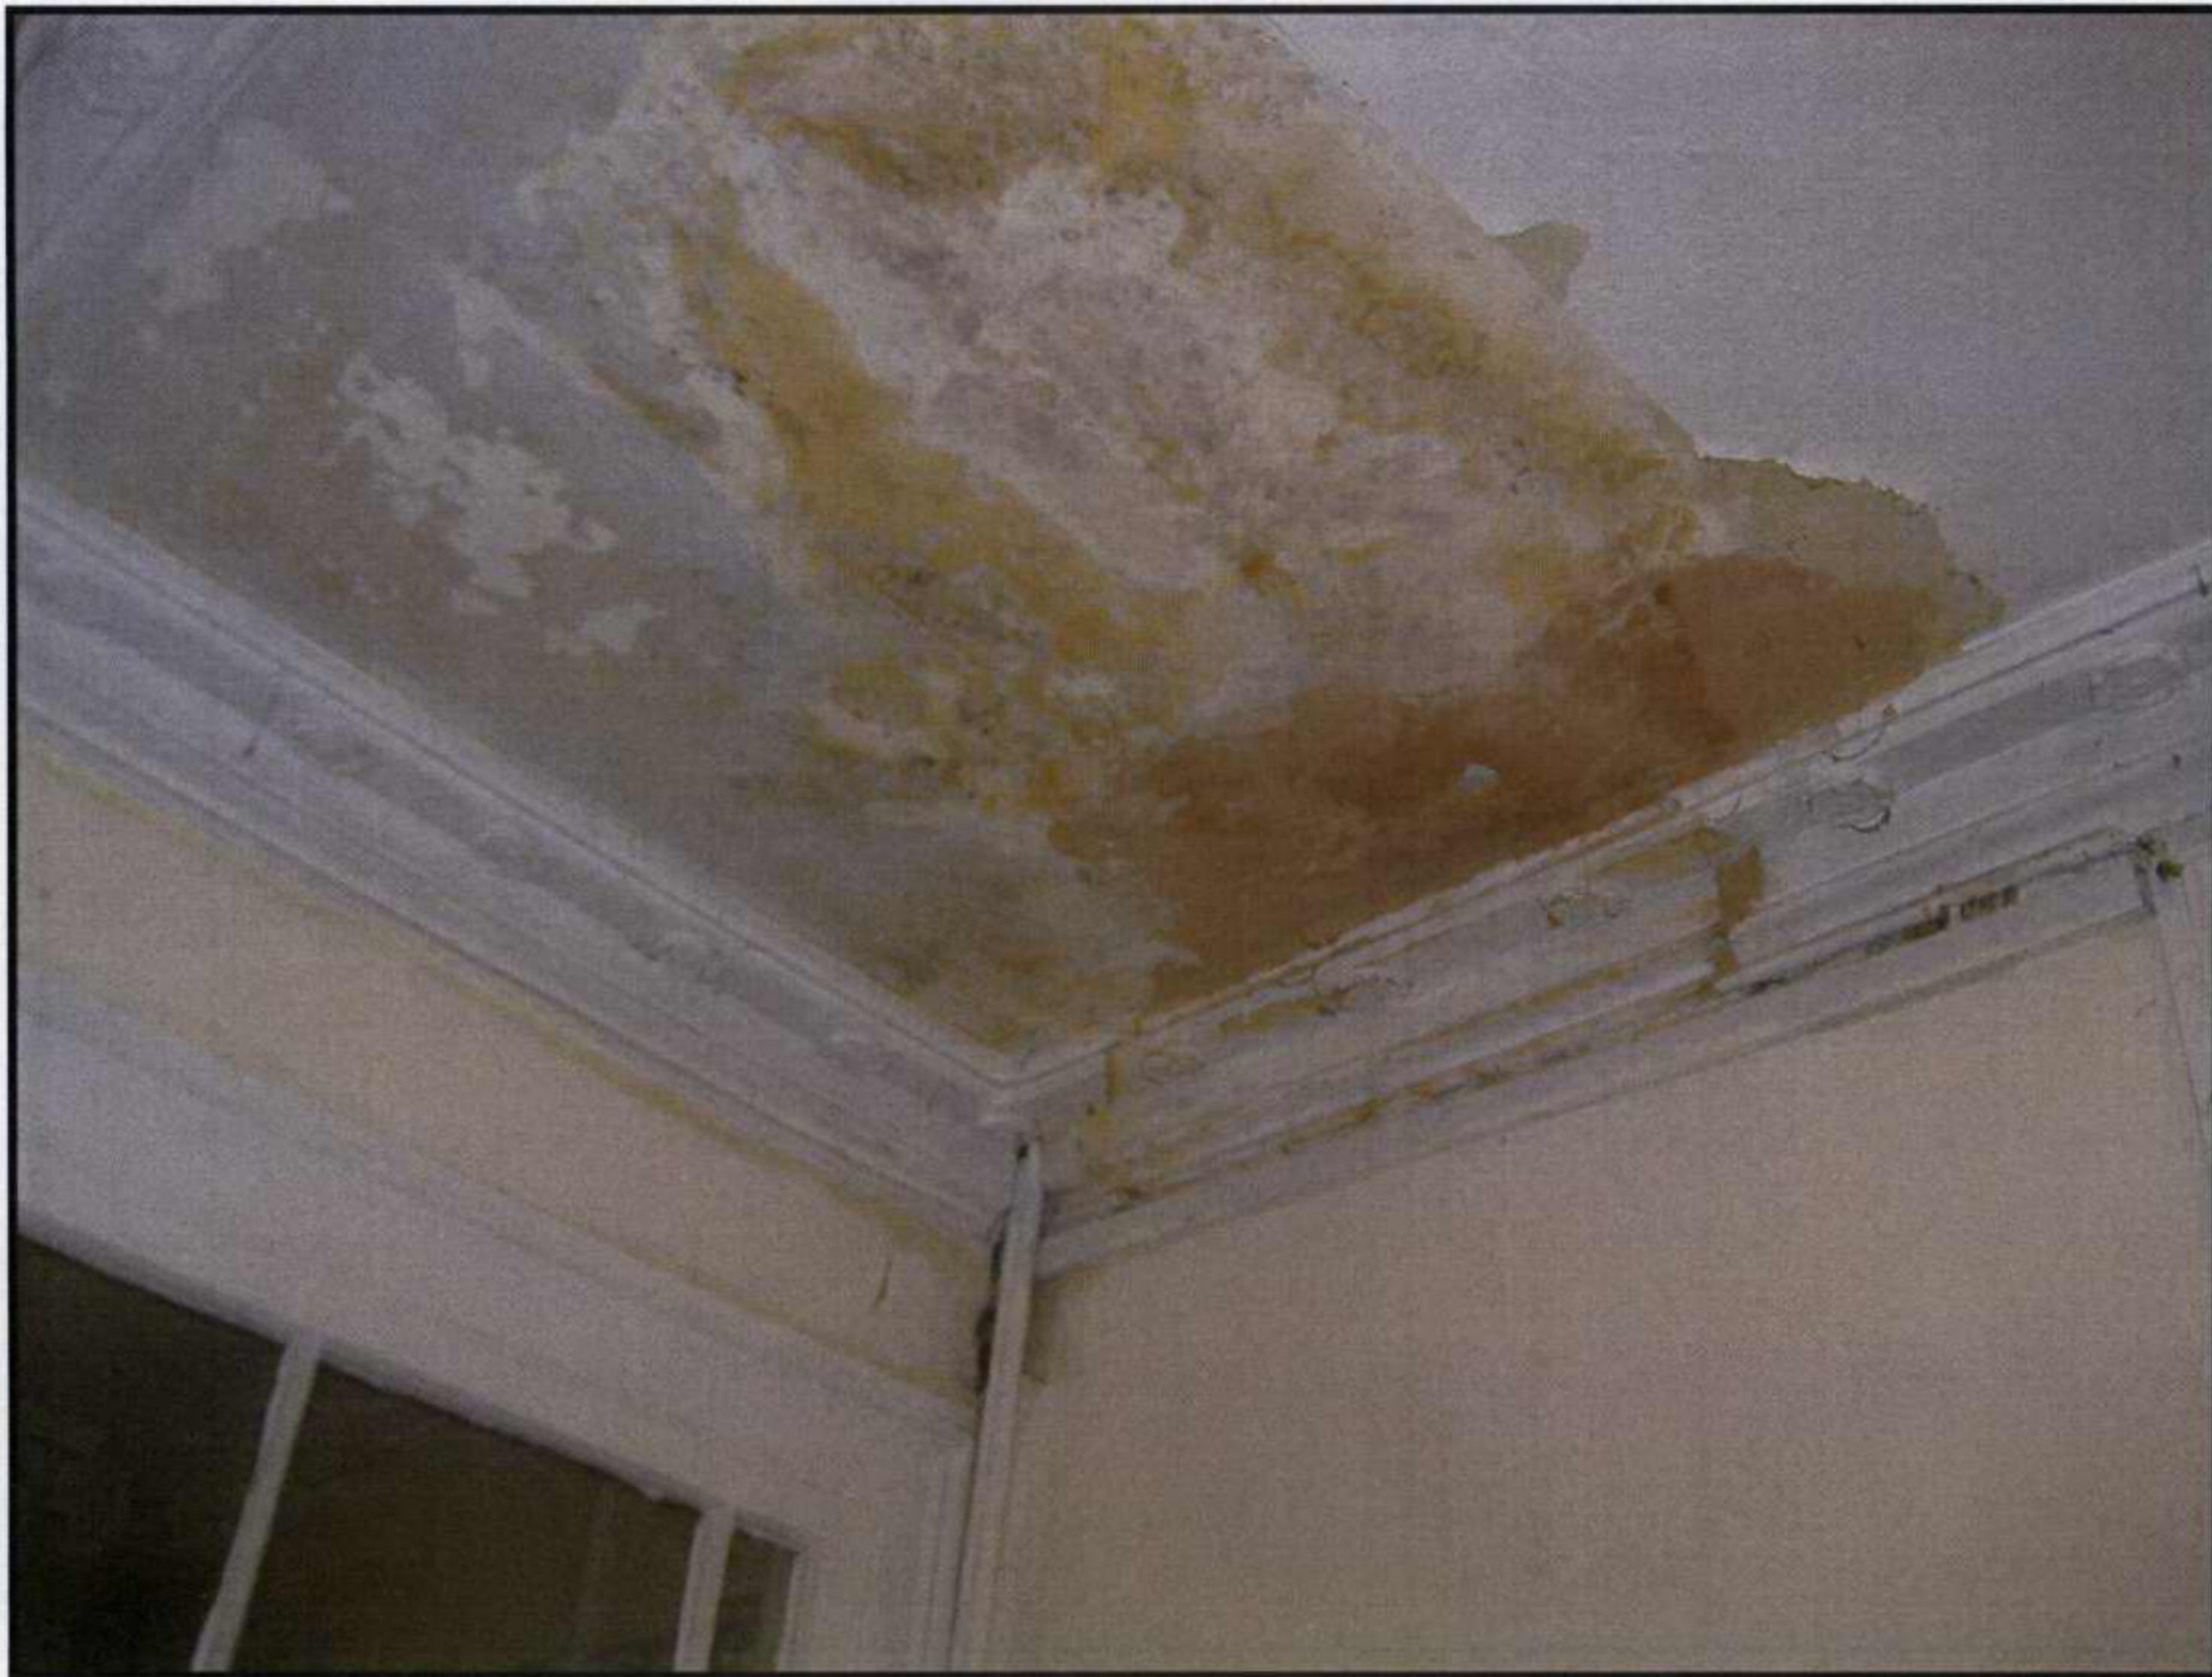
- 3.01.6 There are numerous locations where water ingress is occurring, through missing slates and lead details but also now through the fractures in the masonry which have opened up. The result is that ideal conditions for dry rot exist, and indeed dry rot is occurring extensively in the basement and elsewhere. It is highly likely that there are other concealed areas of dry and wet rot.

12. Water ingress and dry rot possibility to first floor ceiling.
