SUMMARY BUILDING INSPECTION REPORT

**THE MANSE
HIGHGATE ROAD
LONDON
NW5 1BS**

FEBRUARY 2007

**TRIDENT BUILDING CONSULTANCY LIMITED
10 KING WILLIAM STREET
LONDON
EC4N 7TW**

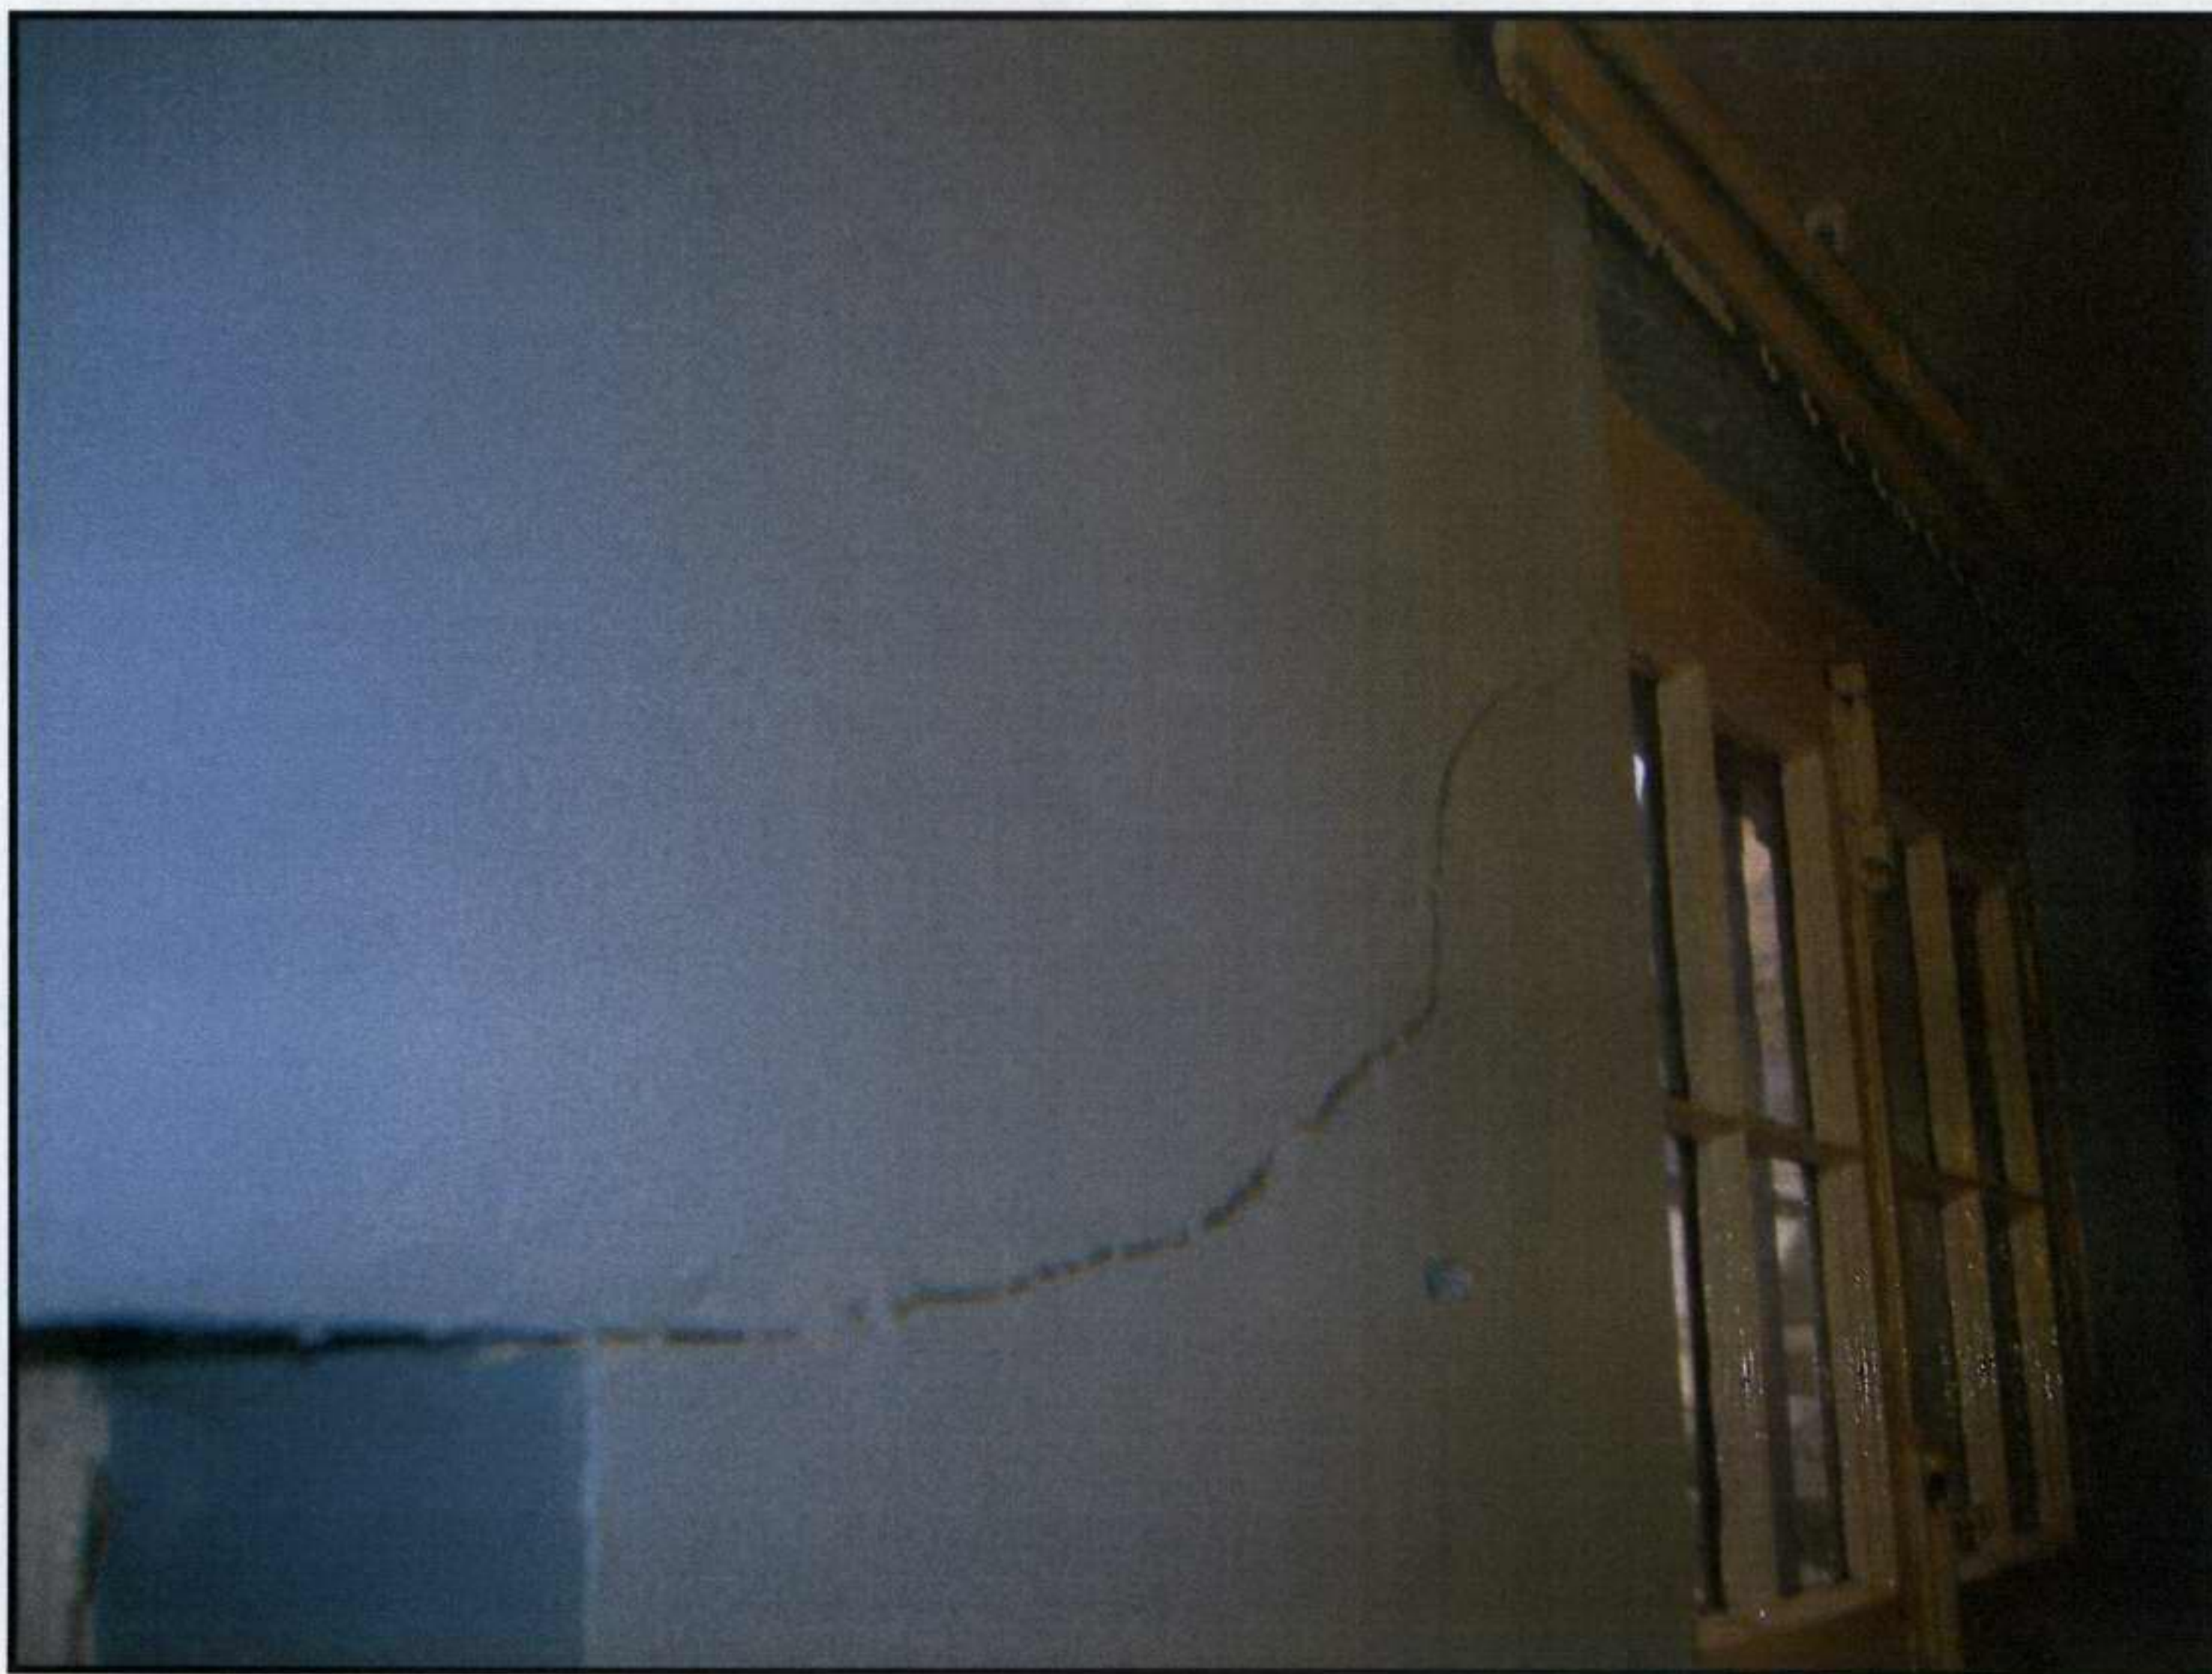
- 3.01.5 The rear elevation outrigger is rotating away from the main building. We believe this to be as a consequence of tree root action, and/or a blockage to below ground drainage in this area. This is also clearly evidenced by severe and alarming vertical fractures internally, of which there are photographs in the appendix.

13. Severe horizontal fracture to rear outrigger at basement level caused by drain blockage from tree roots and rotation of outriggers.

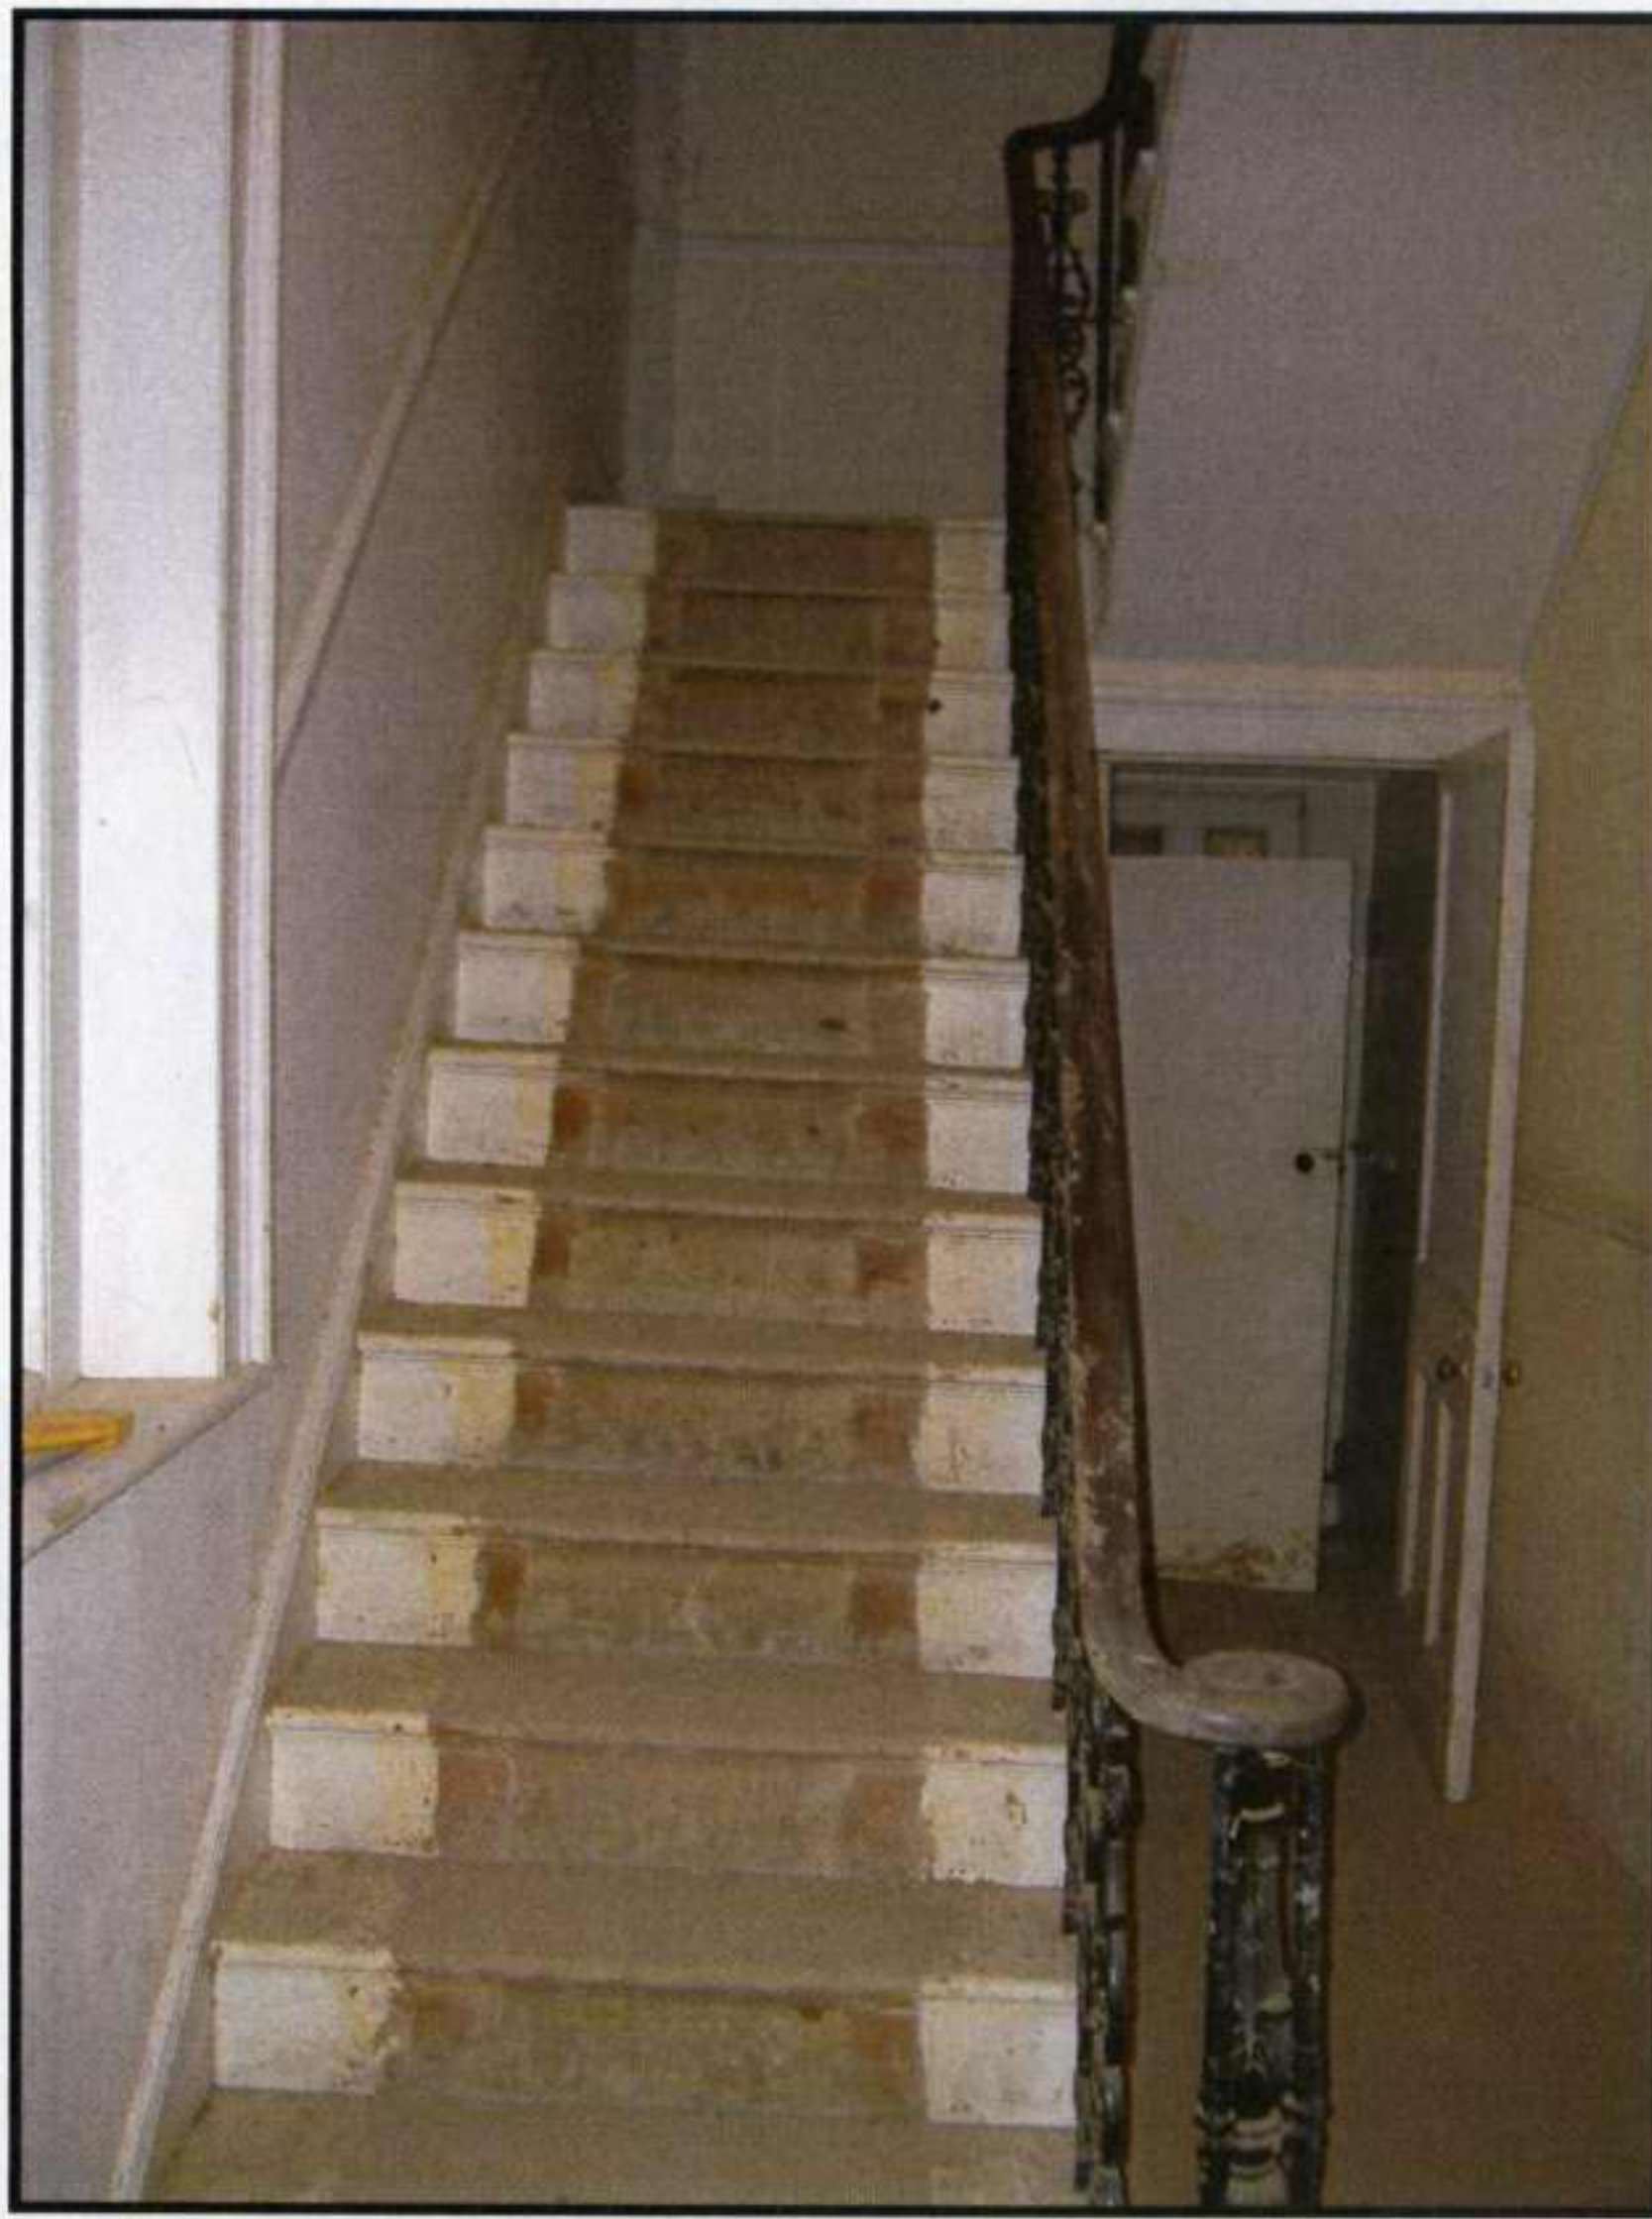
3.01.9 The timber staircase has deflected significantly and requires propping urgently to prevent it from becoming unsafe to use.

14. Severe deflection to staircase at first floor.

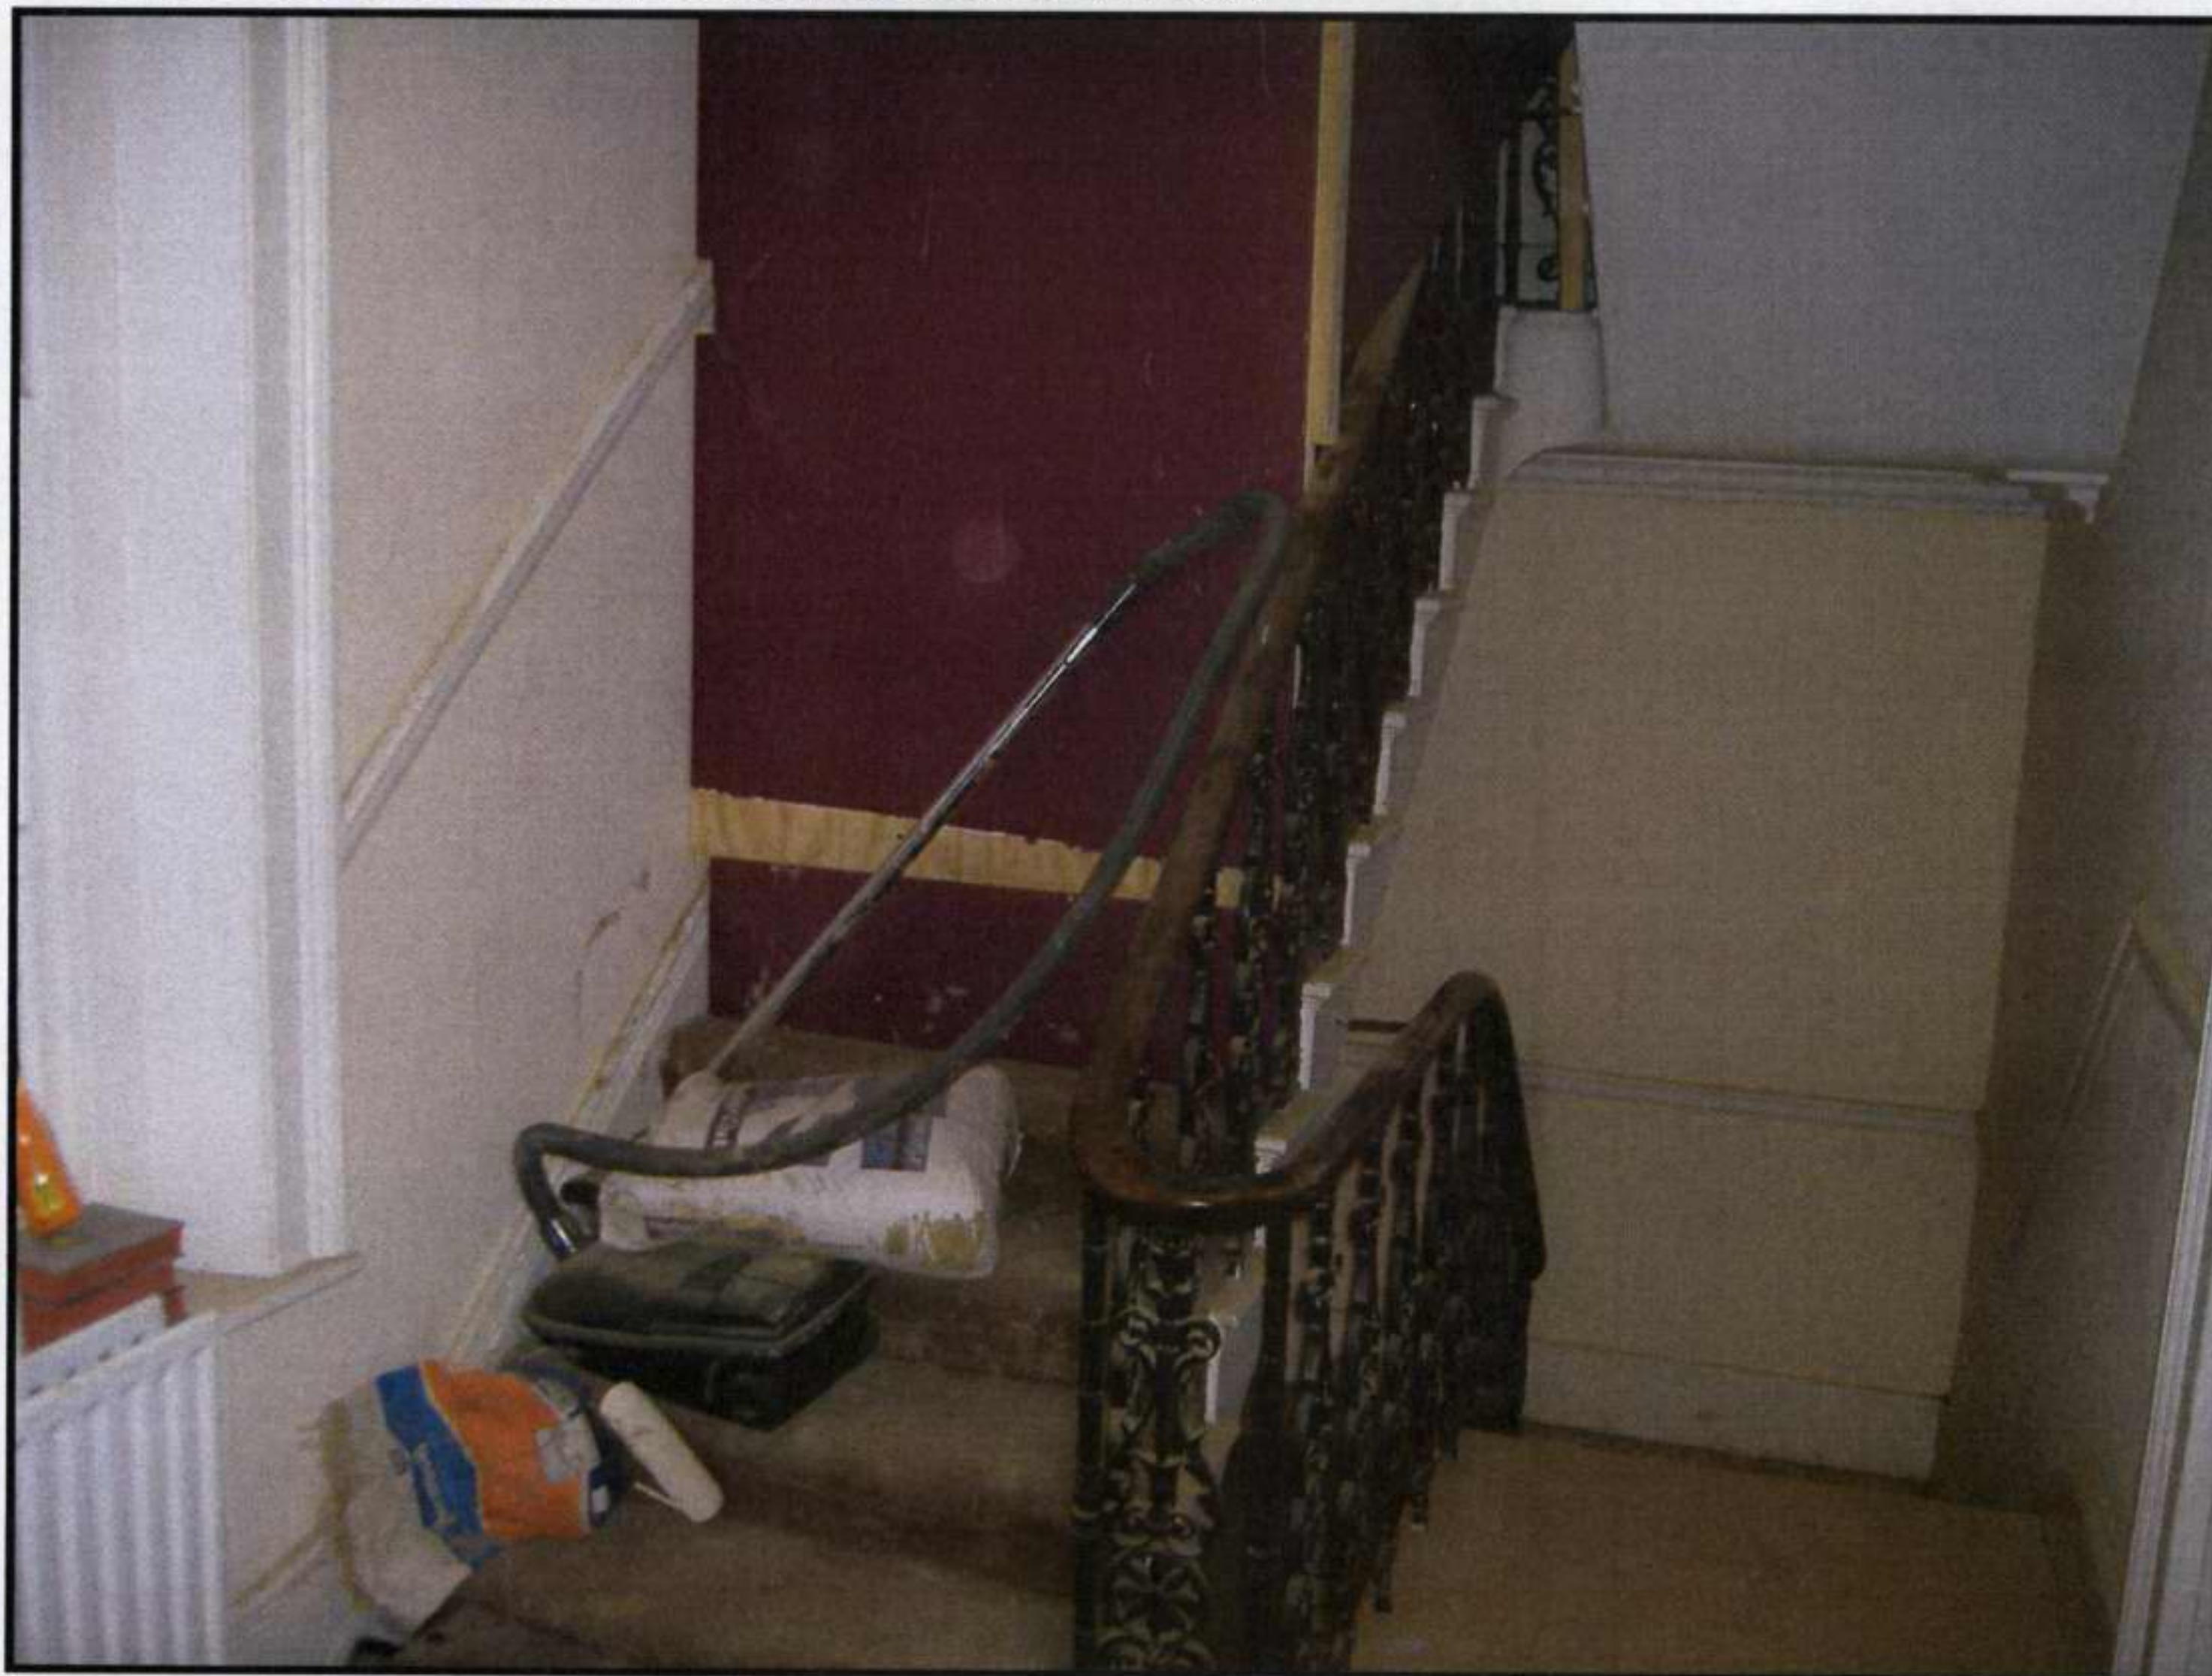
3.01.8 Of particular concern was the fact that the uppermost floor was sealed off as the contractor felt that this was unsafe. We have been unable to inspect this area.

15. Second floor level staircase sealed off by contractor.

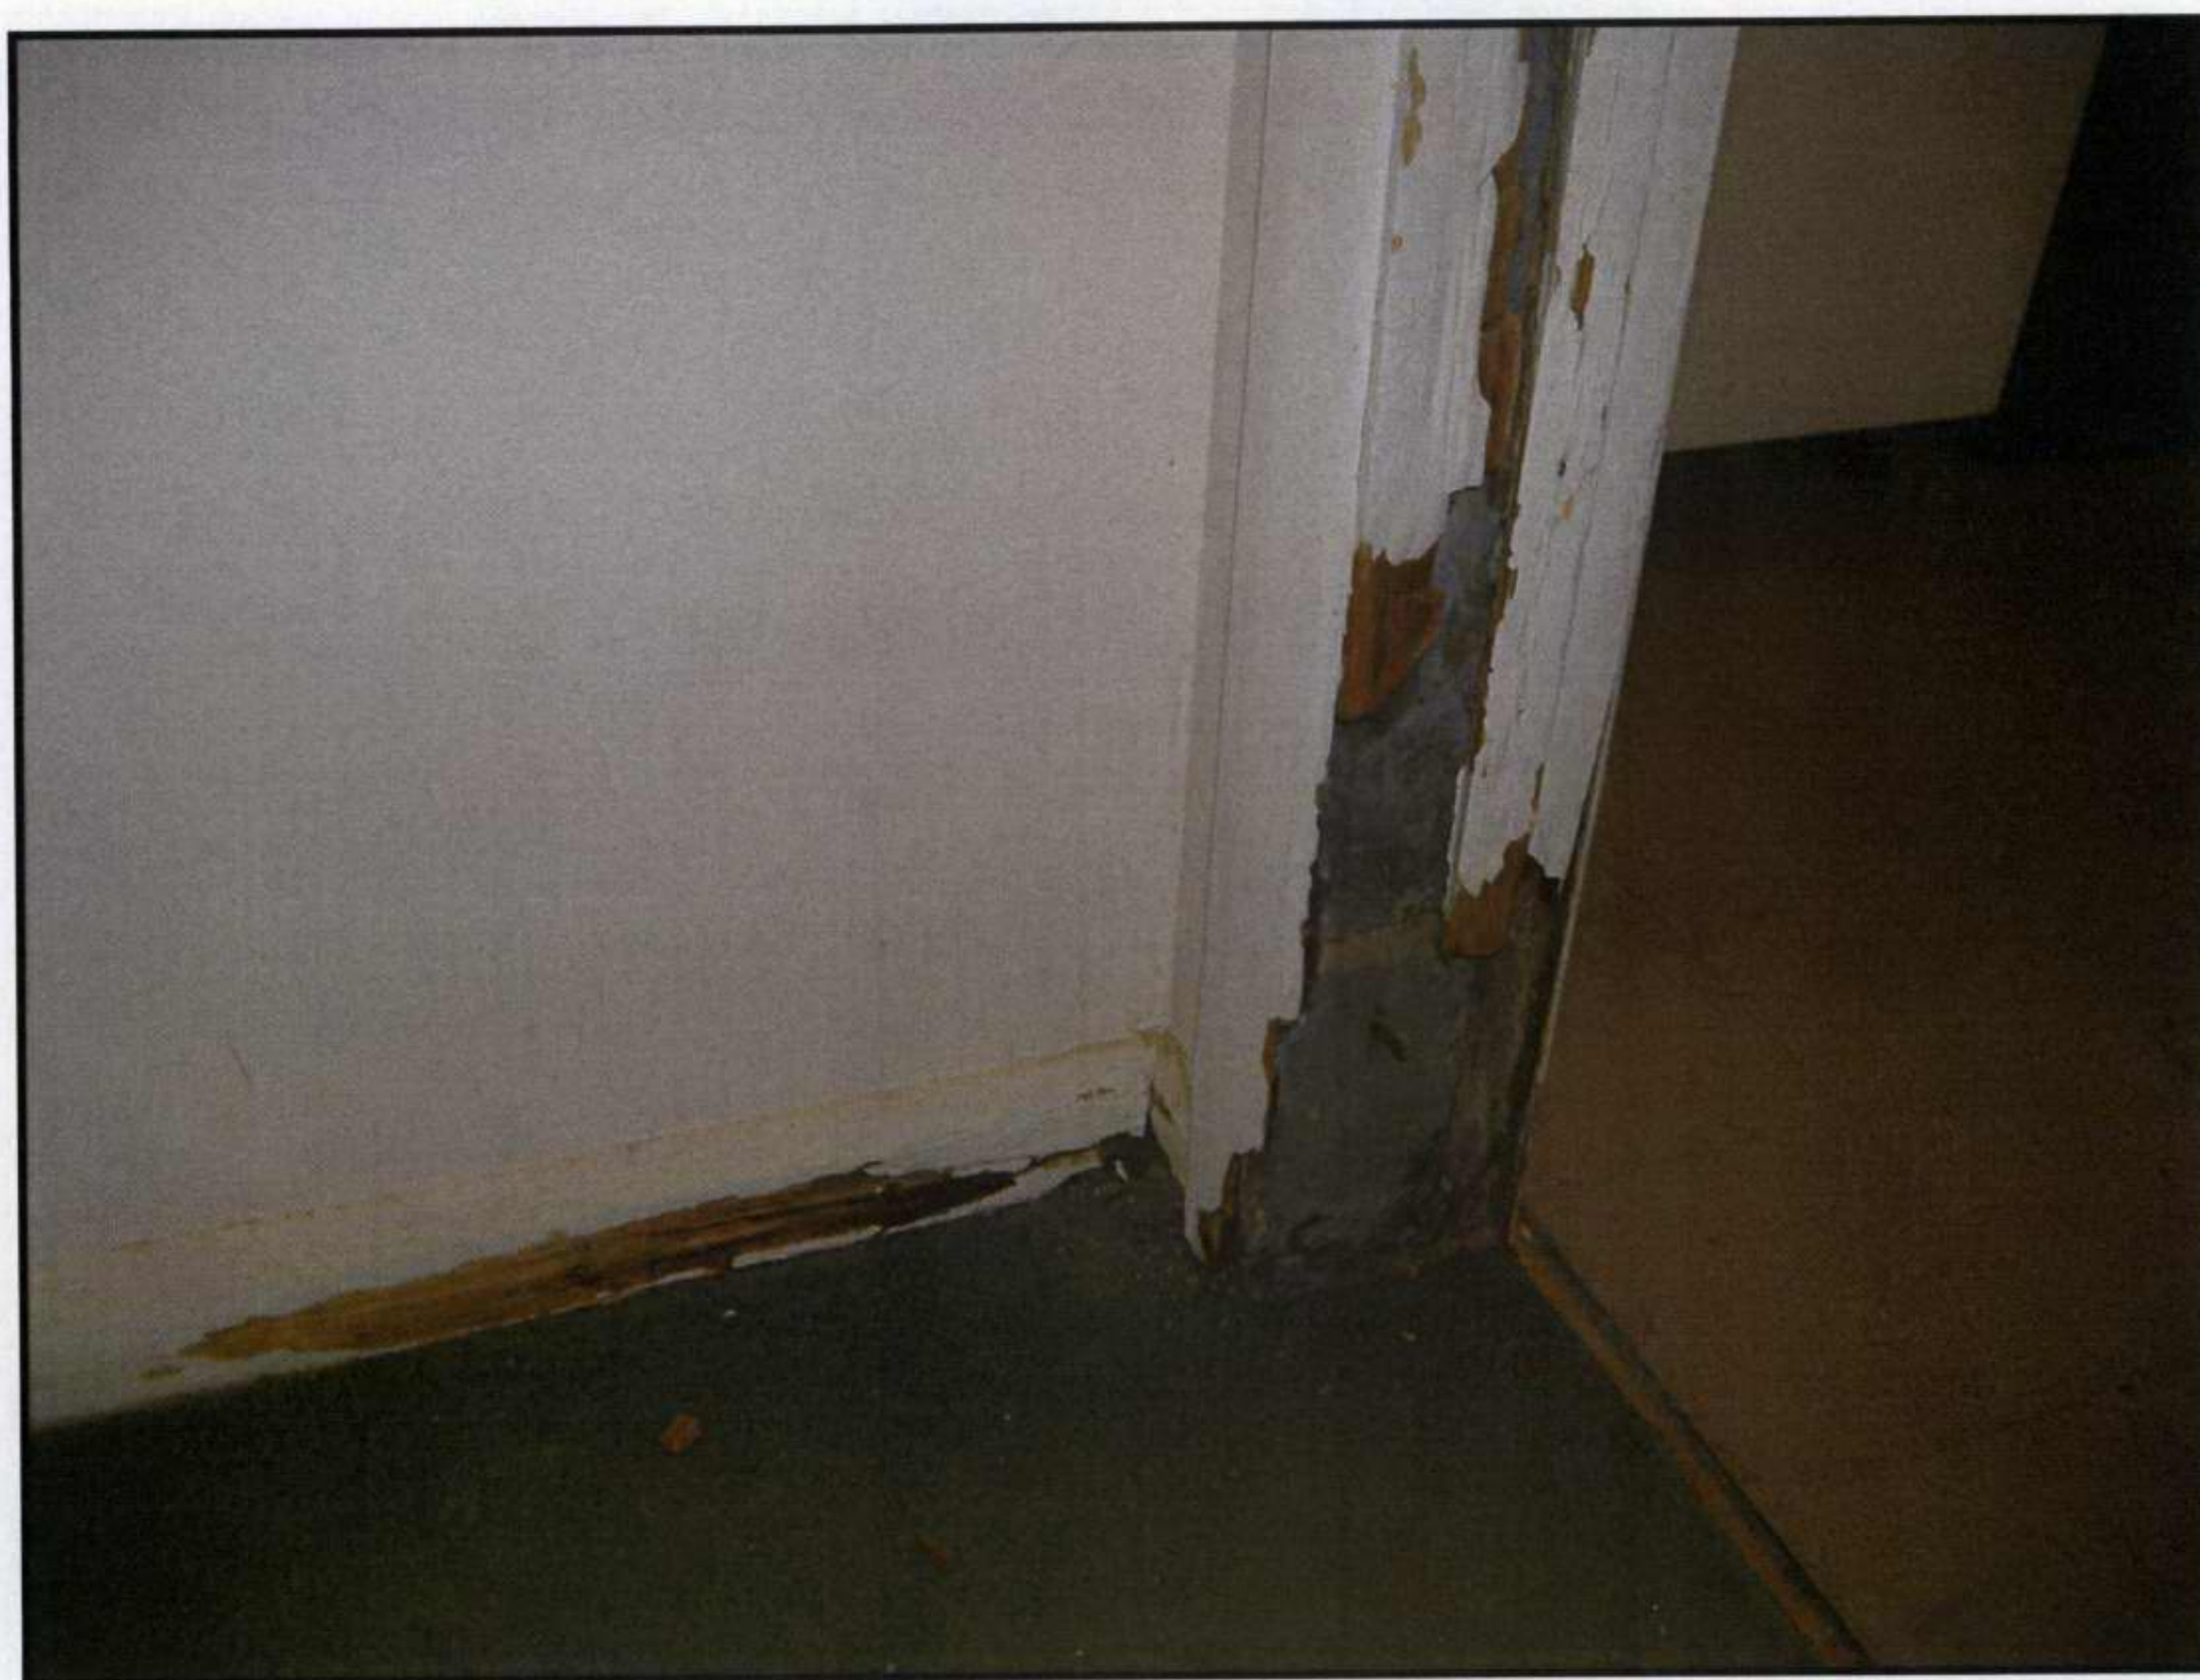
16. Extensive dry rot to timber skirtings and door lining.
