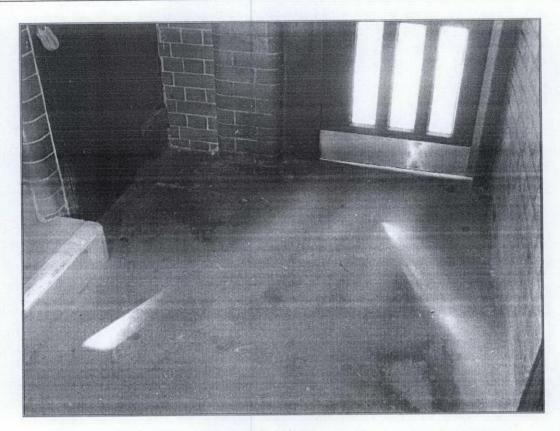
Photo 1 – Typical internal ground floor entrance to the communal staircases.

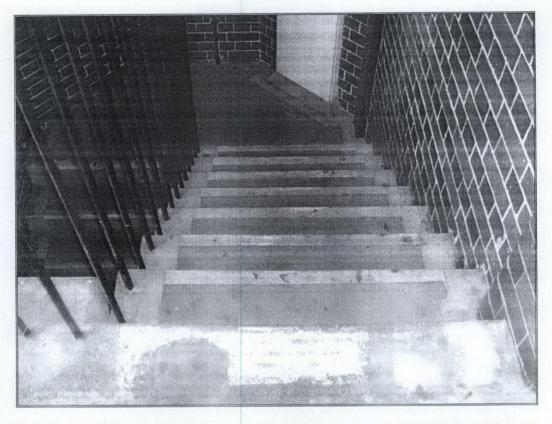
Photo 2 - Typical example of the existing 'Tor' coating to the treads within the staircases.

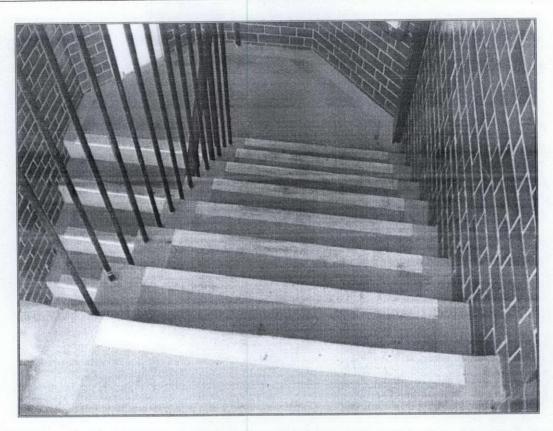
Photo 3 – Another typical example of the existing stair covering within the residential blocks.

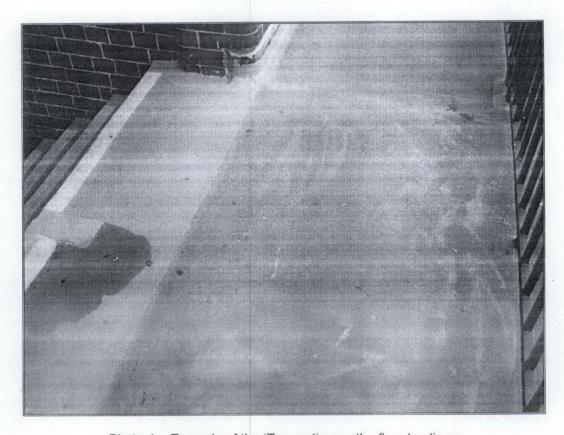
Photo 4 – Example of the 'Tor coating on the floor landings.

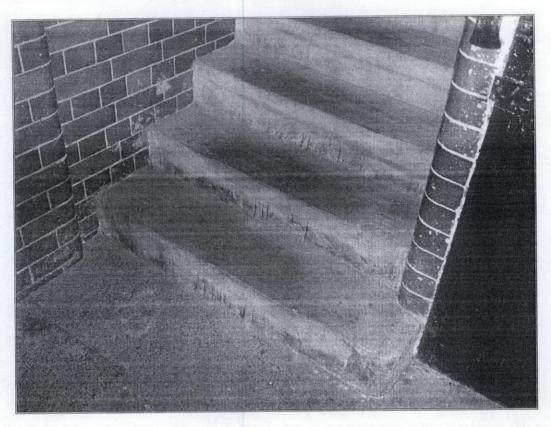
Photo 5 – Example in Scope House where there is no 'Tor' coating to the stairs or landings.

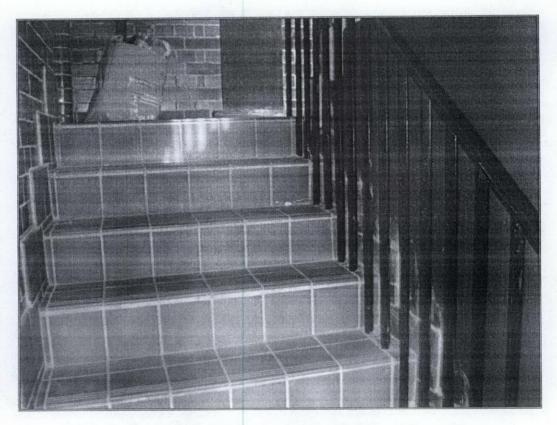
Photo 6 – Quarry tile installation previously undertaken in Laney House.

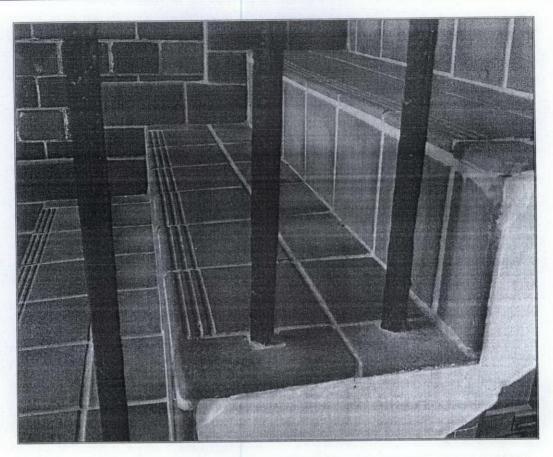
Photo 7 - Another view of the new stair covering in Laney House, undertaken in 2004.

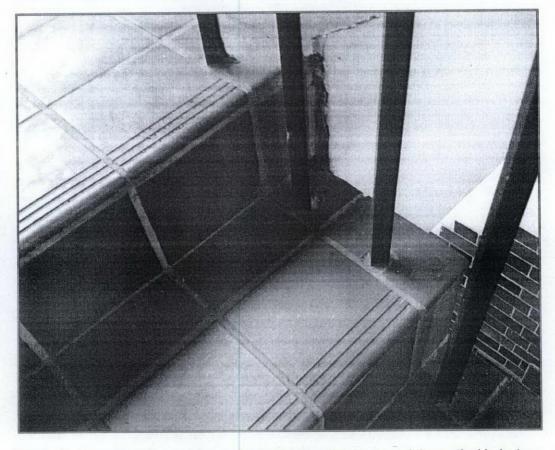
Photo 8 – Example in Laney House of how the tiles are cut around the vertical balusters.
