Marchmont Community Centre
Report on structural effects of trees on near-by structures.

Ref. No.: 070059/TB/IJH/HMH

Date: 17th April 2007

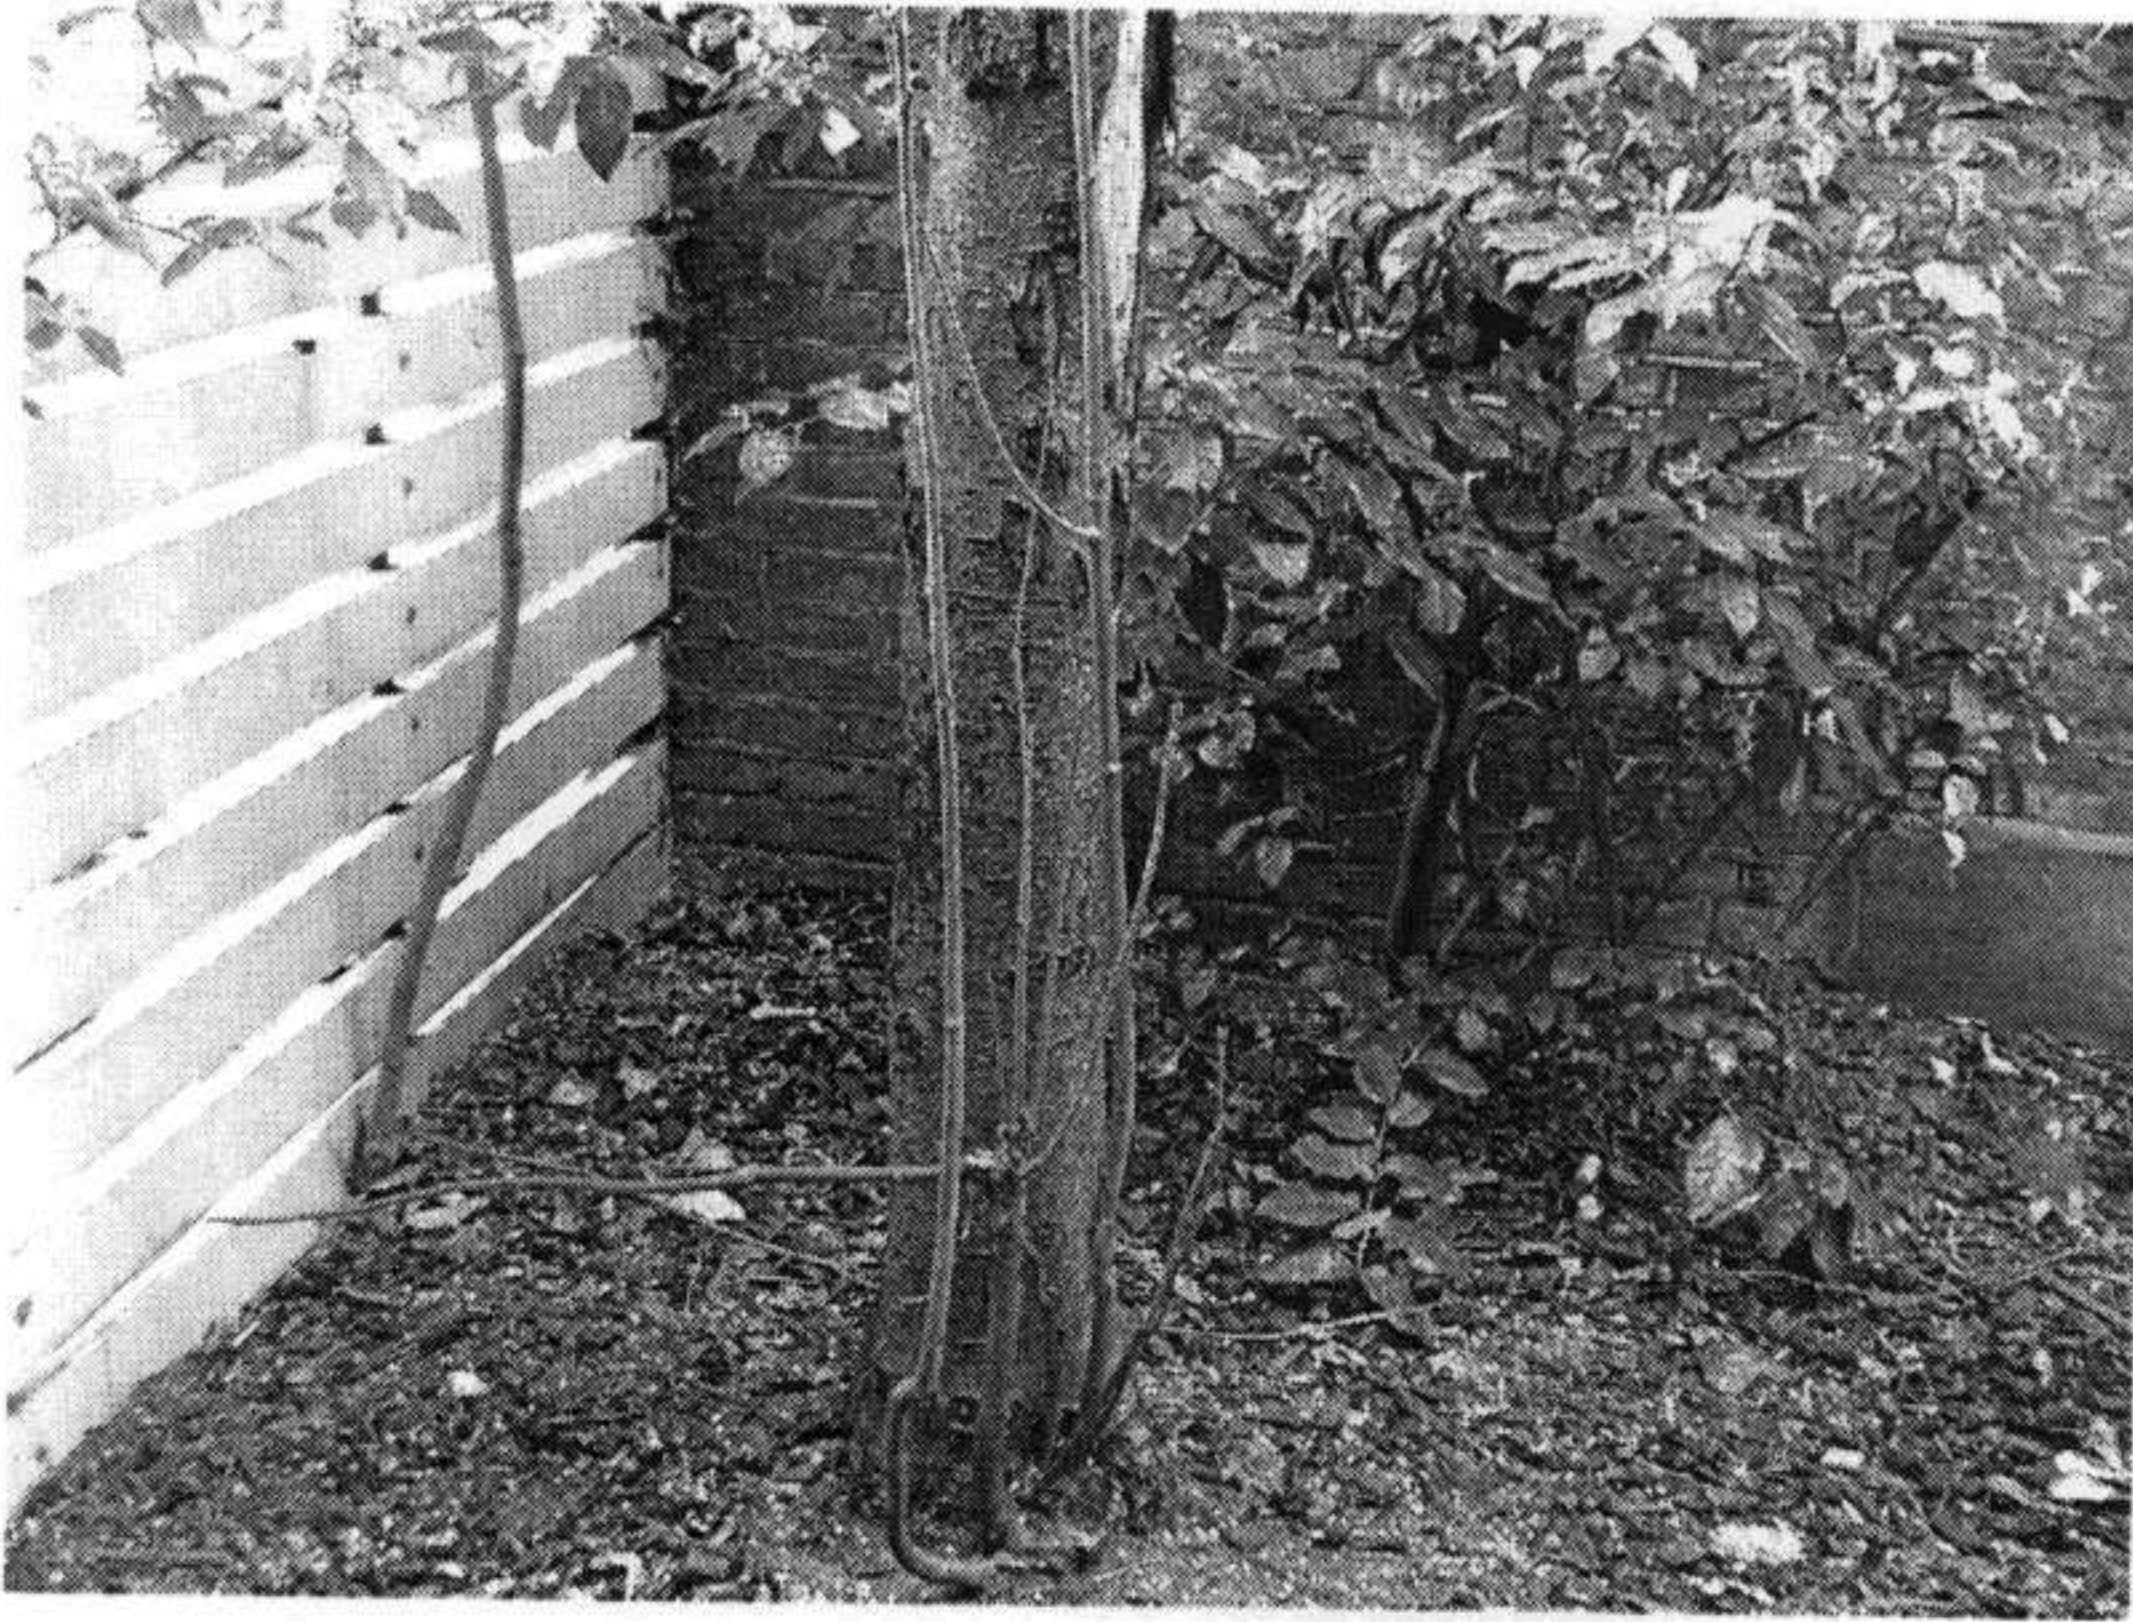
- 2.3 The shrub is thought to be a Cotoneaster, which has self seeded directly next to the wall. These shrubs are known to have considerable potential to cause damage to foundations/retaining walls.

- 3.5 The Cotoneaster should be removed as is highly likely to do damage to the wall/retaining wall in the future.
- 3.6 The seedling next to the wall should also be removed before any (further) damage is done to the wall/retaining wall.

Photo 1, Bases of tree trunks and shrub.

Photo 2: Trees/shrub in relation to retaining wall and existing rear addition (in foreground).

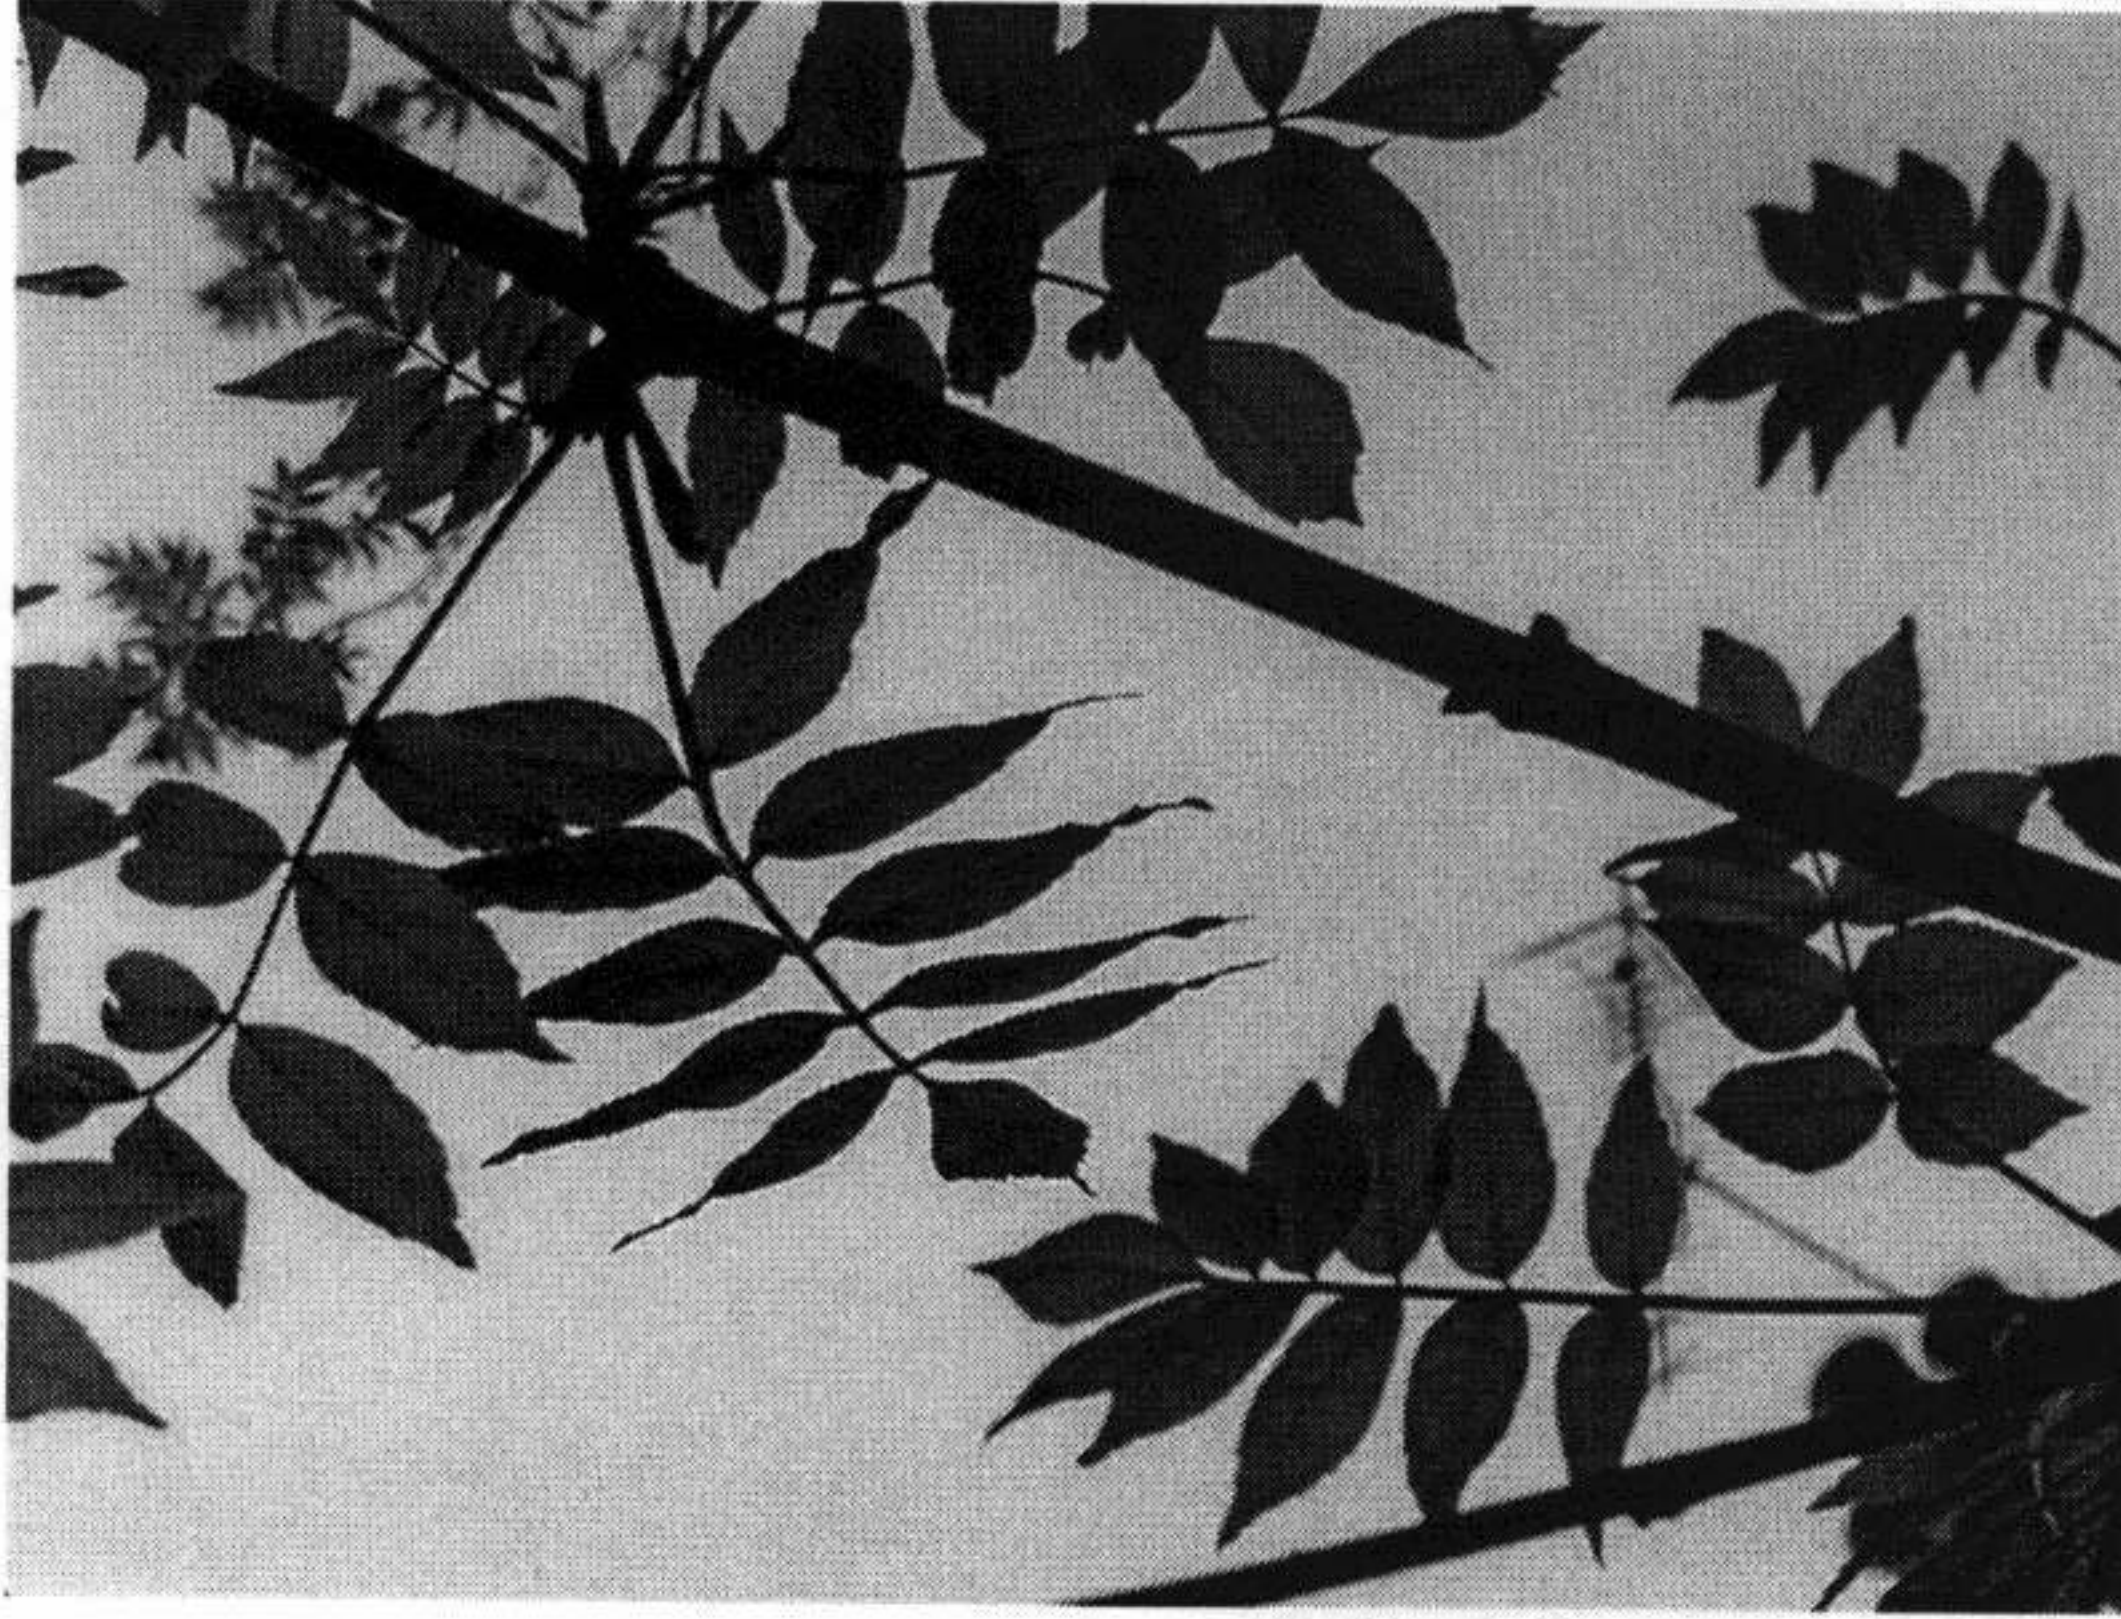
- 2.4 There is another seedling directly next to the wall, identity unknown, however this presently is young and whilst has not done any damage to the internal (courtyard) face of the wall/retaining wall, is likely to have begun some root penetration through the wall

Photo 3: Compound leaves of Rowan

Photo 4: View from Marchmount Community Centre rear courtyard: view to the retaining wall, wall over and seedling and Rowan beyond.
