SLLB Architects

200a Goldhurst Terrace London NW6

ARBORICULTURAL METHOD STATEMENT

TREE CONDITION SURVEY

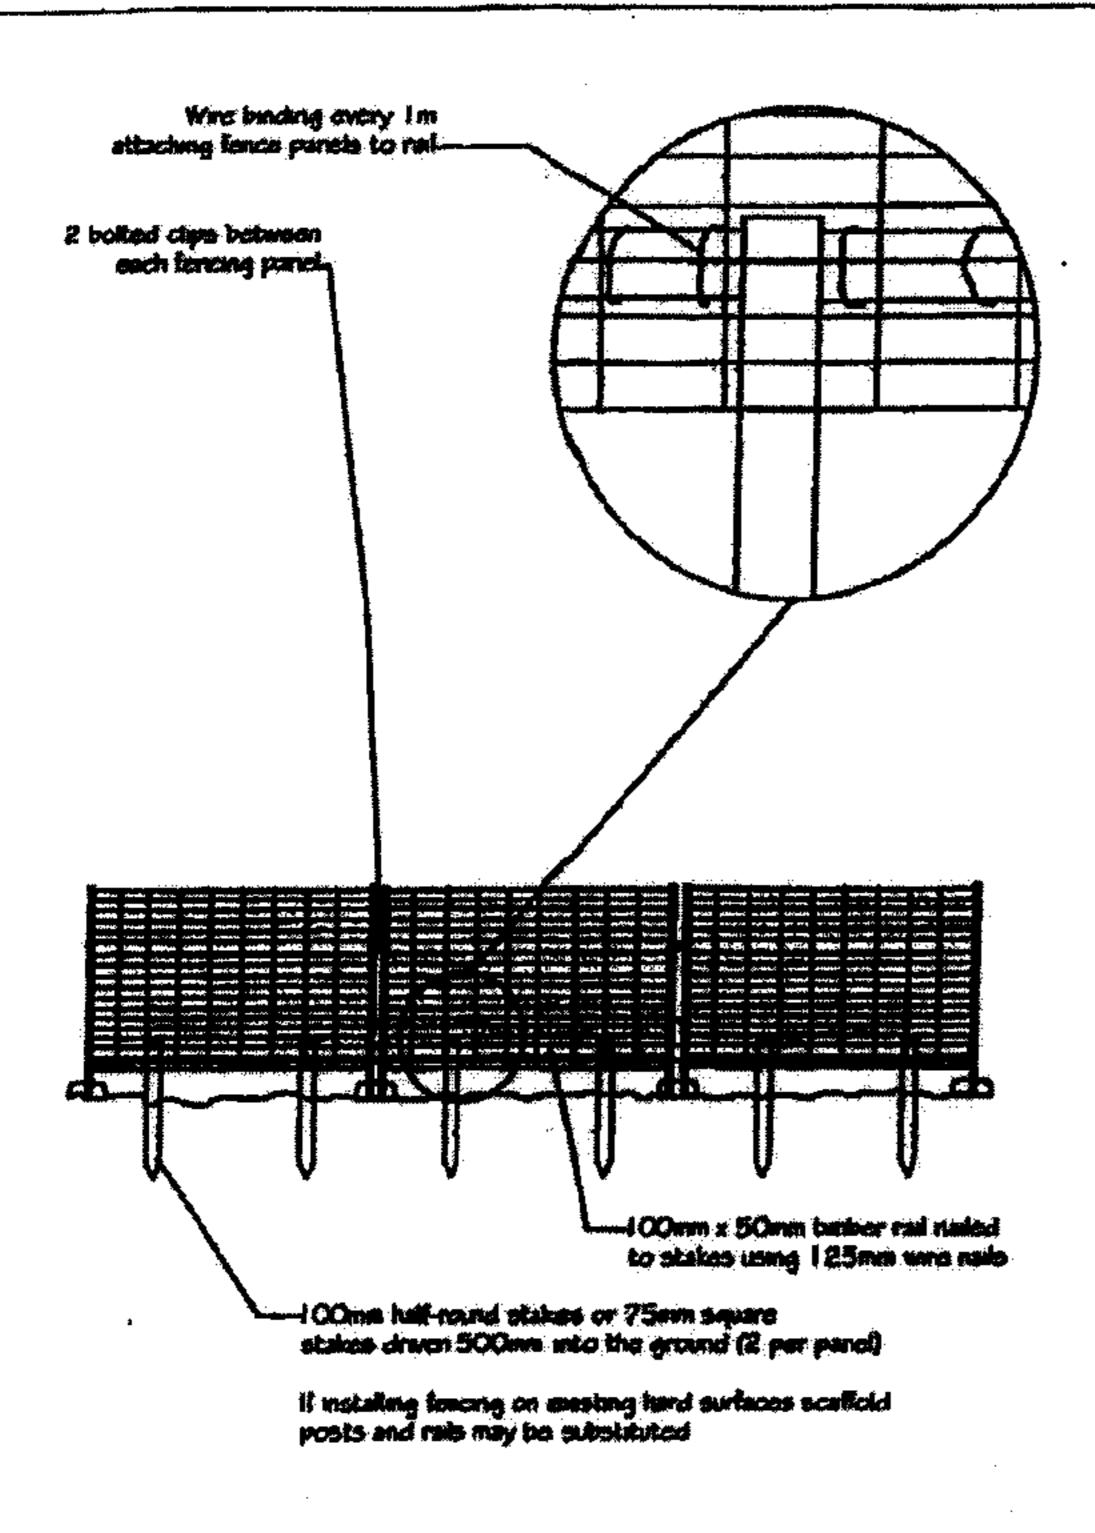
Figure 1: Protective Fencing

Protective lending will protect the TREE PROTECTION ZONE (TPZ). The installation and maintenance of protective lending is covered by planning conditions.

Protective fencing will be installed at the earliest opportunity and before demolition or construction activities begin

The construction of protective fencing will ensure that fencing is robustly fixed in place and cannot be moved without completely dismantling the fence.

Protective lending will remain in place until demolition and construction activities are complete and will only be removed to allow for landscaping within the TPZ.

No personnel, plant or equipment will enter the TPZ without the prior written consent of the Local Authority Arboncultural Officer.

In one area it will be necessary to provide a temporary smaller protected area during demolition of one building
